Mark B. Bezilla
Site Vice President724-682-5234
Fax. 724-643-8069April 4, 2003
L-03-064U. S. Nuclear Regulatory Commission
Attention: Document Control Desk
Washington, DC 20555-0001**Subject: Beaver Valley Power Station, Unit No. 1 and No. 2
BV-1 Docket No. 50-334, License No. DPR-66
BV-2 Docket No. 50-412, License No. NPF-73
Supplemental Information Supporting Proposed Alternative Repair
Methods for Reactor Vessel Head Penetrations (Relief Request No.
BV3-RV-04)**

Beaver Valley Power Station, Unit No. 1 and 2
Supplemental Information Supporting Proposed Alternative Repair Methods for Reactor
Vessel Head Penetrations (Relief Request No. BV3-RV-04)
L-03-064
Page 2

The Embedded Flaw Process for Repair of Reactor Vessel Head Penetrations and Its Application at North Anna Unit 2

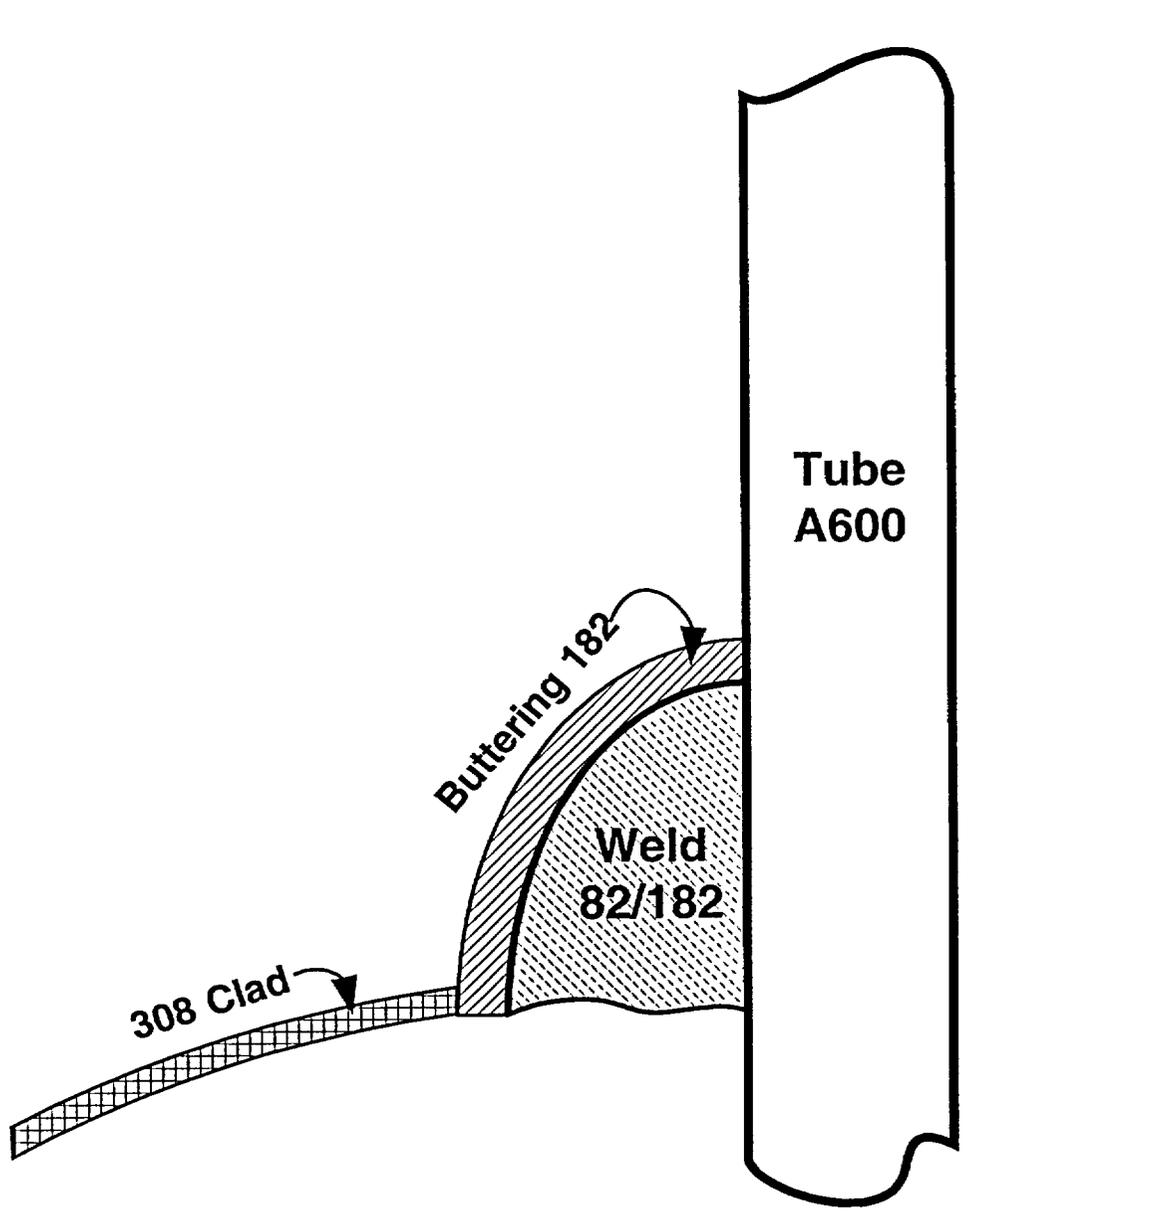
Figure 1-1 As-Built Configuration

The geometry of the J-groove cavity and buttering is shown in Figures 1-1 through 1-7. These figures are based on Rotterdam drawings 30660-1088 [6], and 30660-1097 [7]. They provide the nominal and the minimum and maximum dimensions of the J-groove and buttering, based on varying the depth of the J-groove and the thickness of the buttering. Figures are provided for penetration 51 and penetrations 62 and 63. These figures provide the linear dimensions, expressed in millimeters, for the J-grooves and buttering. The tables below summarize the information on these sketches and the dimensions have been converted to inches.

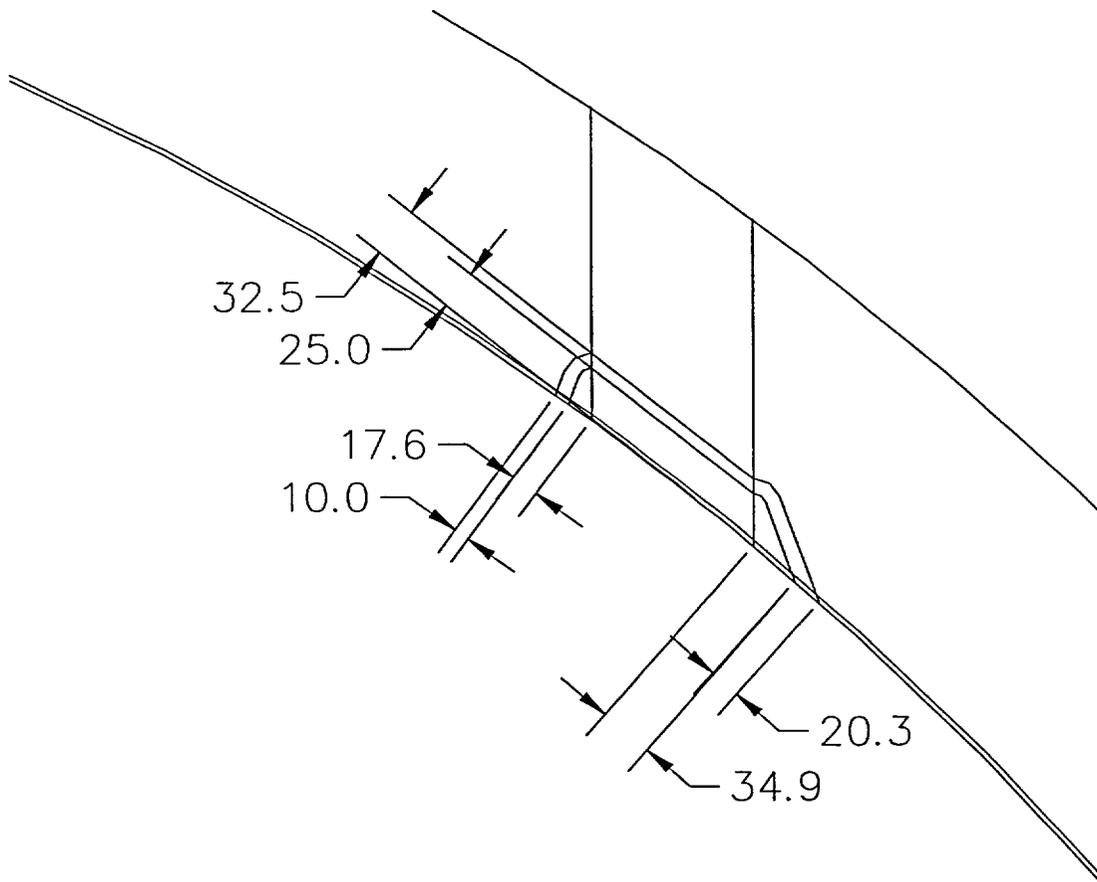
Figure 1-2 Penetration Number 51 Nominal J-Groove Dimensions in Millimeters

Figure 1-2 provides the nominal dimensions for penetration 51, showing that the buttering is much wider on the downhill side of the weld, than on the uphill side. This is because of the angular nature of the weld preparation, as well as the curvature of the head. From Figures 1-3 and 1-4 (penetration 51), we see that the width of the buttering on the downhill side can range from 12.7 to 34.8 millimeters. The results for penetrations 62 and 63 show the weld sizes are slightly larger, as seen in Figures 1-5 through 1-7.

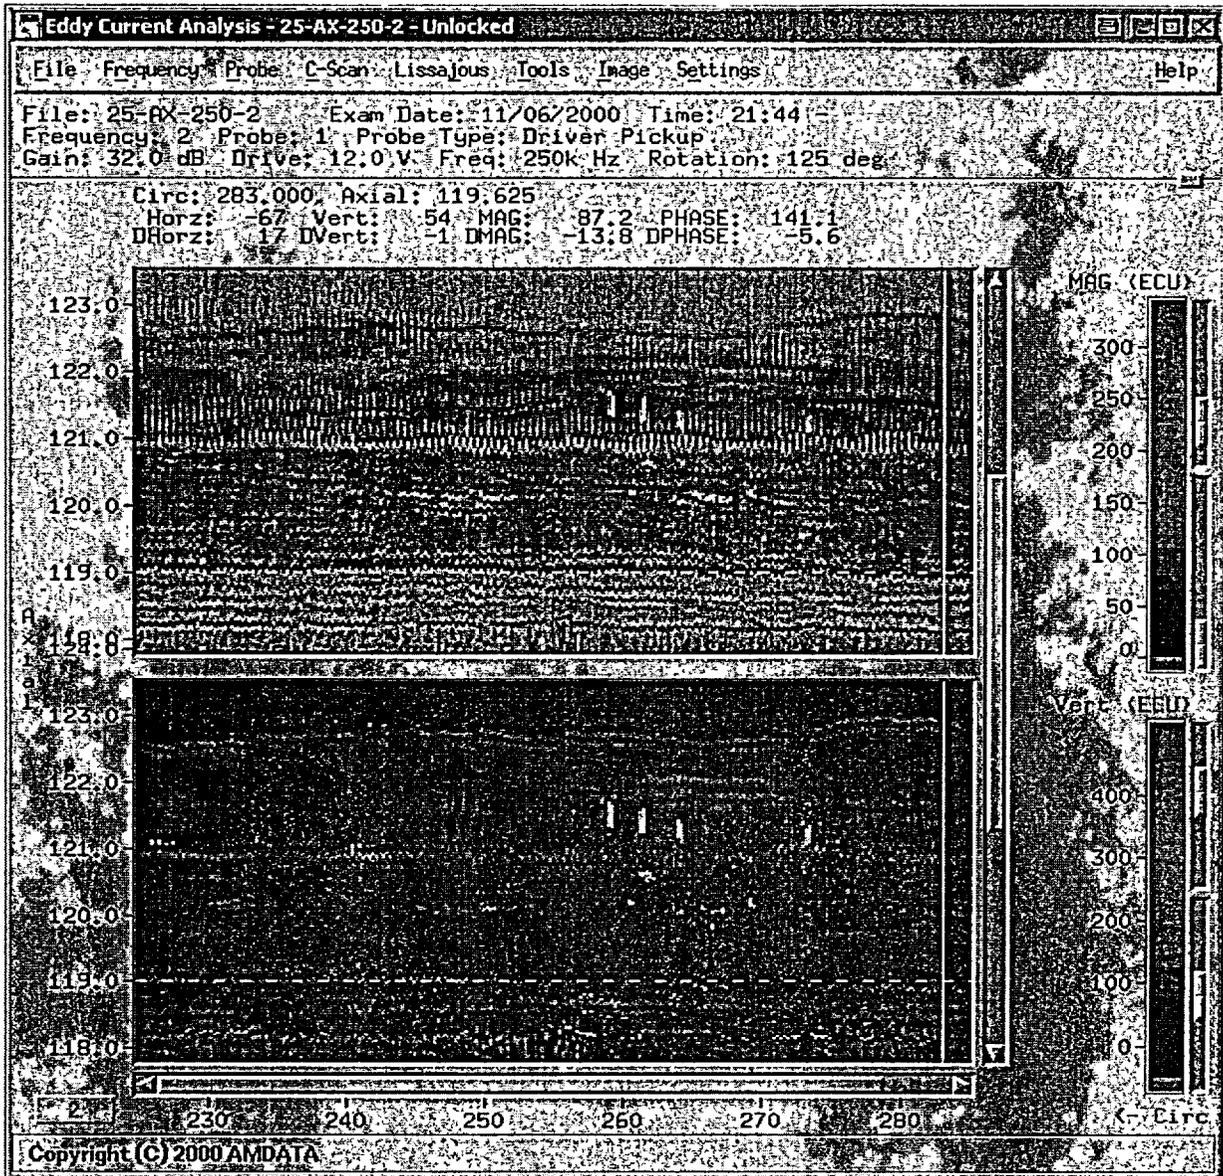
The alternative approach is to apply a nondestructive test to determine the boundary of the stainless steel clad to Alloy 182 surface. The technique of choice is an eddy current test that can distinguish the change in conductivity and permeability between stainless steel and Alloy 82/182. This method has been previously used during the inspection of an Alloy 82/182 safe end weld attached to a stainless steel clad reactor pressure vessel nozzle. Figure 5-1 shows actual field data employing this technique to identify the stainless/Alloy 82/182 boundary. In this image, a stainless steel pipe (upper green region) is attached to an Alloy 82/182 weld (middle blue region, which also has several crack indications) and then to the stainless steel clad vessel (lower green region). The demarcation between the Alloy 182/82 weld and the stainless cladding is very distinct.

Figure 5-1 ET Result from Alloy 182 Safe End Weld Attached to a Stainless Steel Pipe (top) and Stainless Steel Cladding (bottom)

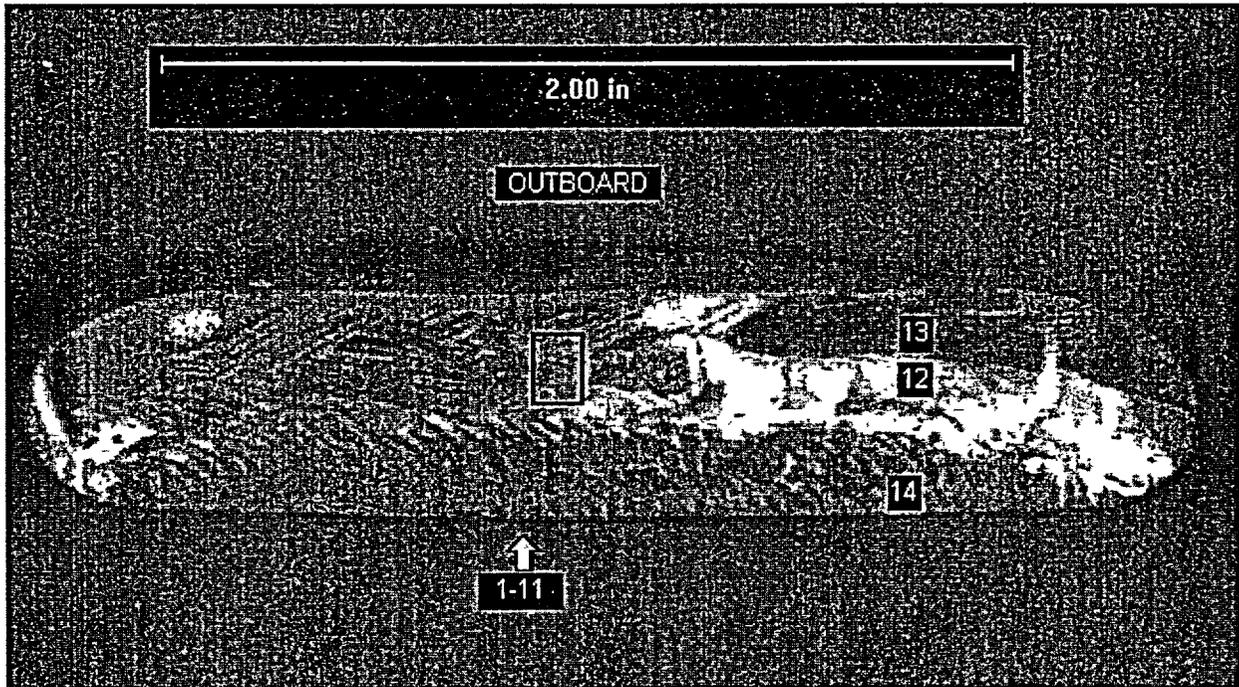
Figure B-2A As-Received Boat Sample Wetted Surface Plan View with Location of EDS Surface Analyses

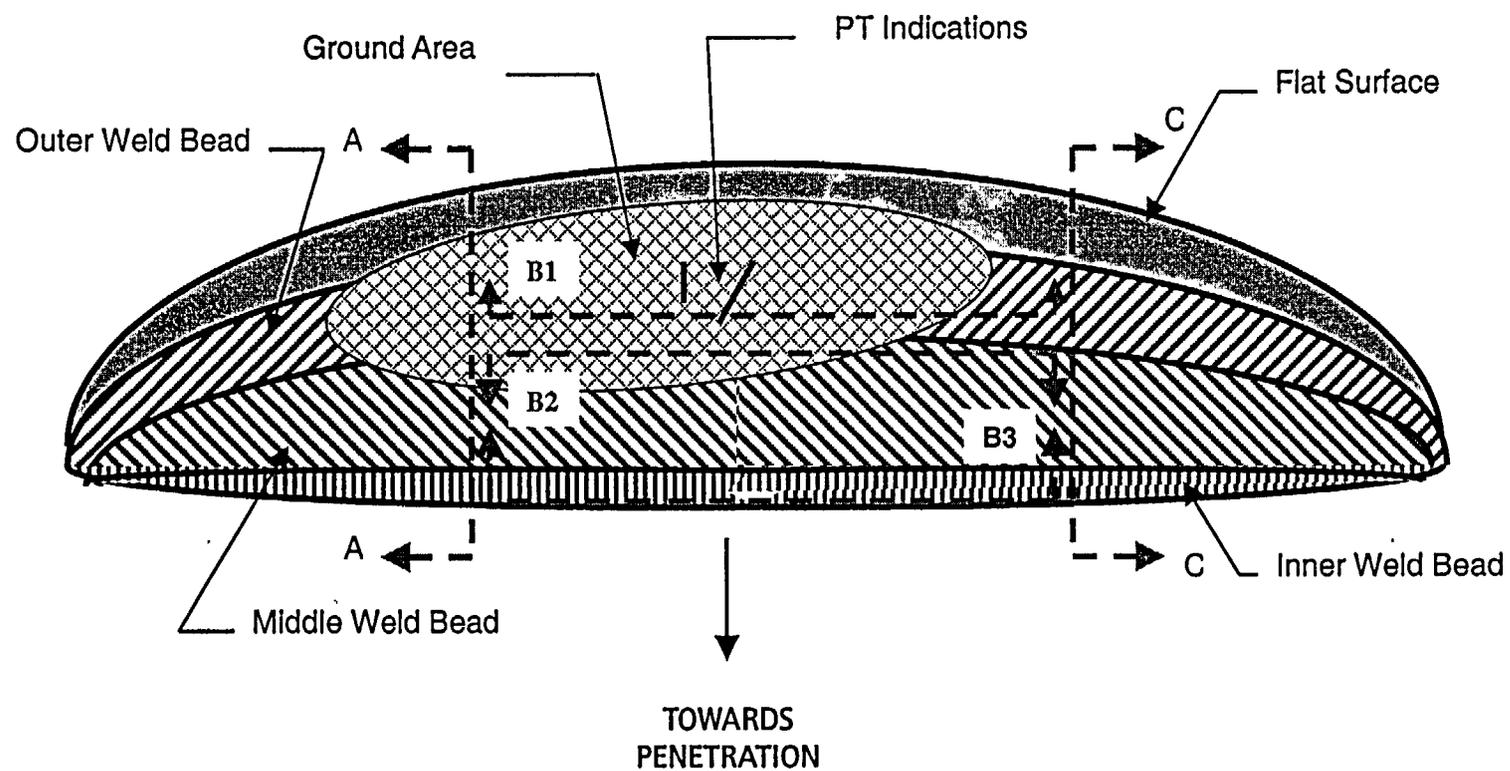
Figure B-3 Boat Sample Surface Appearance and Metallurgical Section Plan

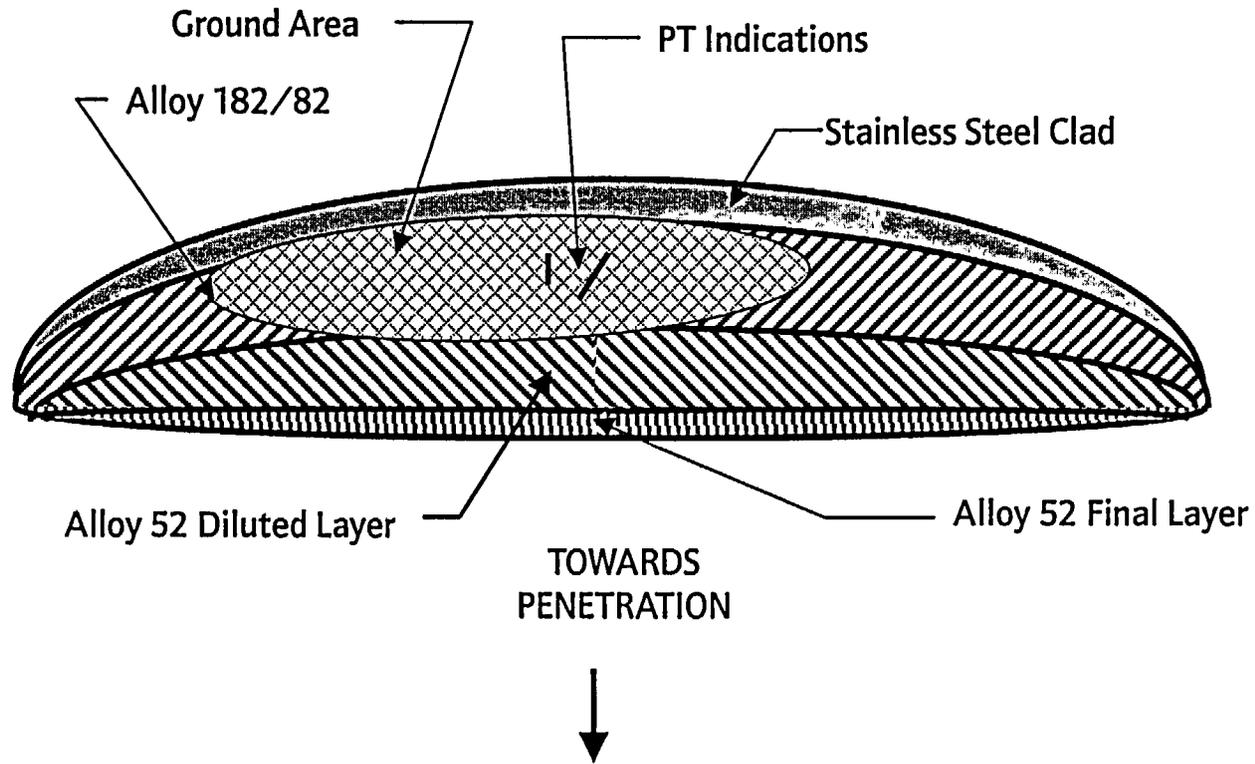
Location No.	Location Description	% Ni	% Fe	% Cr	% Al + Ti	% Nb	% Ni Dilution	% Fe Dilution	Expected % Cr	Probable Filler Metal
	308 (Nominal)	11	69	20	Not spec	Not spec				
	A-82 (Nominal)	72	2	20	< 0.75	2.5				
	A-182 (Nominal)	67	7.5	15.0	< 1.0	1.8				
	A-52(Ht.NX2424JK)	58.8	10.5	28.1	1.21	0.03				
7	Outermost Surface	9.7	64.2	18.0	0.1					308 St St
5	Near Small Crack	29.9	45.8	21.5	0.3		68	71	20.7	A-82
3	Inner Crack Tip	34.3	38.6	22.9	0.5					A-82 or 52
4	0.06" Inboard of Location 3	51.2	20.2	24.2	1.0		15	17		A-52
13	Outermost Surface	8.5	68.0	20.3	0.1					308 St St
12	Outermost Bead	51.7	23.1	21.0	0.4		32	35	20.1	A-82
14	Innermost Bead	56.7	12.9	25.4	1.6		28	24	26.6	A-52

Figure B-5 Sketch of Wetted Surface Plan View with Weld Material Determination based on EDS Analysis in Table B-1

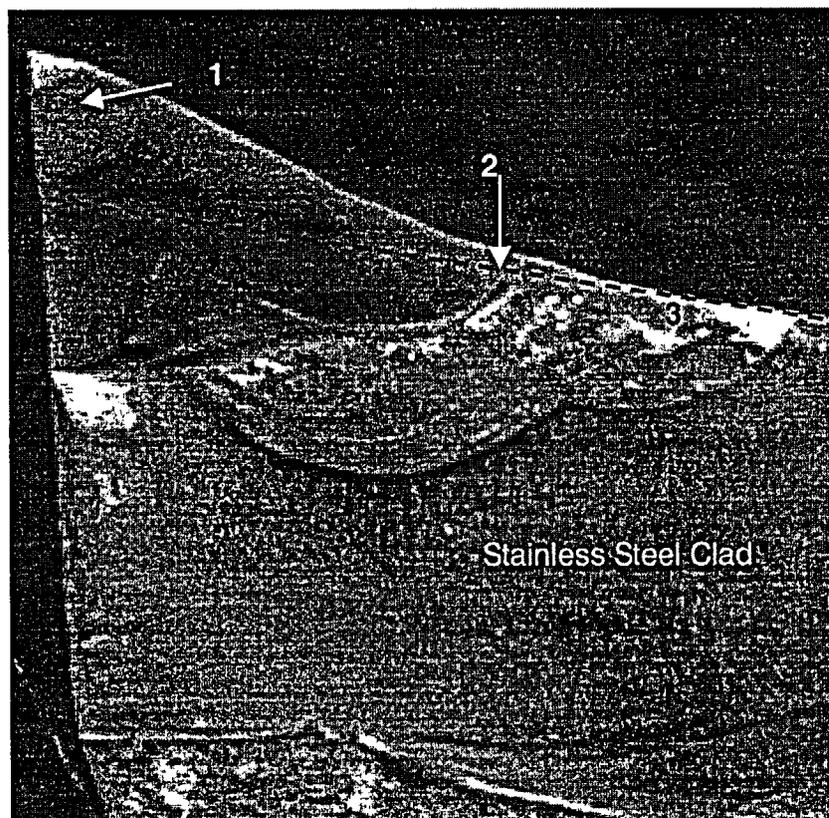
Location No.	Location	Ni	Fe	Cr	Al + Ti	Nb	% Ni Dilution	% Fe Dilution	Expected %Cr	Probable Filler Metal
1	Inboard Bead	54.8	15.7	24.9	1.2					A-52
2	Middle Bead	52.5	18.9	24.2	1.2					A-52
3	Outboard Bead	26.8	48.0	21.6	.53	0.3	65	70	20.2	A-82

Figure B-6A Metallographic Section A-A Ground Repair Weld Configuration with EDS Analyses

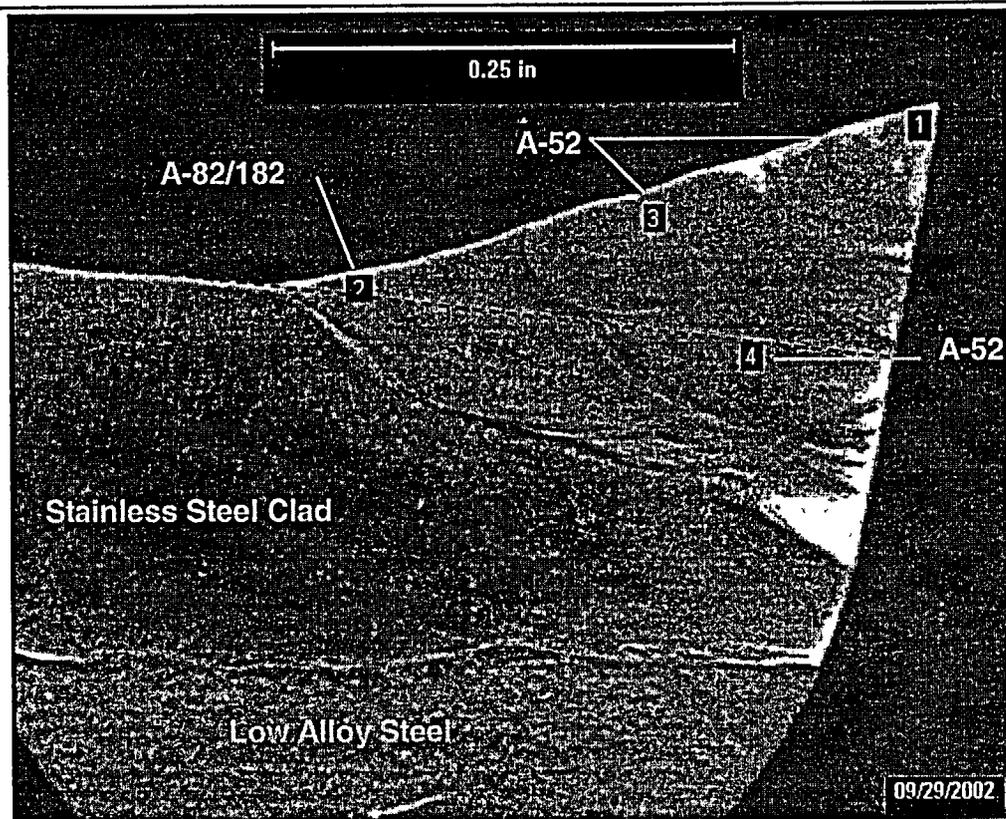
Location No.	Location	%Ni	%Fe	%Cr	% Al + Ti	%Nb	% Ni Dilution	% Fe Dilution	Expected %Cr	Probable Filler Metal
1	Inboard Bead	55.2	15.6	25.0	1.4	0.5				A-52
3	Middle Bead	56.8	13.6	24.4	1.2	0.5				A-52
4	Interior Bead	54.6	17.5	23.2	1.0	0.7				A-52
2	Outboard Bead	47.7	24.8	21.3	0.6	0.9	22	26	20.1	A-82

Figure B-6B Metallographic Section C-C Full Depth Repair Weld Configuration with EDS Analyses
