April 4, 2003 L-03-064

Subject: Beaver Valley Power Station, Unit No. 1 and No. 2 BV-1 Docket No. 50-334, License No. DPR-66 BV-2 Docket No. 50-412, License No. NPF-73 Supplemental Information Supporting Proposed Alternative Repair Methods for Reactor Vessel Head Penetrations (Relief Request No. BV3-RV-04)

WCAP-15986

The Embedded Flaw Process for Repair of Reactor Vessel Head Penetrations and Its Application at North Anna Unit 2

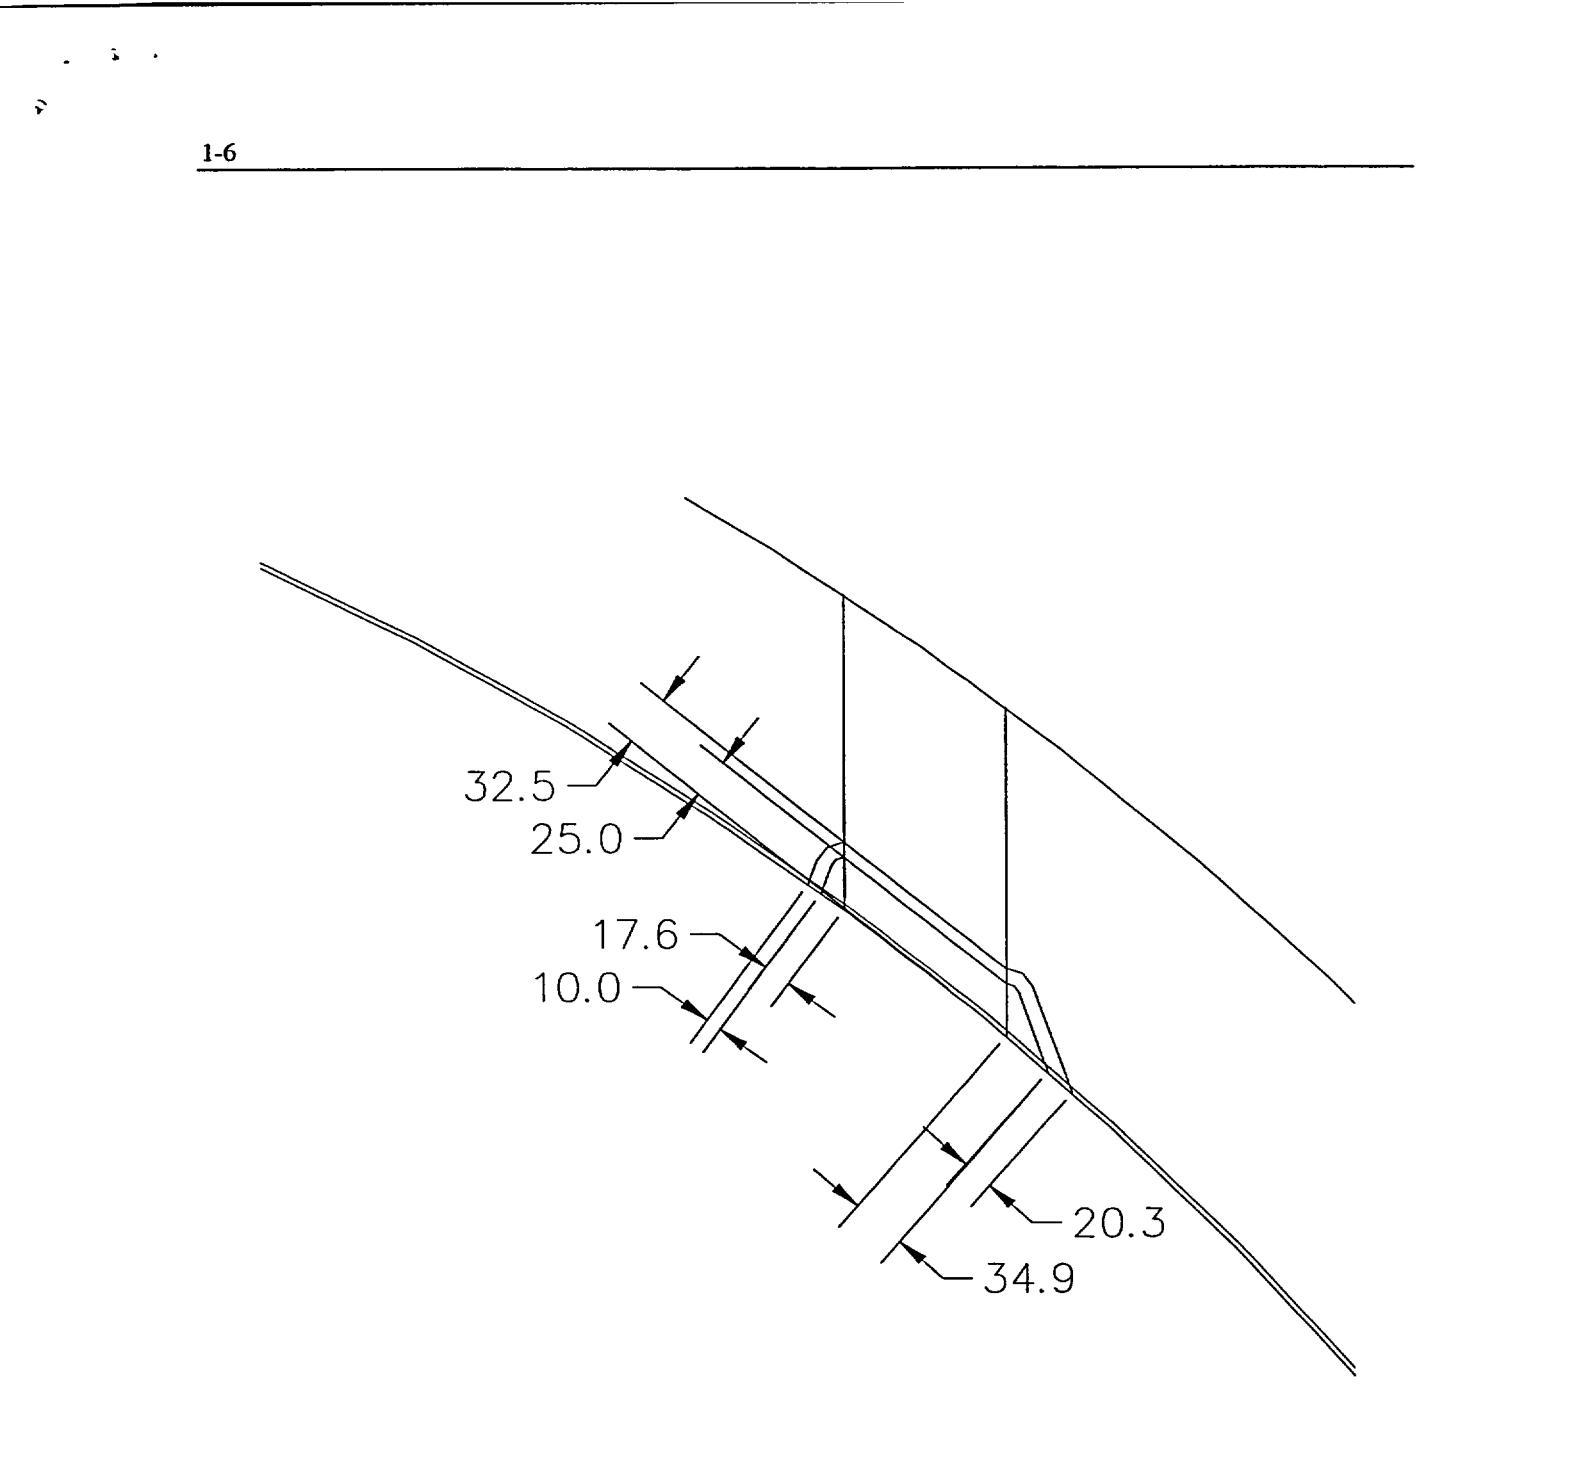
Figure 1-2 Penetration Number 51 Nominal J-Groove Dimensions in Millimeters

Figure 1-2 provides the nominal dimensions for penetration 51, showing that the buttering is much wider on the downhill side of the weld, than on the uphill side. This is because of the angular nature of the weld preparation, as well as the curvature of the head. From Figures 1-3 and 1-4 (penetration 51), we see that the width of the buttering on the downhill side can range from 12.7 to 34.8 millimeters. The results for penetrations 62 and 63 show the weld sizes are slightly larger, as seen in Figures 1-5 through 1-7.

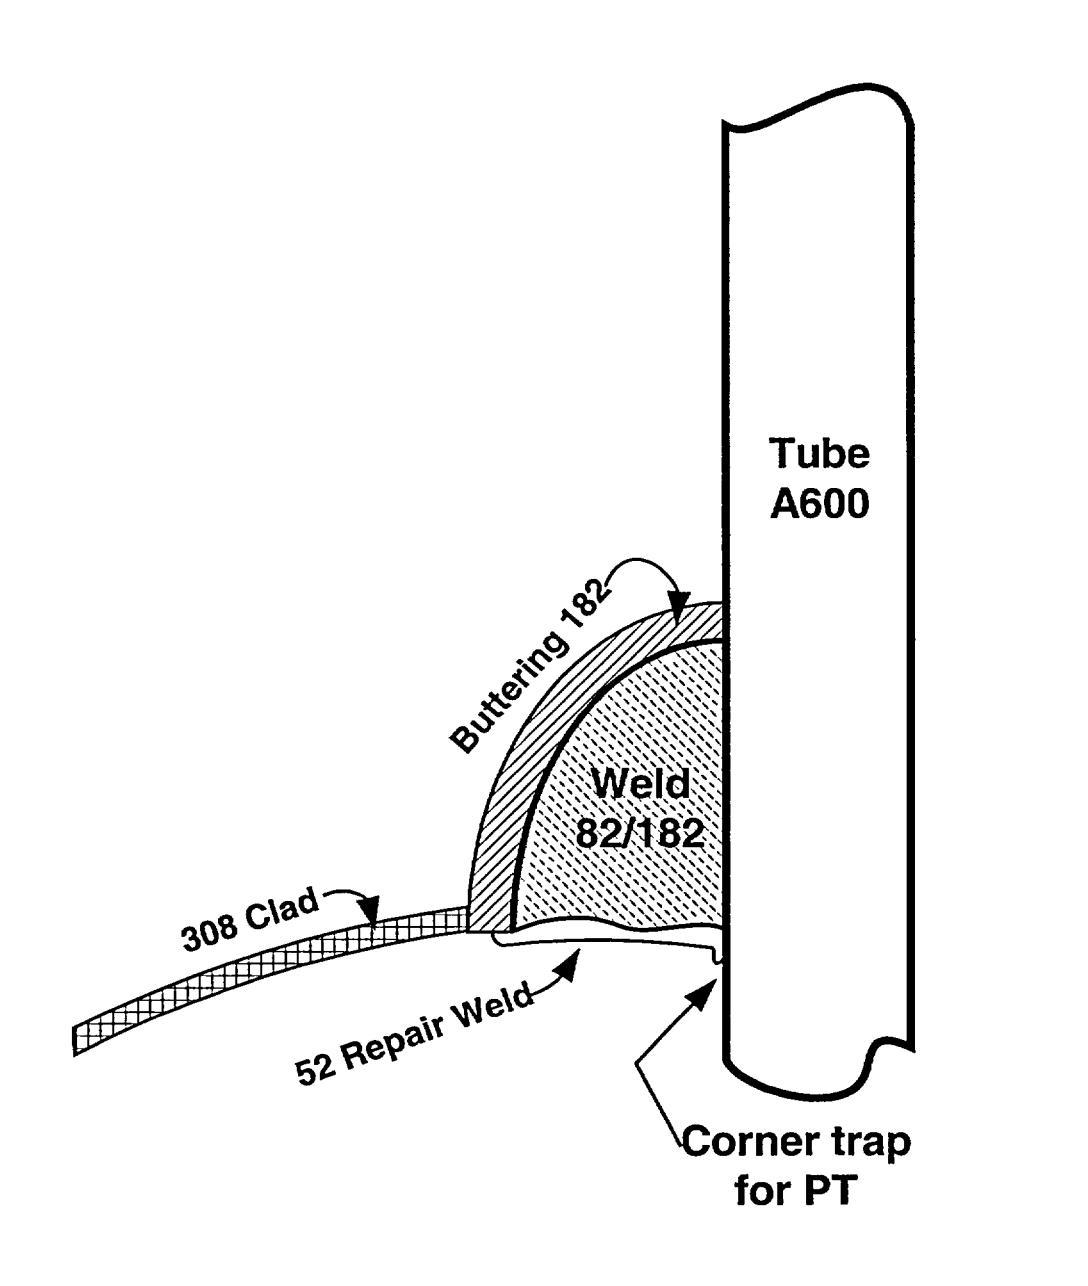
Eight indications were found on the outer periphery of the repair weld, five in penetration 51, one in penetration 62, and two in penetration 63. The results of the initial liquid penetrant exams of penetration 51 are shown in Figures 2-2 and 2-3. Because of their location, additional work has been done to determine their cause, as will be discussed in Section 3.

Note: Indications 51-1, 51-6, and 51-7 were the only indications found in the original PT of 2002. All other indications were uncovered by subsequent grinding.
