# Report to Congress on Abnormal Occurrences

## Fiscal Year 2002

**U.S. Nuclear Regulatory Commission  
Office of Nuclear Regulatory Research  
Washington, DC 20555-0001**

NUREG-0090  
Vol. 25

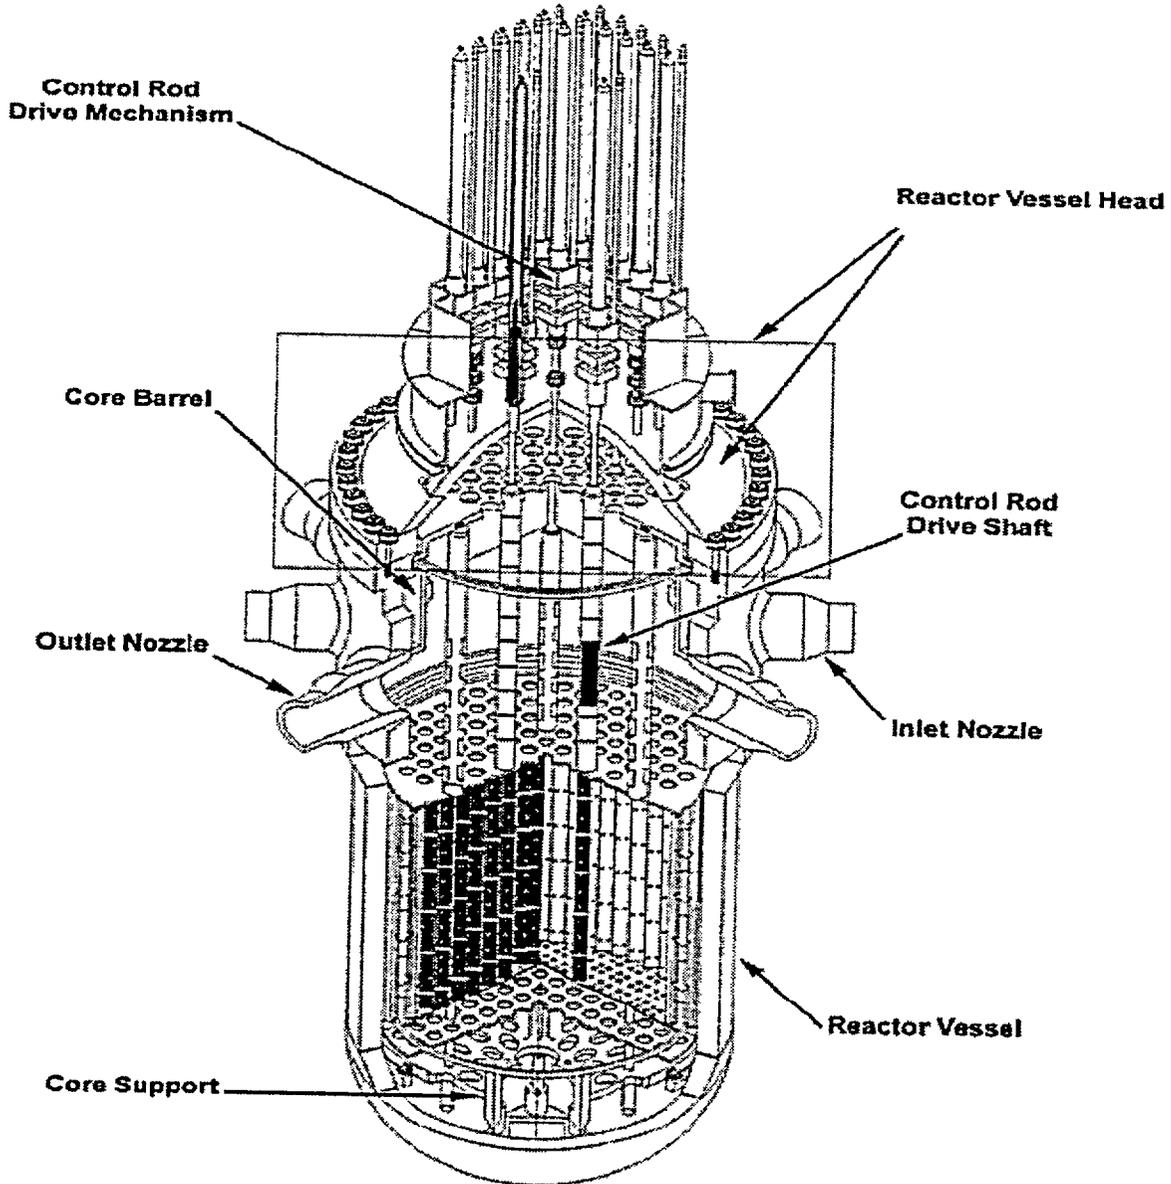
Figure 1. Typical Pressurized Water Reactor (PWR)

Nature and Probable Consequences — On February 16, 2002, the Davis-Besse facility began its 13th refueling outage, which included inspections of the control rod drive mechanism (CRDM) nozzles in accordance with NRC Bulletin 2001-01, "Circumferential Cracking of Reactor Pressure Vessel Head Penetration Nozzles," issued on August 3, 2001. These nozzles penetrate through the reactor pressure vessel (RPV) head and are attached by welds. Nozzle cracking was first discovered in the industry in the late 1980s. The concern with cracking is the potential loss of control rod drive function (rod ejection) and the resultant loss of coolant accident (LOCA) should the cracks reach a critical size and orientation. Also of concern is the potential for the reactor coolant to leak through small cracks in CRDM nozzles and cause boric acid corrosion of the RPV head. The RPV head is an integral part of the reactor coolant pressure boundary (Figure 1) and loss of its integrity can likewise result in a LOCA.
