Davis-Besse Nuclear Power Station
5501 North State Route 2
Oak Harbor, Ohio 43449-9760

Subject: Confirmatory Action Letter Response - Root Cause Analysis Report

Root Cause Analysis Report

Significant Degradation of the Reactor Pressure
Vessel Head

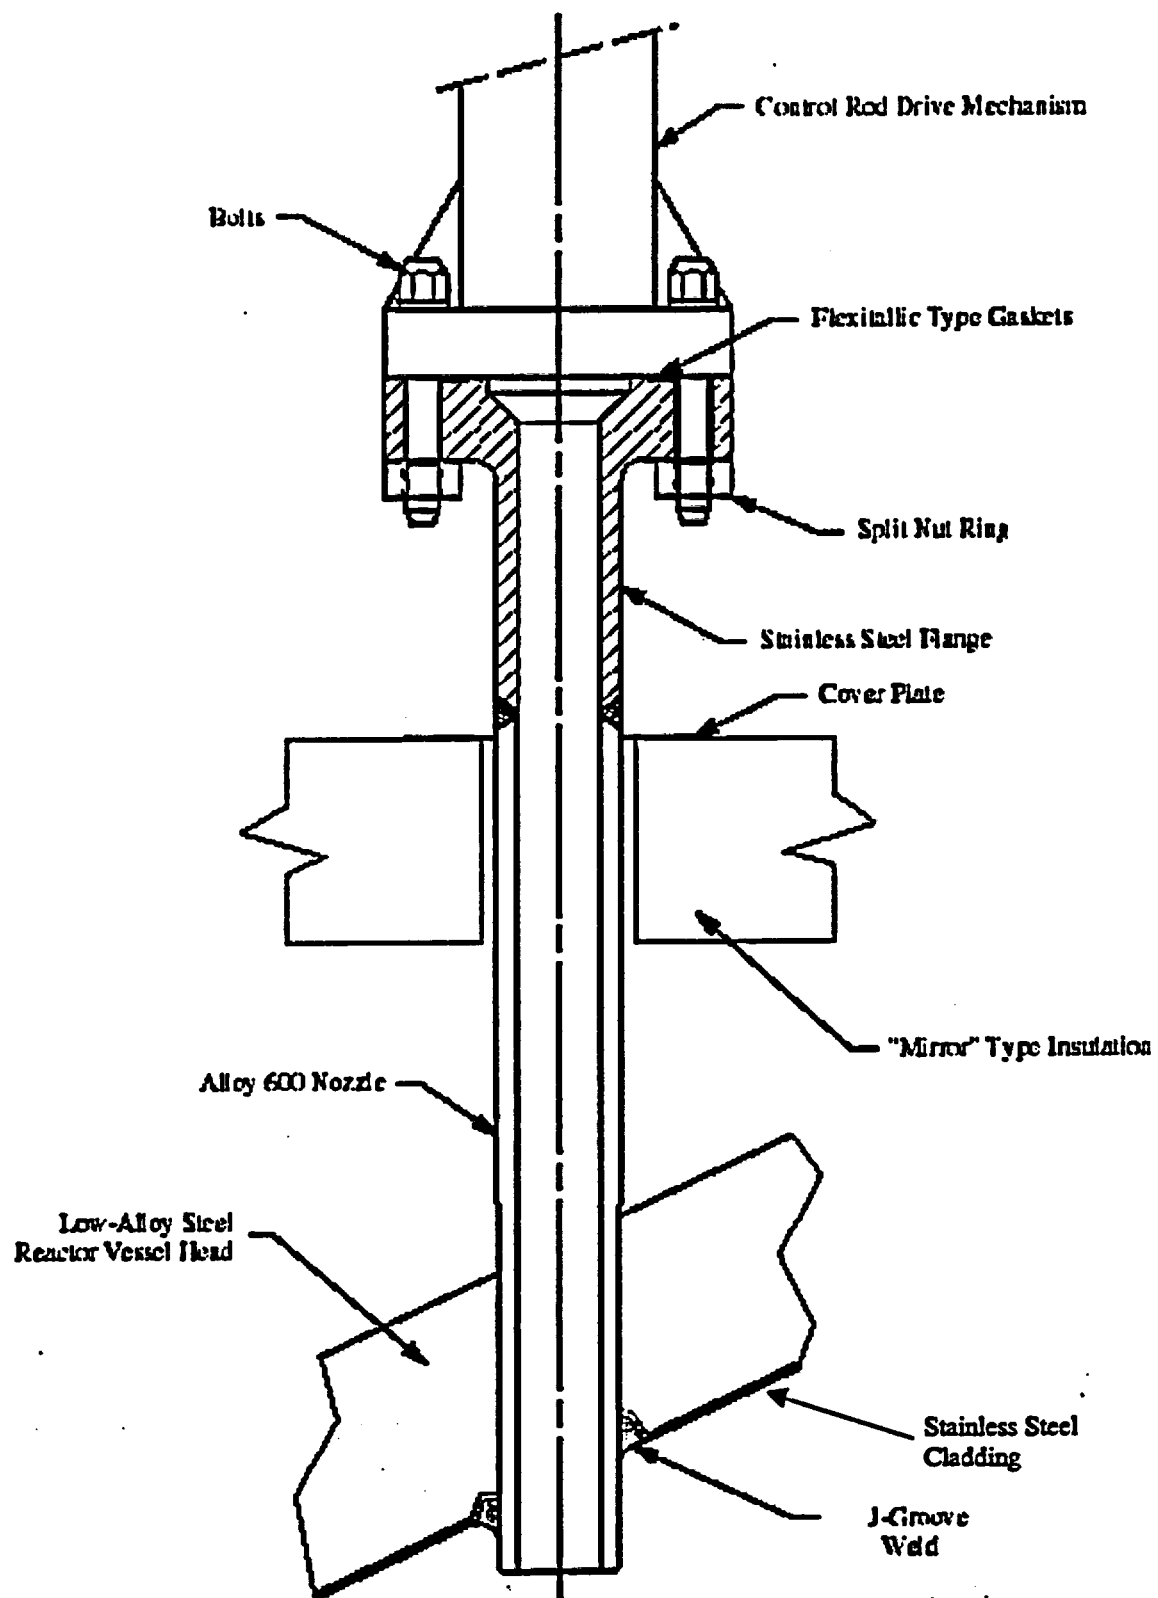
Figure 3. Davis-Besse CRDM Nozzle General Arrangement

Figure 3 shows a typical CRDM flanged joint in a B&W-design plant. The joint consists of an Alloy 600 nozzle welded to the underside of the RPV head by a J-groove weld, a stainless steel flange welded to the Alloy 600 nozzle, a flange on the CRDM, two spiral wound gaskets, two 180° split nut ring segments below the flange and eight bolts.

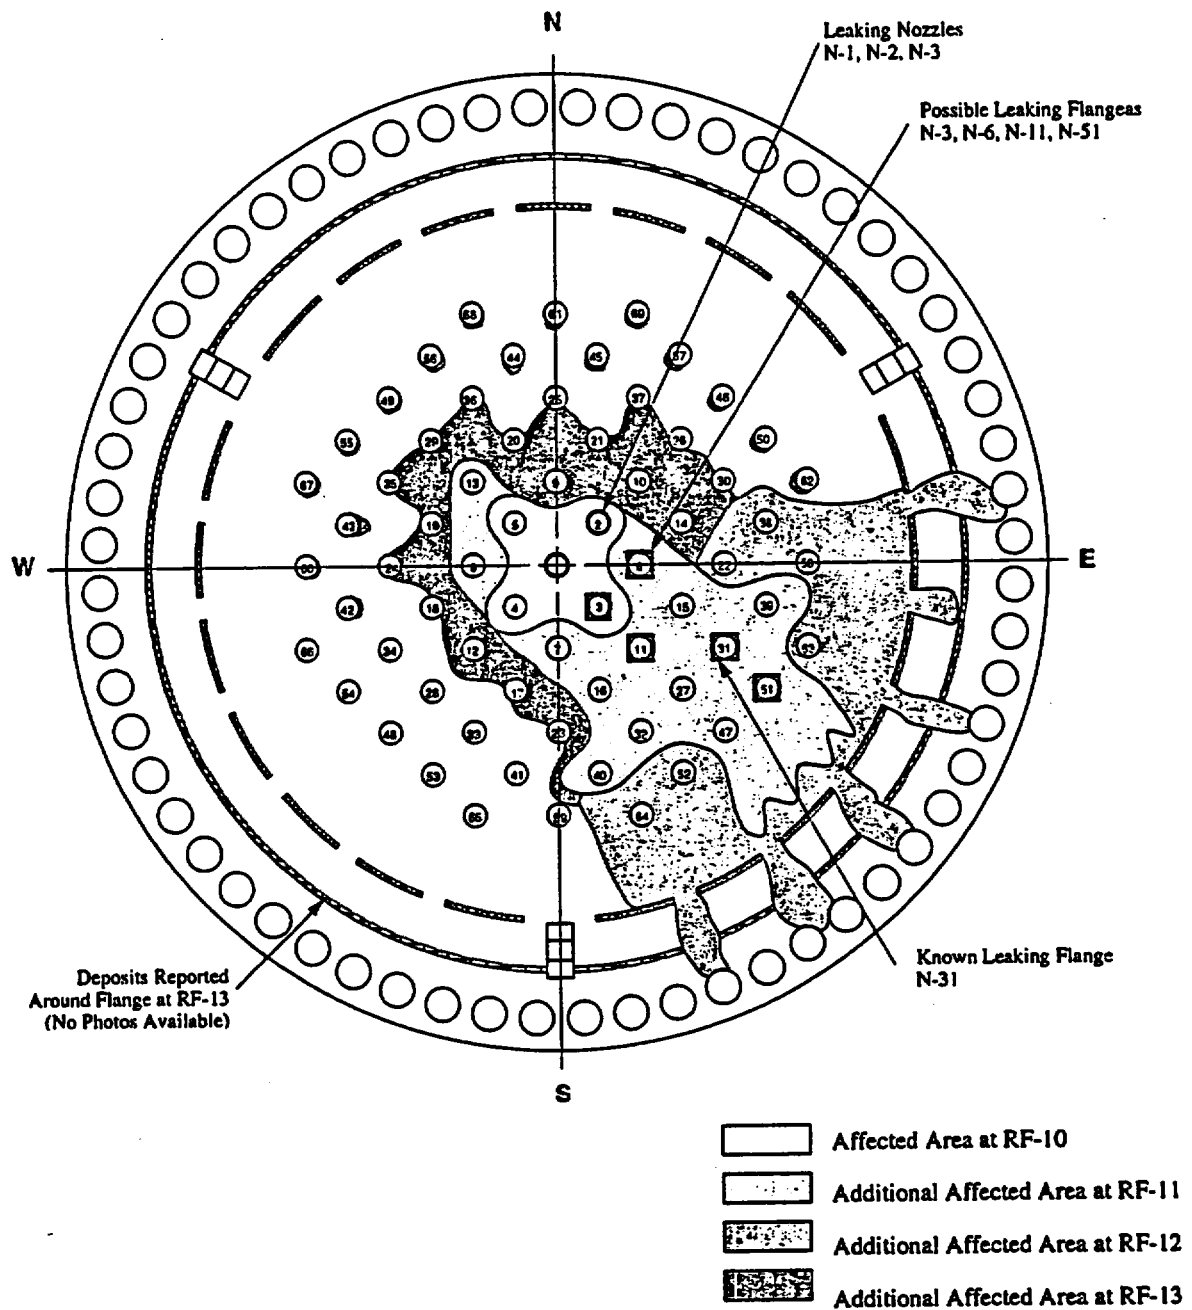
Figure 20. As Found Locations of Boric Acid Deposits on Davis-Besse Vessel Head (10RFO to 13RFO)

Figure 20 provides an overview of the boric acid deposits on the RPV head from 10RFO to 13RFO.

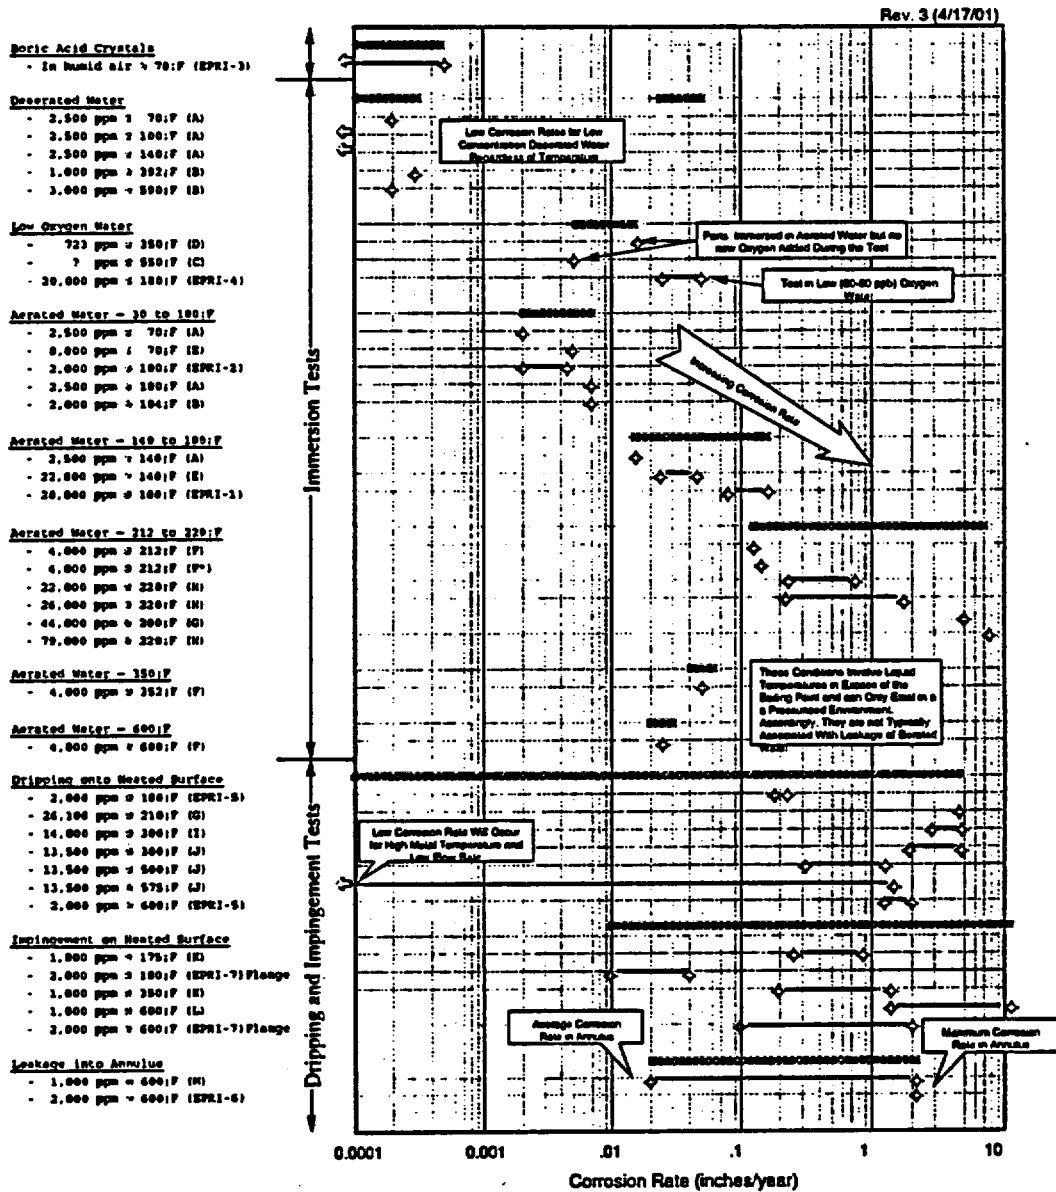
Figure 25. Corrosion Rate for EPRI Experiments

Figure 25 from the Boric Acid Corrosion Guidebook, Revision 1 (reference 5.3) summarizes the available test data regarding boric acid corrosion. These data show that most of the data points for borated water dripping onto hot metal surfaces, impinging onto hot metal surfaces, or leaking into a heated annulus, are in the range of 1.0 to 5.0 inches/year. This is consistent with the observed conditions.

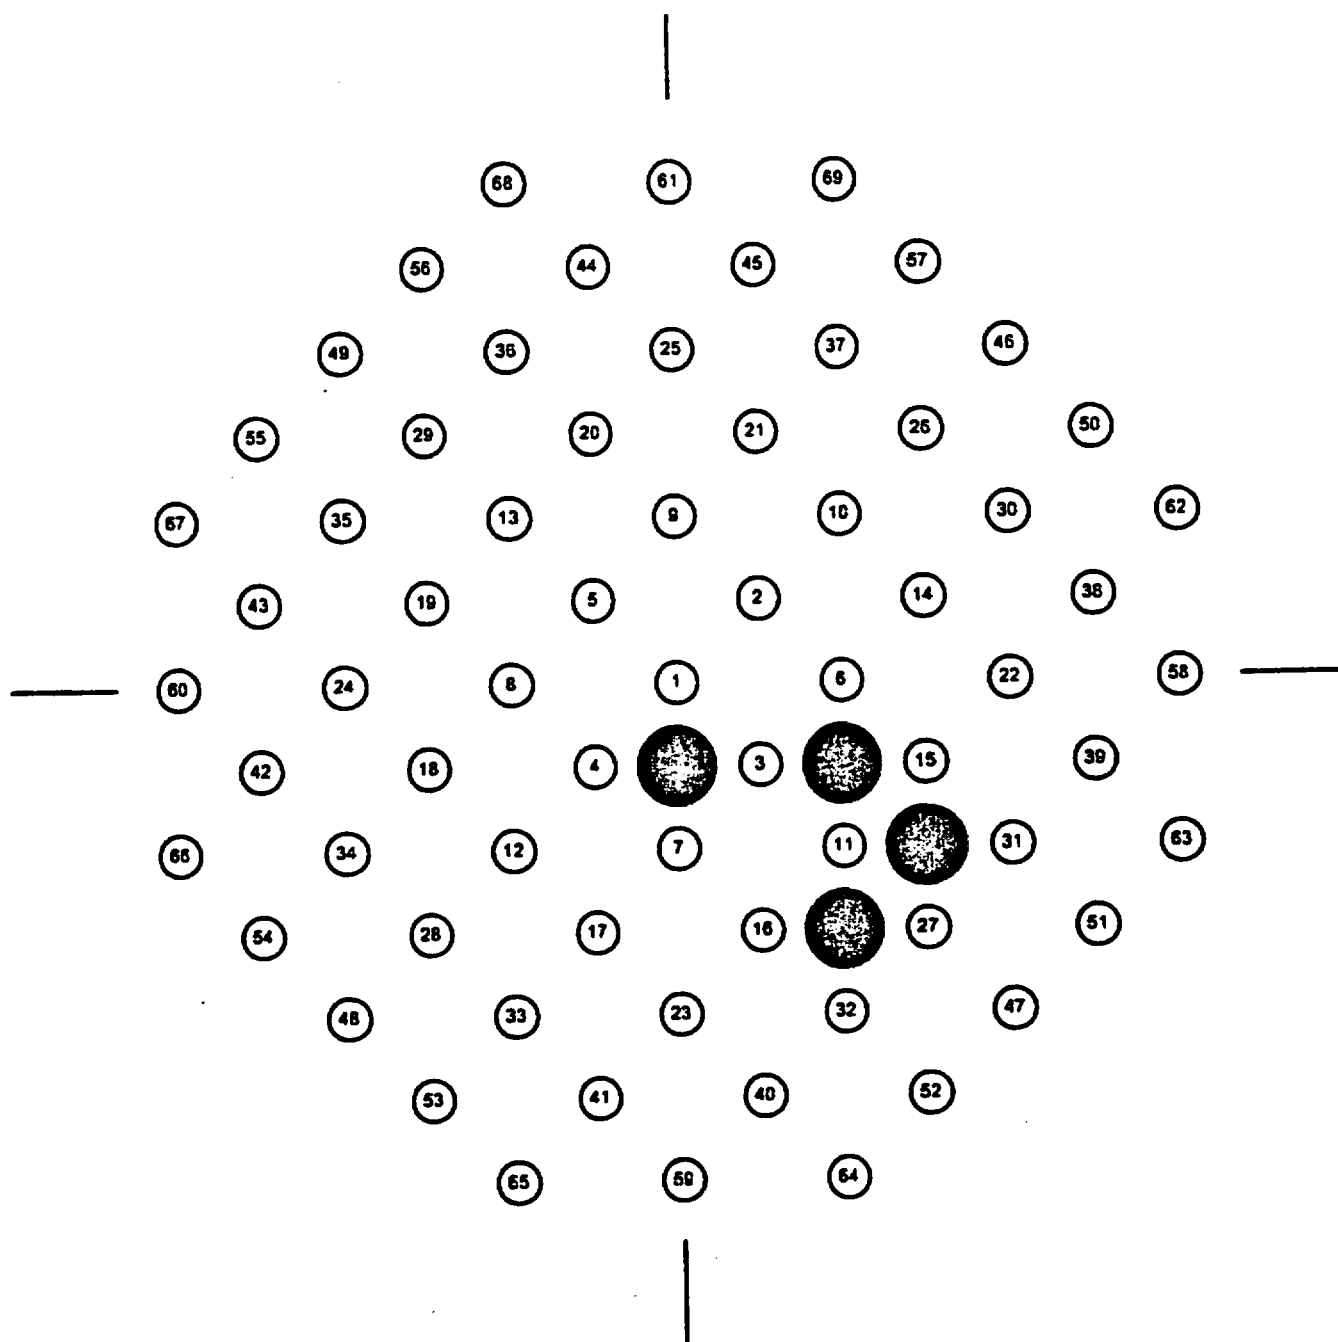
Figure 39. 2000 Interferences with CRDM Flange Inspection

camera to see the upper flange interface. The interference locations, as shown in Figure 39, were identified in the center of the following nozzle blocks:

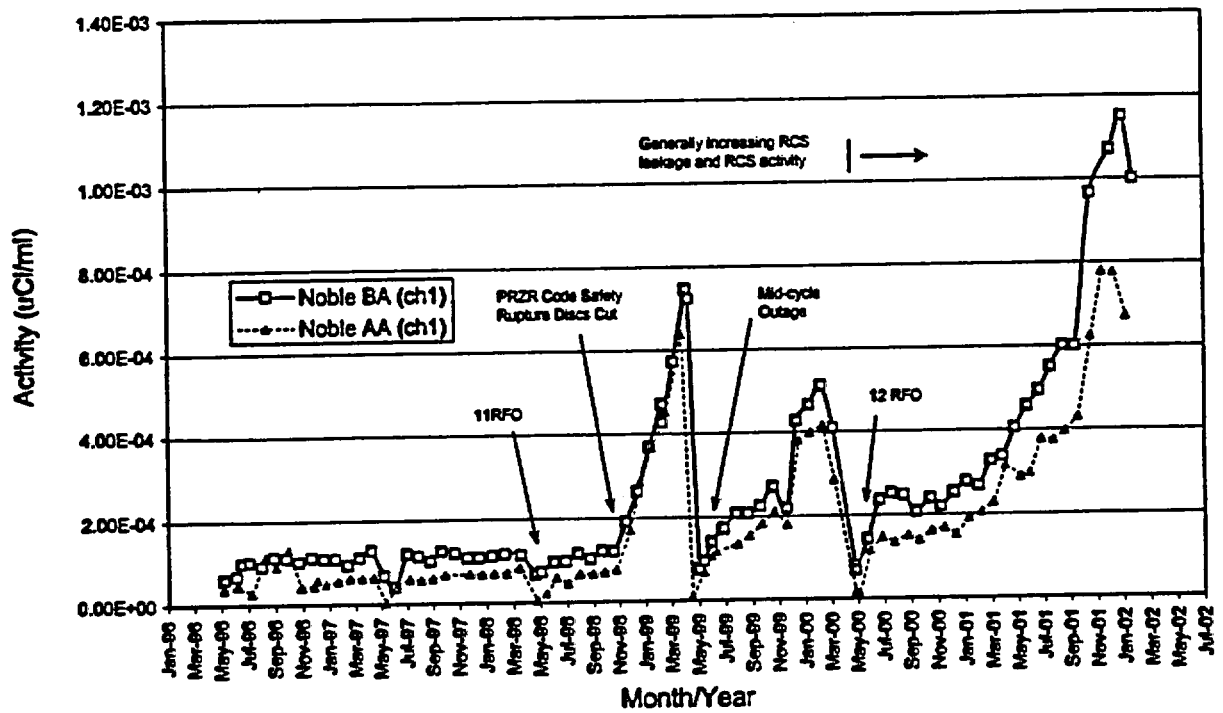
Figure 42. CTMT Radiation Monitors RE4597AA & BA
(Both Noble Gas Channels)

Output data from the detectors was manually recorded on a monthly basis from late 1992 through the present. However, due to high cycle 13 coolant activity and known increases in RCS leakage, the detectors frequently saturated during the fall of 2001. This resulted in a loss of alarm function for the remaining channels. Therefore, the carbon filters were removed from the detectors in November 2001, effectively removing the Iodine Channels from service. Data prior to this time is presented on Figure 41. Although the output indicates a clearly increasing trend, the output readings from this monitor suffer from a significant amount of scatter. The cause of the scatter is not definitively known, however, it might be related to readings being taken near the

After passing through the particulate and Iodine monitors, the gas sample is finally drawn through the noble gas monitor. The monitor housing is a 4 inch 4 pi lead container. The detector is a beta detector with an internal light emitting diode (LED) check source. The output of the detector is fed to a microprocessor where the counts per minute are converted to $\mu\text{Ci/cc}$. Some of the predominant isotopes that remain to be counted by this detector are Xenon 133 and 135, with half lives of 9.2 hours to 5.2 days. For a constant RCS leakage rate and coolant activity, these isotopes will also reach a stable equilibrium value in containment and would thus theoretically provide a direct and valid indication of a slowly evolving RCS leakage trend. Trend data from these monitors is presented in Figure 42.
