**From:** Elaine Raphael  
**To:** Joelle Starefos; Robert Haag; Russ Bywater  
**Date:** 8/29/02 1:37PM  
**Subject:** draft report

### 3. REVIEW

### 3.1 The NRC Failed to Adequately Assess Operating Experience Relevant to Alloy 600 Nozzle Cracking and Boric Acid Corrosion of Carbon Steel Components

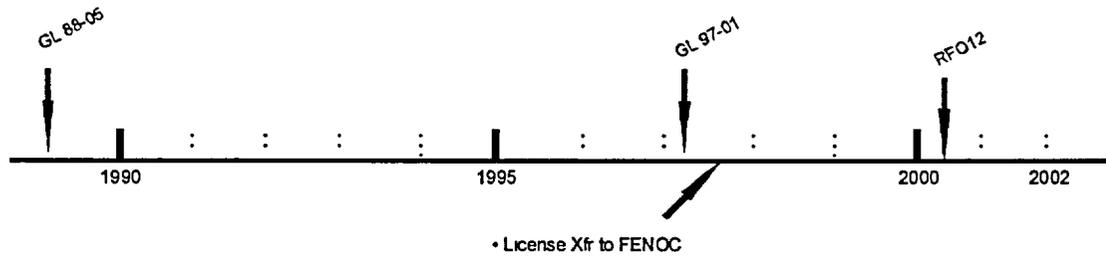
Figure 3.4-1  
NRC and Industry Failed to Establish Adequate Requirements and Guidance

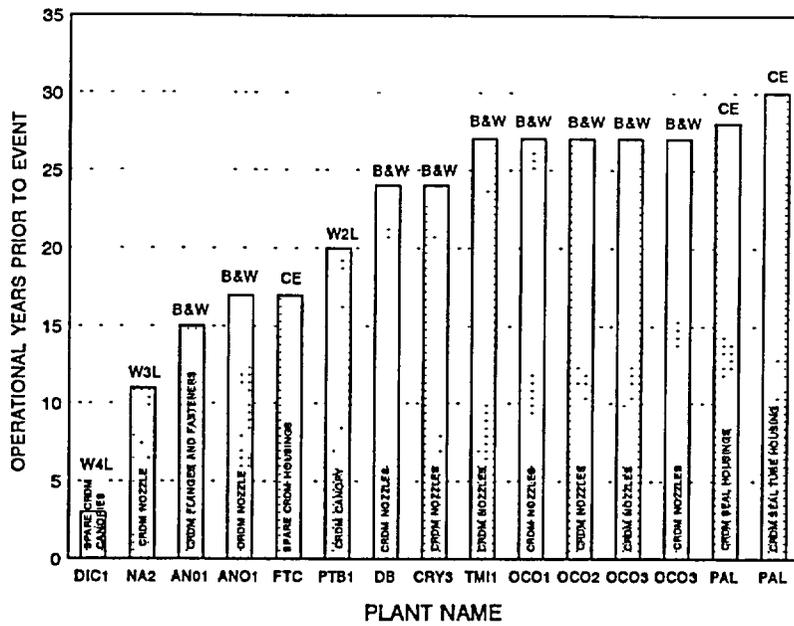
As shown by Figure 4, "Control Rod Drive Mechanism Leakage," B&W designed plants dominate control rod drive mechanism (CRDM) leakage. There were 15 documents relating to CRDM leakage of which 9 occurred at B&W plants. When considering that B&W plants make up less than 10 percent of the plants within the sample of 73 PWRs, the B&W plants are greatly over-represented. Figure 4 shows the component that had leaked, the specific facility experiencing the leakage, the design type of the plant, and the number of years of operation prior to the event being discovered. The types of boric acid leakage events include CRDM nozzles (dominant failure), spare CRDM canopies, CRDM seal housings, and a CRDM tube housing.

Combustion Engineering is appropriately represented given that CE plants represent approximately 20 percent of the PWR sample of 73, and approximately 20 percent of the CRDM event reports (3 of 15 reports).

Figure 4. Control Rod Drive Mechanism Leakage  
 2.6 Extensive Control Rod Drive Mechanism Nozzle Cracking and Leakage at B&W plants

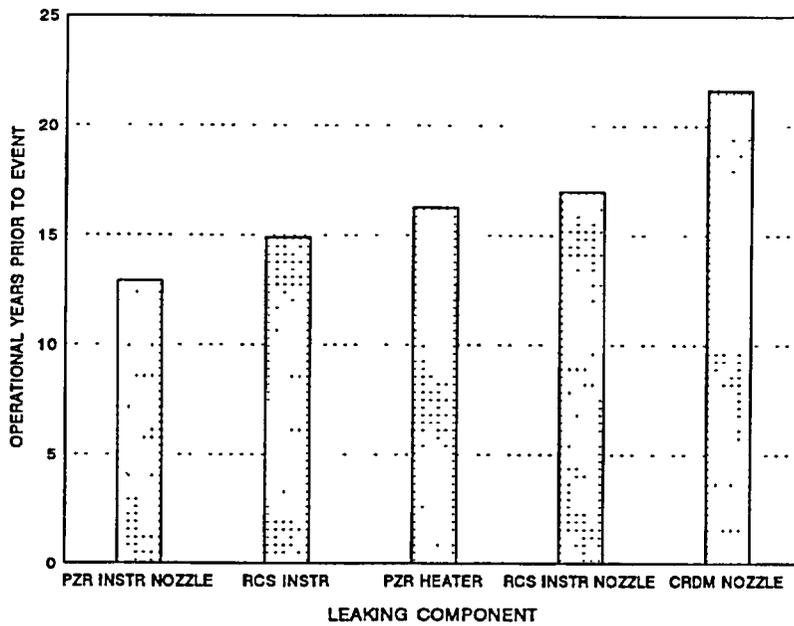
Operating experience was reviewed to determine the average number of operating years prior to discovery. The operating time to leak discovery was determined by comparing the event date with the date that an operating licensee for the plant was obtained from the NRC. Figure 6, "Average Number of Operational Years Prior to Leakage Event for Selected Components," provides several insights to five of the most prevalent leakage areas, CRDM nozzle leakage (15 reports), RCS instrumentation nozzles (13 reports), pressurizer instrumentation nozzles (9 reports), pressurizer heater sleeves (7 reports), and RCS instrumentation (7 reports) Most

reports contained multiple occurrences of leakage. These events and the operational experience to be gained were available to DBNPS. The licensee for DBNPS relied substantially on industry susceptibility models to postpone VHP nozzle inspections. As shown from the operational experience data, DBNPS was within the average operating time period to expect CRDM penetration cracking and leakage. The industry average operating time for CRDM penetration leakage is 21.6 years. The operating time period for DBNPS' discovery of leakage was 24 years, which exceeded the average time period.

Figure 6. Average Number of Operational Years Prior to Leakage Event for Selected Components

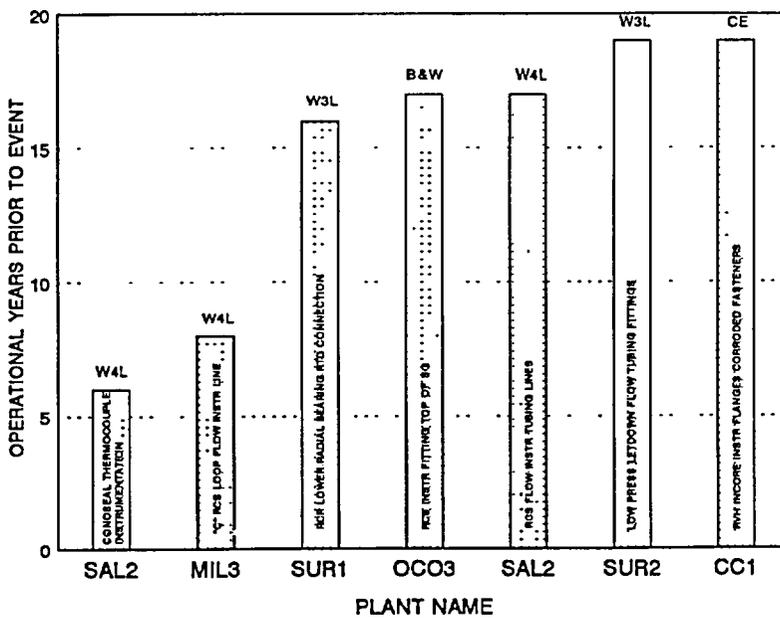
Although RCS instrumentation leakage has occurred at B&W and CE designed plants, Westinghouse plants dominated with five out of seven recorded events. Once again, the recorded events do not show indications of repetitive failures of similar components. Two of the events occurred on Westinghouse three loop plants, while three events occurred on Westinghouse four loop plants. See Figure 10, "Reactor Coolant System Instrumentation Leakage" for a brief description of the event and the number of years of operation prior to each event. Of note, is that five of the seven events occurred after 15 to 20 years of operation.

#### Figure 10. Reactor Coolant System Instrumentation Leakage

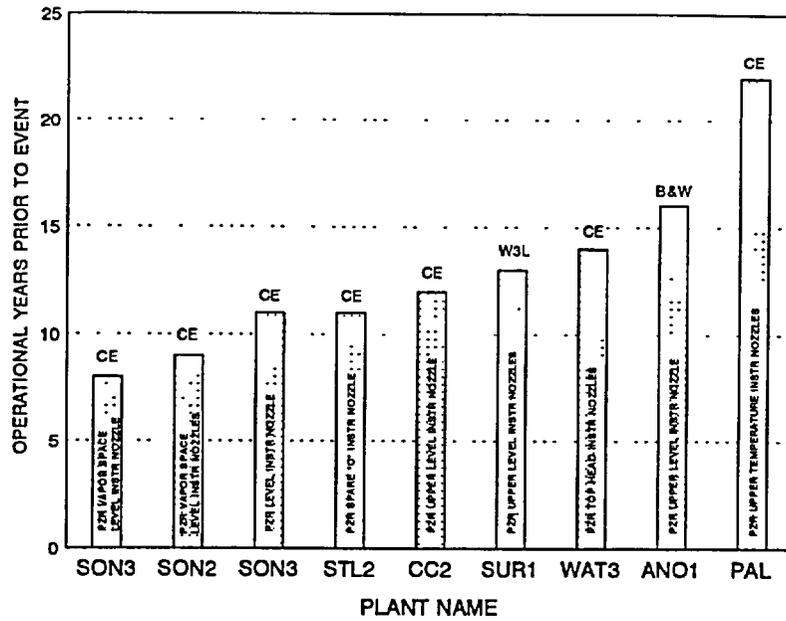
As shown in Figure 11, "Pressurizer Instrumentation Nozzle Leakage," CE plants dominate the recorded events. Seven of nine pressurizer instrumentation nozzle leakage events occurred at CE plants. Most of the events involved pressurizer level instrumentation. Most (5 of 8) of the pressurizer instrumentation events occurred between 11 and 14 years of operation.

Figure 11. Pressurizer Instrumentation Nozzle Leakage

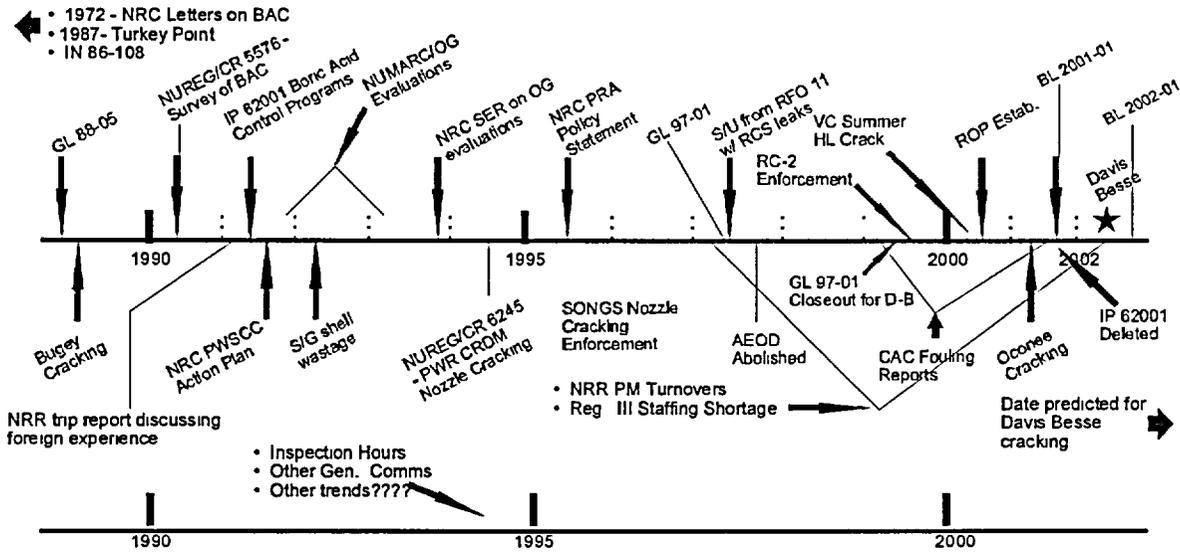
Figure 3.1-1

### NRC and Industry Failed To Assess Operating Experience

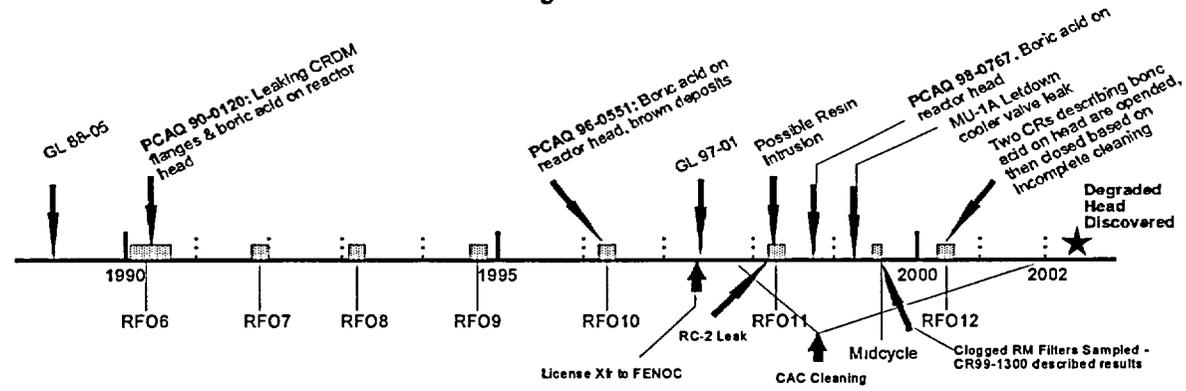
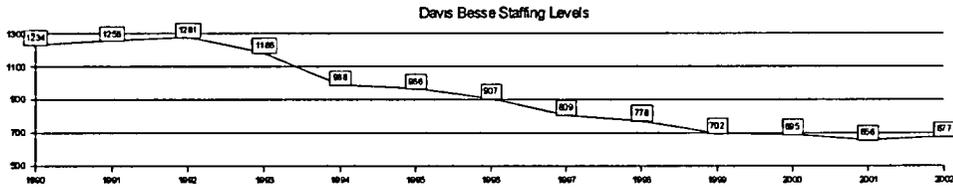
Figure 3.2-1

Licensee Failed to Identify Boric Acid Deposits and Correct

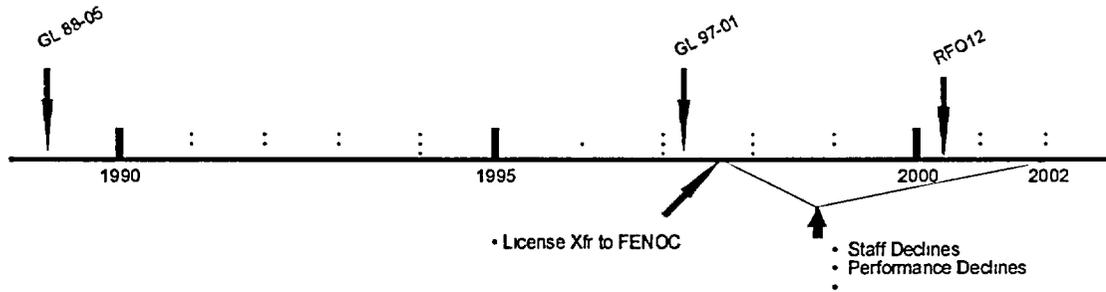
**Figure 3.3-1**  
**NRC Failed To Assess Safety Performance at Davis Besse**
