# Reactor Vessel Head Inspection Current Status and Future Plans

Calvert Cliffs  
Nuclear  
Power Plant  
Unit 2

March 18,  
2003

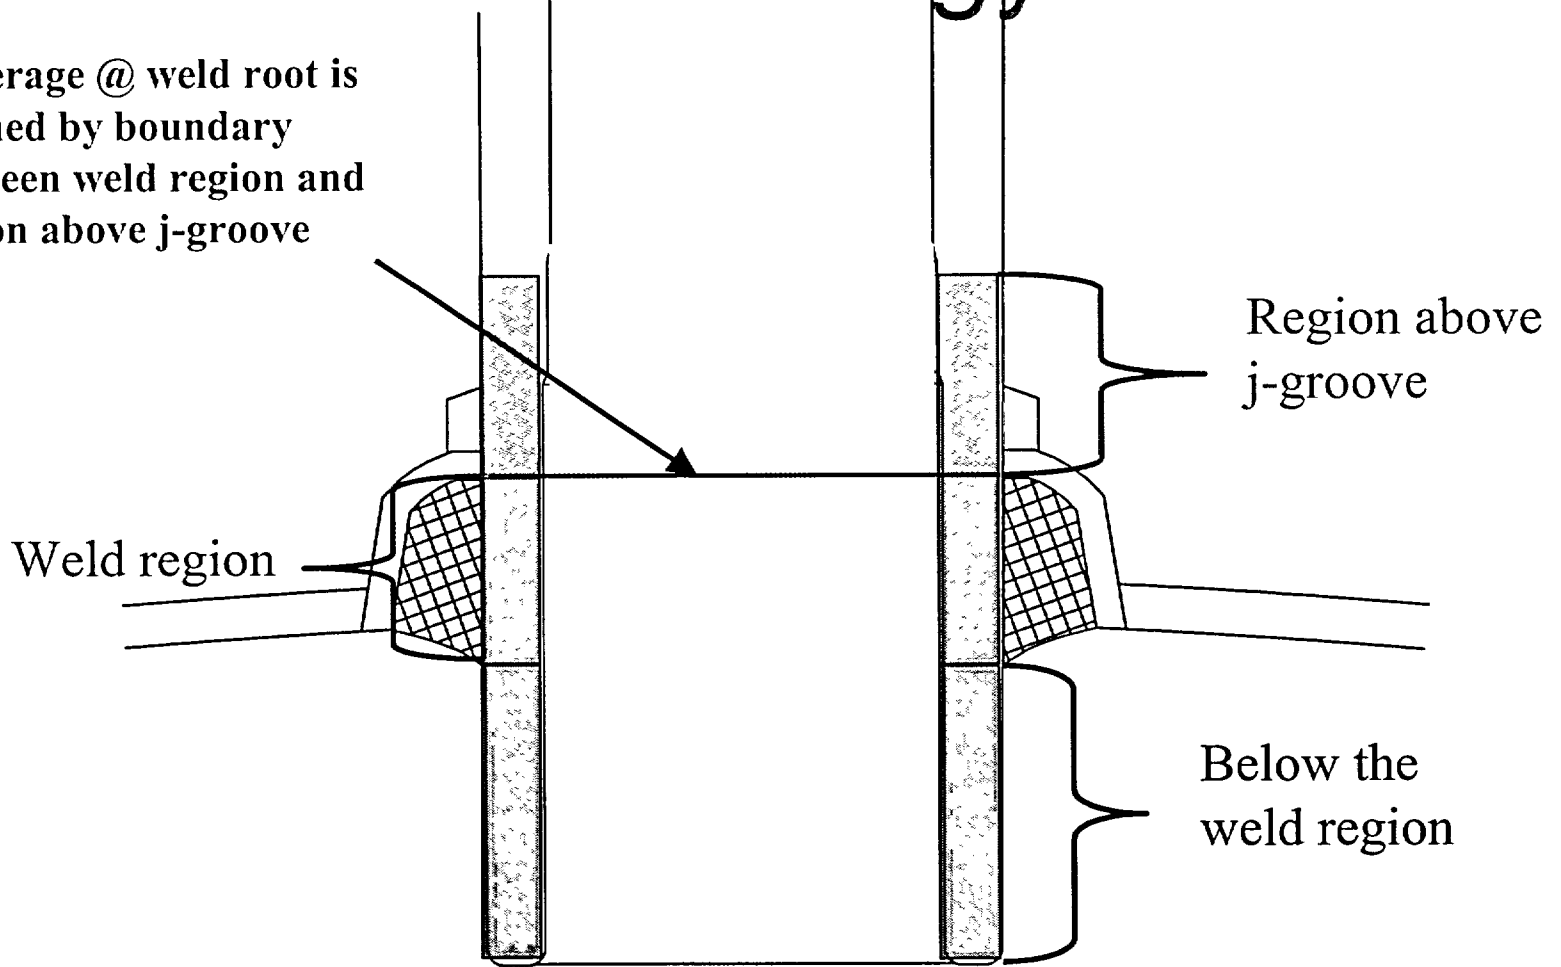
# Nozzle Exam Coverage Terminology

Coverage @ weld root is defined by boundary between weld region and region above j-groove weld
