## UNITED STATES NUCLEAR REGULATORY COMMISSION OFFICE OF NUCLEAR REACTOR REGULATION WASHINGTON, D.C. 20555

### June 15, 1988

NRC INFORMATION NOTICE No. 88-38: FAILURE OF UNDERVOLTAGE TRIP ATTACHMENT ON GENERAL ELECTRIC CIRCUIT BREAKERS

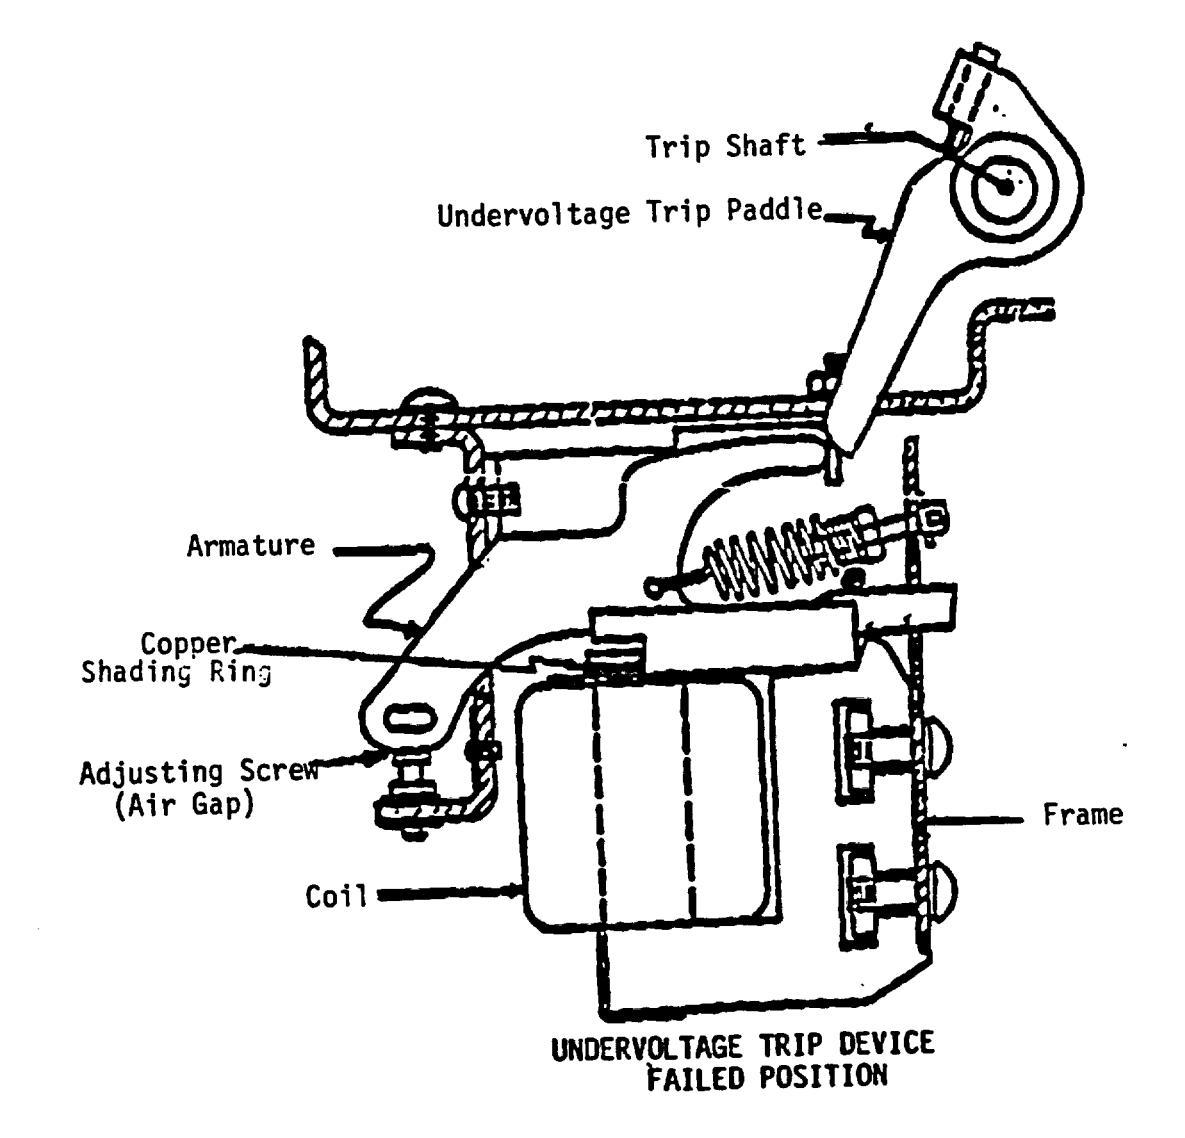
The Rancho Seco licensee's investigation determined that the failure mode of the UVD also involved internal binding of the UVD's linkage. However, the root cause of the binding at Rancho Seco differed from that at TMI 1. The Rancho Seco licensee found that the clearance between the armature and trip paddle was inadequate. The licensee also determined that the armature disk was improperly welded in a position both vertically and horizontally off center of the end of the armature. This altered the armature/trip paddle points of contact from the prescribed configuration shown in Figure 3a to the undesirable configuration shown in Figure 3b. Another factor relating to the incident is the lack of adequate clearance between the armature disk and the trip paddle in the energized position.

Because of the mechanical oscillation inherent in an ac powered electromagnet, the armature of the UVD vibrates continuously. Since the armature disk and trip paddle were in contact, these vibrations eventually created a groove in the upper portion of the armature disk and in the end of the trip paddle. As long as the grooves in the disk and trip paddle were in a certain configuration, the device operated properly. However, when the disk/trip paddle groove relationship was disturbed (side movement), the disk would bind on the trip paddle resulting in failure of the UVD to trip the breaker (Figure 4). The affected breaker was removed from service and a spare breaker was installed. All RTBs were taken out and visually inspected for the anomalies identified above; no abnormal UVDs were identified. The licensee has also modified its preventive maintenance procedure to ensure that all known problems with these breakers have been addressed to preclude the recurrence of these problems.
