UNITED STATES
NUCLEAR REGULATORY COMMISSION
OFFICE OF NUCLEAR REACTOR REGULATION
WASHINGTON, D.C. 20555

NRC BULLETIN NO. 88-01: DEFECTS IN WESTINGHOUSE CIRCUIT BREAKERS

Subject			Westinghouse Circuit Breakers Type DS/DSL: Welds on Breaker's Pole Shaft			Number			NSID-TB-87-11		
System(s)			All Plant Systems			Date			December 1, 1987		
Affected Plants			All Plants with DS/DSL Circuit Breakers			S.O.(s)			309, 386, BOP		
References			See Below			Affects Safety Related Equipment			Yes <input checked="" type="checkbox"/> No <input type="checkbox"/>		
						Sheet			1 Of 17

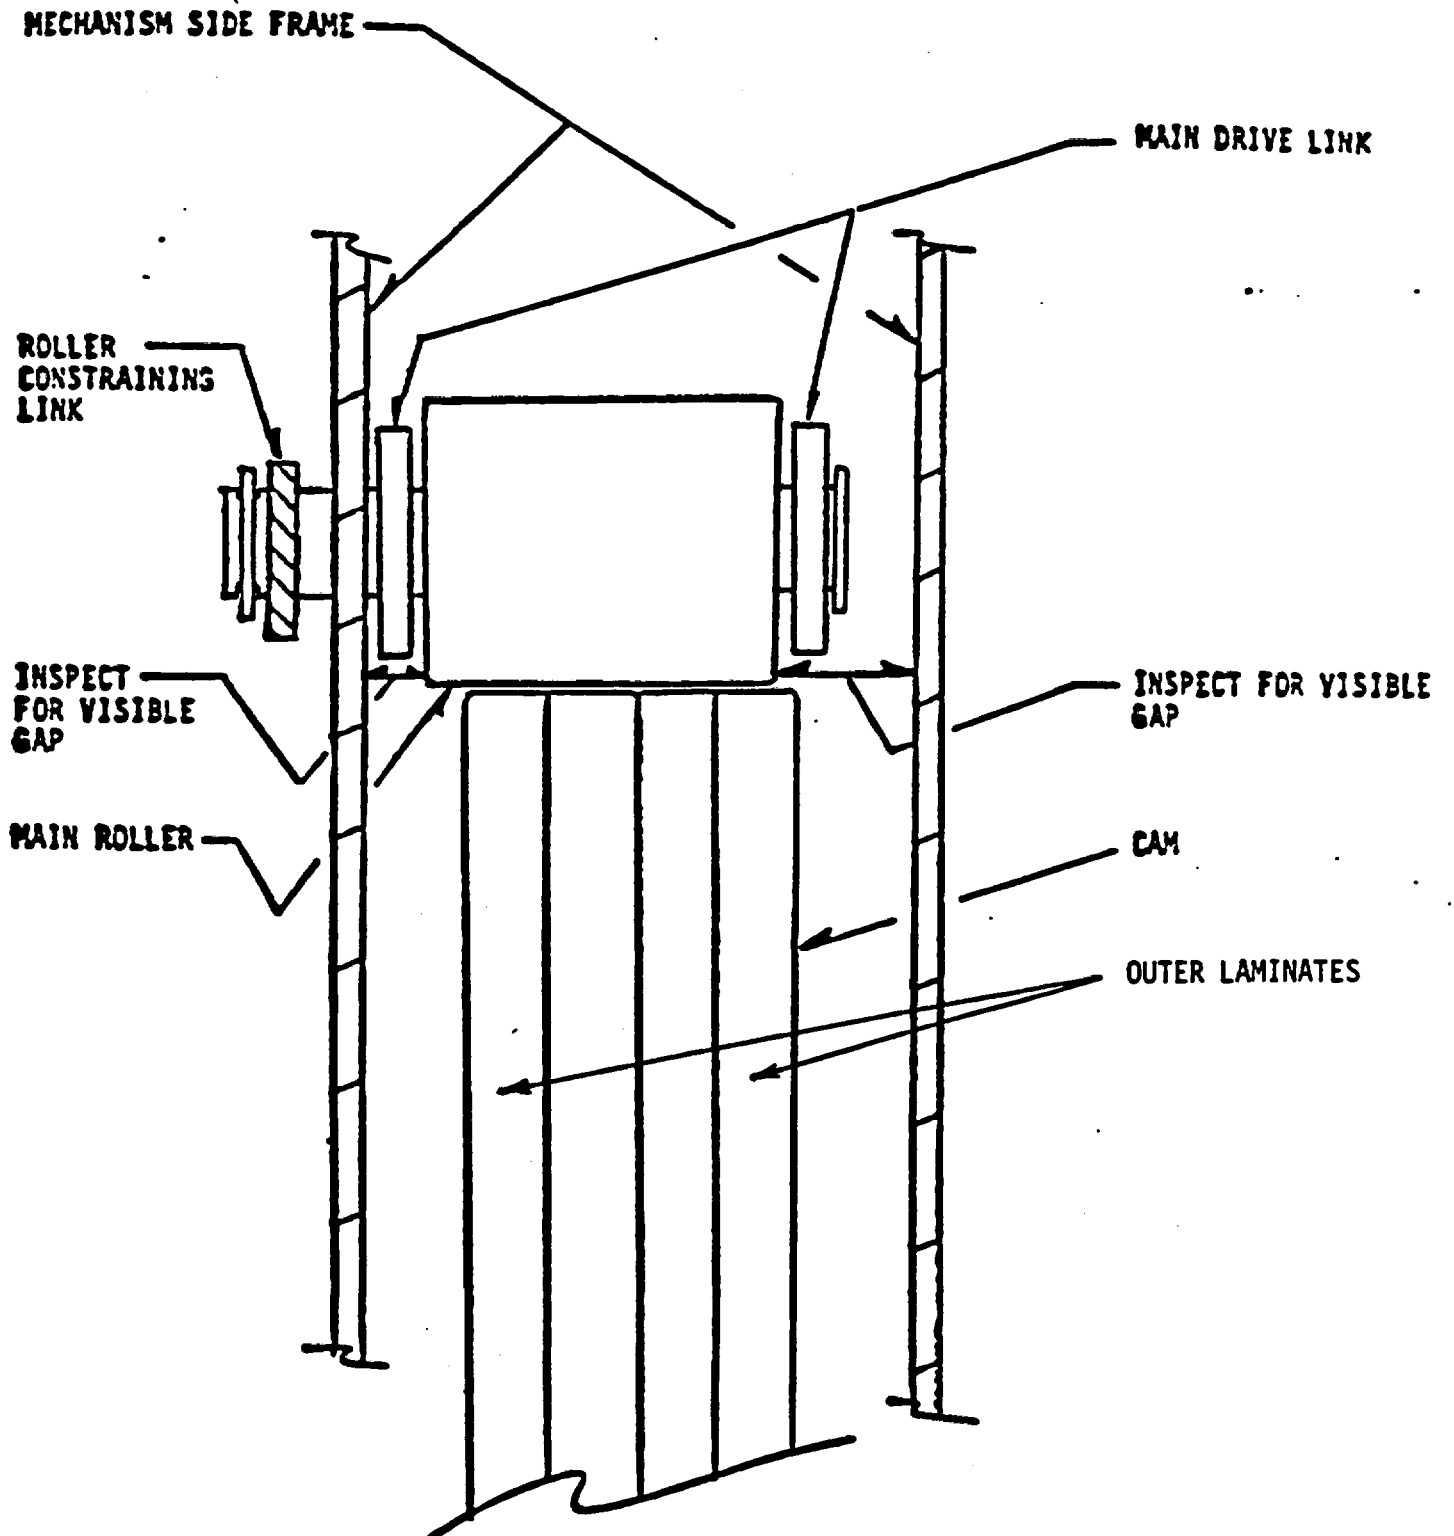
FIGURE 3

It is recommended that personnel assigned to do this task review Figure 3 before beginning the tasks. It shows the components involved in this procedure.

PARTIAL VIEW OF BREAKER COMPONENTS
