UNITED STATES
NUCLEAR REGULATORY COMMISSION
OFFICE OF INSPECTION AND ENFORCEMENT
WASHINGTON, D.C. 20555

SSINS No.: 6835
IN 86-13

IE INFORMATION NOTICE NO. 86-13: STANDBY LIQUID CONTROL SYSTEM SQUIB VALVES
FAILURE TO FIRE

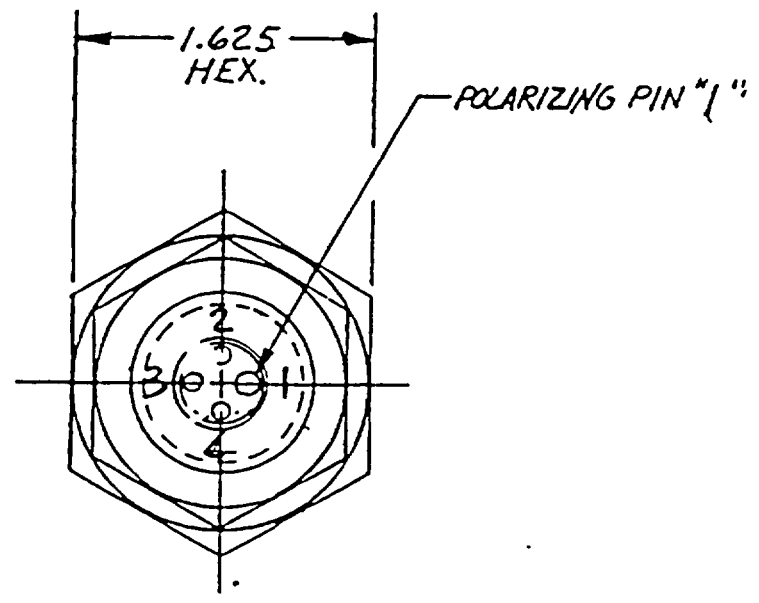
The explosive primer charge assembly for the SLCS at Vermont Yankee was supplied by Conax Corporation. The explosive primer charge assembly has two sets of resistance wires, i.e., bridgewires, internal to the charge either of which will fire the explosive. However, some of the charges were manufactured with incorrect pin-to-bridgewire groupings so that when connected at Vermont Yankee, two high-side leads were connected to one bridgewire set and two neutral leads were connected to the other bridgewire set internal to the explosive primer. Examination of spare squibs at Vermont Yankee identified four others with incorrect pin-to-bridgewire groupings.

The explosive primer charge assembly may be tested for correct pin-to-bridgewire grouping with an ohmmeter that is current limited to no more than 10 millamperes. Larger currents will cause the charge to explode.
