Subject: 10CFR21 Reporting of Defects and Non-Compliance -
Engine Systems, Inc. Report No. 10CFR21-0087, Rev. 0

EMD Electric Start Motors at Oyster Creek

Report No. 10CFR21-0087
Rev. 0: 06/11/03

10CFR21 REPORTING OF DEFECTS AND NON-COMPLIANCE

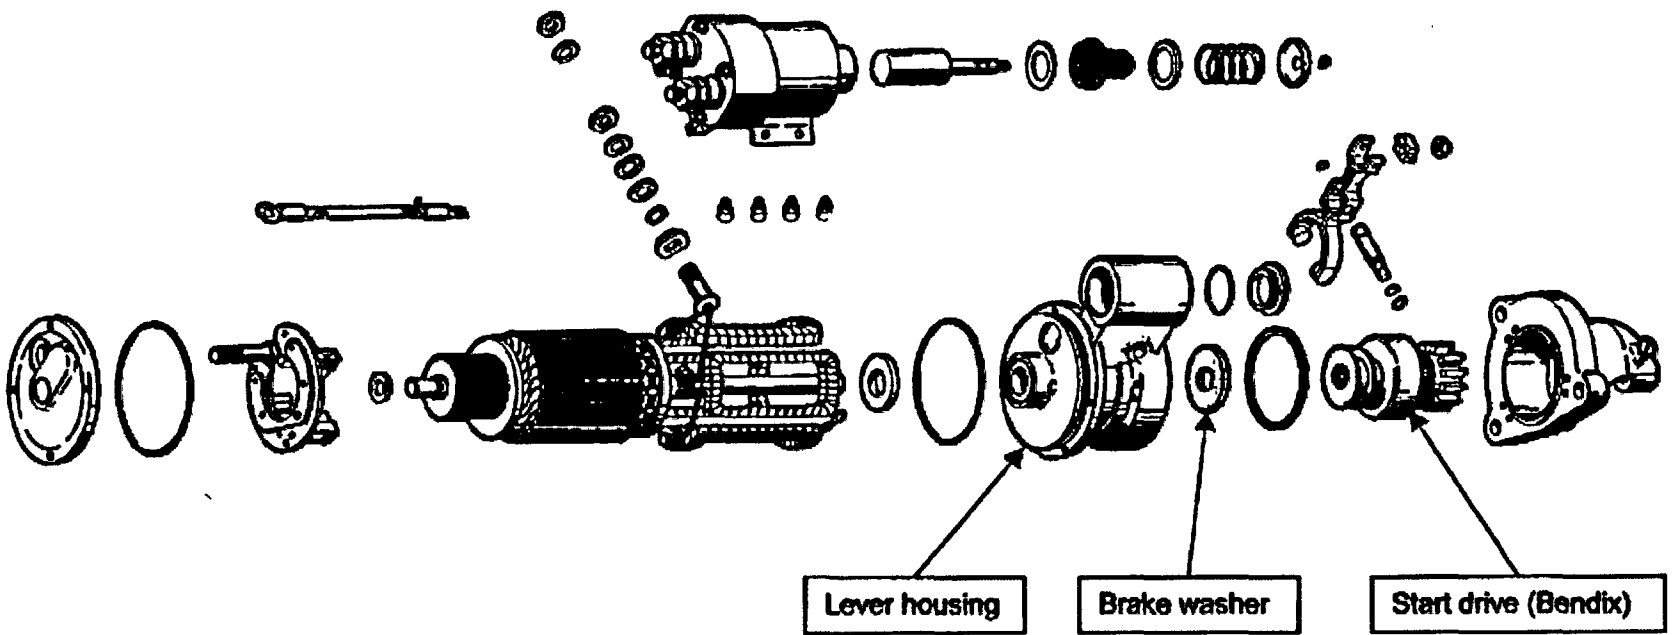
Upon removal of the Bendix assembly from the starter, a white opaque ring of material was found adhered to the lever housing. This material was in a position such that the Bendix assembly would rest against it in the de-energized state.

Non-drive end of Bendix assembly, brake washer surface

The function of the brake washer is to slow down the starter's armature after the engine starts and the pinion disengages. This reduces the starter's coast down time and conserves brush life.

ESI contacted the manufacturer, Delco Remy, to discuss the findings. The representative reviewed photos of the material found and determined it was an RTV adhesive formerly used to adhere the brake washer. Delco Remy's practice is to either adhere the brake washer to the lever housing or to the Bendix assembly. In the early 1980's, RTV was used exclusively to adhere the brake washer. In 1986, their sub-supplier applied a mastic type adhesive on the brake washer. Sometimes the pre-applied adhesive did not provide sufficient bond strength, so RTV was used occasionally as a supplemental adhesive. At some point in 1999, the manufacturer stated that they had a process problem in which the brake washer was installed in the standard manner, but RTV was applied to the opposite side also. Delco Remy could not confirm the exact dates of this problem, but they estimate that it occurred only over a 2 week period. In April, 2001 a stronger adhesive was applied by the brake washer sub-supplier and the use of RTV was eliminated.

Improper operation of the starter's drive assembly was caused by the presence of silicone RTV adhesive on the face of the lever housing. In this starter assembly, the brake washer was apparently adhered to the Bendix assembly using the pre-applied adhesive while RTV was applied to the lever housing and/or to the opposite face of the brake washer. The RTV surface maintained a sticky finish relative to the face of the brake washer, and this led to higher than normal required forces to separate the two. Therefore, with normal test voltage applied to the starter's solenoid, the Bendix would not engage.

After removal of the improperly applied RTV, the Bendix assembly operated properly.

1. Inspect starters with serial numbers containing "99" for a "sticking" starter drive. Two (2) starting motors are required for the engine. The solenoids of each motor are connected in series; therefore, the starter drive must engage at ½ of the minimum system voltage.
2. Starters with sticking drives should be disassembled and the RTV removed; or, returned to ESI for evaluation and repair.
