**SOUTH TEXAS PROJECT UNIT 1  
BOTTOM MOUNTED INSTRUMENTATION NOZZLE  
LEAKAGE ISSUE**

**Matthew A. Mitchell, Senior Materials Engineer  
Materials and Chemical Engineering Branch  
Office of Nuclear Reactor Regulation**

**Advisory Committee on Reactor Safeguards Full Committee Meeting  
July 11, 2003**

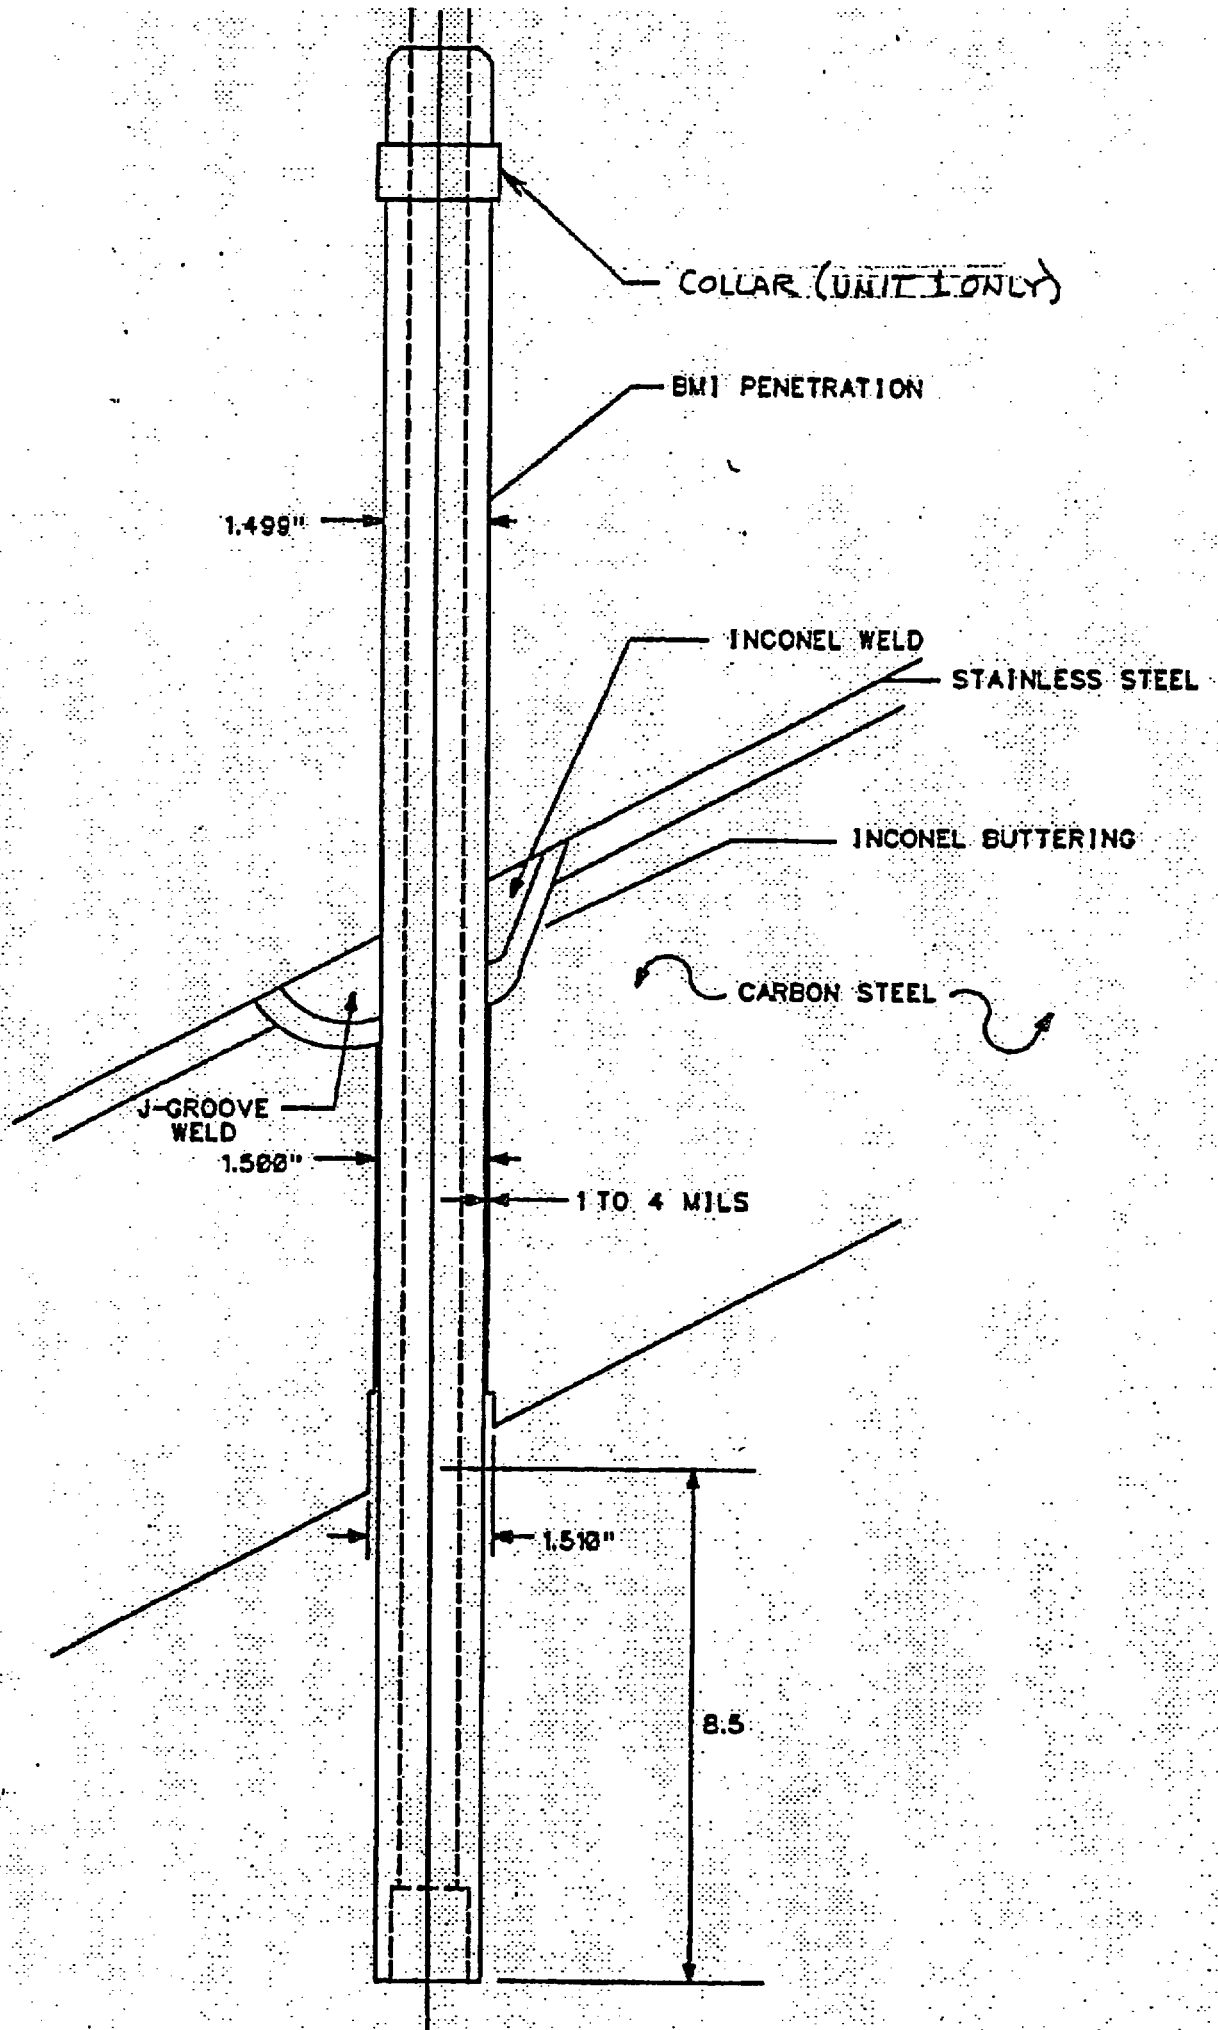
# Penetration #1

- In April 2003, the licensee discovered deposits characterized as, in total, “about the size of one half of an aspirin tablet” around bottom mounted instrumentation (BMI) penetrations #1 and #46.
- Chemical analysis showed evidence of boron and lithium, indicating the reactor coolant system (RCS) to be the most likely source of the deposits.
- Radiochemical analysis based on cesium isotope dating indicated that the deposits were approximately four years old.

- Based on the information currently available, two principal root cause theories are under consideration by the licensee.
  - (1) The cracking was caused by primary water stress corrosion cracking (PWSCC) which initiated in the nozzle at the toe of the J-groove weld.

- Inconsistent with the fact that no cracking was observed in other penetrations
  - (2) The cracking initiated at “discontinuities” (weld lack of fusion, etc.) at the tube/weld interface and propagated to the tube surface.

- Consistent with observed discontinuities in #1 and #46
    - Consistent with understanding of general fabrication practices/issues
    - Inconsistent with the fact that discontinuities were evident in other penetrations

- The licensee has repaired STP Unit 1 nozzles #1 and #46 using a “half nozzle repair” similar in design to those used to repair other Alloy 600 penetrations.
- The repair was made using Alloy 690 nozzle material and Alloy 52/152 weld material, including the installation of a temper bead weld pad on the outside of the RPV lower head. The RCS pressure boundary weld was moved to the outside surface of the RPV.
- Questions regarding future inspections of the repair, along with inspections of the ferritic base material which will be left exposed to the reactor coolant, are being addressed by the licensee in support of NRC staff review and approval of the repair.
