South Texas Project Electric Generating Station P.O. Box 289 Wadsworth, Texas 77483

July 11, 2003
NOC-AE-03001557
10CFR50

South Texas Project
Units 1 & 2
Docket Nos. STN 50-498, STN 50-499
Additional Information Regarding STP's Commitment to Investigate and Repair
Bottom Mounted Instrumentation Penetration Indications

South Texas Project Status Report on Resolving the Unit 1 BMI Issue

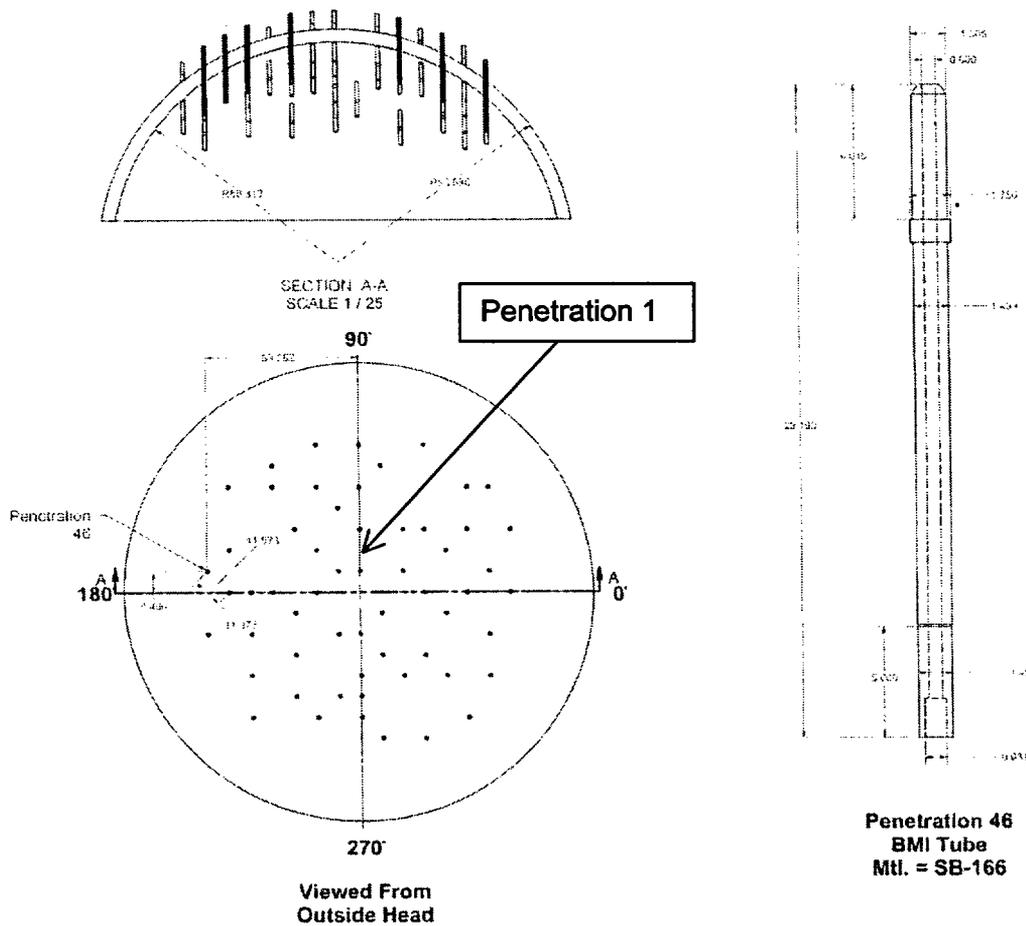
Nozzle number 1 is located about 8.5 inches due north of the center of the bottom head. The nozzle is nearly perpendicular to the reactor bottom head. Penetration number 46 is about 8.5 inches north of the east-west center line and just over 59 inches west of the bottom head center (Figure 3). Nozzle number 46 penetrates the head at 42.6 degrees.

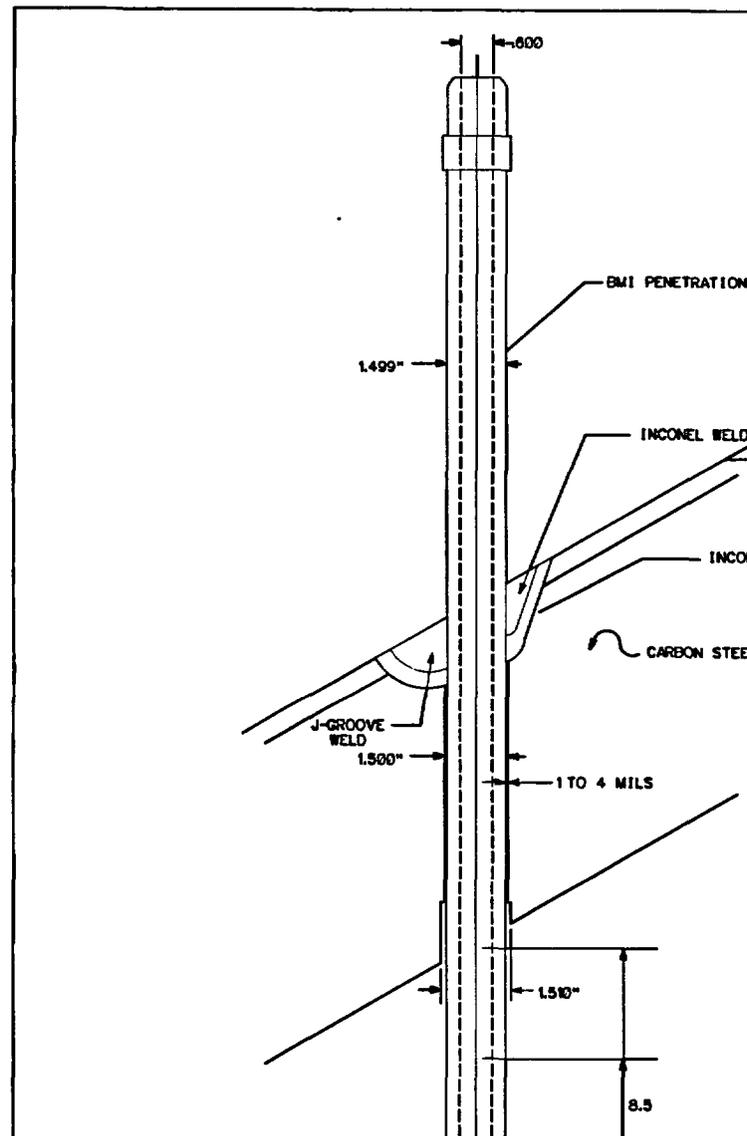
weld repairs being made with either 182 or 82 weld material. The vessel itself is 5.38-inch thick low alloy carbon steel with 0.22 inches of stainless steel cladding on the interior surface. Each penetration bore in the reactor bottom head is nominally 1.5 inches in diameter. There is an open annulus between the nozzle and the reactor head below the J-groove weld. Figure 4 provides a simplified view of a typical nozzle configuration

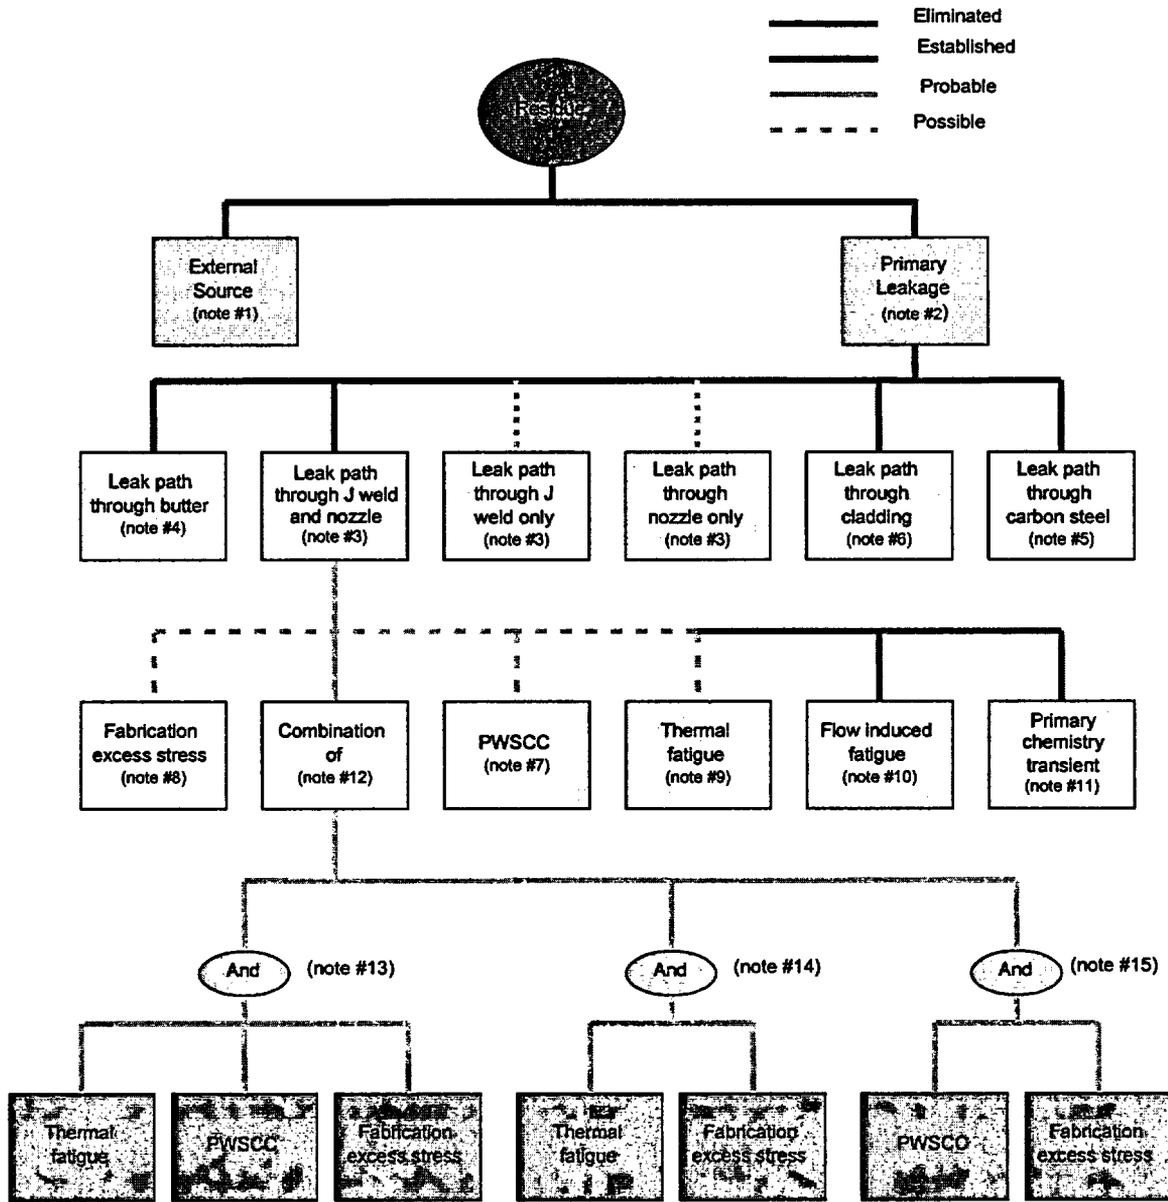
South Texas Project Status Report on Resolving the Unit 1 BMI Issue – Attachment 3 Fault Tree Analysis

Note #1: Swipes and visual inspection of the outside surface of the RPV do not support outside source for the boron residue.

Note #15: This postulates a fabrication flaw that was missed by the final PT examination or propagated to the surface during the initial hydro vessel testing and later grew through the weld zone by PWSCC.
