Bottom Mounted Instrument Penetration Condition Resolution

INTRODUCTORY REMARKS

Evidence of Very Small Leakage Found in Routine Inspection

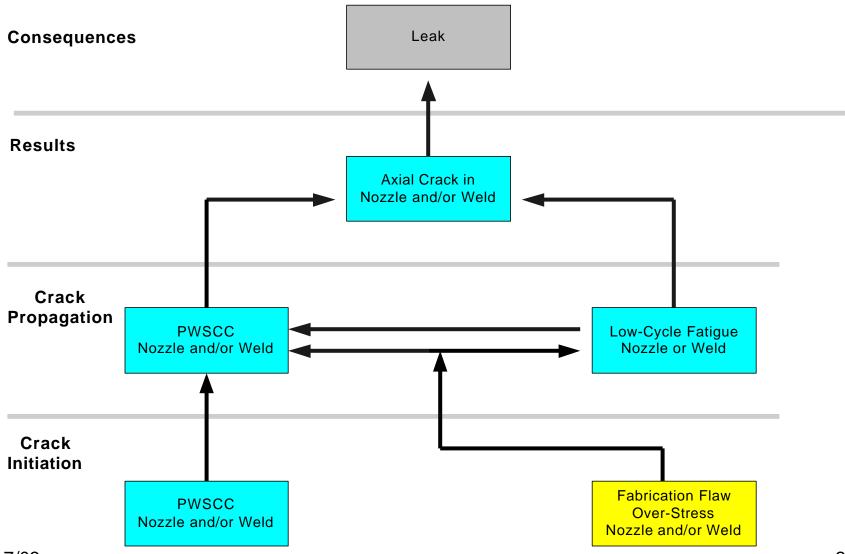
Two Possible Causes

Facts Inconsistent with PWSCC

- No cracks identified except in #1 and #46
- Cracks relatively old (3-5 yrs), about same age
- Cracks not ID initiated

- Cracks not at highest residual stress locations
- Penetrations #1 and #46 are different in terms of residual stress
- Some cracks do not appear to be in contact with primary water
