5. TESTING

5.1 Test Planning

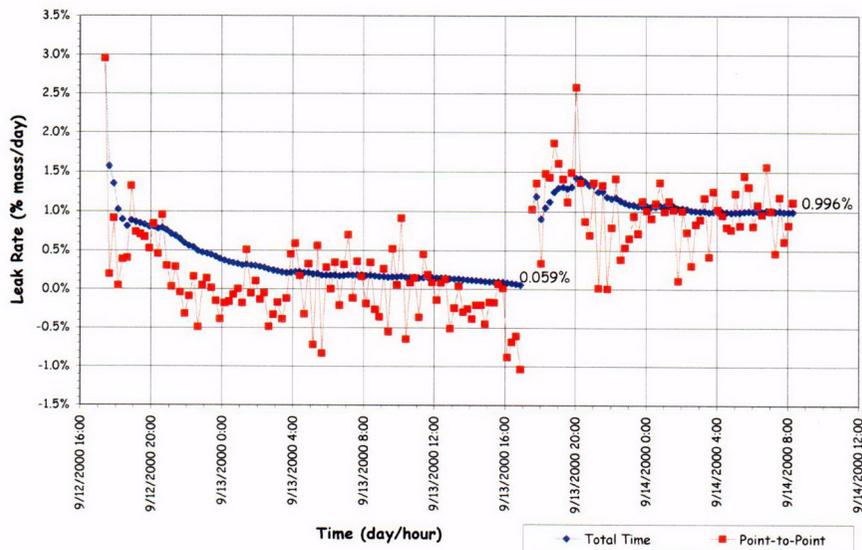
Figure 5.9 Integrated Leak Rate Test Leak Rates

The ILRT for the PCCV model was a hybrid of these procedures. The ILRT pressure, P_{ILRT} , was 0.9 Pd (0.35 MPa or 51.2 psig) based on JEAC 4203 and the Absolute Method for a Type A Test per ANSI/ANS N56.9 (Section 5.0) was followed. After depressurizing from the P_{SIT} to P_{ILRT} , the model was held at P_{ILRT} for approximately one hour to allow the model atmosphere to stabilize before the start of the leakage rate test. The ILRT commenced after all stabilization criteria were achieved and the duration of the test was “sufficient to enable adequate data to be accumulated and statistically analyzed so that a leakage rate ... can be accurately determined” but no less than 24 hours. Data was collected at least once every hour. The measured leakage rate at P_{ILRT} , L_{tm} , was determined using both the (a) total time analysis and (b) point-to-point analysis techniques. The nominal atmospheric pressure at the elevation of the test site (verified by checking the Sandia Photovoltaics Weather Station reading) was used for leak rate calculations. The calculated leak rate after 24 hours at 0.9 P_d , was 0.059% mass/day.

After the ILRT was completed, the model was initially depressurized by venting through the 1mm orifice plate, calibrated for a leak rate of 1% mass/day. After approximately 16 hours, a stable leak rate of 0.996% mass per day was calculated, again confirming the accuracy of the leak rate instrumentation.

Per JEAC 4203, the maximum leak rate at the ILRT pressure should be less than 0.1% mass/day. Similarly, per 10 CFR 50, the specified maximum allowable leak rate, L_a , at the design accident pressure, P_d , for the prototype containment is 0.1% mass/day. The maximum leak rate at the ILRT pressure level, L_i , is

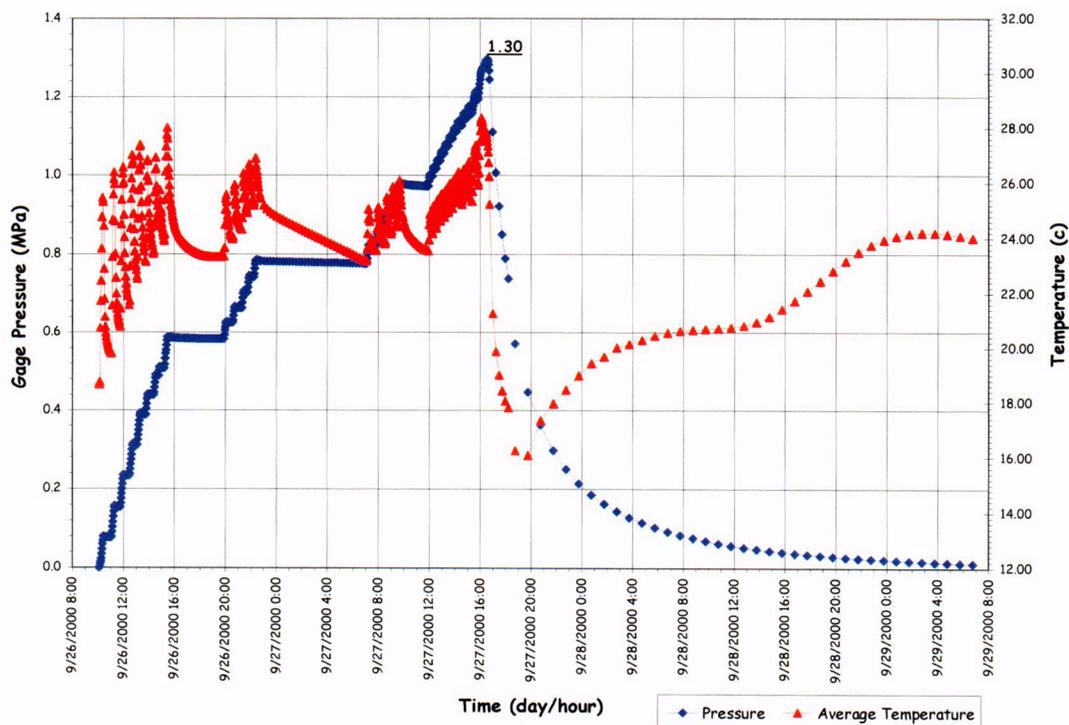
Figure 5.15 Limit State Test Pressure and Average Temperature

The pressure and average temperature time histories during the LST, including depressurization, are plotted in Figure 5.15. The LST followed the planned pressurization sequence up to the point where the model began leaking.

Initially, the model pressurization sequence matched the pressurization steps followed for the SIT to allow for comparison of the model response to two identical cycles of loading. The gage stability criteria used during the SIT (i.e. Equation 5.1) was also applied during the LST. Pressurization continued in increments of approximately $0.2P_d$ until a pressure of $1.5 P_d$ (6.0 kg/cm^2 or 85.3 psig) was reached at approximately 4:30 PM. At this pressure, the first planned leak check was conducted by isolating the model and monitoring the temperature and pressure. After approximately three hours, a leak rate of 0.48% mass/day was calculated. Considering previous experience from the ILRT, which

demonstrated that thermal expansion of the model during the day yielded apparent leak rates in this range, the results were interpreted to indicate that the PCCV model was leak-tight.

Pressurization of the model continued in increments of approximately $0.1P_d$ until a pressure of $2.0P_d$ ($8.0 \text{ kg}_f/\text{cm}^2$ or 113.8 psig) was reached at approximately 11:00 PM. At this pressure the model was again isolated to perform a planned leak check. This leak check was also planned to be held for 8 hours to allow the test team to partially stand down for a rest period. A 'skeleton crew' consisting of the TC, Data Acquisition System Operator (DO), and Nitrogen Supply Operator (NO) continued to monitor the response of the model and all other systems until approximately 7:00 AM on September 27. This pressure hold and leak check was also selected below the lower bound prediction for the onset of structural yielding (i.e. yielding of the rebar or tendons) to ensure the model would remain relatively stable during this period. After approximately eight hours, the calculated leak rate was 0.003%, i.e., essentially zero. This confirmed the interpretation of the leak check results at $1.5 P_d$ and also demonstrated the greater accuracy of the leak rate results when the model is thermally stable.

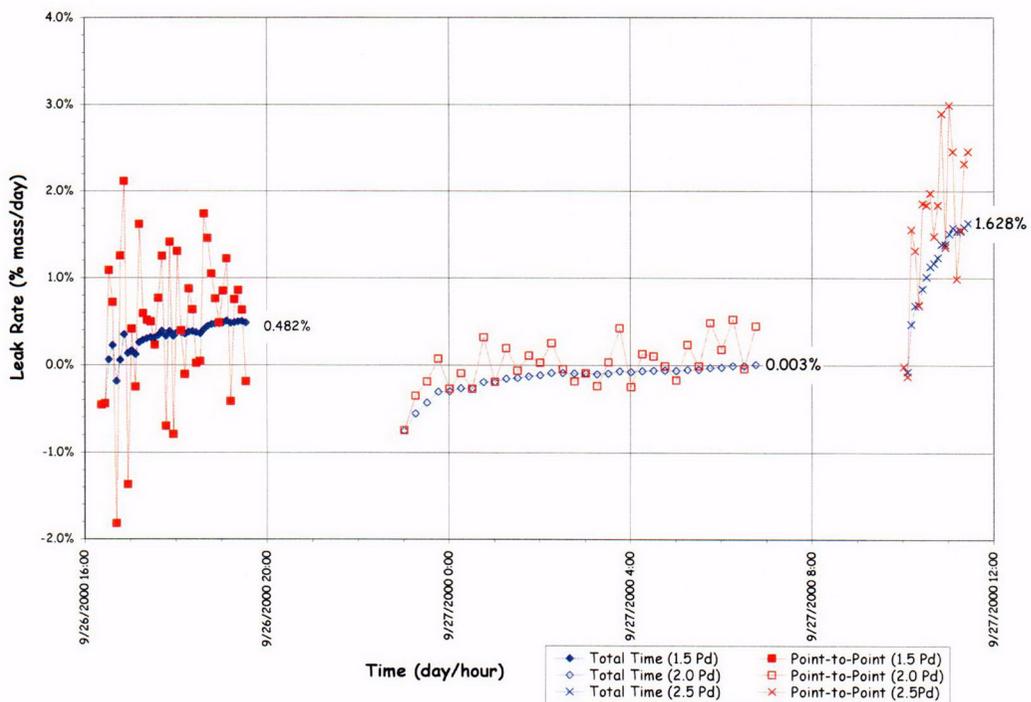
Figure 5.16 LST Calculated Leak Rates at 1.5, 2.0 and $2.5 P_d$

Pressurization of the model resumed at 7:00 AM in increments of $0.1P_d$, with increasing dwell time between pressure steps (~30 minutes) required to meet the gage stability criteria. As the pressure was increased to the next planned leak check at $2.5P_d$, liner strain gages in the vicinity of the E/H (LSI-C-K5-12) began registering rapidly increasing strains in excess of 1%. At $2.4P_d$ the acoustic system operator (AO) reported hearing a change in the acoustic output which might indicate that "something had happened." At approximately 10:00 AM at a pressure of $2.5P_d$ ($10.0 \text{ kg}_f/\text{cm}^2$ or 142.2 psig), the model was isolated for the third planned leak check. After approximately 1-1/2 hours, a fairly stable leak rate of 1.628% mass per day was calculated. The leak rate calculations at 1.5, 2.0, and $2.5P_d$ are plotted in Figure 5.16. Coupled with the acoustic data that continued to confirm some new event had occurred, it became clear that the model was leaking, most likely from a tear in the liner in the vicinity of the E/H. Plots of the output of the four internal acoustic sensors surrounding the E/H at 2.3, 2.4, and $2.5 P_d$ are shown in Figure 5.17.

After consulting with NUPEC and the NRC, the TC concluded that the model had functionally failed between 2.4 and $2.5 P_d$ and directed a change in the pressurization plan. Since the model was leaking, the next goal was to pressurize the model as highly as possible to collect data on the inelastic response of the structure and to observe, if possible, a structural failure mode. Pressurization continued in increments of $0.05 P_d$, as planned. However, the gage stability criteria was abandoned and the hold time at each pressure step was reduced to less than 10 minutes.

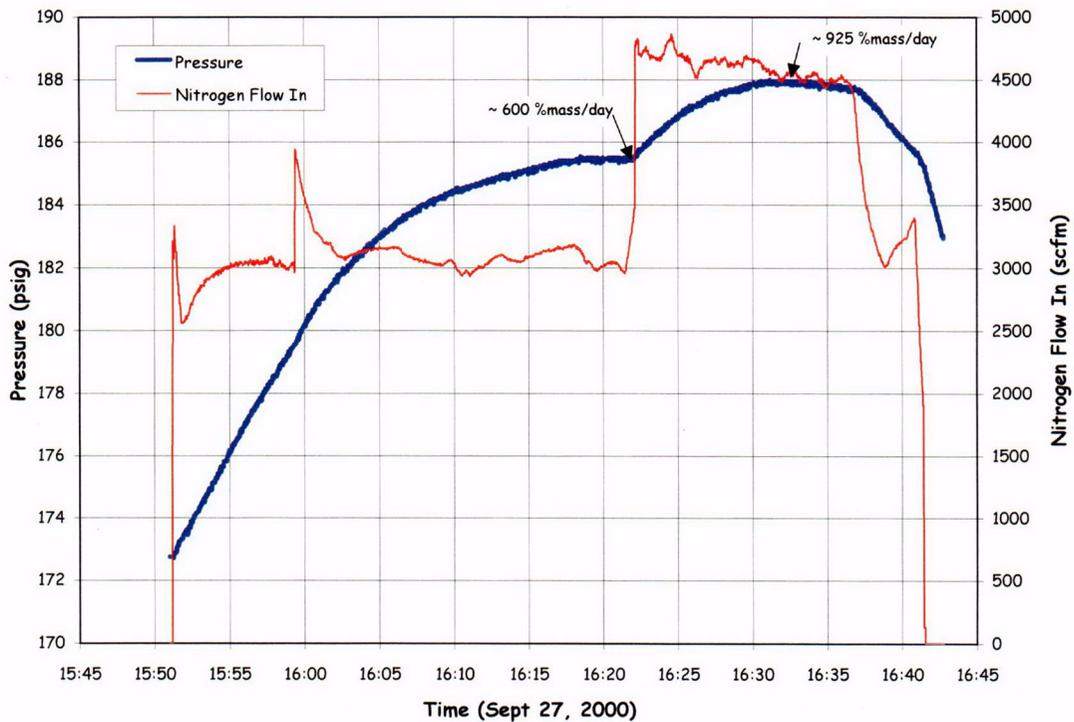
Figure 5.19 LST Pressure and Flow Rates at Maximum Pressure

The PCCV model was pressurized to approximately $3.0P_d$, with increasing evidence of leakage and increasing liner strains. At $3.0P_d$, it became increasingly difficult to pressurize the model, and the nitrogen flow rate was increased to 99 std.m³/min (3500 scfm). At this flow rate, the pressure in the model was increased to $3.1P_d$. However, the pressure dropped steadily after reaching this pressure. The leak rate at this point was estimated to be 100%.

The nitrogen flow rate was increased to the maximum capacity of the pressurization system, 142 std.m³/min (5000 scfm), and the pressure was increased to slightly over $3.3 P_d$ before the leak rate exceeded the capacity of the pressurization system. The pressure time history and flow rates during the final phase of the test are shown in Figures 5.18 and 5.19. Since it was no longer possible to increase the pressure in the model and the supply of nitrogen was nearly exhausted, the TC decided to begin terminating the test.

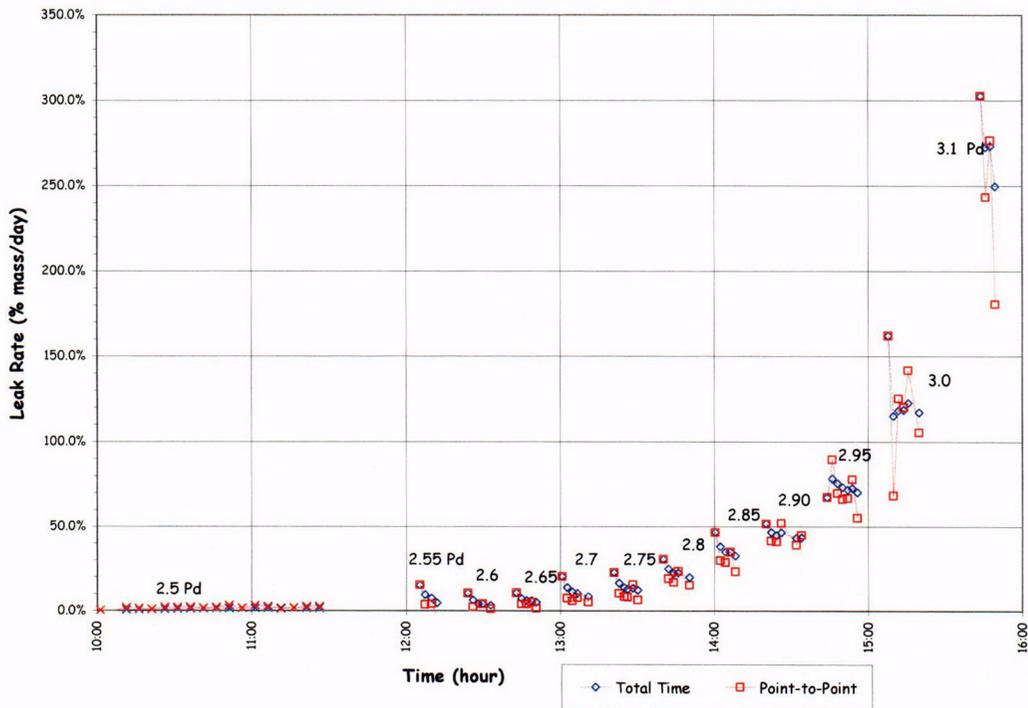
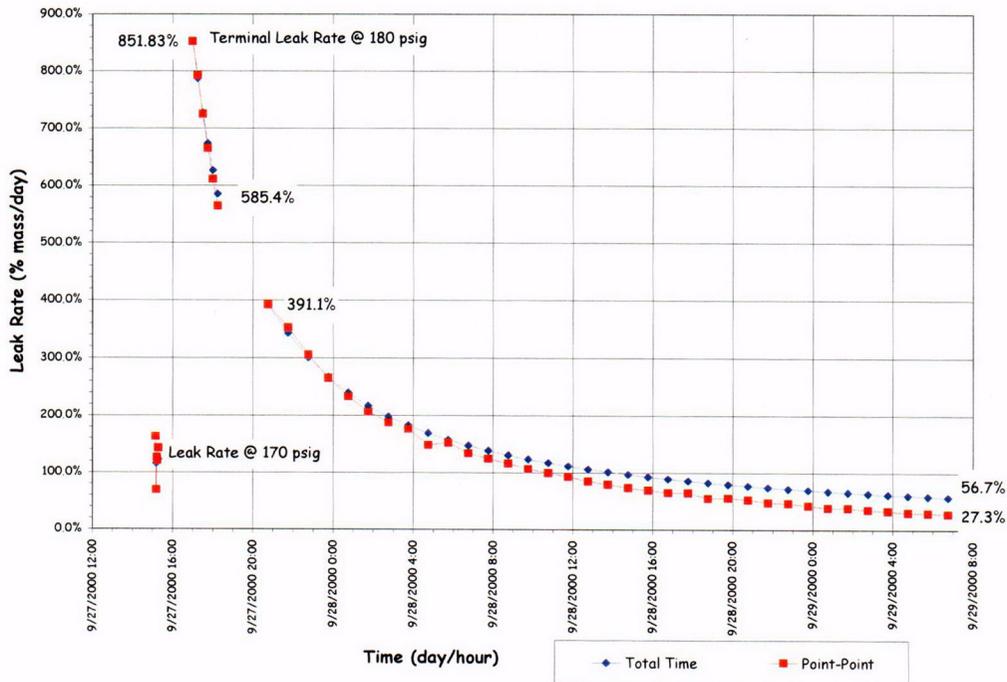
The isolation valve was closed and the model was allowed to depressurize on its own. The terminal leak rate was estimated to be on the order of 900% mass/day. (The maximum flow rate of nitrogen, 5000 scfm, is equivalent to a leak rate of 1000% mass/day.) Estimated leak rates during the final pressurization and depressurization phases are shown in Figures 5.20 and 5.21.

After the model pressure was reduced to $1.0 P_d$, test personnel were able to inspect the model close-up. Nitrogen gas was observed (heard and felt) escaping through many small cracks in the concrete around the penetration sleeves and at the tendon anchors. It was speculated that the liner acted as a leak chase, allowing nitrogen gas escaping through a tear or tears in the liner to travel between the liner and the concrete until it found an exit path through a crack in the concrete or a conduit in the tendon duct.

At maximum pressure, local liner strains of up to 6.5% were recorded and global hoop strains (computed from the radial displacement) at the mid-height of the cylinder averaged 0.4%. While large liner strains were observed, causing suspicion that the liner might have torn in several locations, the remainder of the structure appeared to suffer very little damage with the exception of more extensive concrete cracking at some locations. The largest crack was observed to the left of the E/H, shown in Figure 5.22. This is the same location as the crack photos shown in Figures 5.10 and 5.11. There was no indication of tendon or rebar failure. The detailed results of the LST are discussed in Section 5.3.2.1.

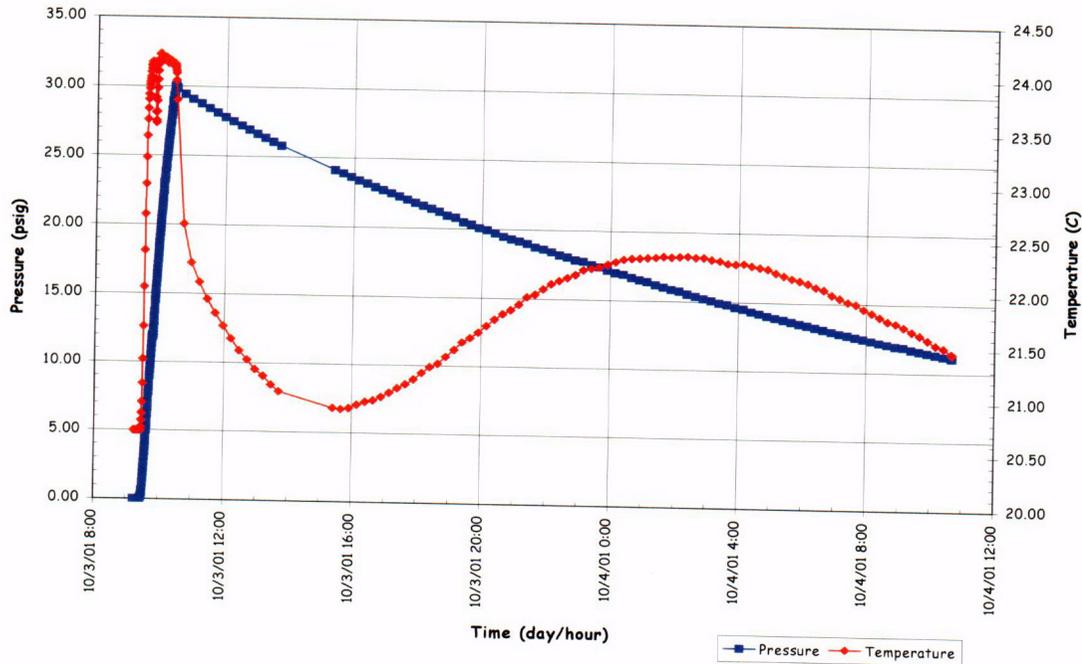
Figure 5.27 Pre-SFMT Leak Test Pressure and Temperature

After completing the installation and all test-readiness checks, the E/H cover was installed and sealed. A low pressure pneumatic test was conducted to check for leaks on October 3, 2001. The pressure and temperature time histories for the leak test are shown in Figure 5.27. The leak test began at approximately 09:30 and a leak was detected (via the acoustic system) at approximately 0.2 Pd (~12 psig). Pressure was increased to the target pressure of 0.5Pd (30 psig), at which time the vessel was isolated and monitored for a 24-hour leak test. The acoustic system (multiple sensors) continued to output signals consistent with a leak in the model and several potential leak locations were identified.

Once the model was deemed stable, the nitrogen supply was isolated and a close inspection of the model was conducted. Through a combination of visual/auditory inspection, hand-held acoustic monitoring, and the application of soap-water solution, a number of locations were discovered where nitrogen gas was leaking from the model.

- The largest apparent leak was from a crack on the left-hand side of the 90-degree buttruss at an elevation of approximately 6 m (20') above the top of the basemat (Level 6 in the cardinal coordinate system). This leak was the first detected by the acoustic system and was immediately confirmed during the close-up inspection.

- Secondary leaks, identified by the acoustic system, were confirmed at 150 degrees/3 and 6 m (10 and 20') and 210 degrees/4.5 m (15'). These leaks appeared to be through previously existing cracks in the concrete. The leak at 150 degrees was along the horizontal construction joints between C1, C2, and C3 as well as along a vertical crack extending between C2 and C3. The leak at 210 degrees also appeared to be through a previous crack.

- The acoustic system also suggested leaks at 300 degrees/1 to 2 m (3 to 6-1/2') and 360 degrees/0 m, but close-up examination could not confirm leakage at either location.

- During the close-up inspection, a leak was also detected at 30 degrees/5 m (16') which was not initially identified by the acoustic system.
- Close-up inspection of the penetrations also revealed leakage at the F/W penetrations. There was no evidence of leakage at the E/H, A/L, or M/S penetrations.

These results indicated that, in spite of the manufacturer's quality control procedures coupled with detailed visual inspection (individual locations that appeared suspect were also sealed with silicone sealant prior to closing the model), the sprayed-on liner was not impermeable. Once the gas escaped through the sprayed-on and steel liners, it migrated between the steel and concrete until it found an exit path. The pressure did not appear high enough to tear the sprayed-on liner when a leak was first detected.

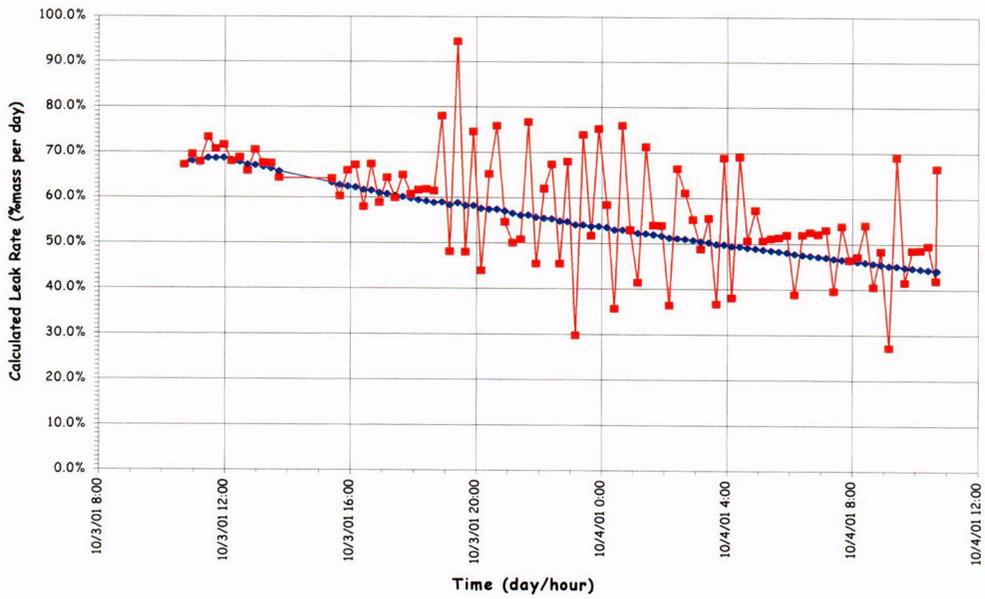
Figure 5.28 Pre-SFMT Leak Rate Test

The calculated leak rate, shown in Figure 5.28, was initially 70% mass/day at the maximum pressure of 2.1 kg_f/cm² (psi) decaying to 45% at 0.77 kg_f/cm² (11 psi) over 24 hours. The sound levels as detected by the SoundPrint system (shown in Figure 5.29), which are roughly proportional to the rate of gas escaping, indicated a stable leak rate that was, to a large extent, independent of the pressure.

Based on these results, it was concluded that the leak was most likely due to a pre-existing hole(s) in the sprayed on liner which did not increase (or decrease) significantly during pressurization or during the leak test. (The equivalent orifice size reduced from about 6 mm (0.25") at 2.1 kg_f/cm² (30 psi) to 5 mm (0.20") at 0.8 kg_f/cm² (12 psi), based on the calculated leak rates.) As a result, the SFMT could be conducted without repairing the sprayed-on liner while maintaining a reasonable chance that the leak would not grow significantly and overwhelm the capacity of the pressurization system. (Nevertheless, during an unscheduled one-month postponement of the SFMT, the surface was retested with a 'spark-tester,' and a few small holes were discovered and sealed. The model was then resealed and readied for filling with water.)

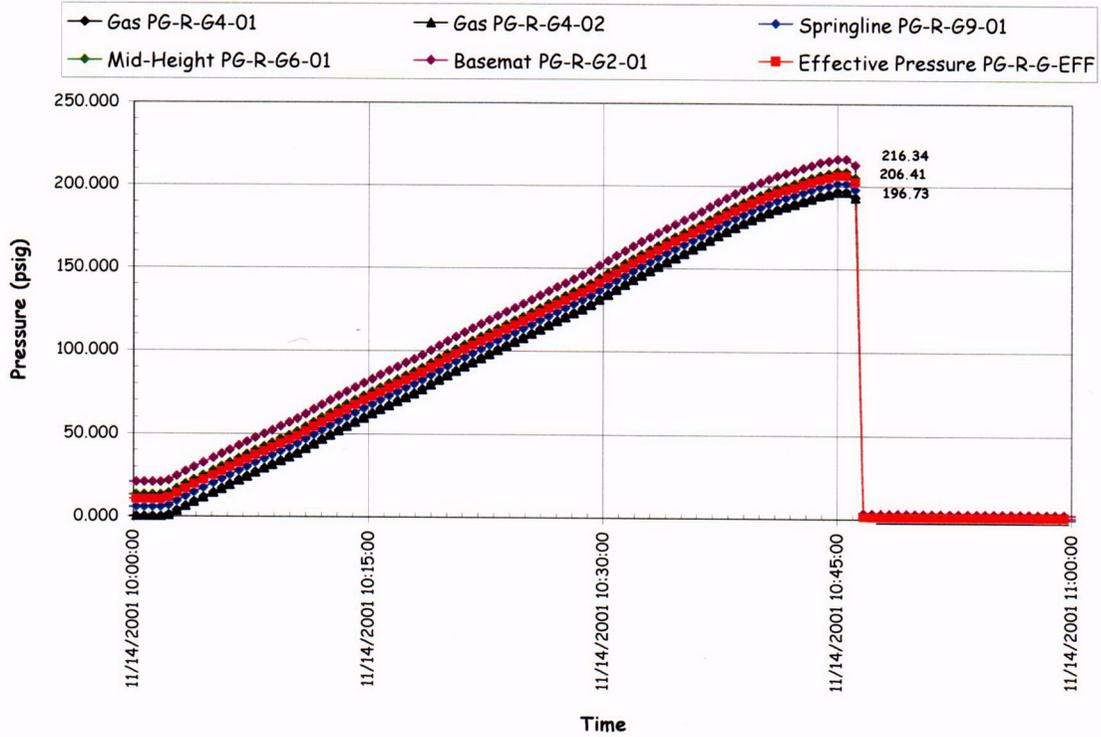
Figure 5.31 SFMT Pressure Time Histories

The SFMT began shortly after 10:00 AM on Wednesday, November 14, 2001. The pressure time histories are shown in Figure 5.31. The pressure time history of all five gages are shown along with the effective model pressure, which is calculated as a volume-weighted average. Any references to the SFMT pressures are to the effective pressure, unless noted otherwise.

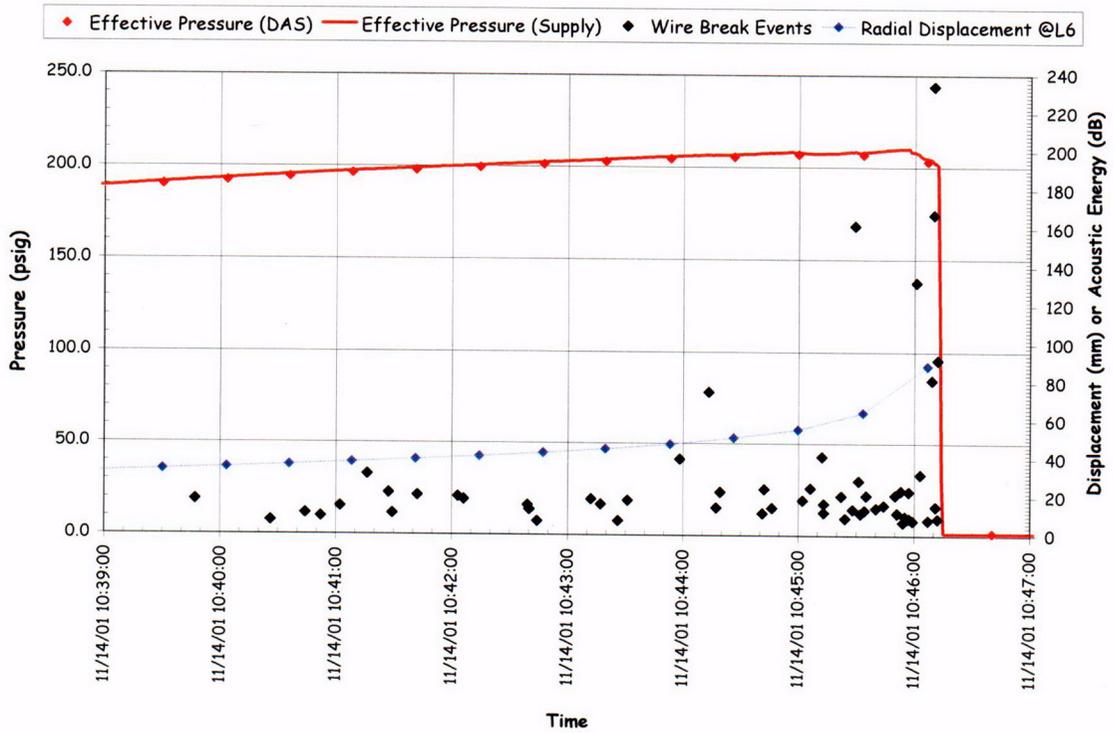
Figure 5.32 SFMT Wire Break Events vs. Pressure vs. Displacement

The model was continuously pressurized at a rate of approximately 0.35 kg_f/cm² (5psi)/min. All active sensors were continuously scanned at intervals of approximately 30 seconds and the video cameras continuously recorded the response of the model. As the pressure increased, evidence of leakage was visible as increasing wetting of the concrete surface. At 10:38 AM, the effective pressure in the model equaled the peak pressure achieved during the LST, 3.3 Pd (1.29 MPa or 188 psig). At approximately 10:39 AM, the acoustic system recorded a very high noise level event, which was interpreted as the breaking of a tendon wire. At this point in the test, events occurred very quickly. Shortly after detecting the wire break, a small spray of water was observed at approximately 0 degrees Azimuth and additional tendon wire breaks were detected by the acoustic system with increasing frequency. The wire break events are plotted in Figure 5.32, along with the effective pressure and the radial displacement at Azimuth L (324 degrees), elev. 6 (6280), as a function of time.

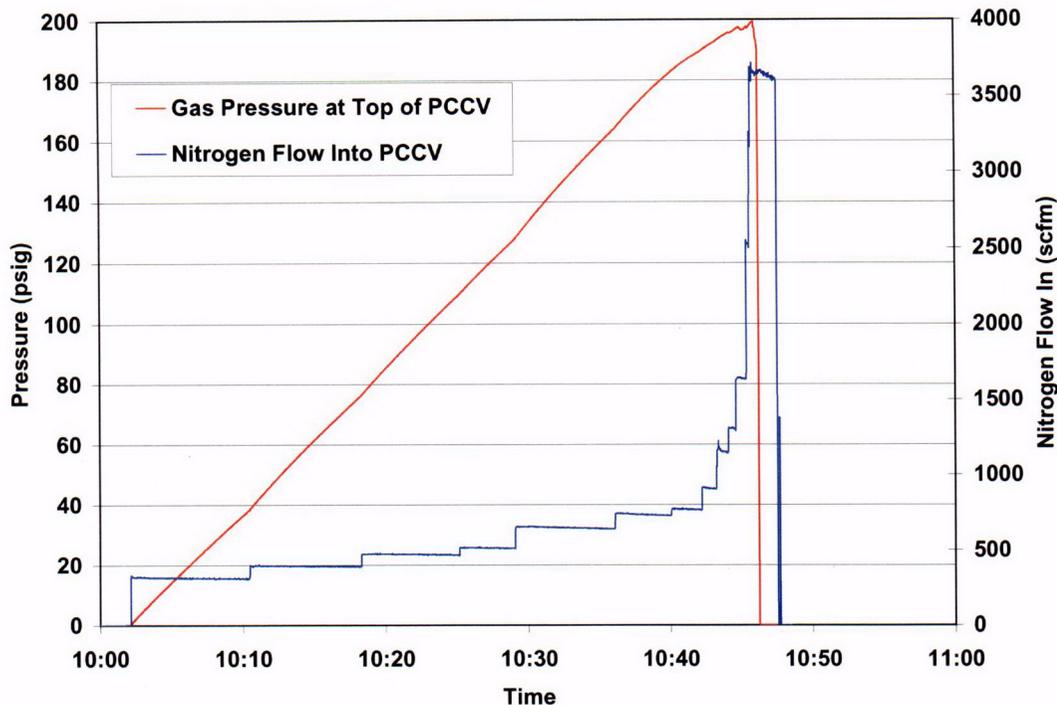
Figure 5.33 SFMT Pressurization System Data

The rate of pressurization decreased and the nitrogen flow rate was increased to maintain the pressurization rate. The gas pressure and flow rates are shown in Figure 5.33. The water surface inside the model, viewed through the internal video camera, was dropping slowly, but it was unclear if this was due to leakage or radial expansion of the vessel.
