5.3.2 Limit State Test Results

5.3.2.2 Posttest Inspection

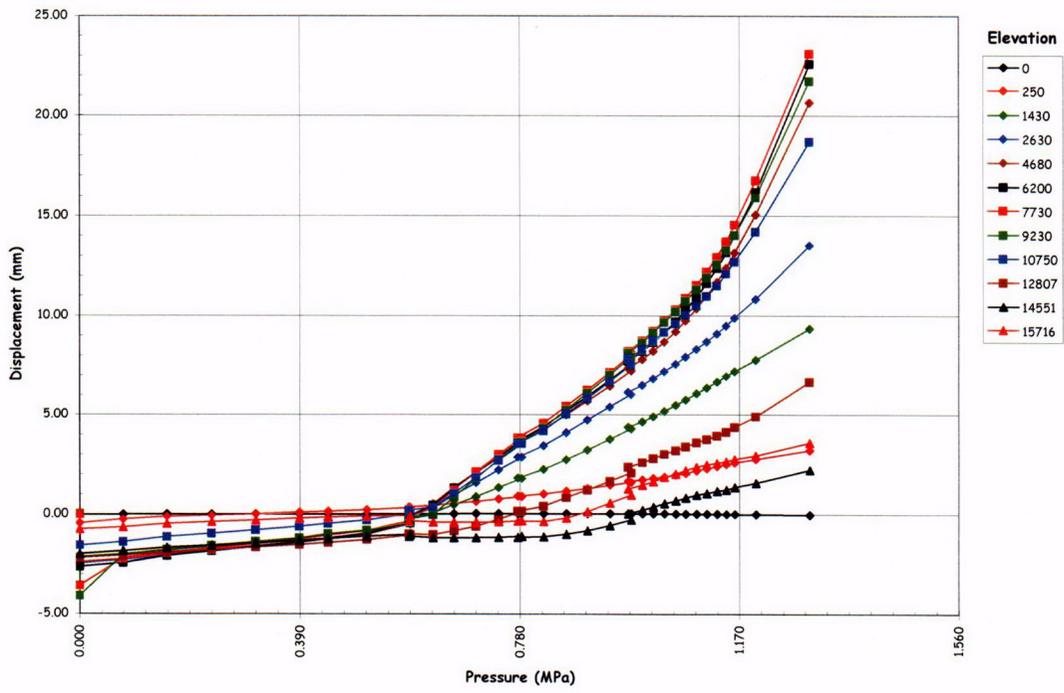
Figure 5.39 LST - Radial Displacement at Azimuth 135 degrees

The radial displacement of the model at the cardinal elevations along Azimuth 135 degrees, selected to represent the 'free-field' or axisymmetric response of the model, is shown in Figure 5.39. This plot illustrates several features of the response data that should be noted. The initial values (i.e. at P=0) reflect the inside surface motion of the liner between March 3rd and the start of the LST, thereby reflecting the influence of prestressing, changes in ambient temperature, creep, etc. The response due to pressure alone is the reported displacement minus the displacement at the start of the LST (i.e., at P=0 on 10:03 a.m., 26 September, 2000).

The initial data also suggests that the liner most likely separated from the concrete wall at some locations, as evidenced by the relatively large displacements that occurred during the first pressure step. At these locations, the first increment of pressure 'pushed' the liner back into contact with the concrete surface. This behavior can also be observed in the SFT and SIT/ILRT data, including a restoration of the gap after depressurization. The liner separation is most likely a result of differential thermal expansion and prestressing, resulting in compressive stresses that may have bowed or slightly buckled the liner.

The response remains essentially elastic up to 1.3 to 1.5 P_d, after overcoming the prestress (~1.2 P_d) and tensile cracking of the concrete. It is interesting to note that even though drying and shrinkage cracks were present prior to pressure testing, the onset of generalized concrete tensile cracking is quite distinct. Beyond 1.5 P_d to approximately 2 to 2.5 P_d, the response is still linear, although the loss of concrete tensile stiffness is quite distinct. Beyond 2.5 P_d, the response becomes increasingly nonlinear, particularly in the mid-section of the cylinder, as the model exhibits generalized yielding in the hoop direction.

The data also exhibits some apparent discontinuities at 1.5, 2.0, and 2.5 P_d. These apparent discontinuities coincide with the leak checks of the model and reflect, primarily, the response to changes in ambient thermal conditions over the time the model was isolated. The jump in displacement at 2.5P_d, however, most likely includes creep effects, since the temperature was stable over the relatively short (1-1/2 hour) hold at this pressure.

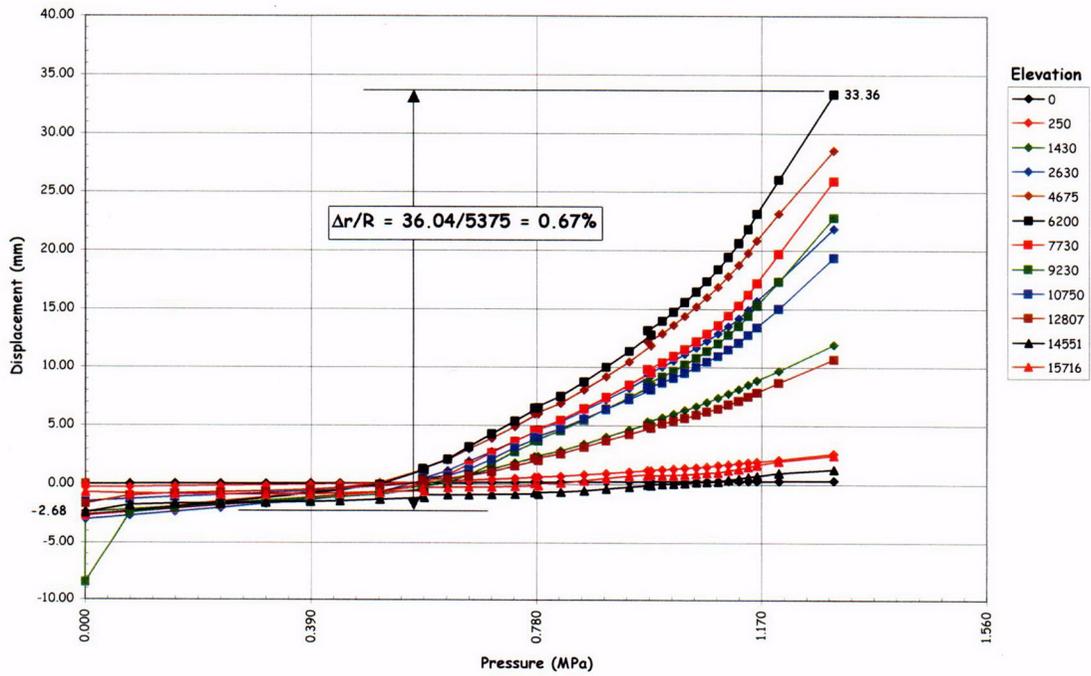
Figure 5.40 LST - Radial Displacement at Azimuth 324 degrees

Figure 5.40 displays the displacements at Azimuth 324 degrees, which coincides with the centerline of the E/H. The largest radial displacement recorded during the LST, 33.36 mm, occurred at this Azimuth at El. 6200, above the E/H. Computing the equivalent hoop strain due to pressure at this location from kinematics,

Similarly, calculating the local hoop strain in the vicinity of the equipment hatch at 2.5P_d, corresponding with the onset of liner tearing and leakage, yields a value of approximately 0.28%.

Figure 5.40 again illustrates the liner separation phenomena, previously described, at elev. 9230. In this case the large magnitude of the displacement clearly indicates that the liner buckled. (A review of the post-prestressing data indicates that this occurred shortly after the completion of prestressing, most likely in conjunction with thermally-induced compressive strains.) This behavior did not, however, compromise the integrity of the liner and no tears were discovered at this location.

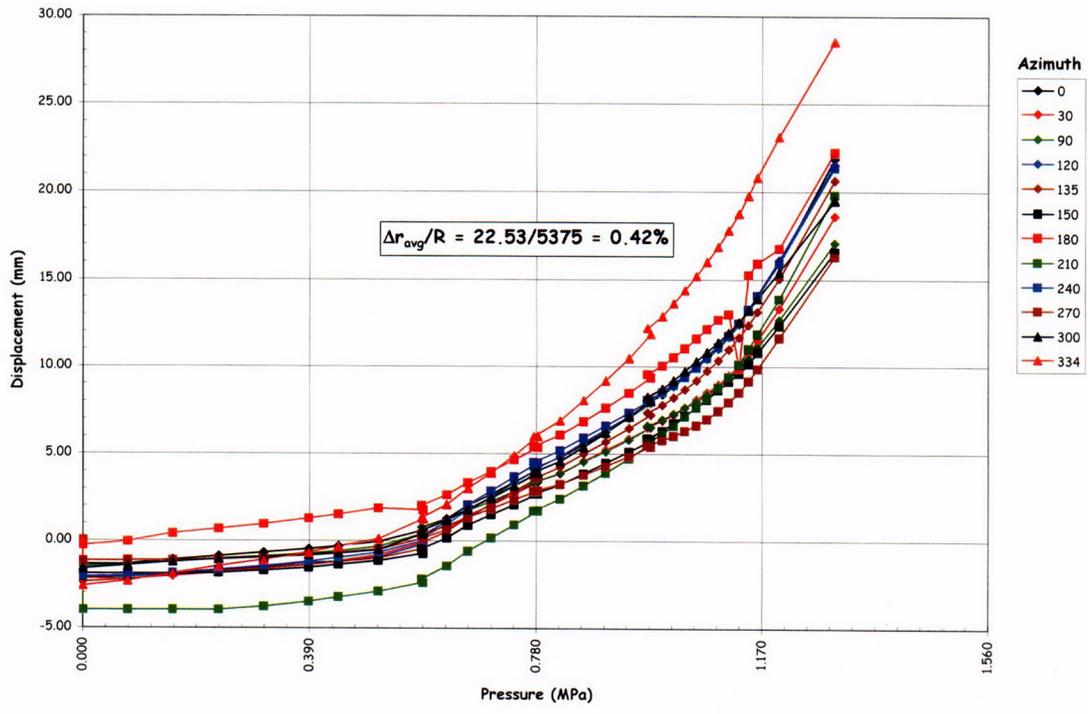
Figure 5.41 LST-Radial Displacement (DOR) at EL 4680

Figure 5.41 compares the displacement response as a function of Azimuth at elev. 4680, nominally the mid-height of the cylinder and the centerline of the E/H, A/L, and M/S penetrations. Ignoring some variation in initial conditions, reflecting some 'out-of-roundness' following prestressing, the response is fairly uniform, i.e. axisymmetric, except at 324 degrees, where largest deflections were already noted to occur. Averaging the radial deformation due to pressure yields a nominal average hoop strain of 0.42% at the peak pressure 3.3P_d. Similarly, the average hoop strain at 2.5P_d, coinciding with the onset of liner tearing and leakage, was 0.18%.

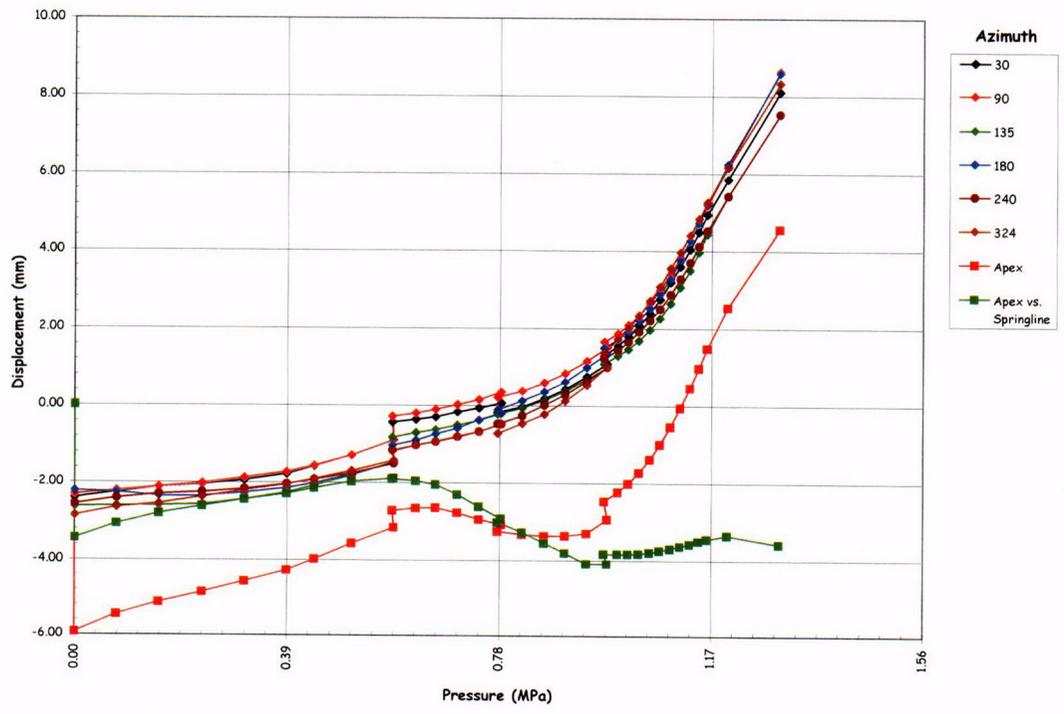
Figure 5.42 LST-Vertical Displacements (DOR) at Springline, El. 10750

Figure 5.42 shows the vertical displacement of the springline at various azimuths. The vertical displacement at the apex and the differential displacement between the average springline displacement and the apex are also plotted. The vertical displacement exhibits similar behavior to the hoop displacements. In the vertical direction, however, the loss of stiffness due to concrete cracking occurs around 2.5 P_d. Yielding in the vertical direction does not appear to occur. This is due to the higher level of vertical prestress in the cylinder wall and the lower tensile forces induced by the pressure. The

The vertical displacements illustrate, much more dramatically, the effect of ambient temperature and creep during the leak checks.

Figure 5.42 also shows that beginning around $1.5P_d$, the dome apex deflects downward relative to the springline, most likely due to increasing force in the vertical tendons once the initial prestressing force is overcome by the pressure. (The vertical prestressing applies a compressive force on the cylinder wall approximately equal to the tensile force exerted by a pressure of $1.88P_d$.)

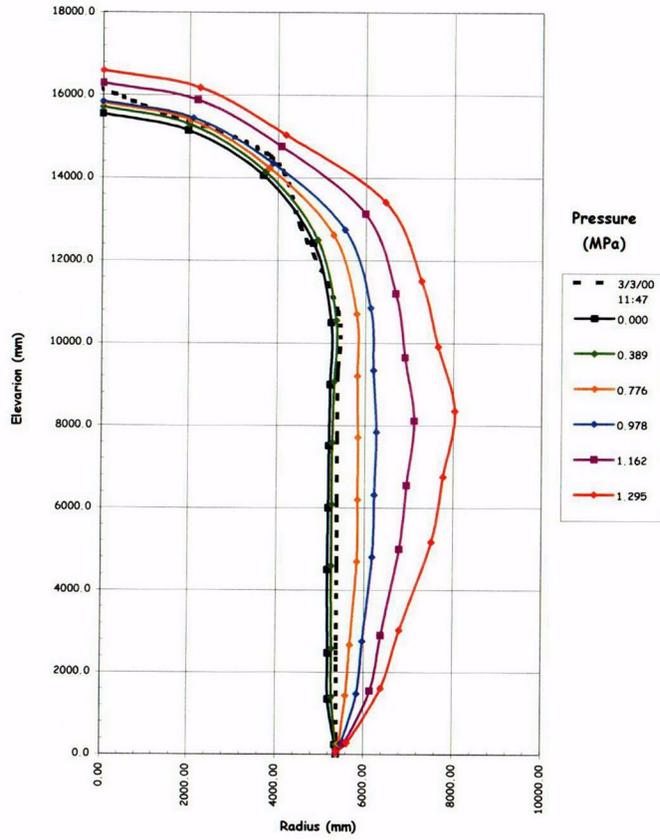
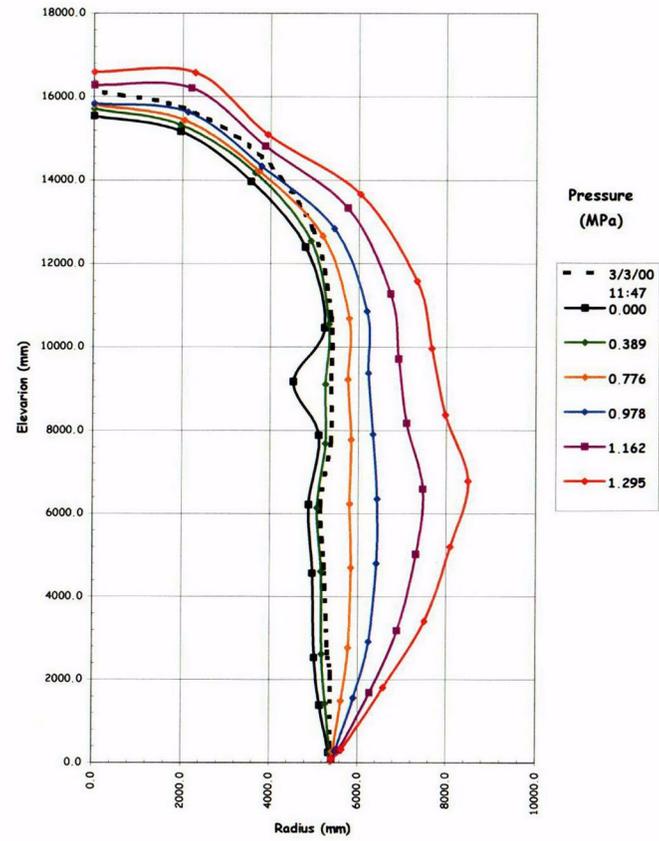
Figure 5.44 LST - Deformation at Azimuth 240 degrees and 324 degrees (I and L) × 100

- The unusual deformation patten in the dome at 135 degrees and 324 degrees coincides with the regions where the East-West and North-South sets of vertical tendons overlap with the hoop tendons in the dome, where higher prestressing forces are present than in other regions of the dome.
- The initial buckling of the liner at Azimuth 324 degrees, elev. 9230 is clearly shown in Figure 5.44.

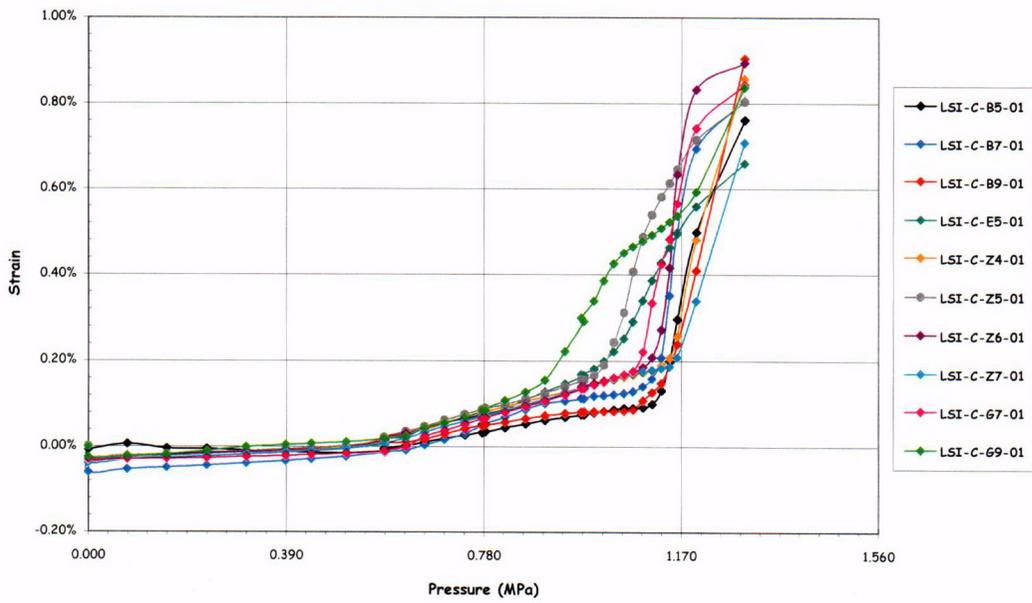
Figure 5.46 LST – Free-Field Liner Hoop Strains

Figure 5.46 shows all the free-field liner hoop strain gages that exceeded 0.5% at the end of the test. It is interesting to note that up to 2.5 Pd, the free-field liner strain hoop strains were almost all below 0.2%, which compares favorably with the average hoop strain computed from the displacements, 0.18%.

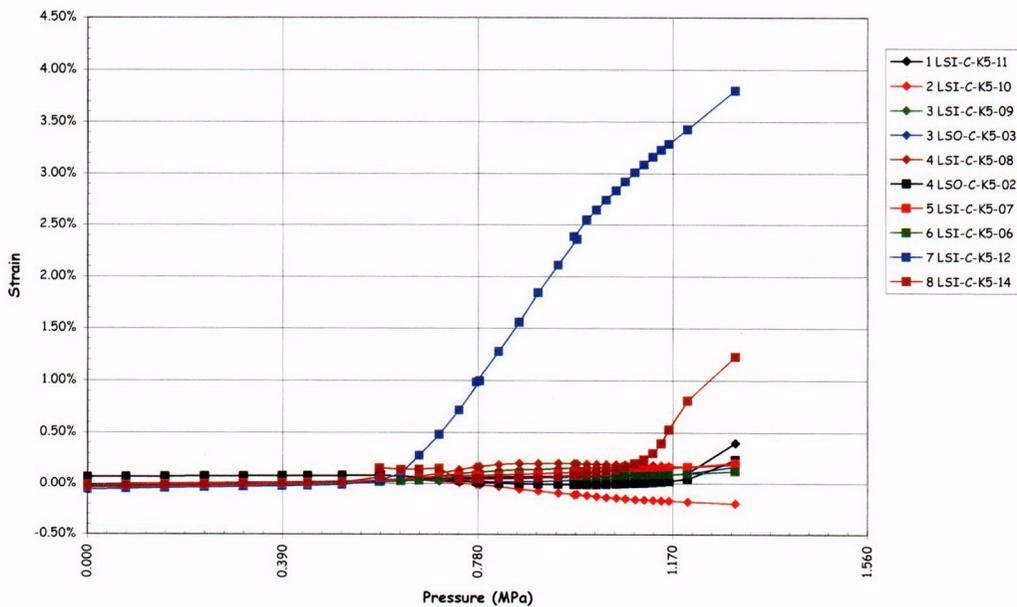
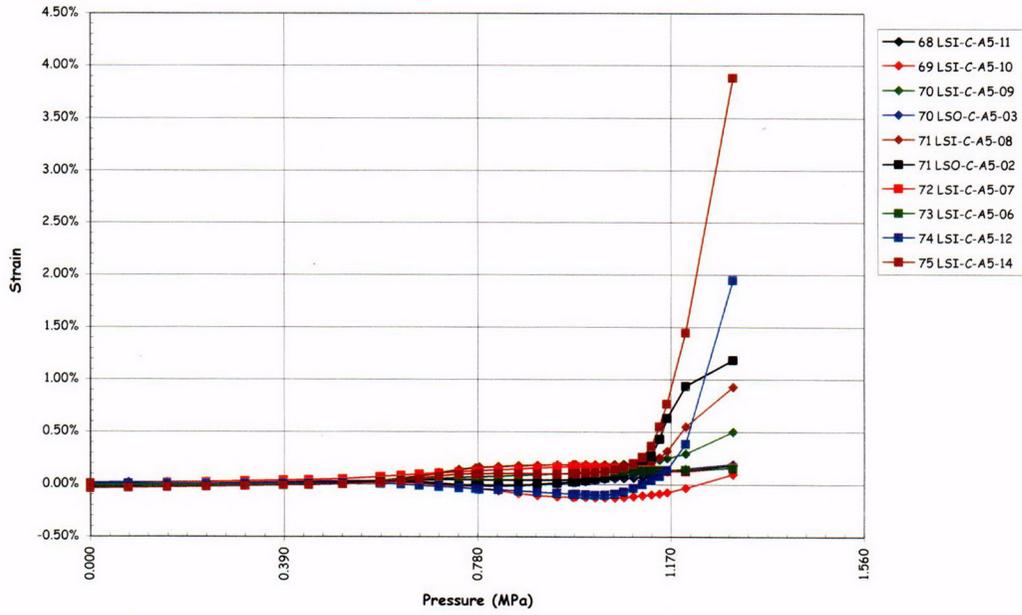
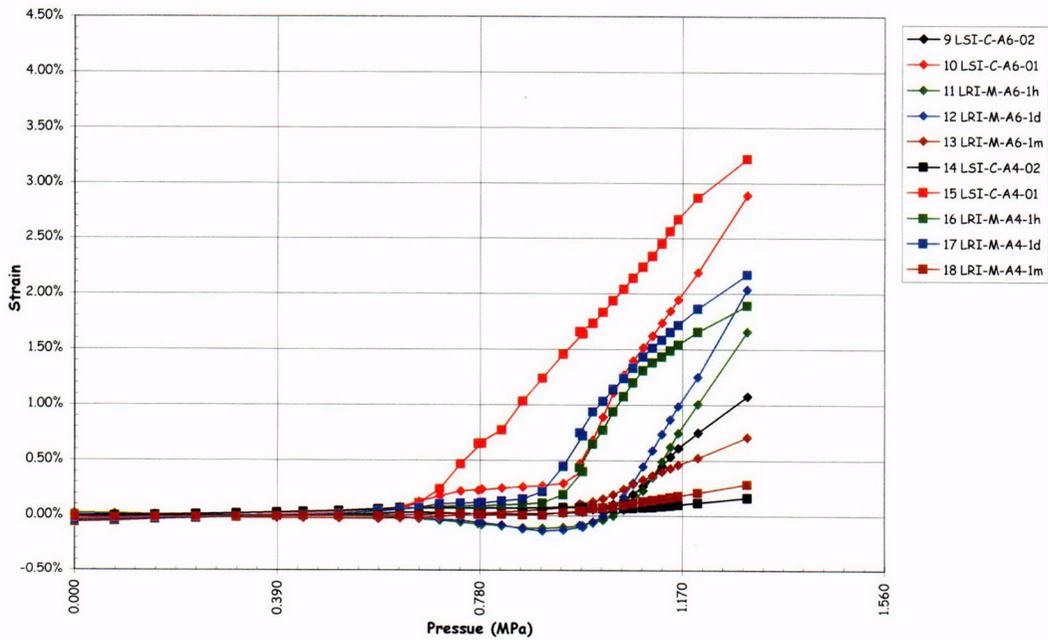
The strains at the middle of the 'left' (#1-8) and right (#68-75) edges of the embossment are shown in Figures 5.49 and 5.50. The strains at the upper and lower 'left' corners are shown in Figure 5.51. With the exception of gage #7, the strains at the mid-sides of the embossment are all very small until global yielding of the model occurs just below $3P_d$. At the corners, however, liner strains begin increasing earlier, with gage #10 showing increasing strains beginning at $1.5P_d$, while most of the other gages show significant increases beginning at $2.5P_d$, when liner tearing was believed to

have occurred. At first glance, it appears unfortunate that the liner tore on the opposite side from the strain gages (pretest analyses suggested the highest strains would occur on the 'left' side). However, it has been found that strain gages near tears often see lower strains than would be expected, since the tear acts as a strain relief mechanism. While it is apparent that the strains on the 'right' side were higher, it is unlikely that gages at those locations would have recorded higher strains than those on the left side. This is demonstrated by comparing gages #7 on the left and its mirror image, #74, on the right.

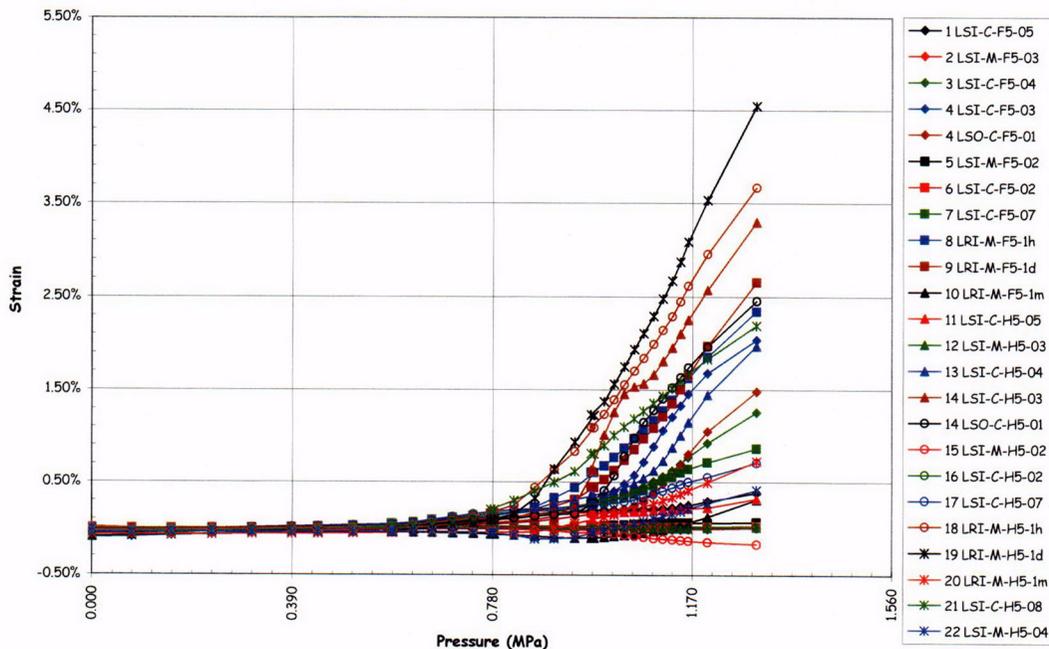
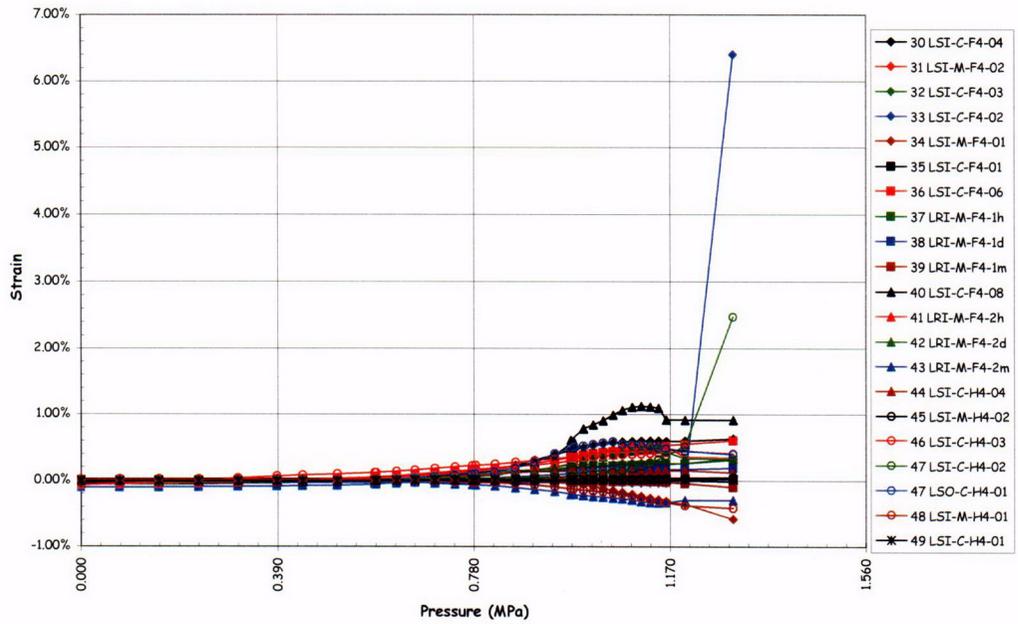
Liner strains at the M/S and F/W penetrations are shown in Figures 5.52 and 5.53. The layout of the liner strain gages is shown on Drawing D-SN-P-220 (Appendix E).

Several large tears occurred at each end of the F/W penetration, beginning at the weld between the thickened insert plate and the liner; however, no tears occurred at the M/S penetration event, though the free-field hoop strains at the M/S are higher since it is closer to the mid-height of the cylinder. There are a number of reasons why this occurred, primarily liner fabrication issues discussed in Section 5.3.2.2. It is interesting to note that even though the strain gages at the F/W penetration were located near the tear (see Figure 5.54), measured strains were relatively low until the very end of the LST, when some strains increased very rapidly. This might indicate that a tear in the vicinity of a strain gage can act as a strain relief mechanism on the surrounding material. The 'jump' in the strain near the end of the test may also be due to material distortion in the vicinity of the tear as the tear propagated. On the other hand, the strains recorded at the M/S penetration begin to climb rapidly at 2.0 to $2.5 P_d$, reaching values as high as 4.5% without resulting in any liner tearing. Detailed inspections of this location did not reveal any evidence of the fabrication problems that were present at the F/W penetration.

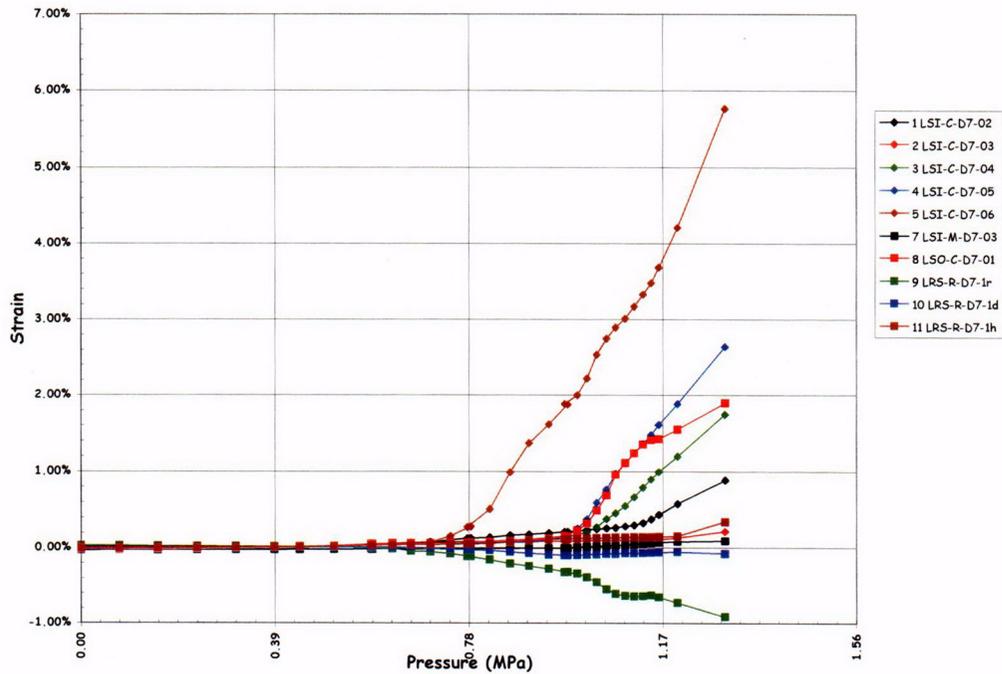
Figure 5.56 Liner Strains (DOR) at D7 Anchor Detail (Ref. R-SN-P-209, a.4)

The interior strain gages at D7 are also shown after the LST in Figure 5.56. The arrangement of these gages is shown on Drawing D-SN-P-209, Detail a.4 (Appendix E). Strains begin increasing between 2.0 and 2.5Pd, reaching a maximum of 5.7% at the maximum pressure. Nevertheless, the liner did not tear. A subsequent comparison of this detail to similar rathole details that did tear, but were not instrumented, revealed a lack of any weld repairs, which was not true of the other locations. This detail appears to demonstrate that the liner is capable of undergoing significant local strain without tearing in the absence of any other factors that might degrade the liner.

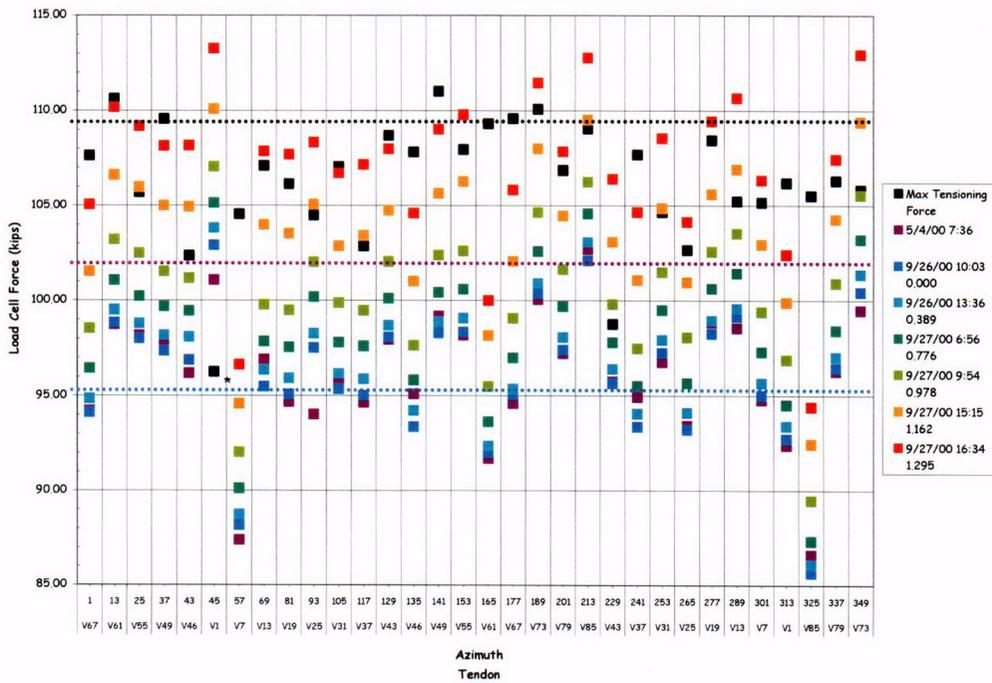
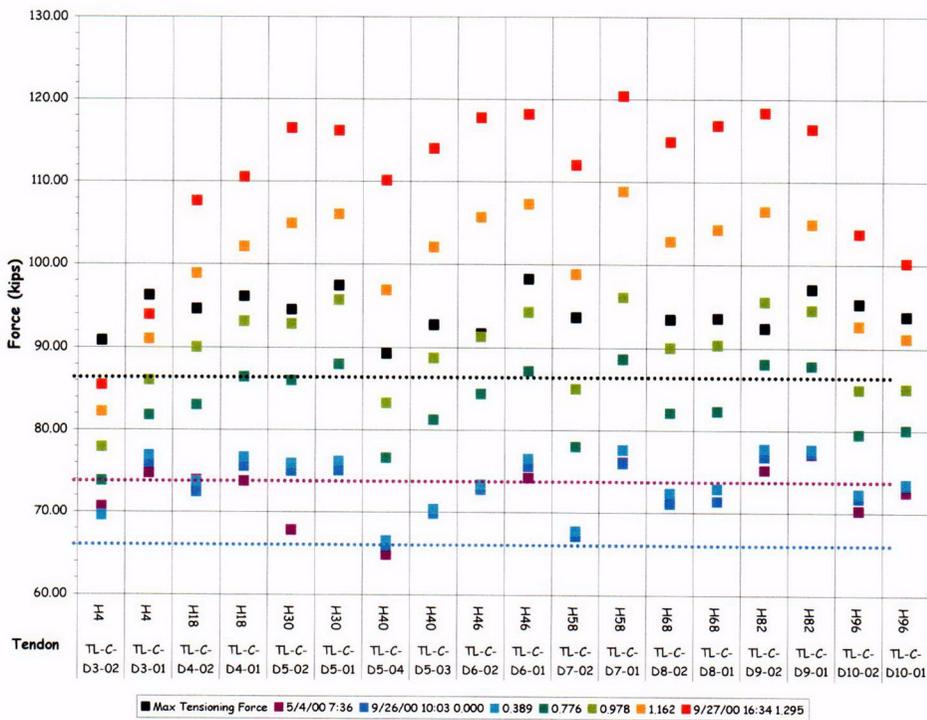
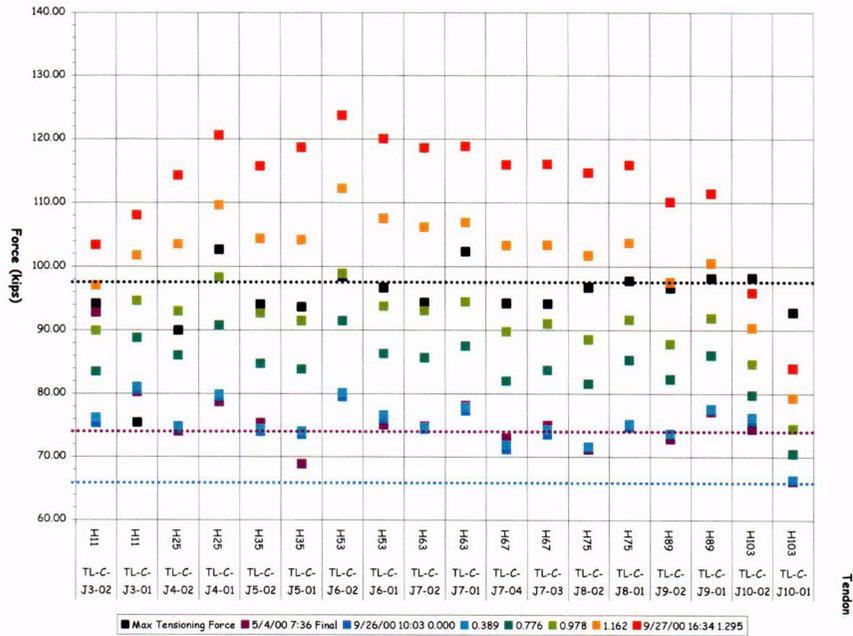
One-sixth of the tendons in the model were equipped with load cells at each anchor prior to prestressing. Figures 5.60 through 5.62 illustrate the tendon anchor forces during the LST. The anchor forces for the vertical tendons with load cells are shown in Figure 5.60. The anchor forces are shown for the maximum tensioning force during prestressing, after the completion of prestressing (on 5/4/00) and during the LST at $0.0P_d$, $1.0P_d$, $2.0P_d$, $2.5P_d$, $3.0P_d$ and at maximum pressure, $3.3P_d$. Similarly, Figures 5.61 and 5.62 show the anchor forces for the hoop tendons anchored at the 90 degree

and 270 degree buttresses. In general, the vertical tendon anchor forces did not exceed the initial tensioning force. The average vertical tendon force at the peak pressure of $3.3P_d$ was 466 kN (104.7 kips) compared to the average tensioning force of 472 kN (106.3 kips). The hoop tendon anchor forces, however, did exceed the initial tensioning force of 424 kN (95.3 kips). The maximum anchor force recorded at the peak pressure of $3.3P_d$ was 550 kN (123.64 kips) for tendon H53. The average anchor force for all the hoop tendons at the peak pressure was 496 kN (111.6 kips). The tendon yield strength (0.2% offset) is approximately 590 kN (132.6 kips), so hoop tendon forces at the anchors were approaching, but had not exceeded their yield strength.
