5.3.3 Structural Failure Mode Test Results

5.3.3.2 Posttest Inspection

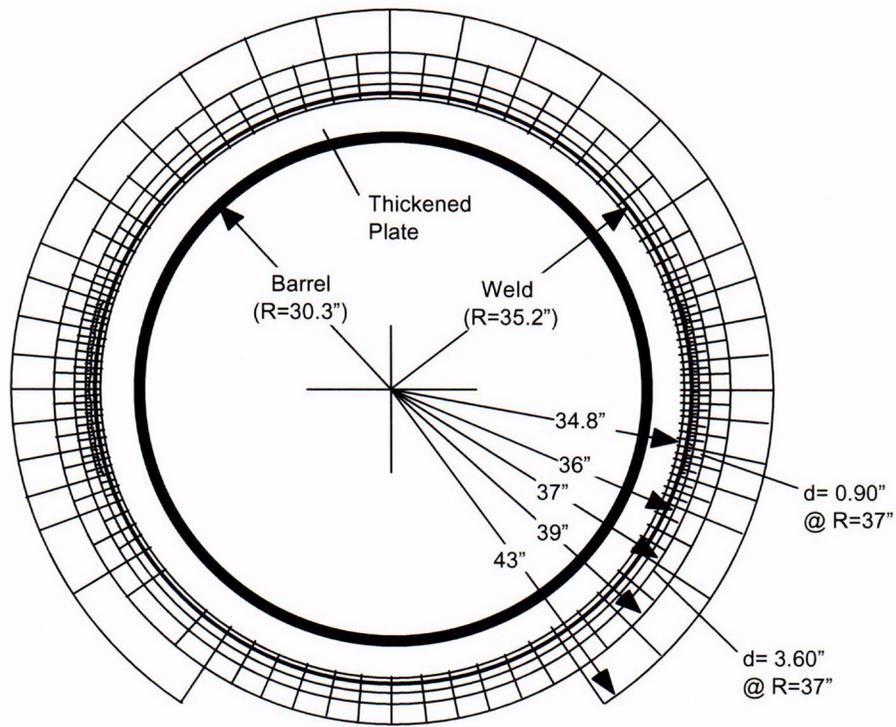
Figure 5.89 E/H Displacement Grid

As described in Section 3.2.5.4, a grid was constructed around the E/H to measure the residual strain field after the test. The pretest analysis predicted large strains near the perimeter of the thickened insert plate surrounding the E/H barrel and near the anchors and stiffeners that terminated near the insert. The grid, shown in Figure 5.89, was drawn, and the position of the grid points was obtained using a 3D digital position mapping tool. After the LST, the grid points were mapped again and the pre- and posttest positions were plotted in Figure 5.90.

Unfortunately, as noted previously, the strains in this region were very small and the resulting residual displacements are barely distinguishable from the pretest positions, given the precision of the digital probe. As a result, no useful information was obtained by this effort.

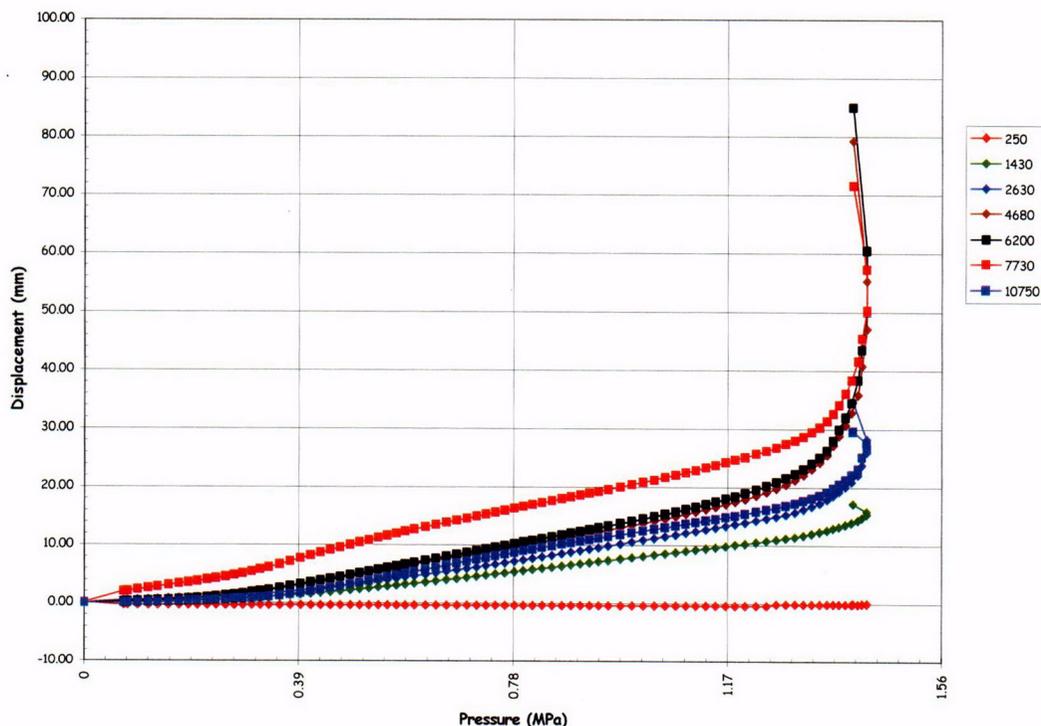
Figure 5.91 SFMT – Radial Displacement at Azimuth 135 degrees (Z)

During the SFMT, the displacement response of the model is essentially linear to just beyond 3.0 Pd, when global yielding begins to occur prior to rupture. The initial stiffness of the model, however, is less than the initial stiffness during the LST. Figure 5.94 compares the response at the mid-height of the cylinder (Z6) during the LST and the SFMT. (The SFMT response was offset in this figure by adding the residual displacement at the end of the LST to facilitate comparison.) This figure shows that the hoop stiffness during the SFMT is essentially identical to the post-cracking stiffness during and after the LST. It also shows that the SFMT displacement is nearly identical to the LST displacement at the maximum LST pressure, suggesting that, if the LST had continued, the response would have been virtually

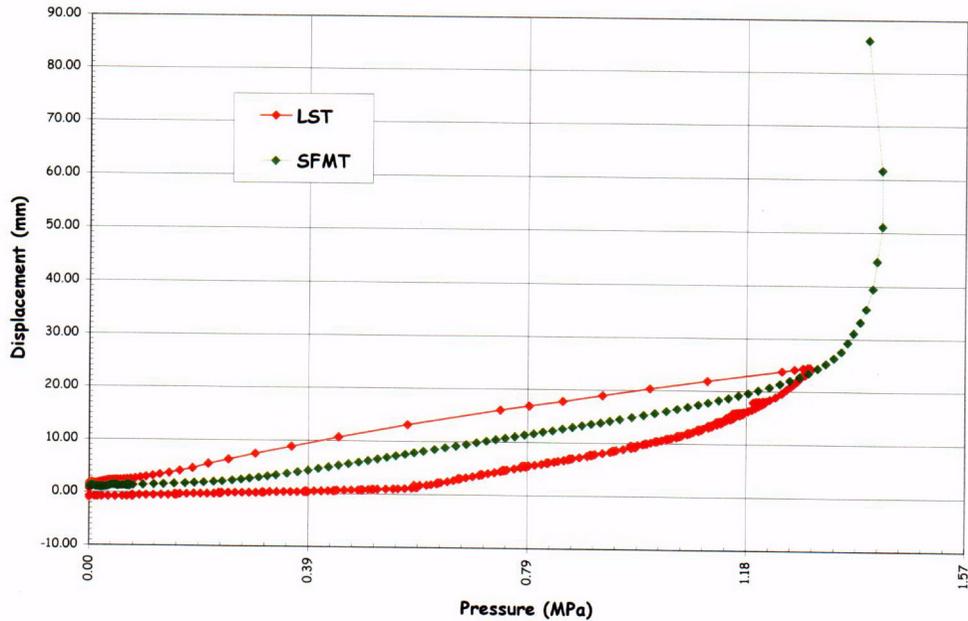
Figure 5.94 SFMT – Radial Displacement at Azimuth 135 degrees, Elev. 6200

identical to that measured during the SFMT. Similarly, the vertical displacements at the apex (offset again) are compared in Figure 5.95.

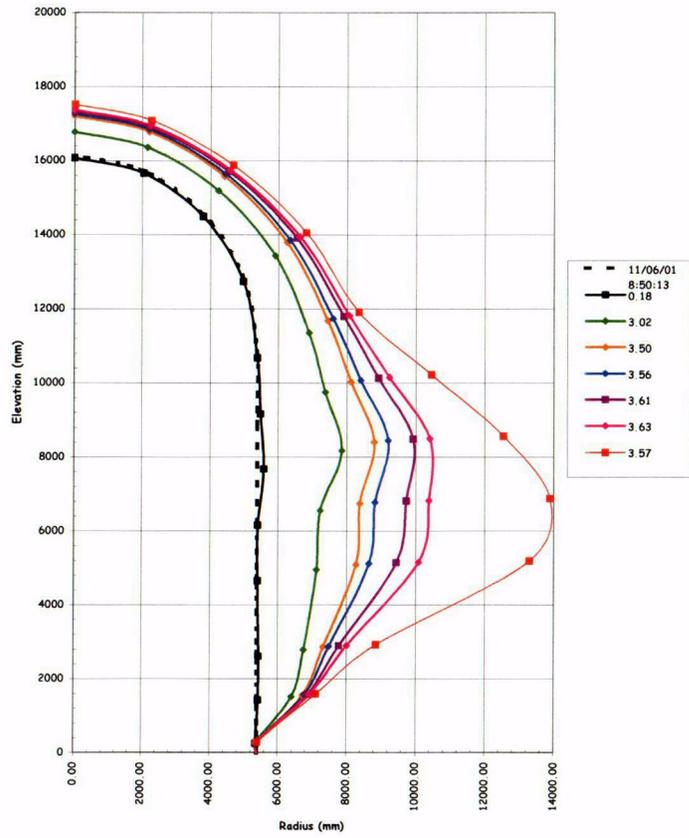
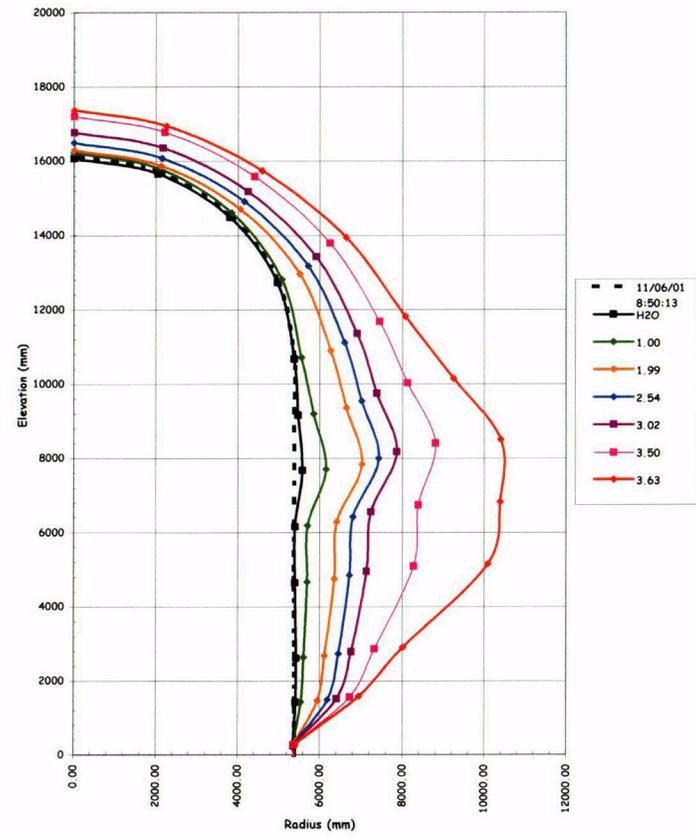
Figure 5.97 SFMT - Deformation at Azimuth135 Degrees (Z) $\times 100$

Deformed profiles of the PCCV model, constructed from the displacement data in a similar manner as those constructed for the LST, are shown in Figures 5.97 through 5.100. For the SFMT, the initial position was again assumed to be defined by the as-built model survey data (Appendix C). However, since the gages were zeroed prior to the start of the SFMT, any deformations of the liner surface or the wall are not reflected in the data.

The as-built position of the PCCV model is plotted in the first portion of the figures, along with the deformed shapes due to the hydrostatic pressure (H_2O) and at approximately $1.0P_d$, $2.0P_d$, $2.5P_d$, $3.0P_d$, $3.5P_d$, and $P_{max}=3.63P_d$. The second portion of each figure provides a more refined breakdown between $3.0P_d$ and $3.63P_d$ and the profile at $P_{final}=3.57P_d$, immediately prior to rupture of the vessel. These figures dramatically illustrate the large deformations that occur as the vessel yields, even though the pressure is dropping. The displacement nearly doubles as the pressure drops from $3.63P_d$ to $3.57P_d$.

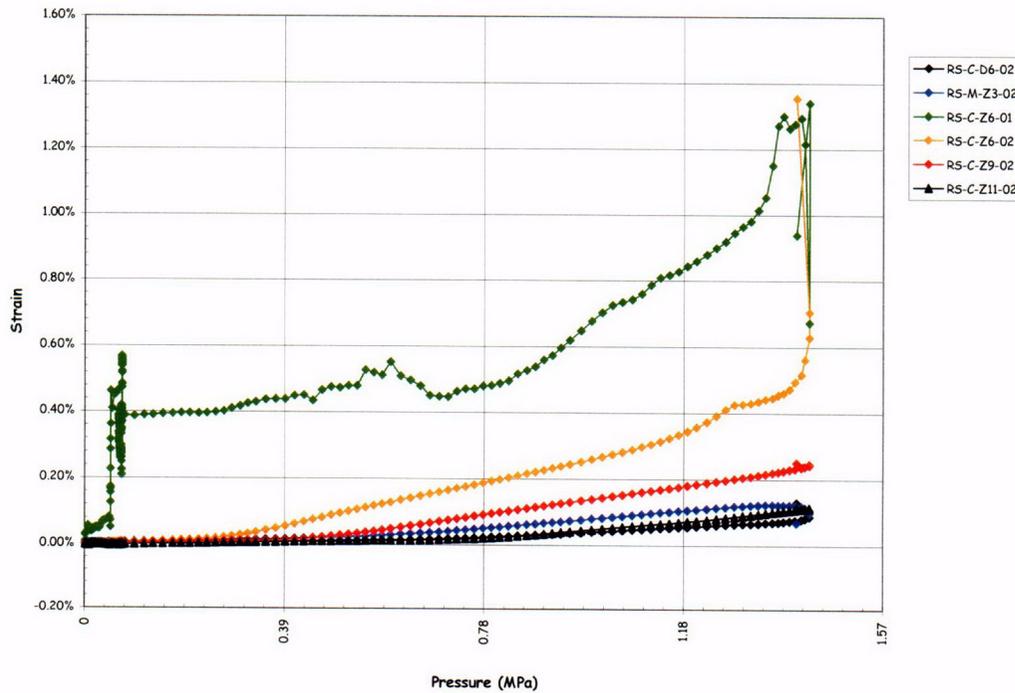
Figure 5.102 SFMT - Free-Field Hoop Rebar Strains

Eighty-two rebar and gage bar gages were selected for monitoring during the SFMT. Of these, four of the main rebar strain gages and all the gage bar strain gages appear to have failed before $0.5P_d$. The strain histories for all 31 surviving rebar gages are shown in Figures 5.102 to 5.104. The maximum free-field hoop rebar strain was 1.4% (RS-C-Z6-02). The maximum free-field meridional rebar strain was 0.3% (RS-M-D6-02). These values are consistent with the global strains based on displacement data. The rebar strains at the wall-base junction show the effect of bending but combined with the other meridional strains, confirm that the model was still essentially elastic in the vertical direction.

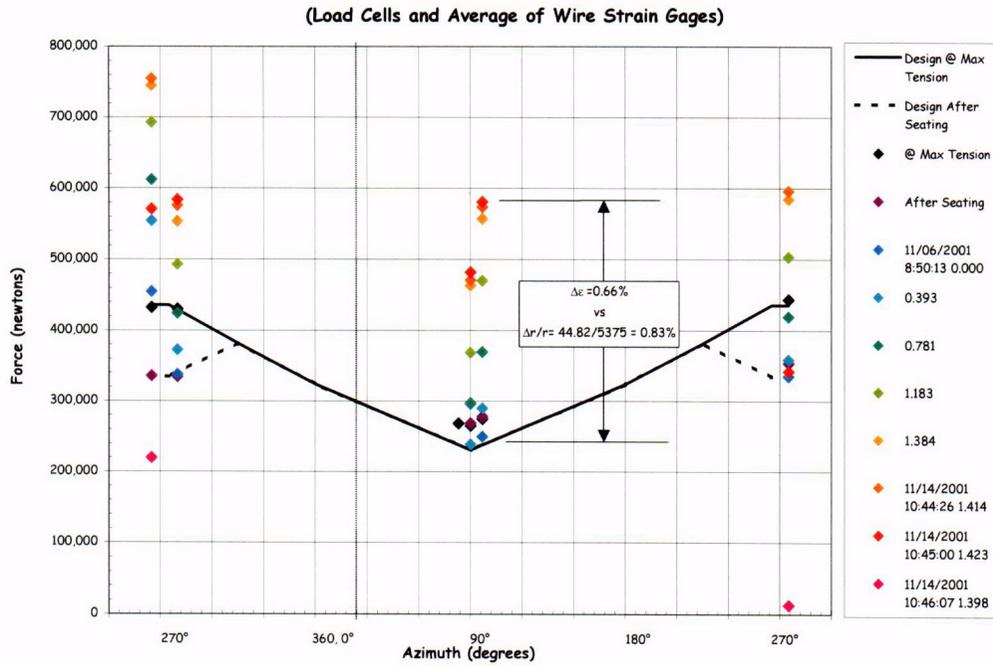
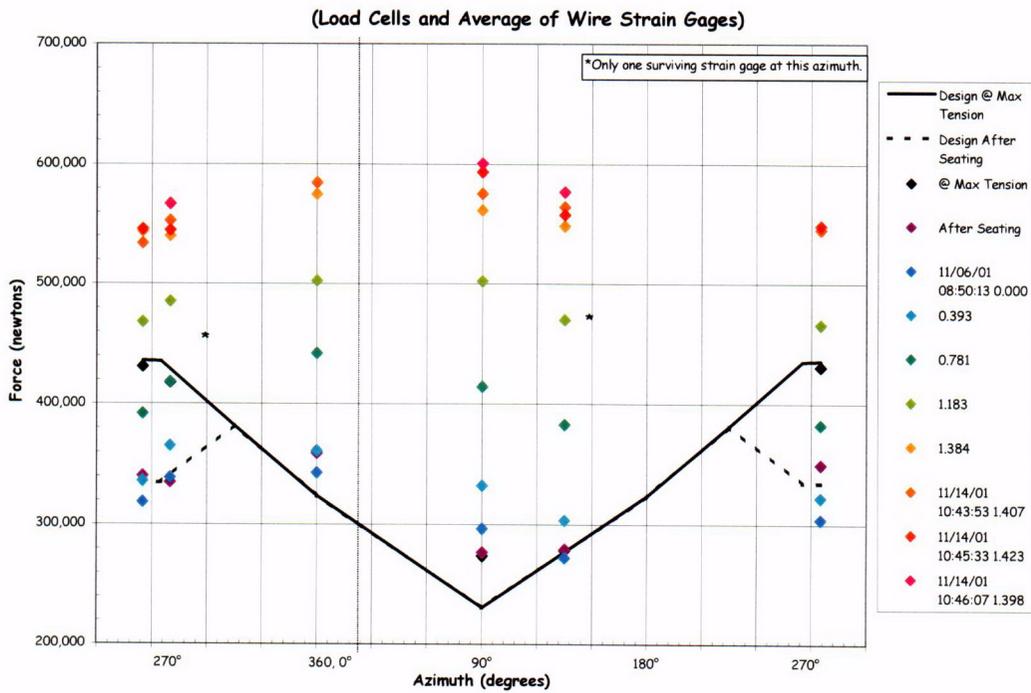
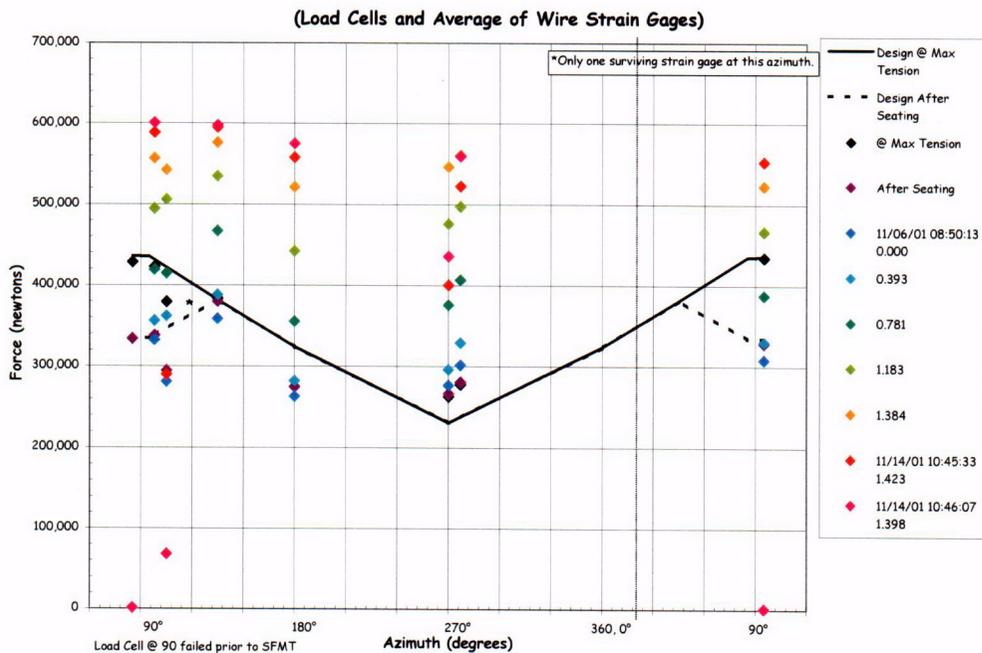
Again, the data is not adequate to assume the shape of the hoop tendon force profile between the surviving measurement positions, and only the force at the measurement locations are plotted, with no attempt to interpolate the strain between the measurement locations. As the pressure is increased, however, and generalized yielding of the model and the tendons occurs, all the plots indicate that the tendon force becomes more uniform along the length, approaching a limiting value of approximately 600 kN (135 kips). One unresolved issue is whether the tendon force equilibrates by slipping relative to the sheath or if the friction is high enough to effectively bond the tendon to the concrete.

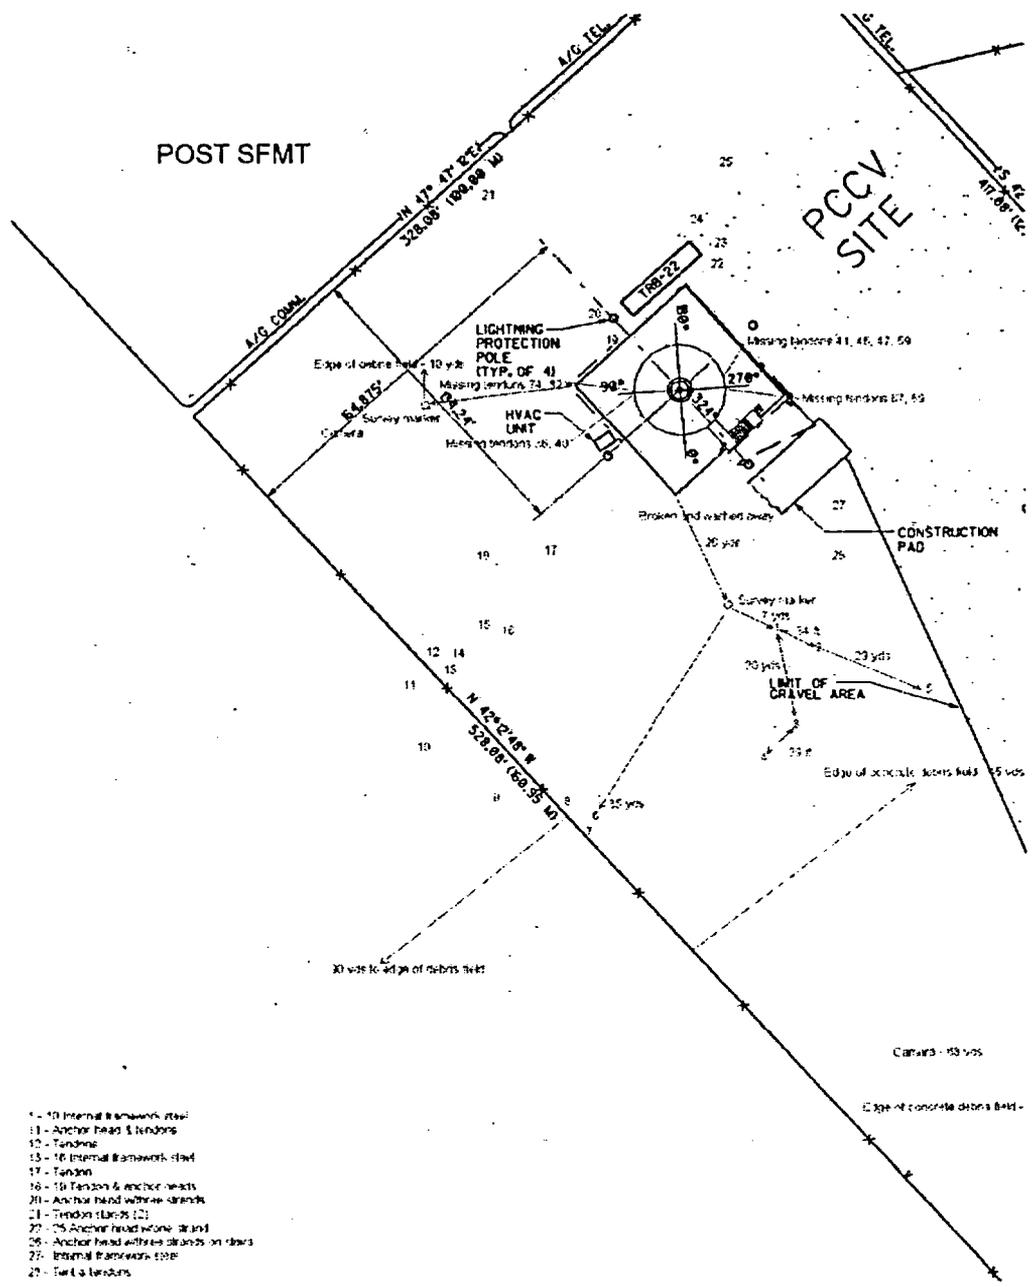
Figure 5.125 SFMT – Debris Map

The position of the model after the SFMT was also noted. Figure 5.124 shows that the model displaced approximately 3" horizontally and tipped in the opposite direction of the rupture. Six tendons were completely ejected from the model and the final location of major pieces of debris were mapped on the site plan, as shown in Figure 5.125. The location of the debris was not only due to the initial rupture, but also by the flow of 350,000 gallons of water escaping from the model.
