Subject: 2003 Annual Pond Inspection Report
Source Materials License SUA-1534
Docket Number 40-8943

**CROW BUTTE MINE
DAWES COUNTY, NEBRASKA**

2003 POND INSPECTION REPORT

October 20, 2003

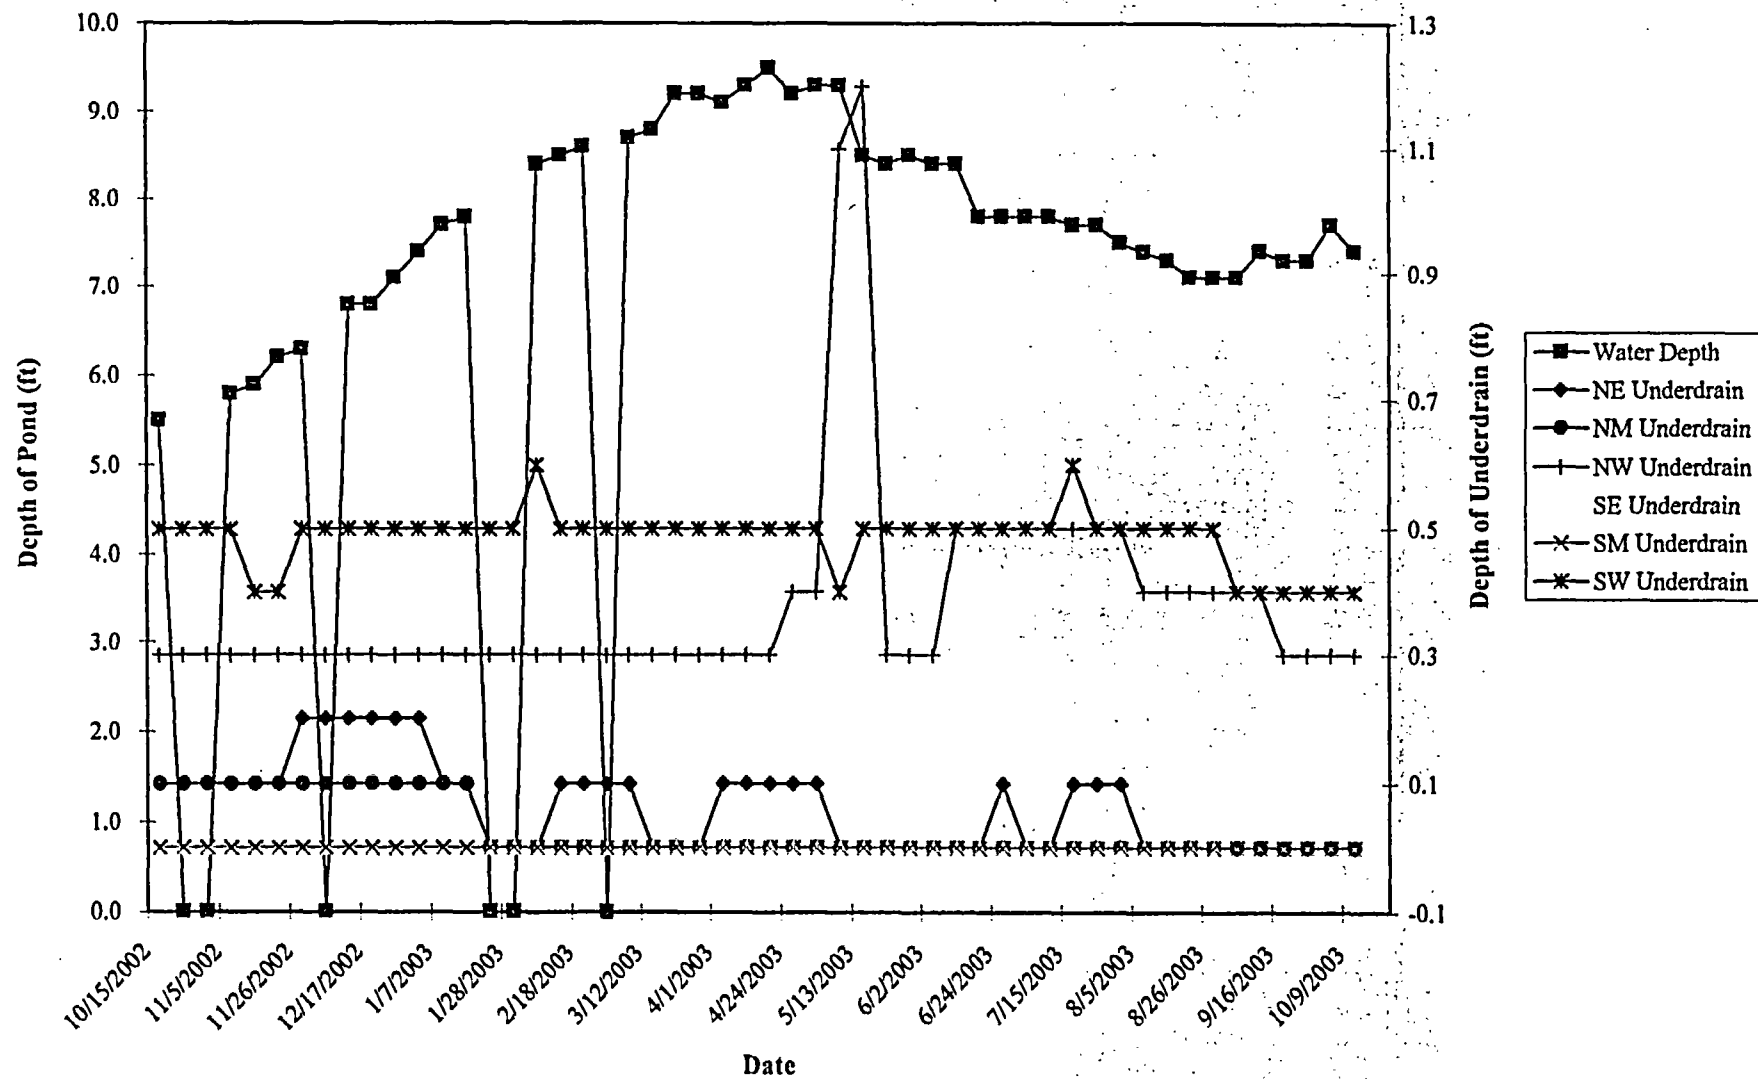
CHART 1

An elevated underdrain conductivity level was detected on the northwest monitoring tube of Pond 1 in May, 2003. The cause of the leak was a small hole in the liner caused by the apparent abrasion on the liner from the spray system. The spray system must have rubbed against the liner during windy weather. A repair of the pond liner was accomplished in June and the conductivity level reduced to an acceptable level. The monitoring tube was flushed with fresh water a couple of times after the liner was repaired. Nebraska DEQ was notified of the liner leak. The records indicate the pond liner was repaired in June, 2003.

This is the second year in a row that a leak has been detected in pond #1 and the leaks have occurred in the same vicinity (northwest corner of pond). The aeration system has been blamed for the principle cause of the leaks.

Commercial Pond 1 - 2003 Report Period

There has been a liner leak in pond #1 the last two years. The leak has occurred in the northwest corner of the pond and the aeration system seems to be the cause of the line damage. An aeration system with a more secure anchor system may prevent future liner damage. High wind activity on this pond must cause the aeration system to drift to the northwest corner of the pond.
