Subject: 2003 Annual Site Inspection and Monitoring Compliance Report for UMTRCA Title II Disposal Sites

2003 Annual Site Inspection and Monitoring Compliance Report for Uranium Mill Tailings Radiation Control Act Title II Disposal Sites

November 2003

**Bluewater, New Mexico
Edgemont, South Dakota
Sherwood, Washington**

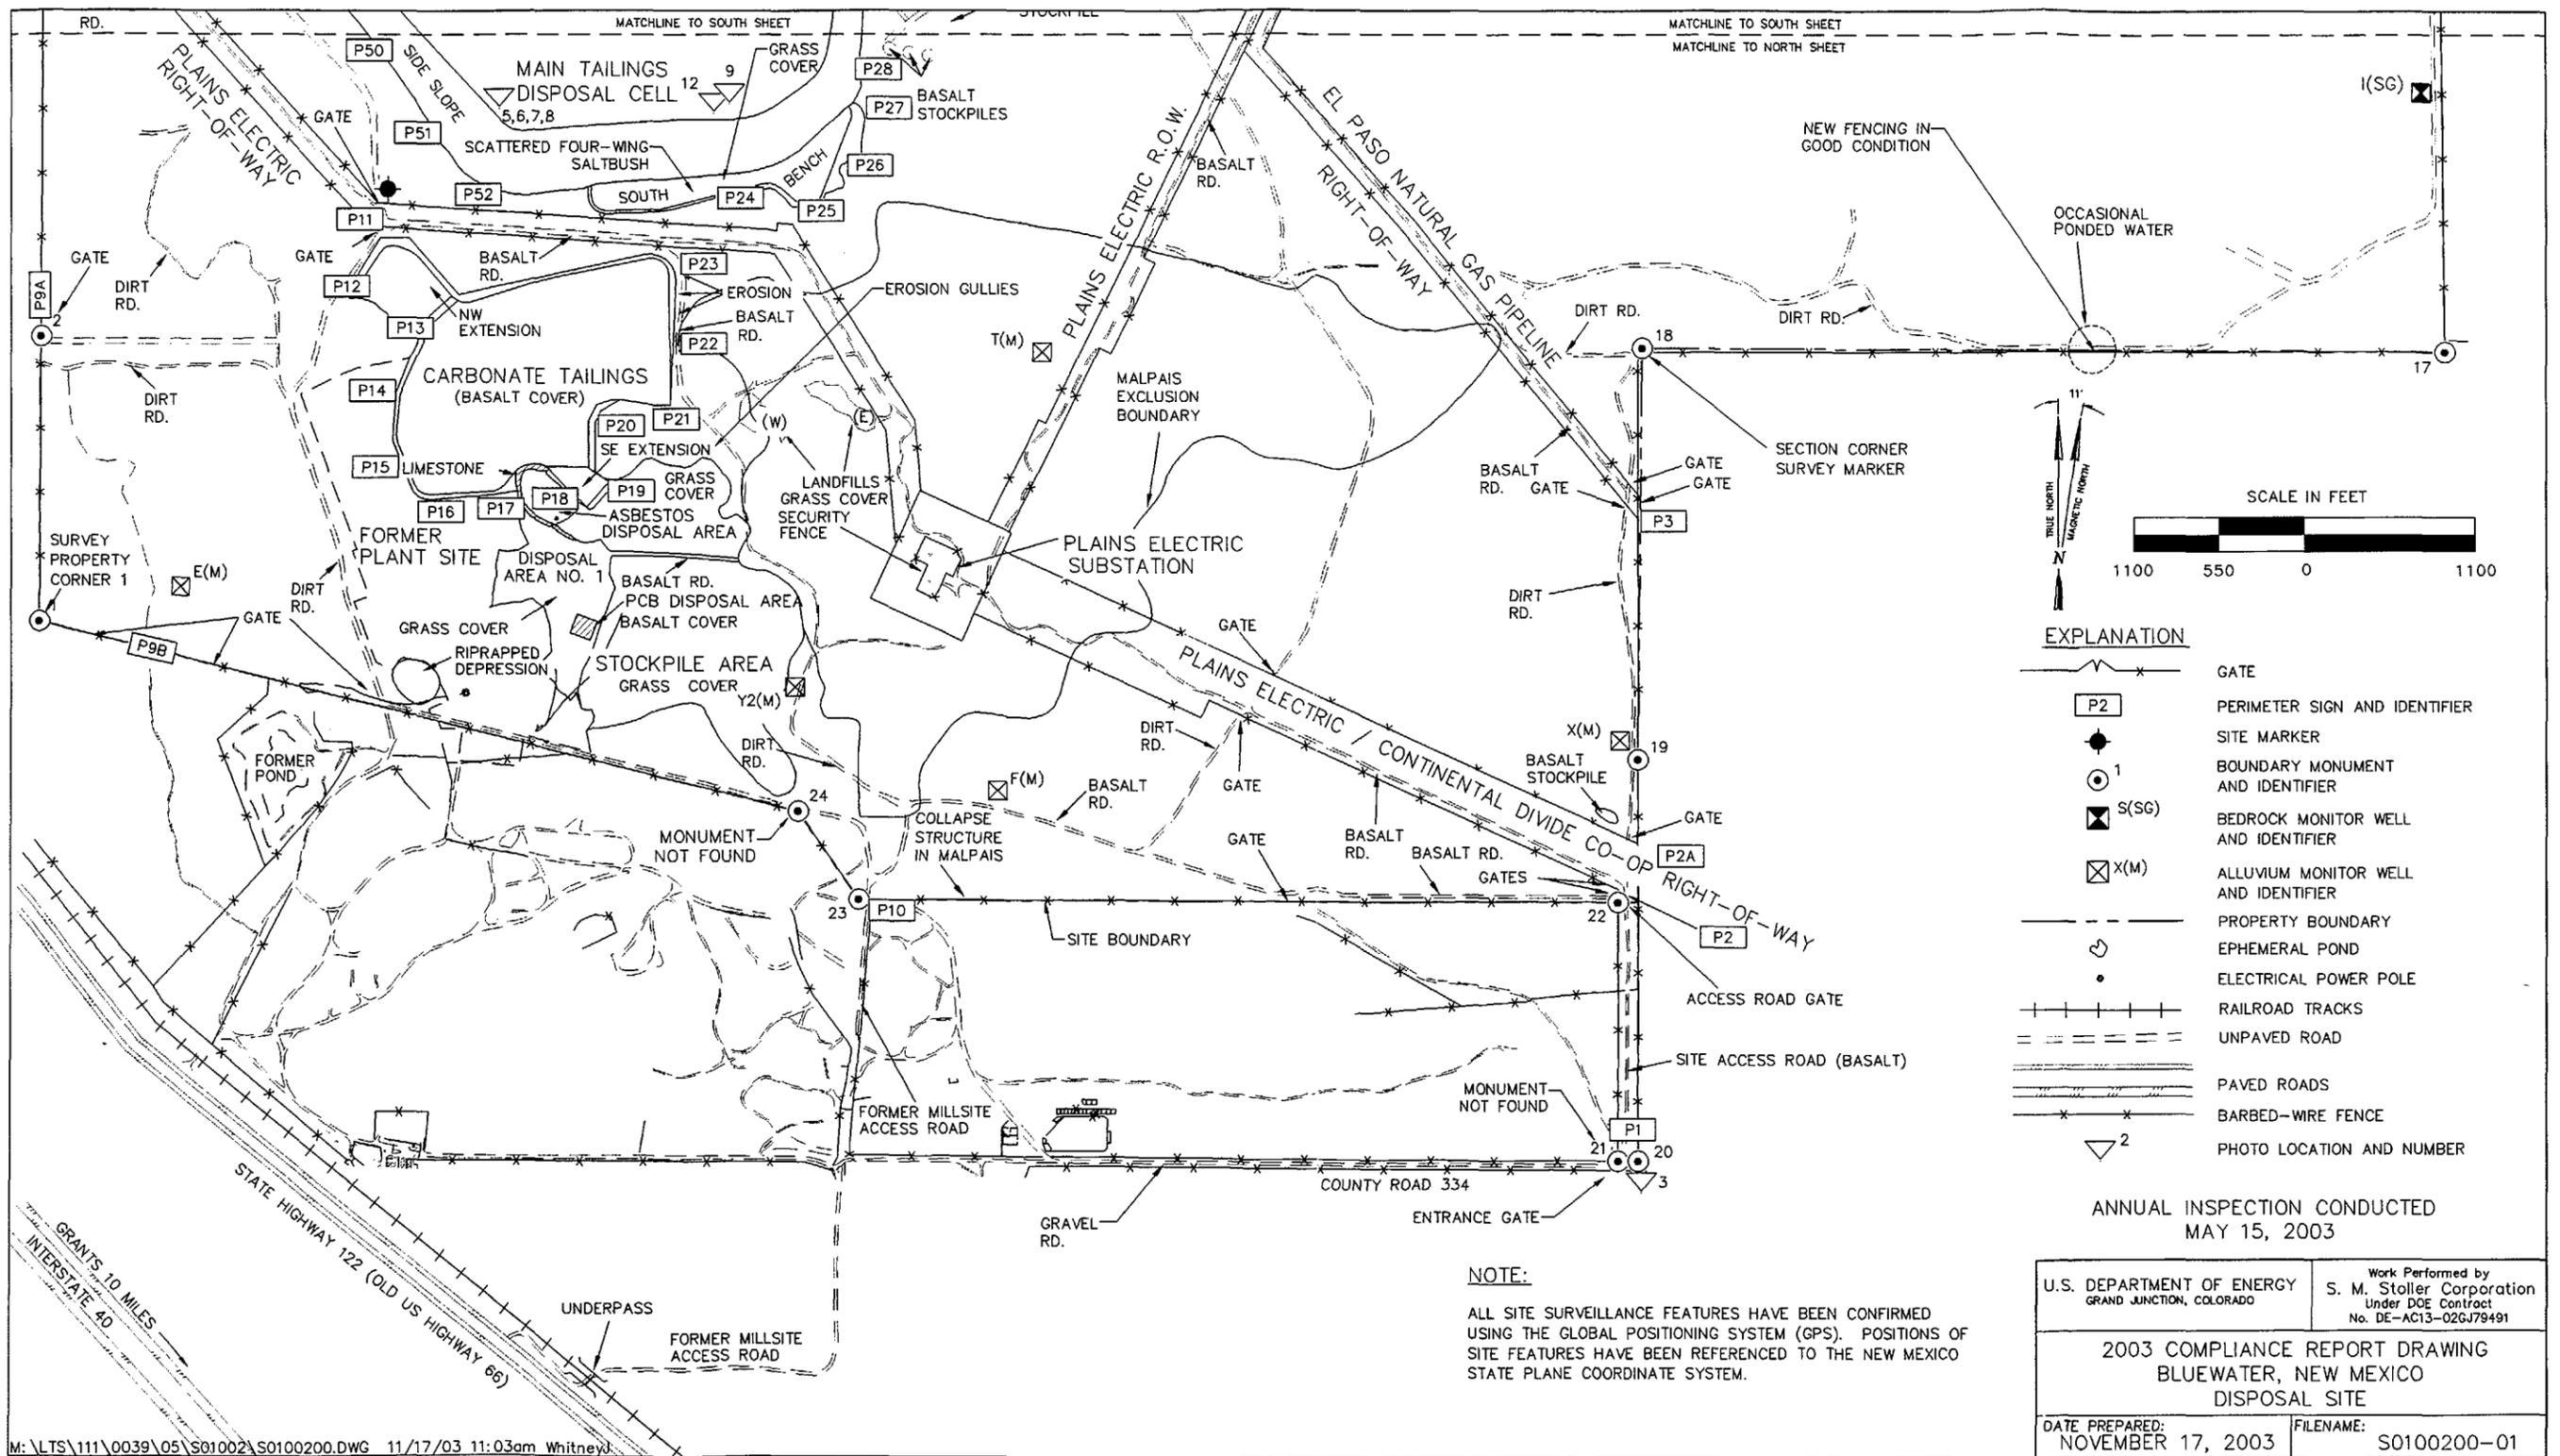
Figure 1-1. Bluewater, New Mexico, South Area, 2003

An electric power substation is enclosed by a security fence near the center of the site along the Plains Electric Company right-of-way (Figure 1-1). Fencing around this station generally is in good condition.

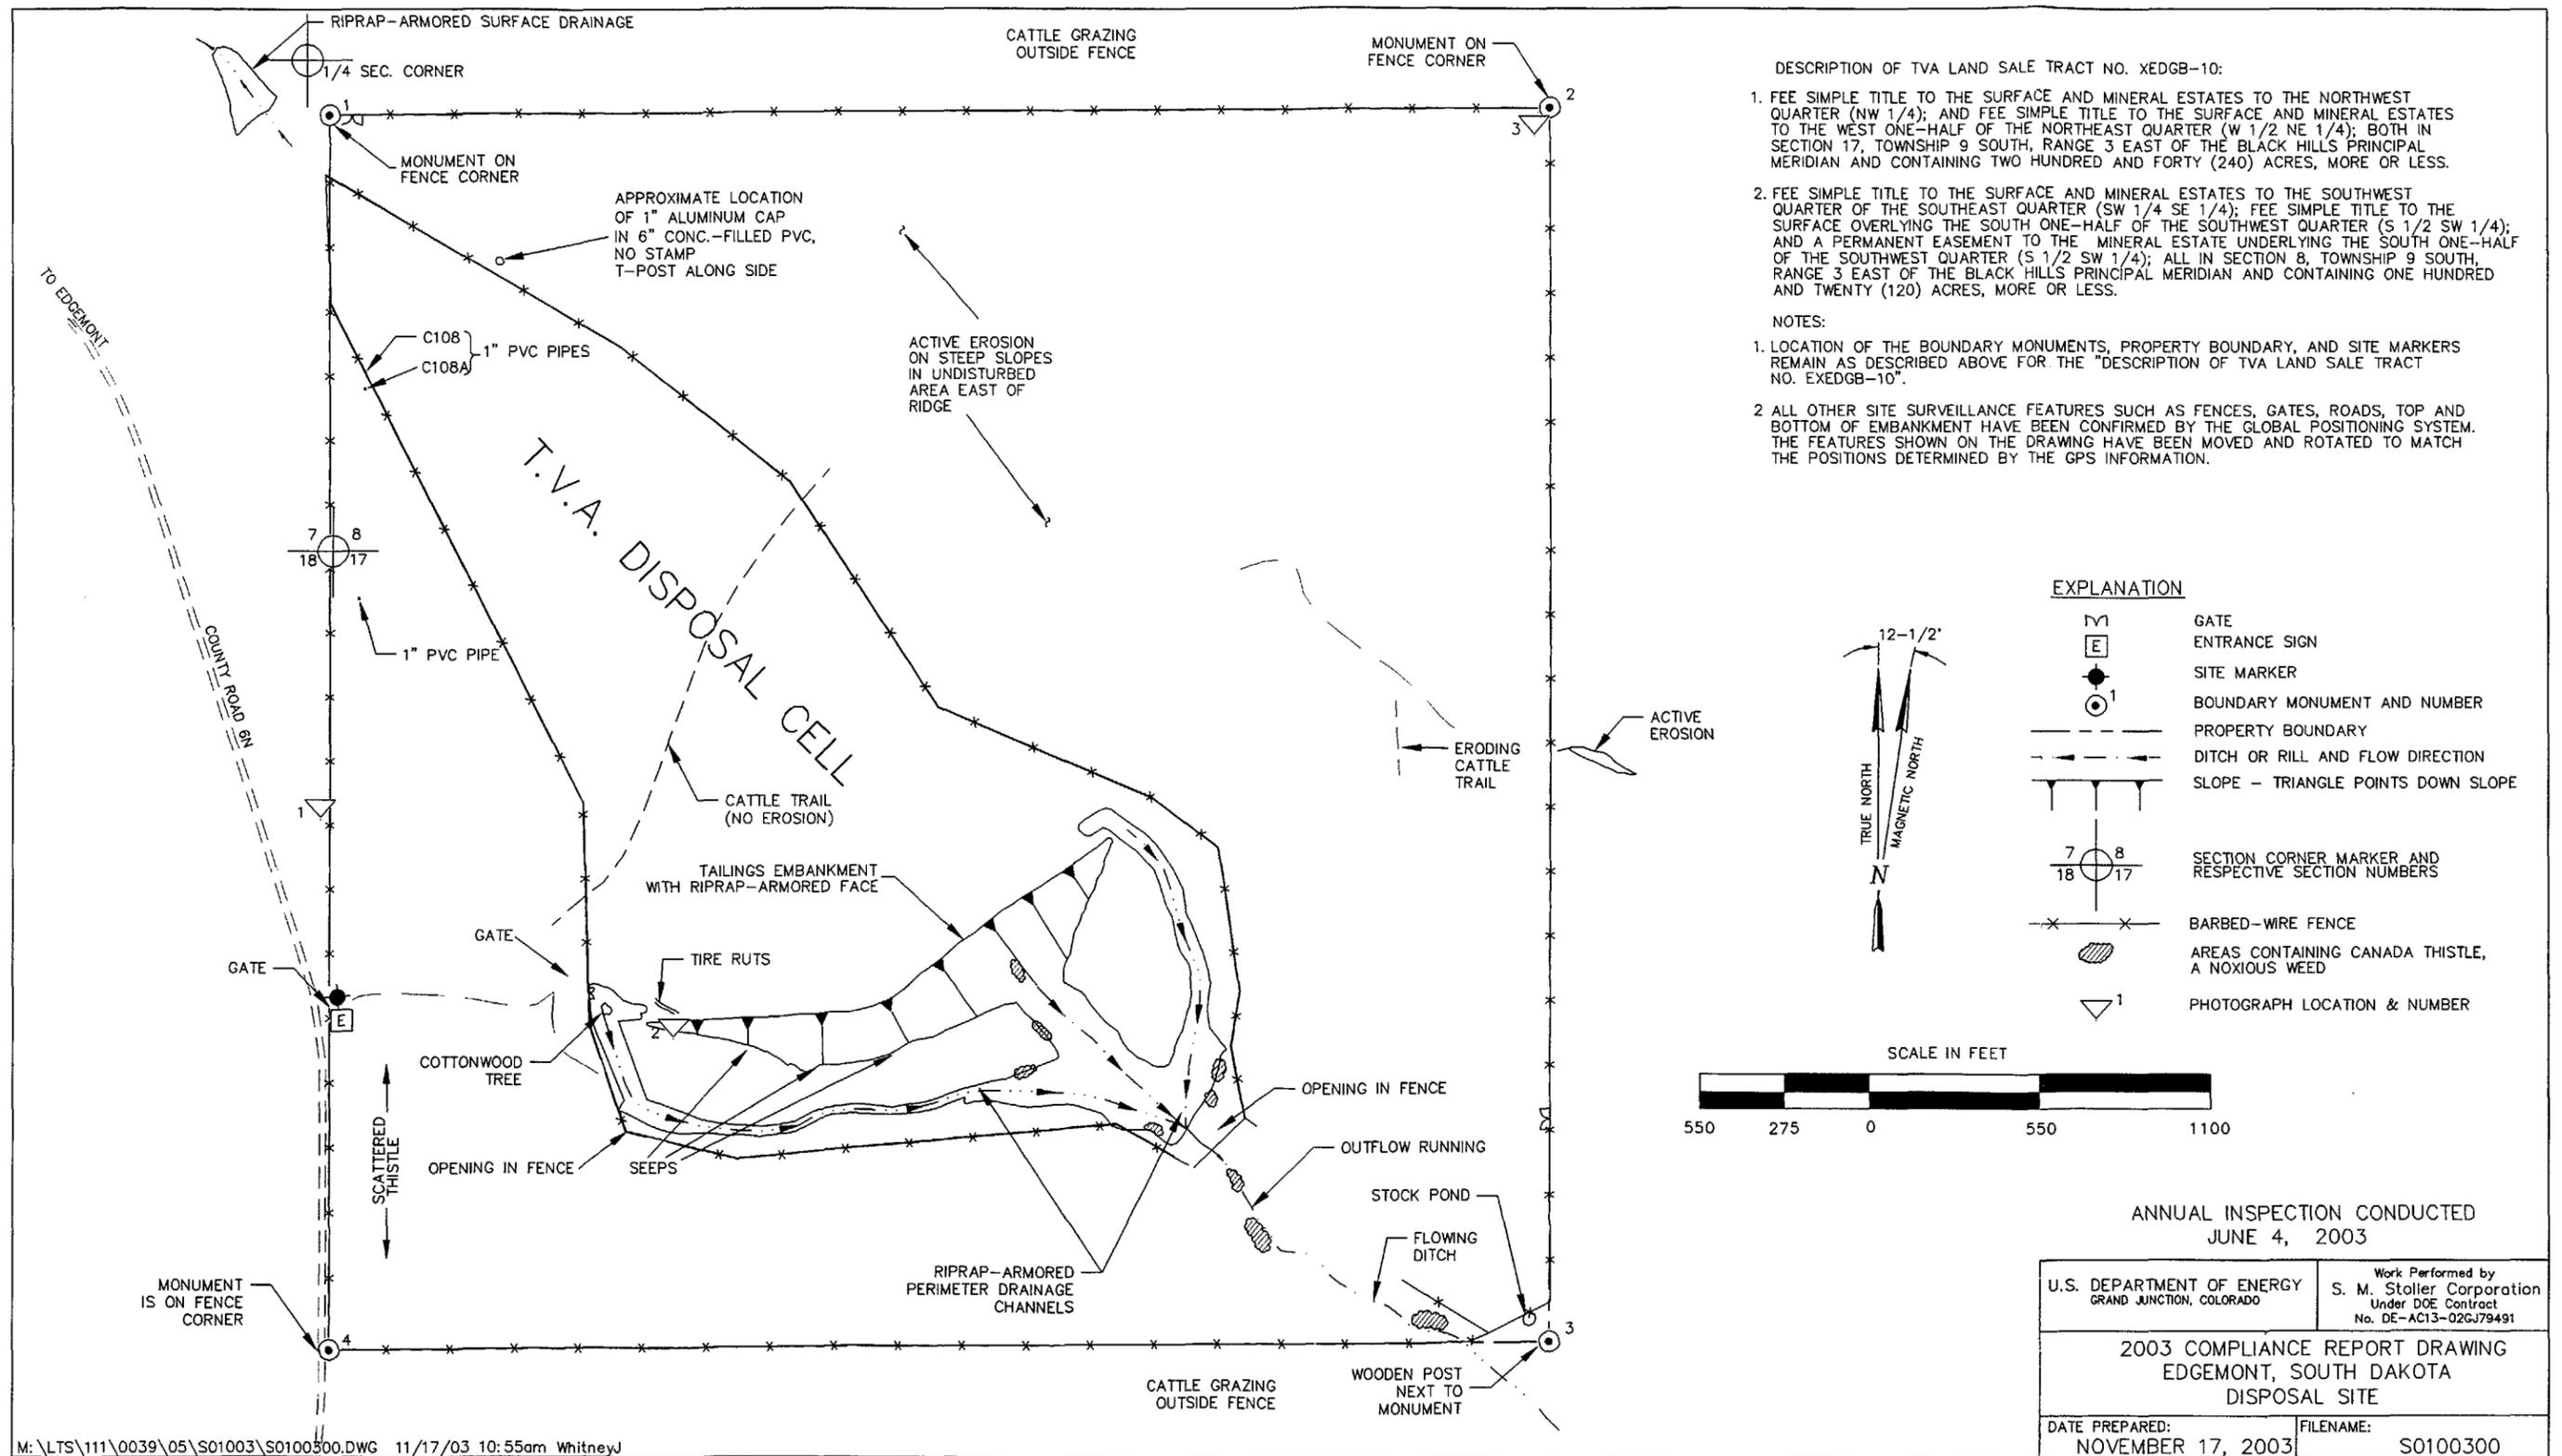
Figure 2-1. Edgemont, South Dakota, 2003

The tailings dam face, the steepest slope on site, is covered with riprap. The slope is stable and the riprap shows no signs of degradation. Scattered plants, mostly grass, grow in the riprap (PL-2). These plants do not pose an immediate threat to stability or function of this structure. The plant density has not increased over the last few years. Plant density in the riprap dam face will continue to be evaluated during future inspections.

Water was present in the drainage outlet below the tailings embankment during the 2003 inspection. The drainage outlet is the lowest point on site and most of the precipitation that falls on the site exits there. There was more water present in the drainage during this inspection than during the 2002 inspection, a result of greater amounts of precipitation falling on the site during the spring and early summer of 2003. Wetland vegetation has established in the drainage outlet below the dam.

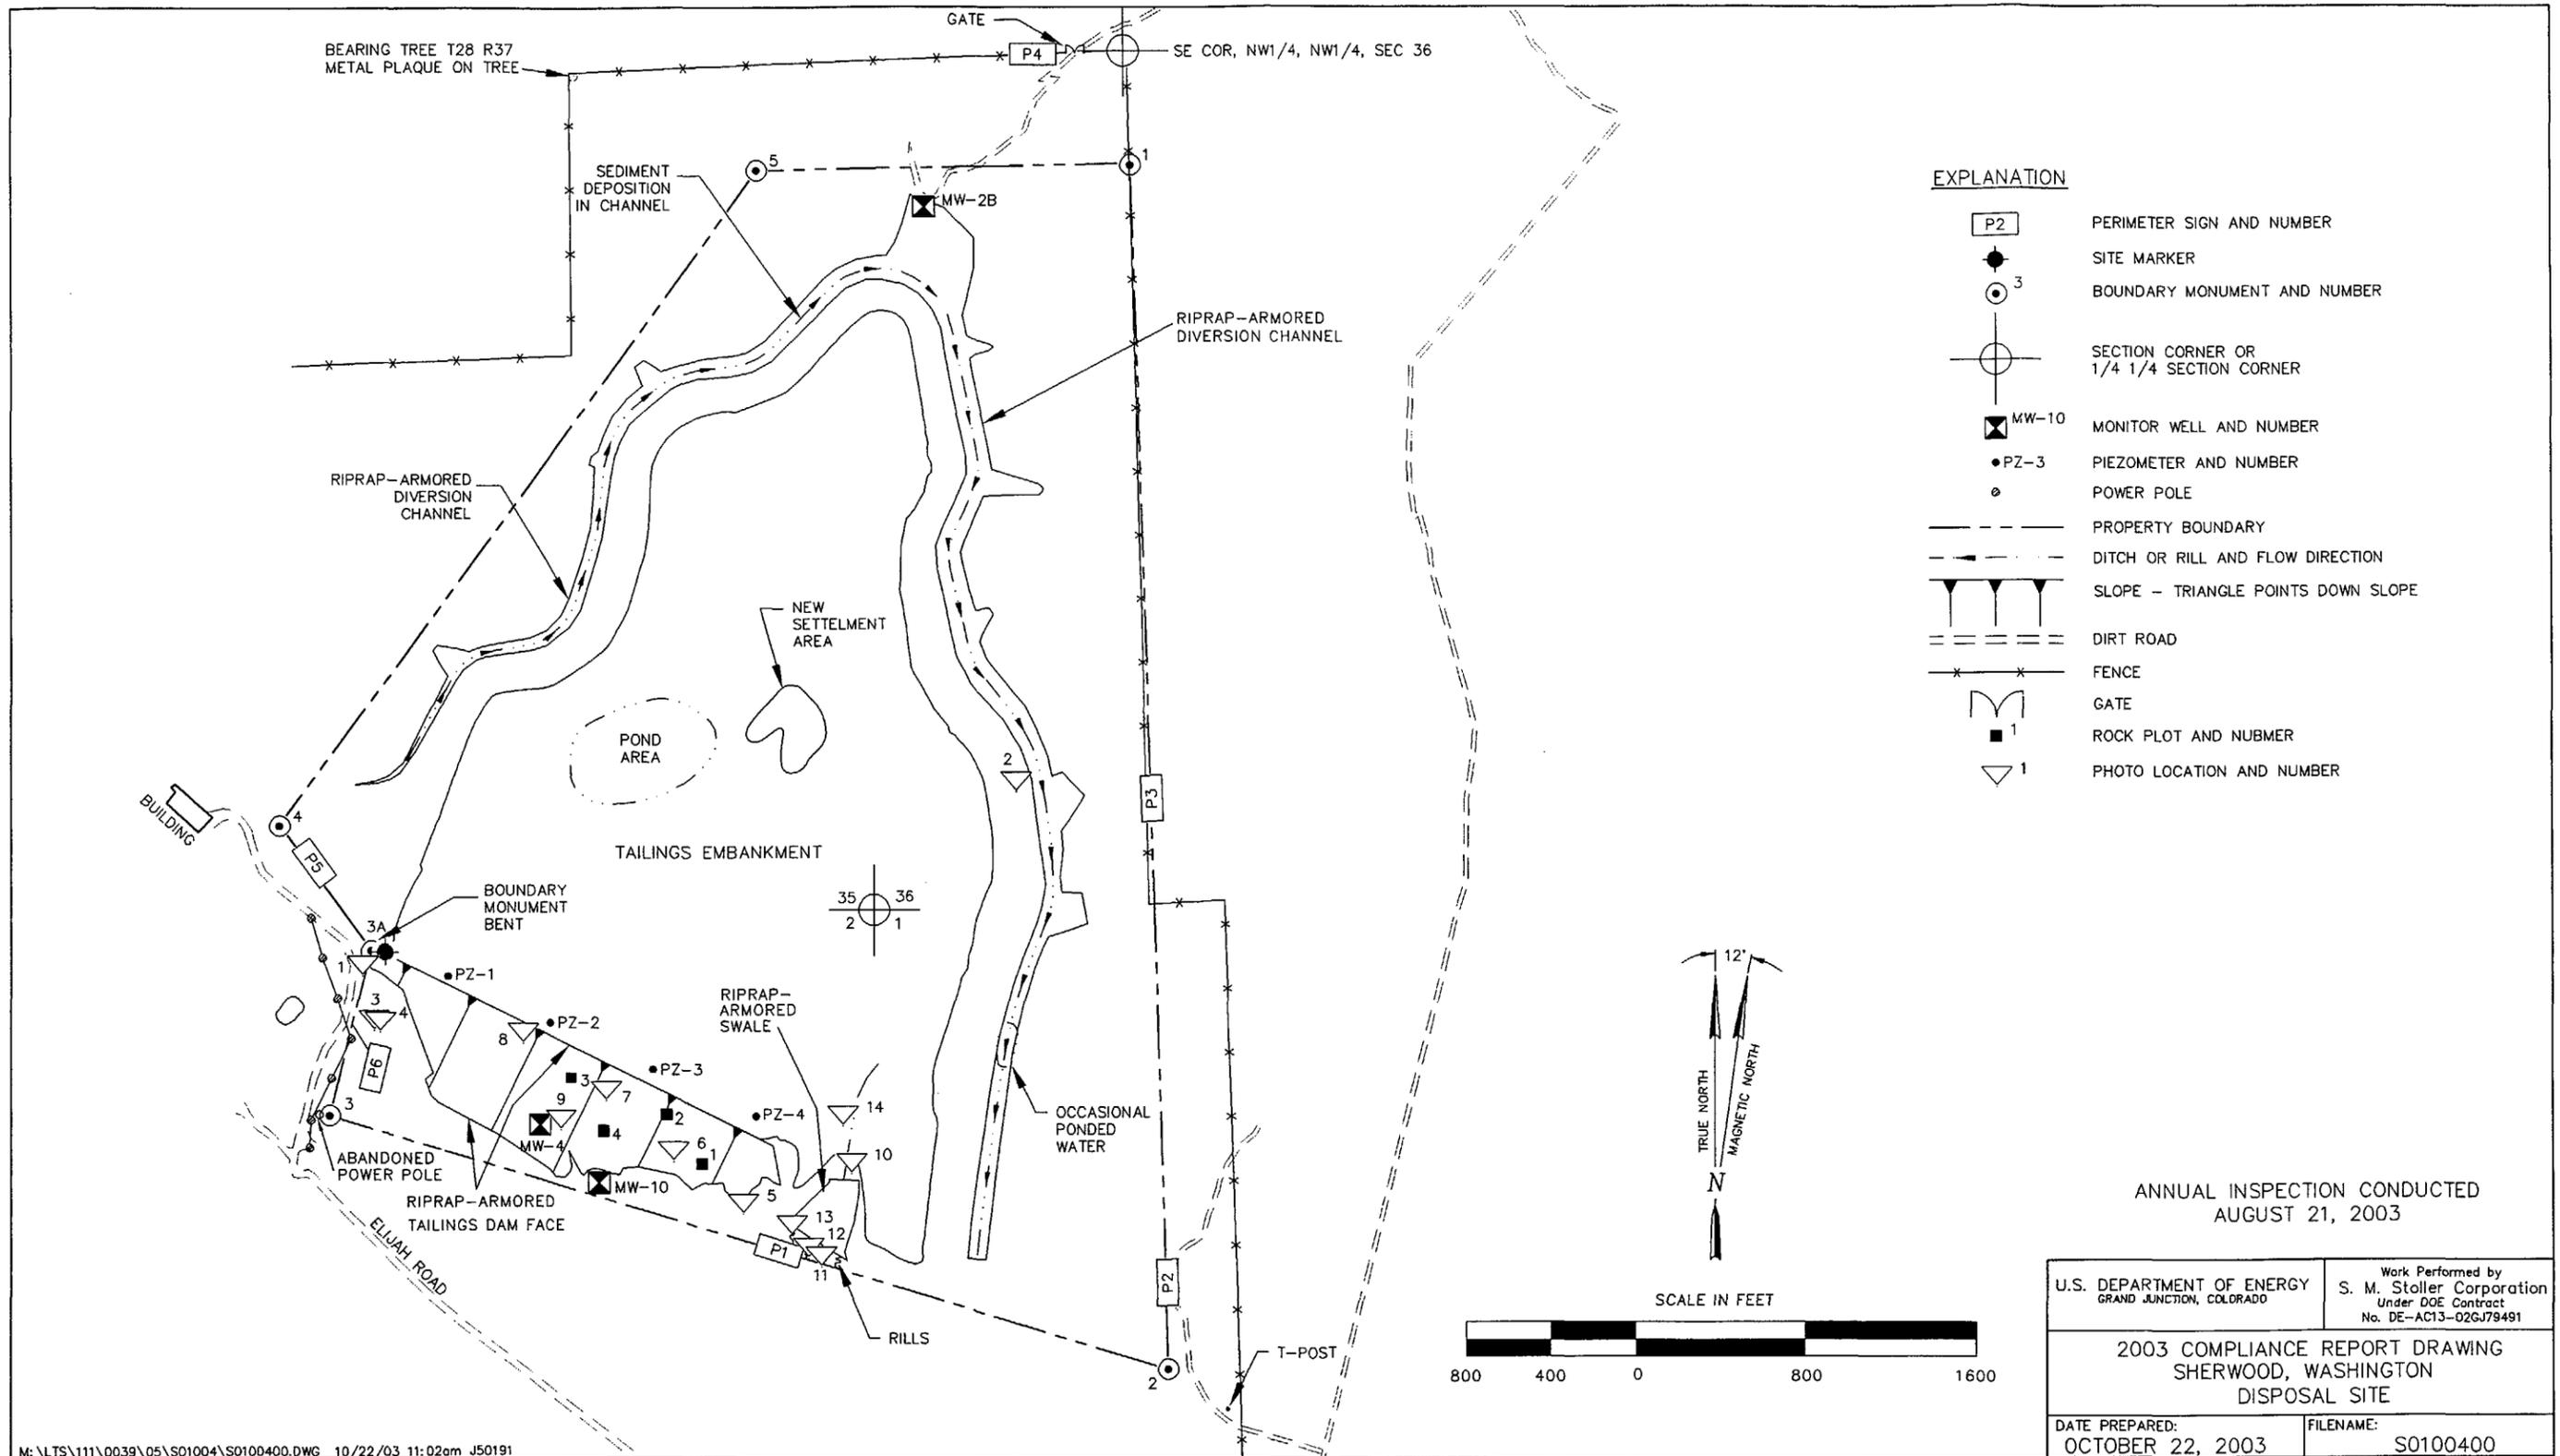
Figure 3-1. Sherwood, Washington, 2003

Designers of the cell predicted that up to 10 feet of settlement could occur on the cover. Settlement has occurred over an approximate 7-acre area that has been referred to as the "pond area" and is shown on Figure 3-1. The pond area contained about 0.5 acre of standing water at the time of the inspection. The pond area was dry during the 2002 inspection. The plant species present indicate that there is year-round moisture below the surface. Vegetation in the pond area is composed primarily of native wetland species such as hardstem bulrush (*Scirpus acutus*), Olney threesquare (*Scirpus americanus*), common spikerush (*Elyocharis palustris*), sandbar willow (*Salix exigua*), and plantain (*Plantago eriopoda*). The pond provides habitat for small mammals, birds, and reptiles and appears to be a water source for larger mammals such as deer and elk, whose sign was abundant in this area.

Inspectors walked the length of the diversion channel. Volunteer plant intrusion within the diversion channel is evident in most areas of the channel; however, because the channel is oversized, this intrusion is not expected to interfere with the channel's design function. Rock condition is good and is the same as observed during earlier inspections. Sediment deposition is evident in places on the west side of the diversion channel, but currently does not interfere with the channel's design function. The degree of sediment deposition should be noted during future inspections although it is not expected to increase to the degree that it could become a maintenance issue. At times, standing water has been observed in the channel along the east side of the impoundment (see Figure 3-1); this area was dry during the 2003 inspection.
