# A Hydrologic Assessment of the September 14, 1974, Flood in Eldorado Canyon, Nevada

By PATRICK A. GLANCY and LYNN HARMSSEN

GEOLOGICAL SURVEY PROFESSIONAL PAPER 930

*A presentation of hydrologic data and interpretations,  
eyewitness accounts of destruction,  
and documentation of flooding*

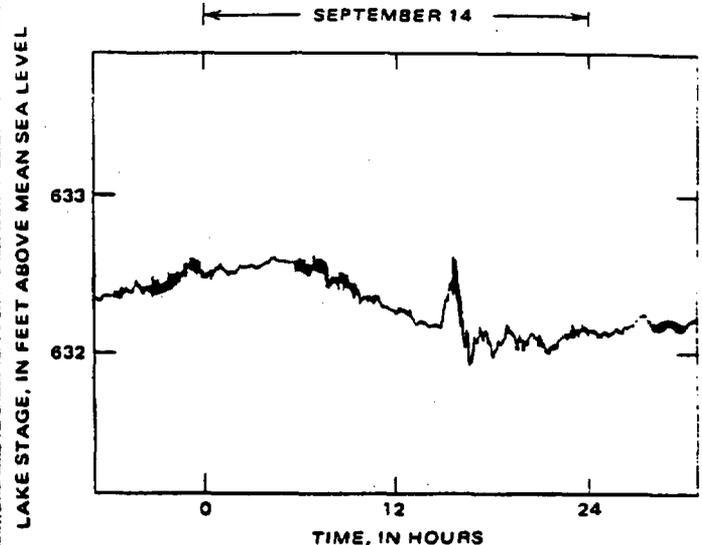
FIGURE 9.—Trace of Lake Mohave stage at Davis Dam, showing approximately 0.45-ft rise. Gage is about 35 mi downstream from mouth of Eldorado Canyon. Figure is reproduction of lake stage recorder sheet.

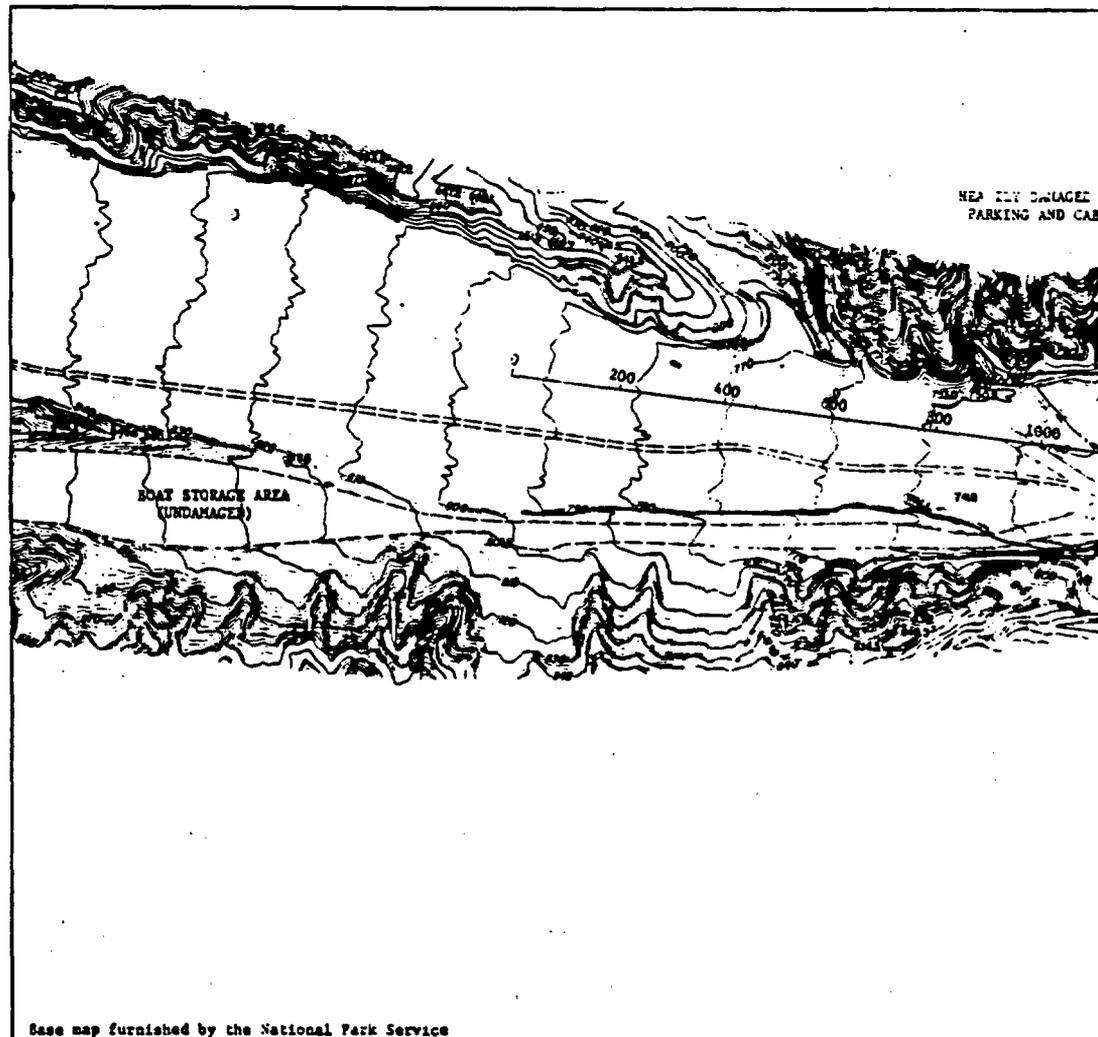
The restaurant was totally destroyed. Five trailer houses were totally destroyed, some have not been found, and a number of others were seriously damaged. Nine cabins near the base of the north canyon wall were destroyed, and 38 vehicles and 19 boat trailers were lost. Twenty-four boat-docking slips were obliterated and 23 boats were lost. Figure 12 shows changes to the boat

docks, the general location of a number of other specific cultural features, and qualitatively describes the nature of the damage sustained. Several photographs of damage to structures and vehicles near the canyon mouth are shown in figure 1. Figure 16 shows an overall view of the heavily damaged trailer park area. When viewing the damage shown in figures 1 and 16, keep in mind that the vehicles and structures receiving the greatest damage are not visible because they were either totally demolished or buried in Lake Mohave. Therefore, the photographs give a somewhat conservative view of the effects of the flood.

FIGURE 12.—Flood boundaries. -streambed

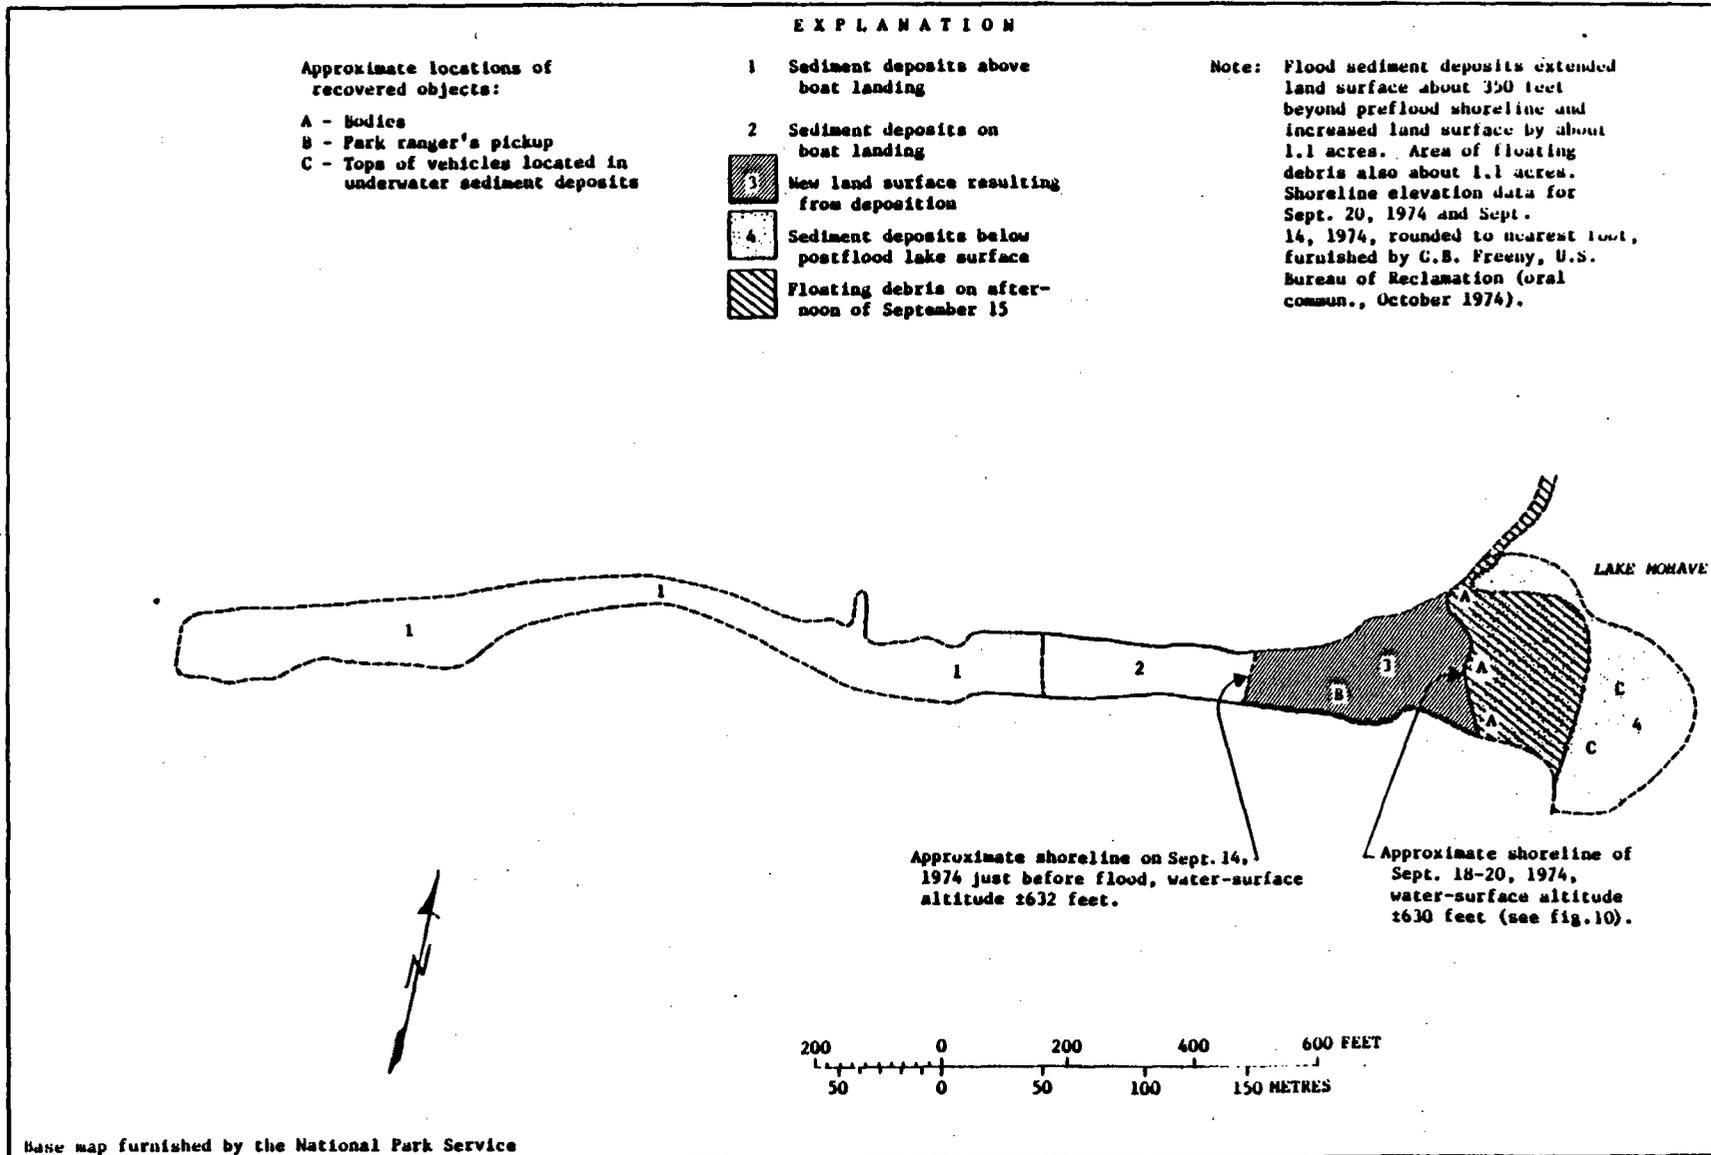
The sediment volume accounted for in known deposits is estimated to be 54,000 yd<sup>3</sup>. Table 4 describes the location and distribution of the known sediment deposits; location of the depositional units is shown in figure 17. The estimate was made on the basis of post-flood configuration of deposits and on some pre-flood topographic information. Estimates of deposits upstream from the pre-flood shoreline of Lake Mohave probably are reasonably accurate because detailed pre-flood topographic data were available. However, no recent pre-flood bathymetric data were available for the harbor or adjacent areas. Some general knowledge of pre-flood water depths is available from observations by the National Park Service staff and others. These sparse data are supplemented with estimates of the quantity of material actually excavated and removed, as well as evidence of depths to apparent pre-flood lake-bottom clays exposed during excavation.

FIGURE 17.—Sediment deposits and locations of pre-flood and post-flood shorelines.
