## POST-IRRADIATION EXAMINATION RESULTS FROM THE BTF-105A LOCA/LOECC TEST

VALLIANT, P.J., IRISH, J.D. and CRAIG, S.T.

Fuel Safety Branch  
Reactor Safety Division  
AECL, Chalk River Laboratories  
Chalk River, Ontario, CANADA K0J 1J0

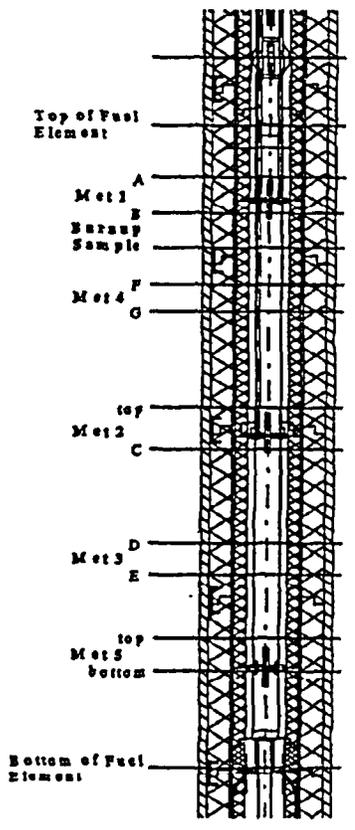
Figure 7: BTF-105A Post-Irradiation Examination Sections

The fuel element and the NILCRA liner and Zircaloy tube of the thermal shroud were cast in epoxy. Transverse sections were taken at 5 elevations over the length of the fuel element, and the sections were examined metallographically (Figure 7). At each cross-section elevation, fuel-sheath-oxide thicknesses were measured along with  $UO_2$  grain size at the centre, mid radius and periphery of the fuel (Table 1). The  $UO_2$  grain size has remained relatively unchanged from as fabricated due to the low temperature (fuel-centreline temperature  $\sim 1400^\circ C$ ) during the 10-day irradiation in pressurized water and due to the short time that the fuel element was at high temperature during the transient. Sheath oxidation ranged from minimal at the top of the fuel element (Figure 8) to through-wall oxidation over the whole bottom half of the fuel element (Figure 9). The  $UO_2$  fuel was heavily cracked throughout the fuel element with fuel relocation in the lower elevations. Figure 10 illustrates the totally oxidized sheath at the lower element elevation. The lower bearing pad (Figure 11) shows the extent of oxidation and sheath transformation. Near the end of the transient, liquid water passed through the test section. At this time the temperature indicated by TFS03 dropped  $1200^\circ C$  in 10 seconds. The thermal shock from this quench resulted in a shattered appearance of the fuel, sheathing and NILCRA insulation at the lower elevations (Figure 9). It has been hypothesized [2] that this quench contributed to fuel sheath failure. Metallography at various elevations showed the rhenium clad thermocouples remained intact, confirming that they survived the transient in reasonable mechanical condition. Figure 8 shows the fuel-centreline thermocouple, TFC01, and external sheath thermocouples, TFS01 and TFS02, from the upper bearing pad location. They appear to be mechanically sound with no apparent sign of damage. TFS03, seen in Figure 9, remains intact and is surrounded by relocated fuel sheathing and  $UO_2$  fuel. The good performance of thermocouples TFS02 and TFS03 [1] attached with Zircaloy clamps, together with the good mechanical condition of the thermocouples as indicated by PIE, showed that thermocouples of this type and the method of attachment should be used for future BTF tests.
