EPRI TR-104721
Project 2229-01
ESEERCO Project EP89-31
Final Report
December 1994

Evaluation of Fuel Rod Leakage Mechanisms—Summary Report

Joint EPRI/ESEERCO/Westinghouse Studies

Prepared by
Westinghouse Electric Corporation
Pittsburgh, Pennsylvania

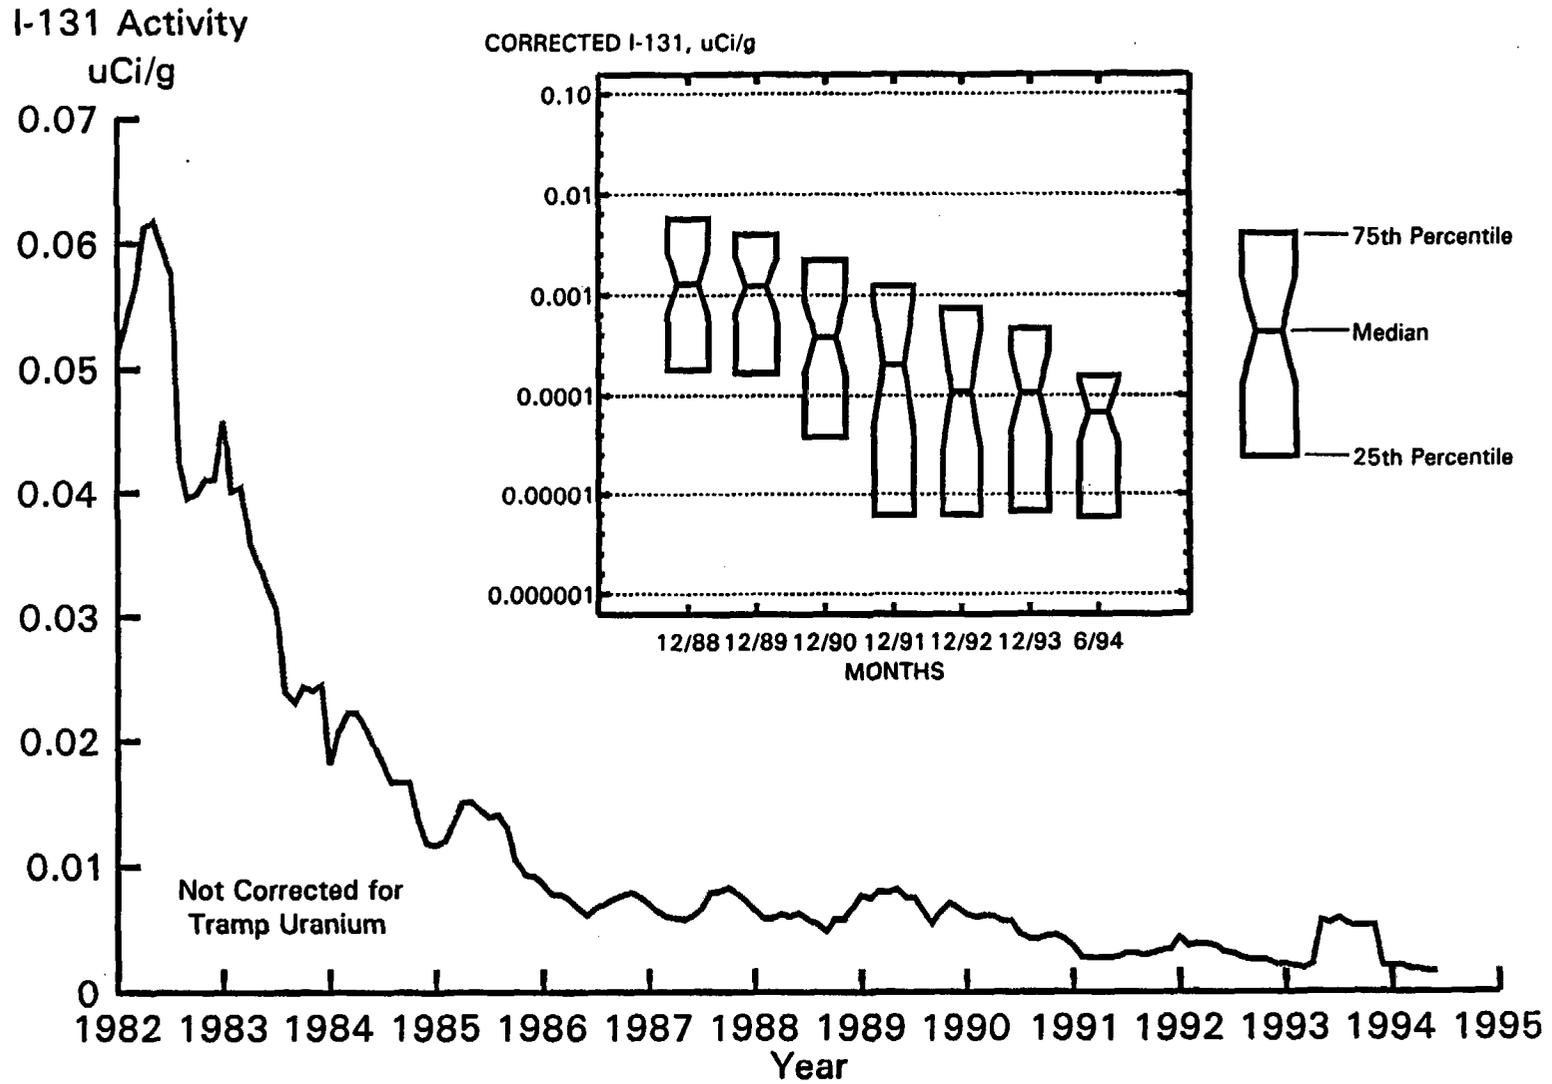
As can be seen in Figure 3.1-1, by 1986 the coolant activity levels had been substantially reduced from the levels of the early 1980's. However, the levels at that time (1986) were still higher than desired. One of the key unanswered questions concerning the cause of coolant activity at this point was whether the leakage mechanisms identified in the earlier examinations were continuing to be operative, but at reduced levels, or whether other mechanisms were not discovered in the previous efforts due to their relatively small number and the limited examination capabilities. Consequently, it was decided that further site examinations were needed to resolve this question. The probability of success of this effort was greatly enhanced over previous campaigns by improvements in on-site examination capabilities. The ability to routinely repair leaking fuel assemblies, by removing the leaking rods previously identified by ultrasonic examination (UT) from the assembly during the refueling outage, became available at about this time.

Figure 3.1-1. Plant Average Coolant Activity Levels Over Time for Westinghouse-Fueled Plants

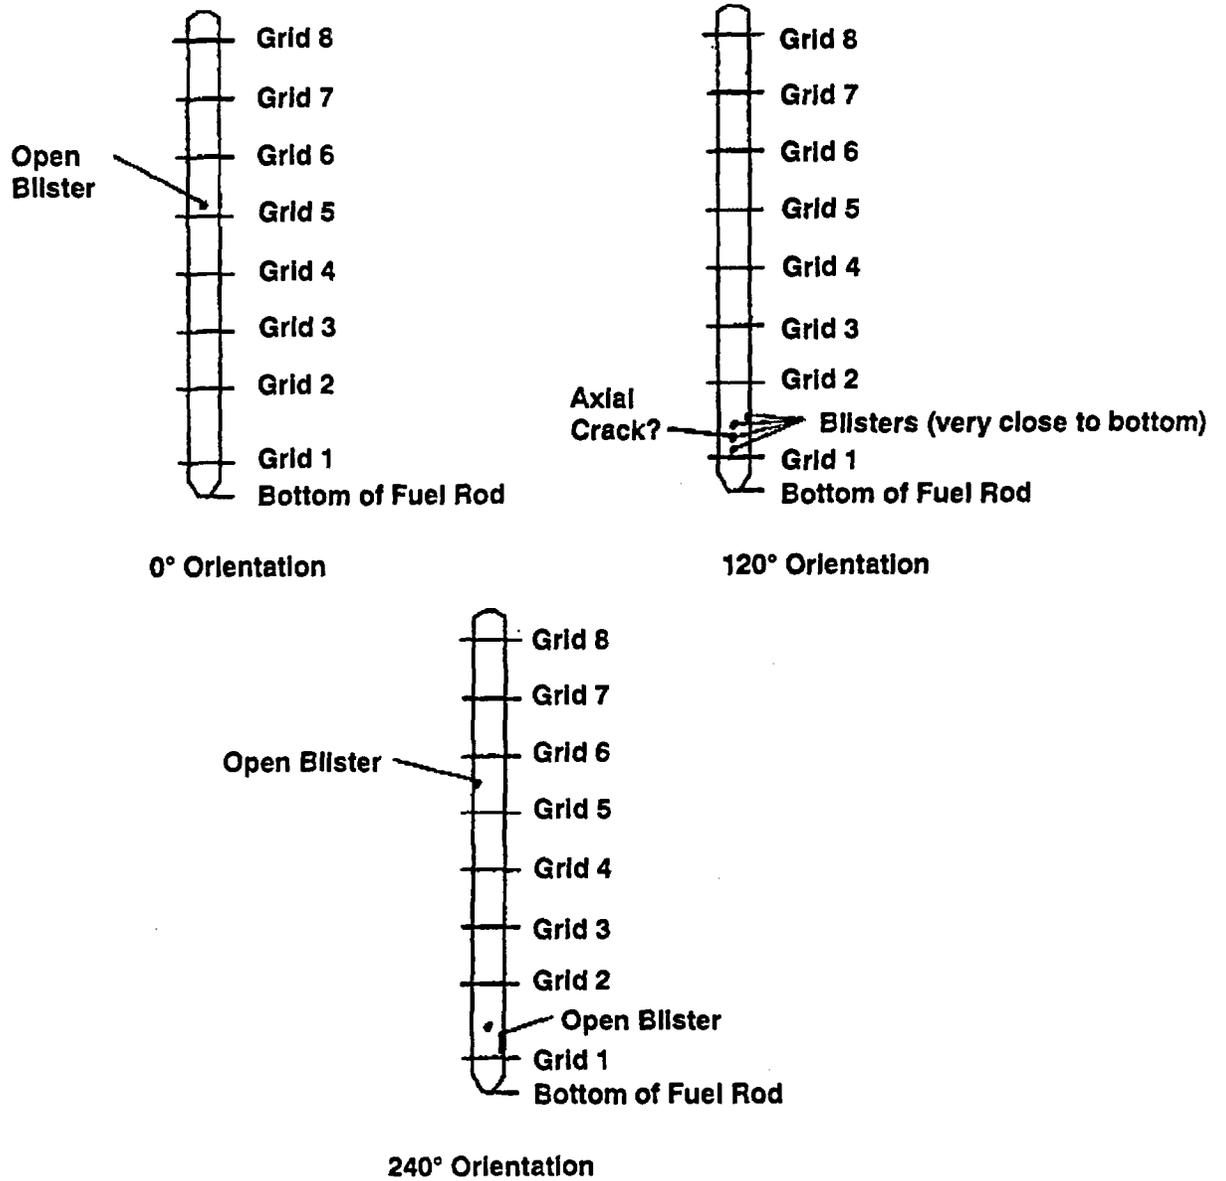
Figure 3.2-2. Byron 2 - Rod T74J/I16

Four of the rods were confirmed to be leaking during visual inspection at the site, but did not have an identifiable root leakage cause. These included rod H12 of assembly D79F (rod D79F/H12) from Byron Unit 1, rod I16 of assembly T74J (rod T74J/I16) and rod D02 of assembly T77K (rod T77K/D02) from Byron Unit 2, and rod Q16 of assembly G08 (rod G08/Q16) from V.C. Summer. The observed leakage sites generally consisted of hydride blisters. Rod D79F/H12 also exhibited an unusual flaking surface appearance. This flaking condition has been observed on several leaking rods from other sites. The primary objective of the hot cell examination of these rods was to identify the root leakage cause. A summary of the visual observations on the rods is shown in Figures 3.2-1 through 3.2-4.

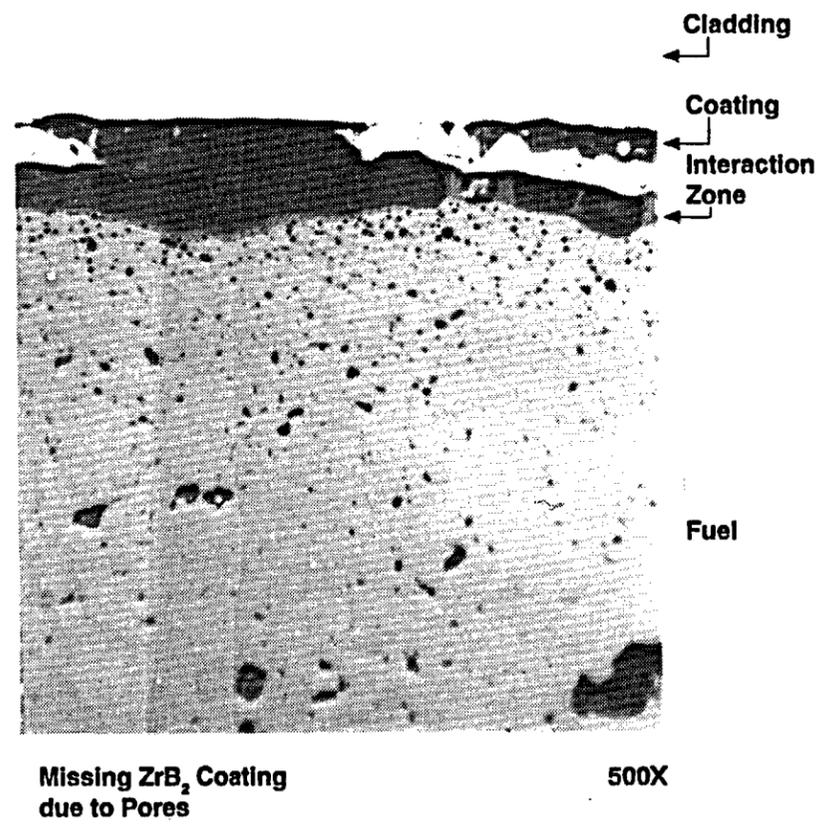
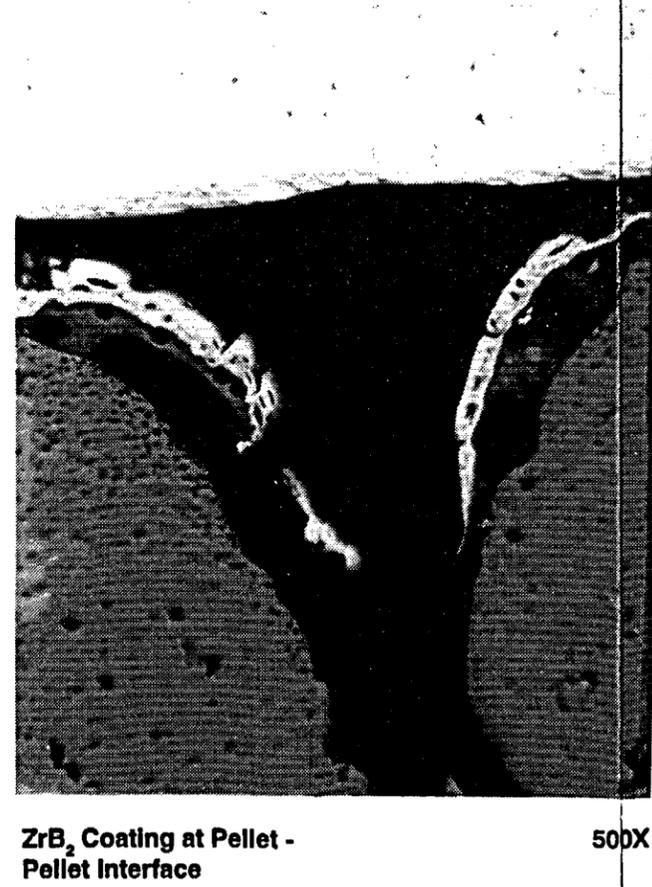
Figure 3.3-9. Appearance of ZrB₂ Coating, ZrB₂-Fuel Interaction Zone, and Pores in the Interaction Zone
