~~CONFIDENTIAL~~  
EPRI TR-104721  
Project 2229-01  
ESEERCO Project EP89-31  
Final Report  
December 1994

# **Evaluation of Fuel Rod Leakage Mechanisms—Summary Report**

## **Joint EPRI/ESEERCO/Westinghouse Studies**

Prepared by  
Westinghouse Electric Corporation  
Pittsburgh, Pennsylvania

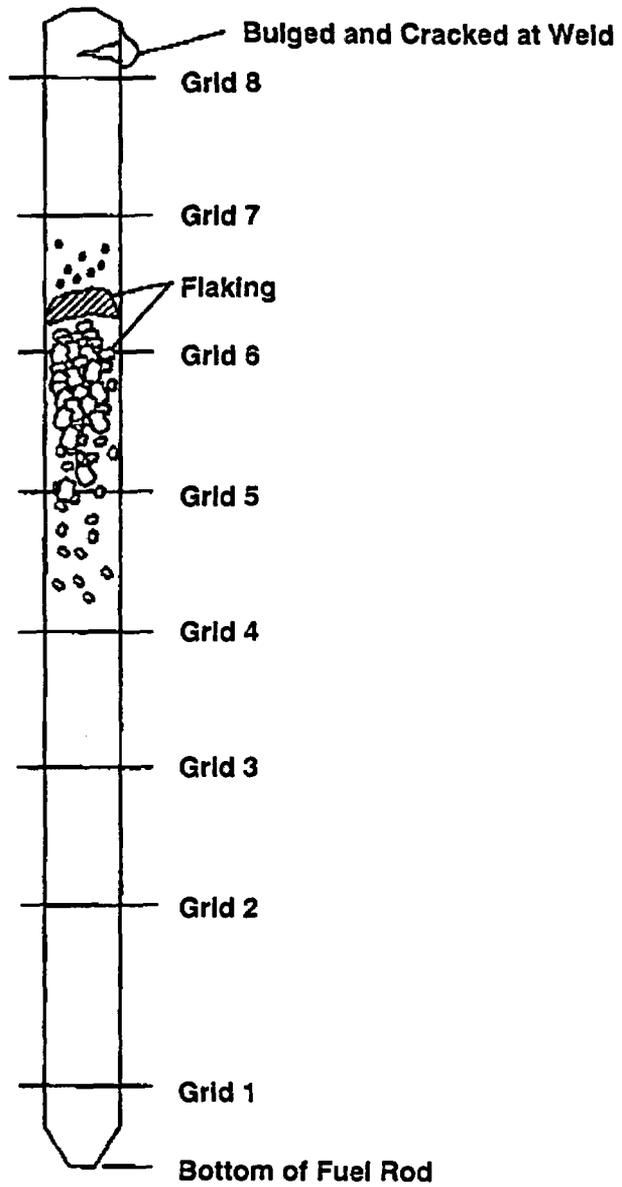
Figure 3.2-1. Byron 1 - Rod D79F/H12

Four of the rods were confirmed to be leaking during visual inspection at the site, but did not have an identifiable root leakage cause. These included rod H12 of assembly D79F (rod D79F/H12) from Byron Unit 1, rod I16 of assembly T74J (rod T74J/I16) and rod D02 of assembly T77K (rod T77K/D02) from Byron Unit 2, and rod Q16 of assembly G08 (rod G08/Q16) from V.C. Summer. The observed leakage sites generally consisted of hydride blisters. Rod D79F/H12 also exhibited an unusual flaking surface appearance. This flaking condition has been observed on several leaking rods from other sites. The primary objective of the hot cell examination of these rods was to identify the root leakage cause. A summary of the visual observations on the rods is shown in Figures 3.2-1 through 3.2-4.

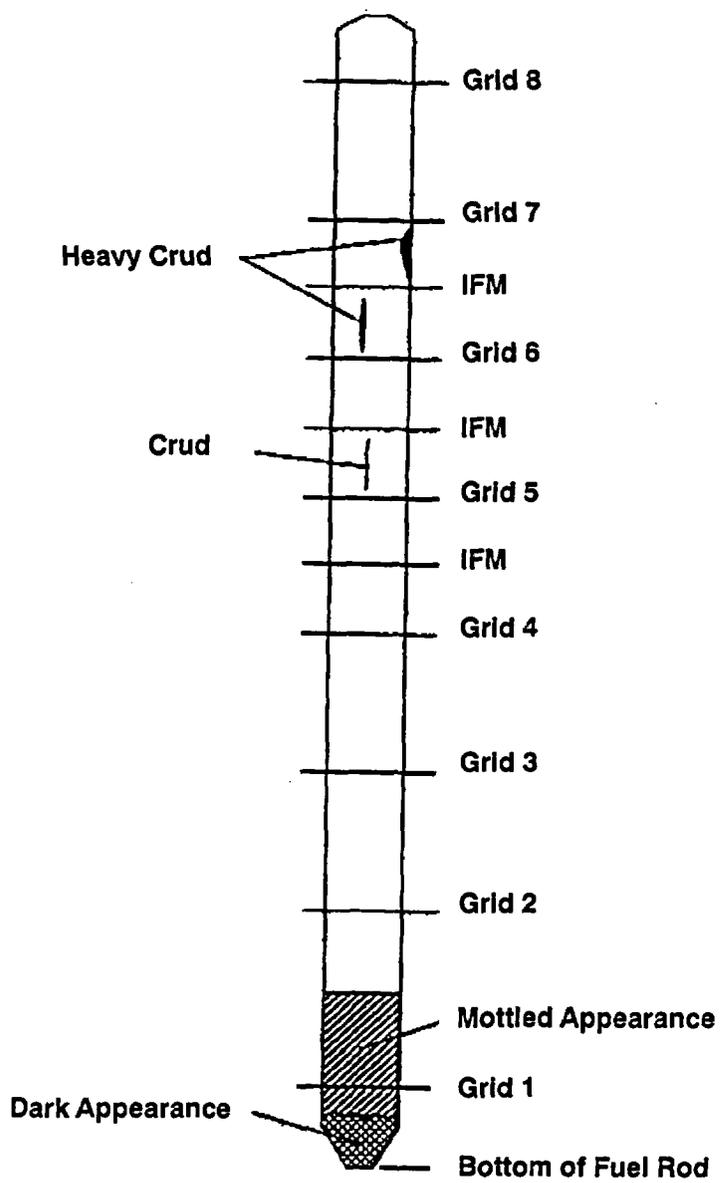
Figure 3.2-5. V.C. Summer - Rod VV2/D07

The four VANTAGE 5 demonstration rods from V.C. Summer - rods D07, J14, K14, and J05 of assembly VV2 (rods VV2/D07, VV2/J14, VV2/K14, and VV2/J05) - made up the fourth group of rods. These rods are non-leaking, but showed evidence of unusual crud deposits and higher than expected oxide film thicknesses, as mentioned earlier. Three of the rods contain ZrB<sub>2</sub> coated fuel pellets (IFBA fuel). The primary purposes of the hot cell examination of the rods were to understand the nature of the crud deposits, and to determine the effect of the crud on the oxide thicknesses and the hydrogen uptake in the cladding. The rod internal pressure measurements of the IFBA fuel rods were also considered to be valuable information. A summary of the visual observations of these rods is shown in Figures 3.2-5 through 3.2-8.
