W3F1-2003-0090

SUBJECT: Response to Request for Information Related to Review of Refuel 11
Steam Generator Tube Inservice Inspection Report SR-03-001-00
Waterford Steam Electric Station, Unit 3
Docket No. 50-382
License No. NPF-38

**List of SG 31 and SG 32
Flaws Found During RFO 11 Inspection**

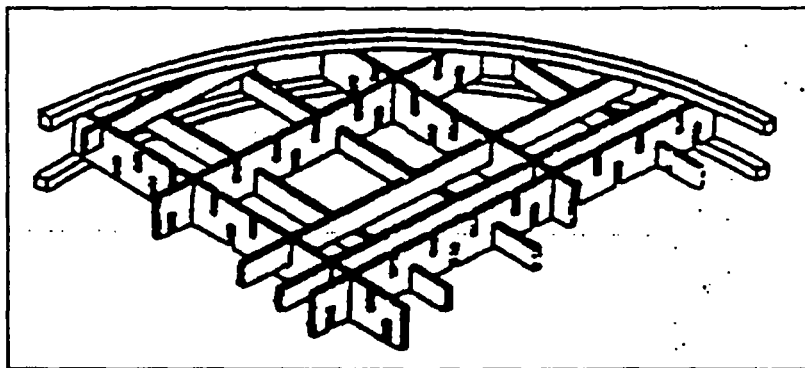
Fig. 3.1 - Egg Crate Assembly

- 3.2.1 **WSES 3** The SGs are Combustion Engineering Model 3410 design and all of the supports are egg crates (see fig 3.1 below). The general design of the SGs is shown in Figures 3.1 A & B. The SGs were built by Combustion Engineering and the plant started commercial service in September 1985. There are 2 SGs each having 9350 tubes and are designated as SG31 and SG32. Each steam generator has 147 rows and 175 columns. The tubes are High Temperature Mill Annealed Inconel 600 with dimensions of 0.75" OD x 0.048" nominal wall thickness oriented on a 1" triangular pitch. The longest tubes are in Row 147, and are 949.625" (79.14') long. Supports are carbon steel and include full egg crates (supports 1 to 7), partial egg crates (supports 8 to 10) and batwings (9 total). The batwings include 2 diagonal and 7 vertical straps (Figure 3.1C). Table 3.1 shows information regarding tube support types, location distances and nomenclature.

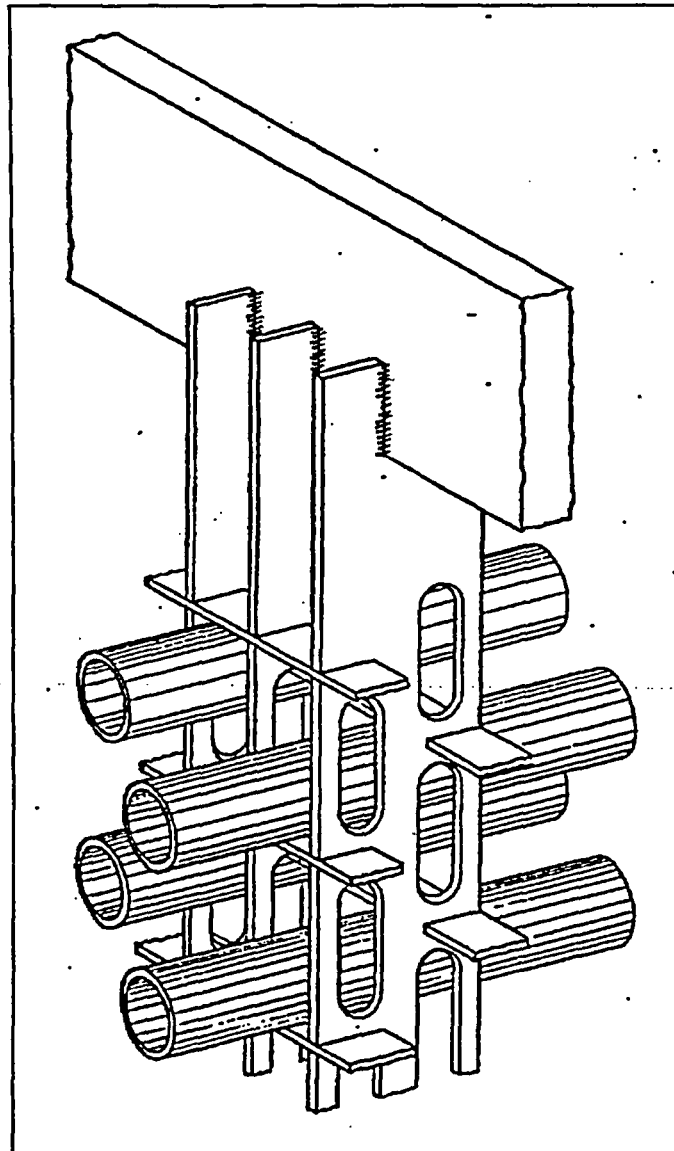
Fig. 3.1C - WSES 3 Vertical Batwing Design

SG 32 tube Row 144 – Column 106 was plugged due to a %Thru-Wall value of 40%. This tube was included in the April 22, 2002 letter (Reference 1) Attachment 1, under Eleventh Refueling, Indications at Eggcrate, Wear Indications ≥ 40 % thru wall for SG#2. This wear indication was located adjacent to a diagonal "Batwing" support, not an eggcrate support. This tube was generically categorized under the eggcrate support category, as compared to the case with an RFO 9 tube discussed in Entergy's response to Question #1. This tube should also be categorized under indications associated with the diagonal "Batwing" supports.
