CNWRA 2003-04

ANALYSIS OF RAIL CAR COMPONENTS EXPOSED TO A TUNNEL FIRE ENVIRONMENT

**U.S. Nuclear Regulatory Commission
Contract NRC-02-02-012**

November 2002

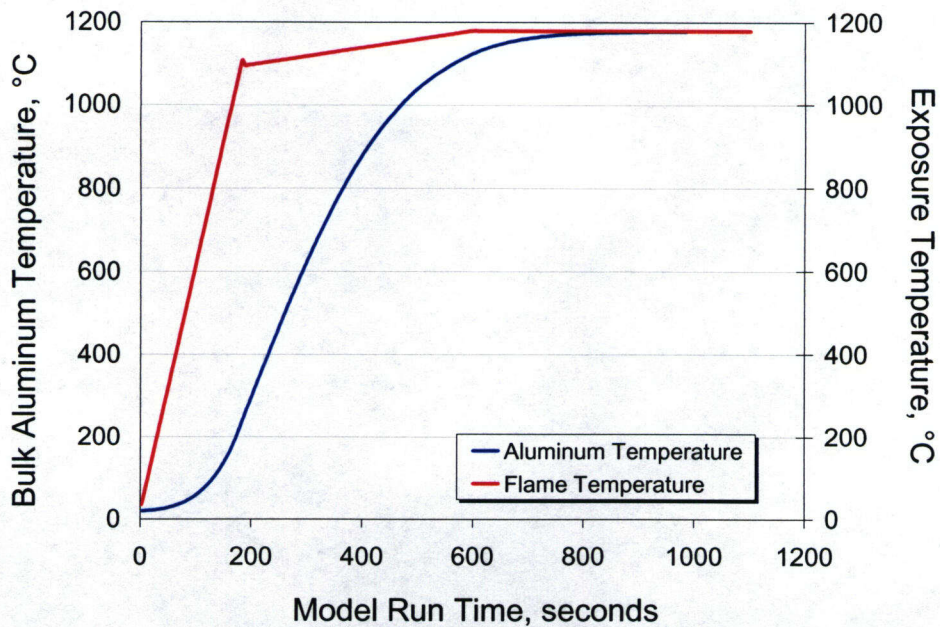
When modeled using this fire exposure, the sample aluminum element exhibits melting at 300 seconds into the exposure (see Figure 5-1).

Figure 5-1. ASTM E 1529 (1993) Ramp Function and Corresponding Aluminum Thermal Profile (Melting Predicted at 300 seconds)

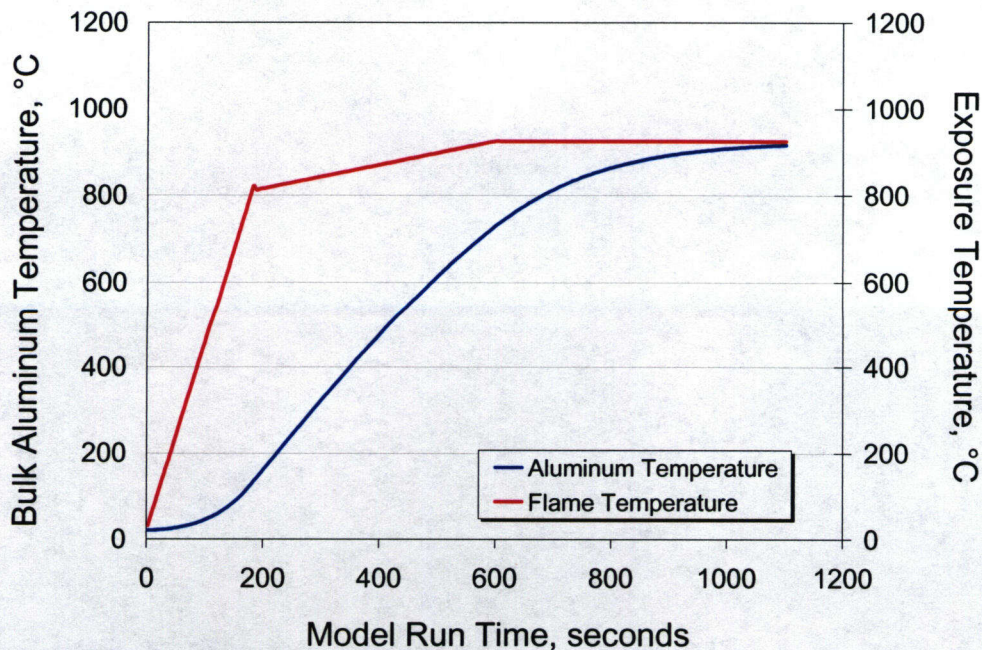
Figure 5-2 illustrates that, when taking the published flame temperature as the maximum temperature experienced by the valve, any exposure time greater than 360 seconds will produce melting conditions.

Figure 5-2. Published Flame Temperature Ramp Function and Corresponding Aluminum Thermal Profile (Melting Predicted at ~500 seconds)

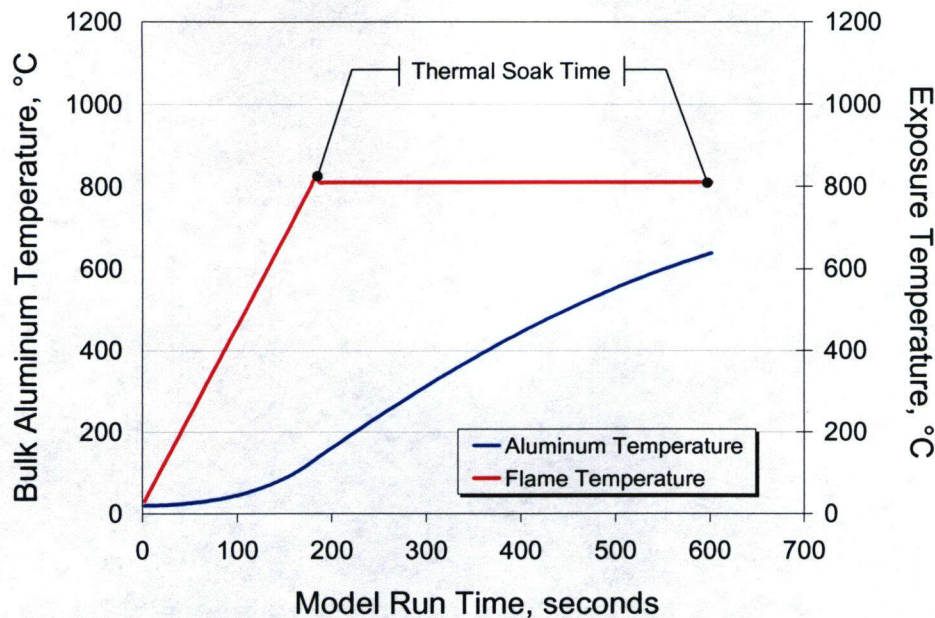
Figure 5-3. Ramp-Plateau Function Demonstrates Melting at Published Flame Temperature for Exposure Times Greater than 360 Seconds

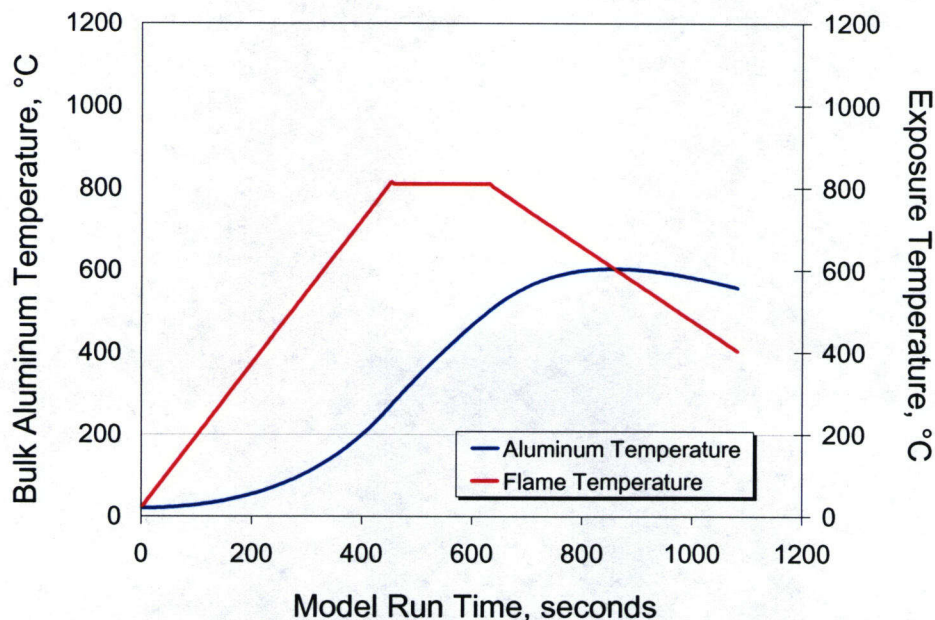
Figure 5-4. Ramp-Plateau-Decay Function and Corresponding Aluminum Thermal Profile (Melting Predicted at ~800 seconds)

The conditions depicted in Figure 5-4 may be more difficult than originally assumed because 810 °C [1,490 °F] is the actual, published flame temperature of the fuel. The valve would have had to be completely engulfed in flames for it to realize these temperatures. Considering the location of the valve, 10 m [33 ft] uphill, and its position in the tunnel (low to the floor), total flame engulfment may have only occurred intermittently and, possibly, for only a short duration.
