Subject: Confirmatory Action Letter Response – Revision 1 to Root Cause Analysis  
Report Regarding Reactor Pressure Vessel Head Degradation

# Root Cause Analysis Report

Significant Degradation of the Reactor  
Pressure Vessel Head

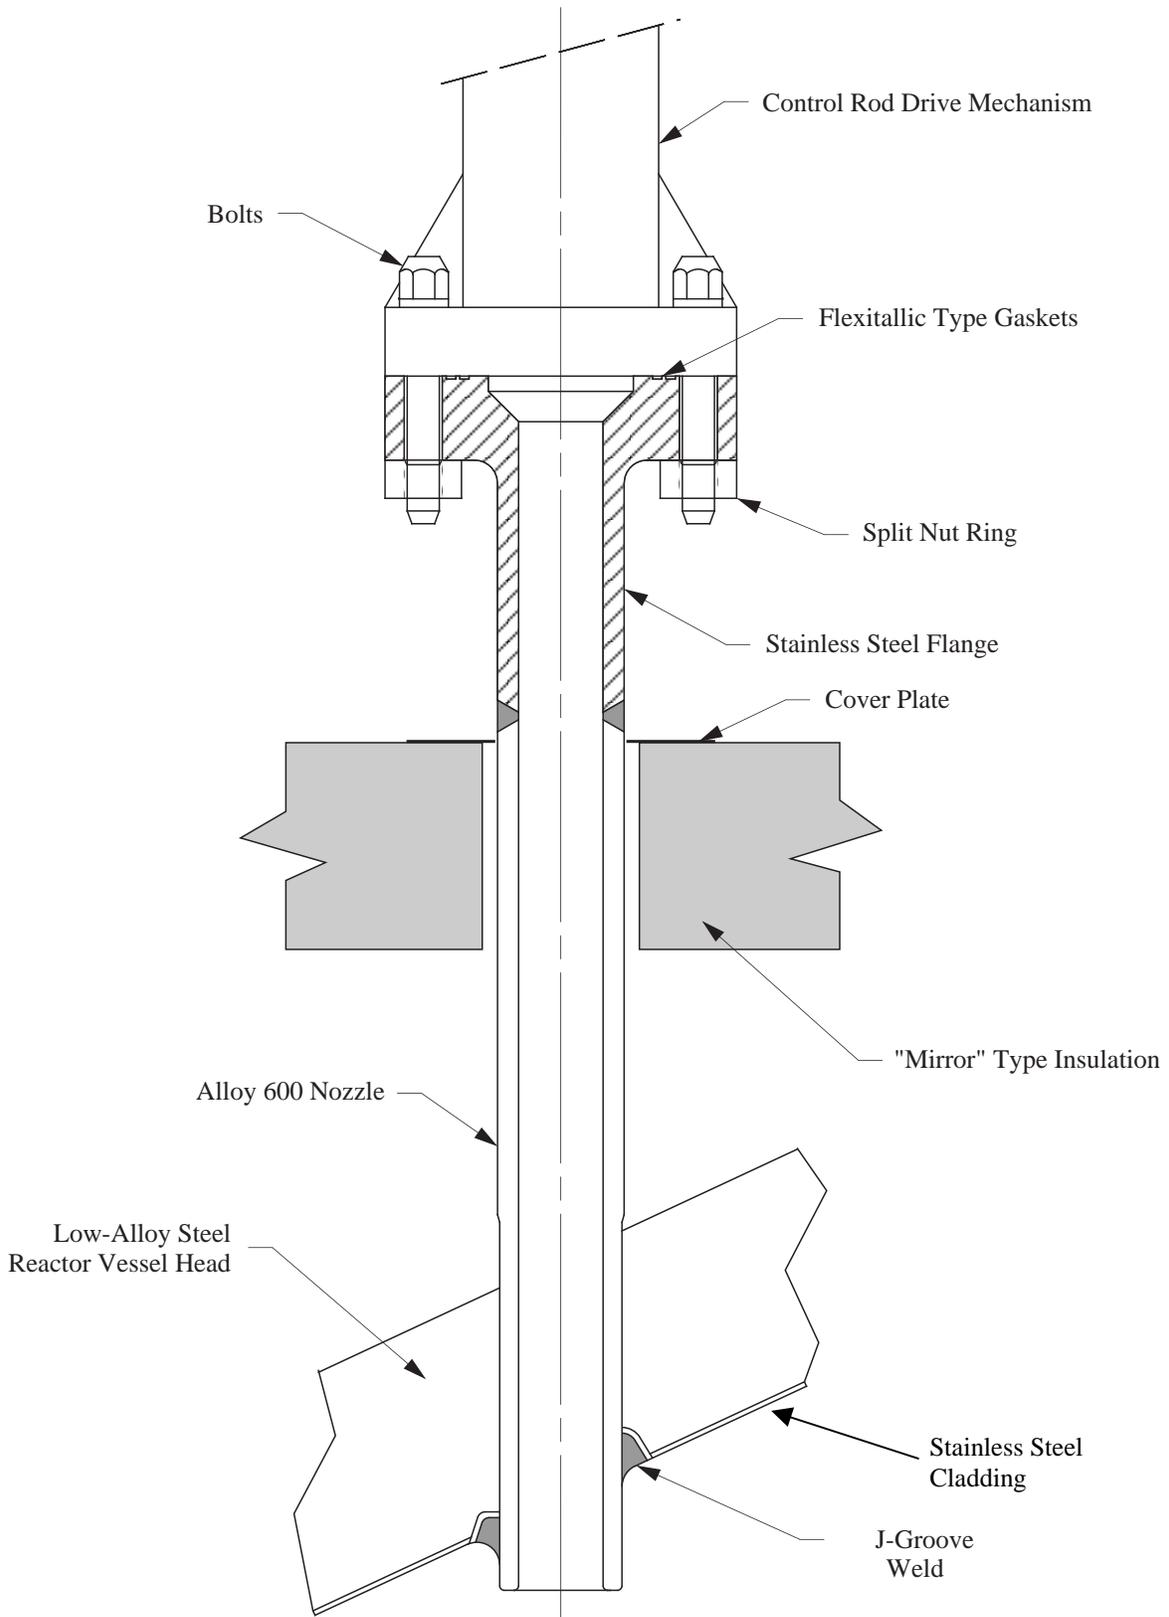
Figure 3. Davis-Besse CRDM Nozzle General Arrangement

Figure 3 shows a typical CRDM flanged joint in a B&W-design plant. The joint consists of an Alloy 600 nozzle welded to the underside of the RPV head by a J-groove weld, a stainless steel flange welded to the Alloy 600 nozzle, a flange on the CRDM, two spiral wound gaskets, two 180° split nut ring segments below the flange and eight bolts.

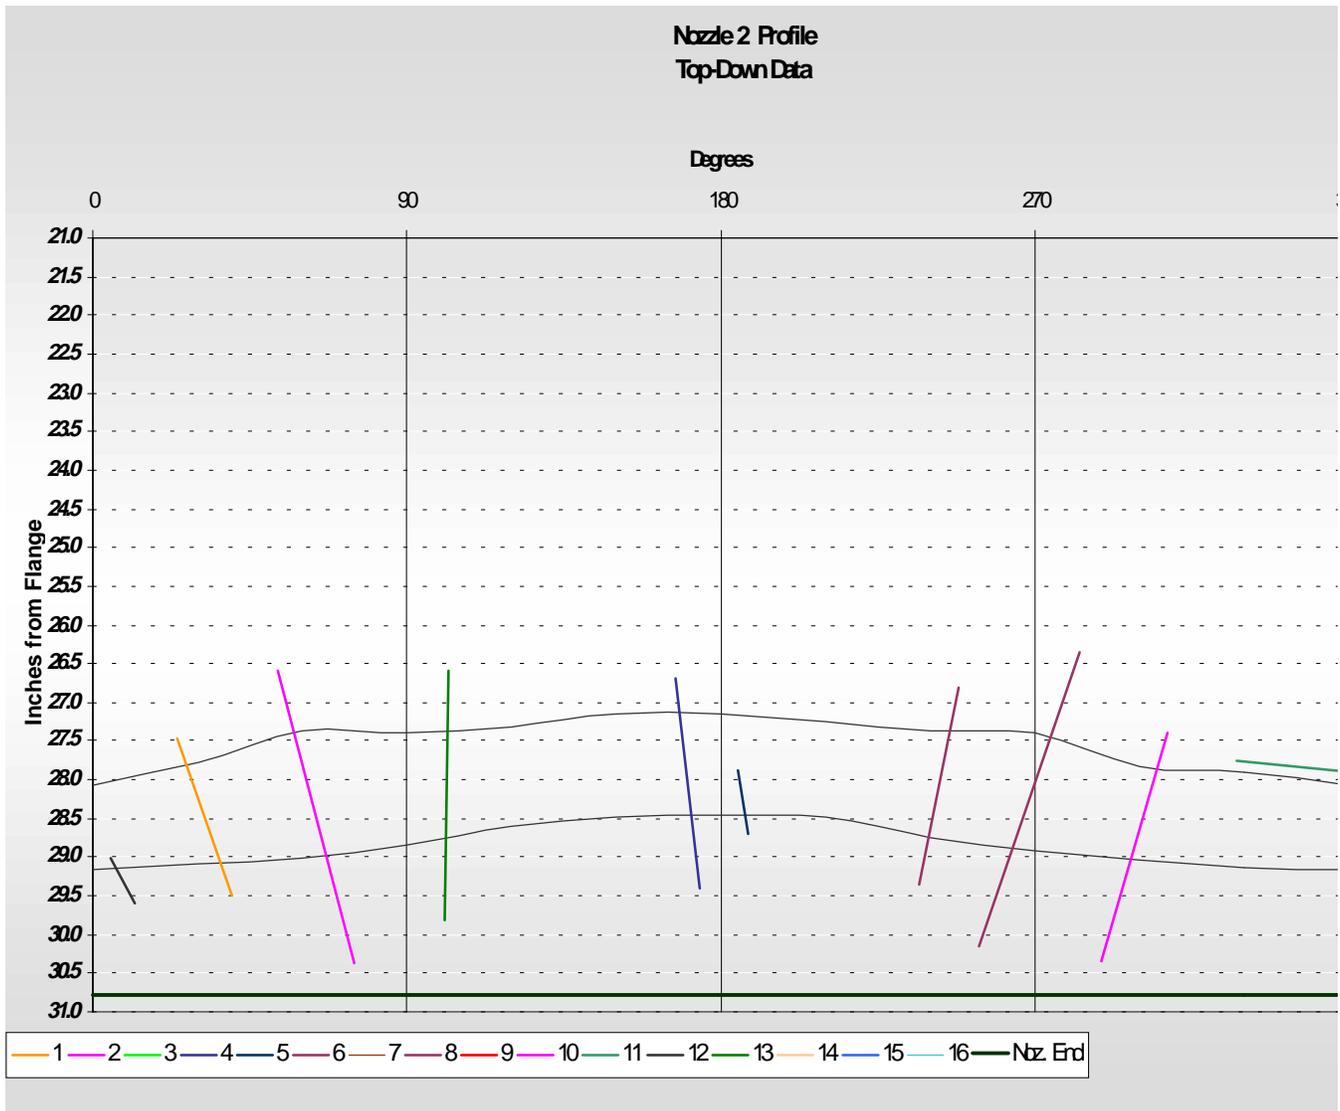
Figure 9. Nozzle 2 Crack Locations and Sizing

The longest crack lengths above the top of the J-groove weld determined by UT measurements are 1.1" for nozzle 2 and 1.2" for nozzle 3. The longest cracks above the J-groove weld previously discovered in other plants with low observed leakage are <1.0 inch. Since the Davis-Besse cracks are longer than in other B&W design plants, higher leak rates would be expected.

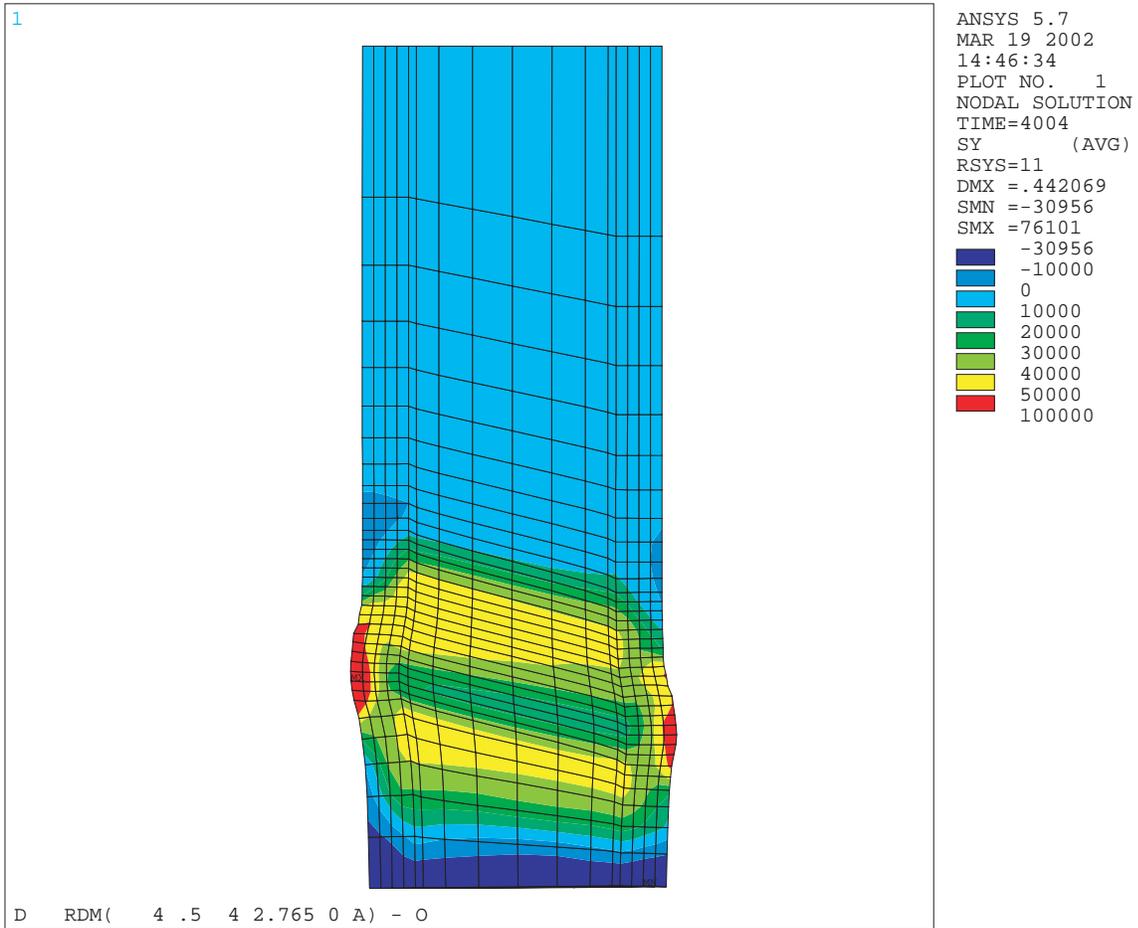
Figure 15. Hoop Stresses and Operating Condition Deflections in CRDM Nozzles 2-5

The finite element model in Figure 15 shows the hoop stresses in the nozzle including the effects of welding residual stresses and operating pressure and temperature. The tensile hoop stress shown in the area of the J-groove weld will tend to open a crack at this location.

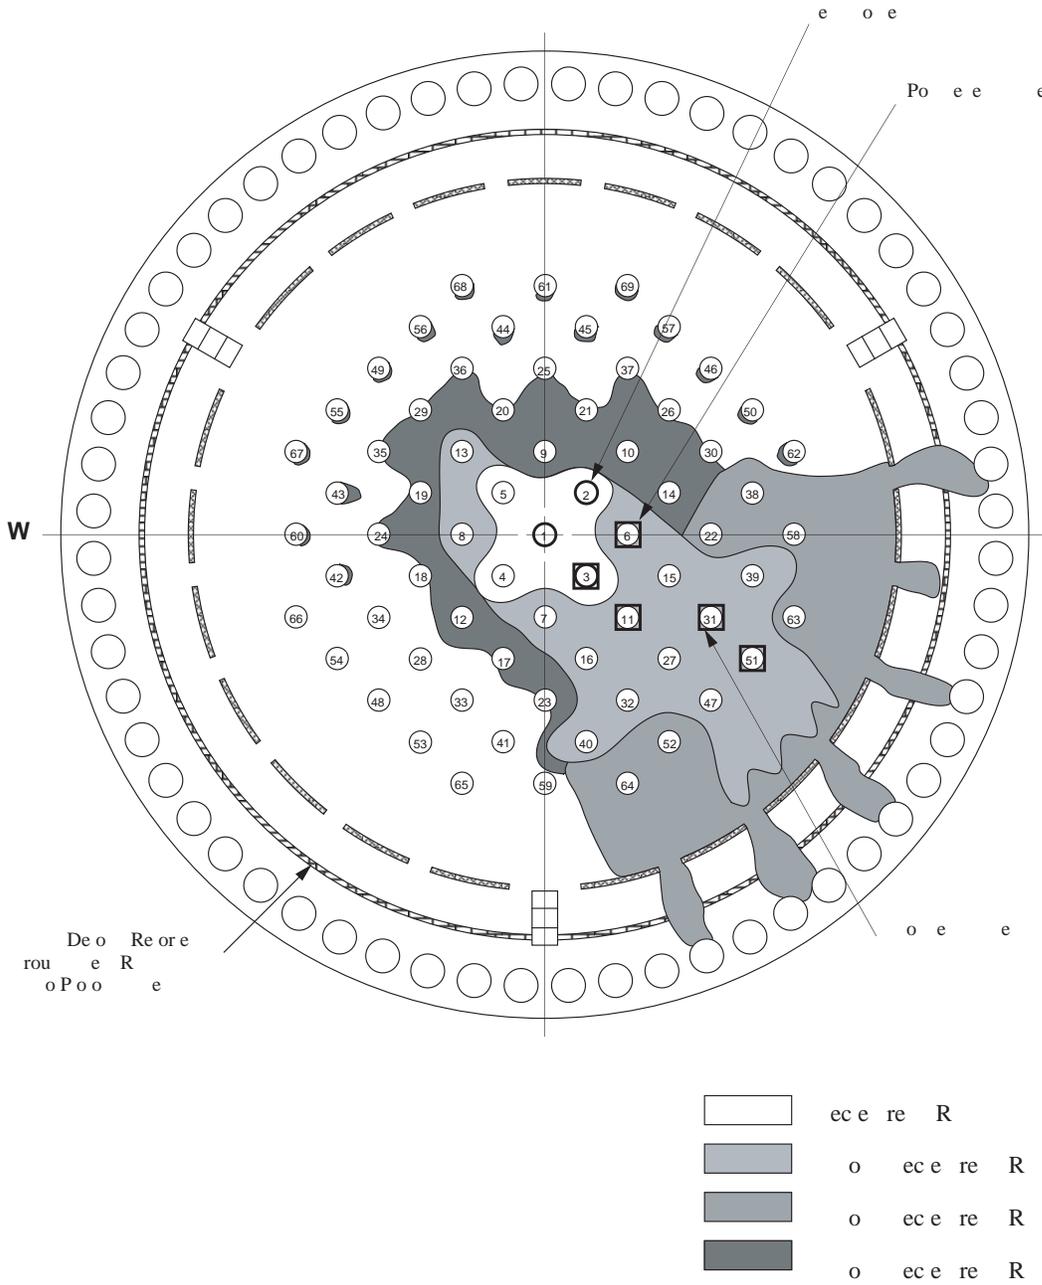
Figure 20. As-Found Locations of Boric Acid Deposits on Davis-Besse Vessel Head (10RFO to 13RFO)

An alternate means to estimate leak rates for this condition would be from boric acid accumulations. Because of uncertainties in how much boric acid left the head region, this method is only useful as a comparison. Figure 20 shows boric acid deposits on the RPV head prior to cleaning at 13RFO. The volume and weight of these deposits are estimated to be 11.5 ft<sup>3</sup> and 900 lb at an assumed density of 1.25 g/cc (reference 8.2.13), which is about midway between the density of boric acid crystals and powdered boric acid. Assuming that the average boron concentration in the primary coolant is 750 ppm, Figure 6-3 of Boric Acid Corrosion Guidebook, Revision 1 (reference 8.5.3) shows that 900 lb of boric acid deposits are the result of about 20,000 gallons of water. Assuming a linearly increasing leak rate over a two-year period of time, the maximum leak rate at the end of three years would be about 0.04 gpm. However, a substantial (but unquantified) amount of boric acid appears to have been drawn out of the CRDM service structure by the CRDM ventilation system and deposited in containment (CTMT). Thus, the leakage estimate may be low. More specifically, 10 ft<sup>3</sup> of wet boric acid were removed from the containment air cooler plenum during 13RFO. While this is almost as much material as was found on the RPV head, it is important to realize that the total unidentified primary leakage during cycle 13 was more than 0.1 gpm. It is not likely that all of this leakage was from nozzle cracks on the RPV head. Therefore, the estimate, 0.04 gpm, based on 900 lbs. of boric acid is a minimum predicted leakage rate from the nozzle cracks.

Figure 20 provides an overview of the boric acid deposits on the RPV head from 10RFO to 13RFO.

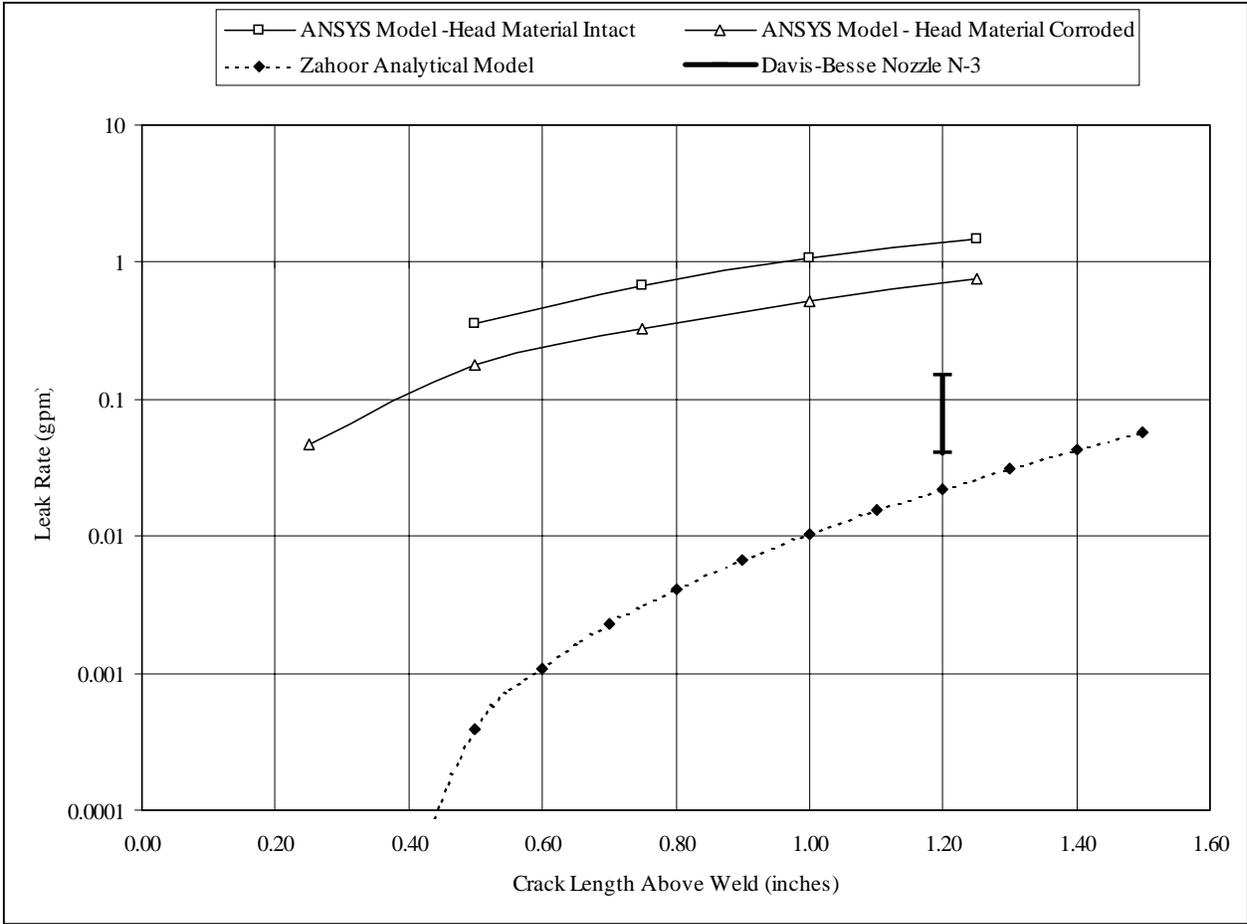
Figure 21. Nozzle Crack Leakage Rate Calculation Results

Dominion Engineering, Inc. Calculation No. C-5509-00-6 (reference 8.2.4) provides predicted leak rates from nozzles with PWSCC cracks. Key results are plotted in Figure 21. The basis for these leak rates are as follows:

Cracks above the J-groove weld can be modeled as through-wall axial cracks in a straight length of pipe subjected to internal pressure. The model used for the results plotted in Figure 21 is based on crack opening areas from the EPRI Ductile Fracture Handbook (reference 8.5.6). Leak rates are computed from the crack opening area using models developed by EPRI [Steam Generator Integrity Assessment Guidelines: Revision 1 (reference 8.5.7), and PWR Steam Generator Tube Repair Limits: Technical Support Document for Expansion Zone PWSCC in Roll Transitions (reference 8.5.8)].

The predicted leak rates are 0.025 gpm for the 1.2" crack at Davis-Besse nozzle 3, 0.018 gpm for the 1.1" crack at nozzle 2, and about 0.012 gpm for the longest previously encountered crack. These results show higher predicted leak rates for the longer Davis-Besse cracks and

that the total predicted leak rate is significantly less than the 0.1-0.2 gpm inferred from the measured unidentified leak rate.

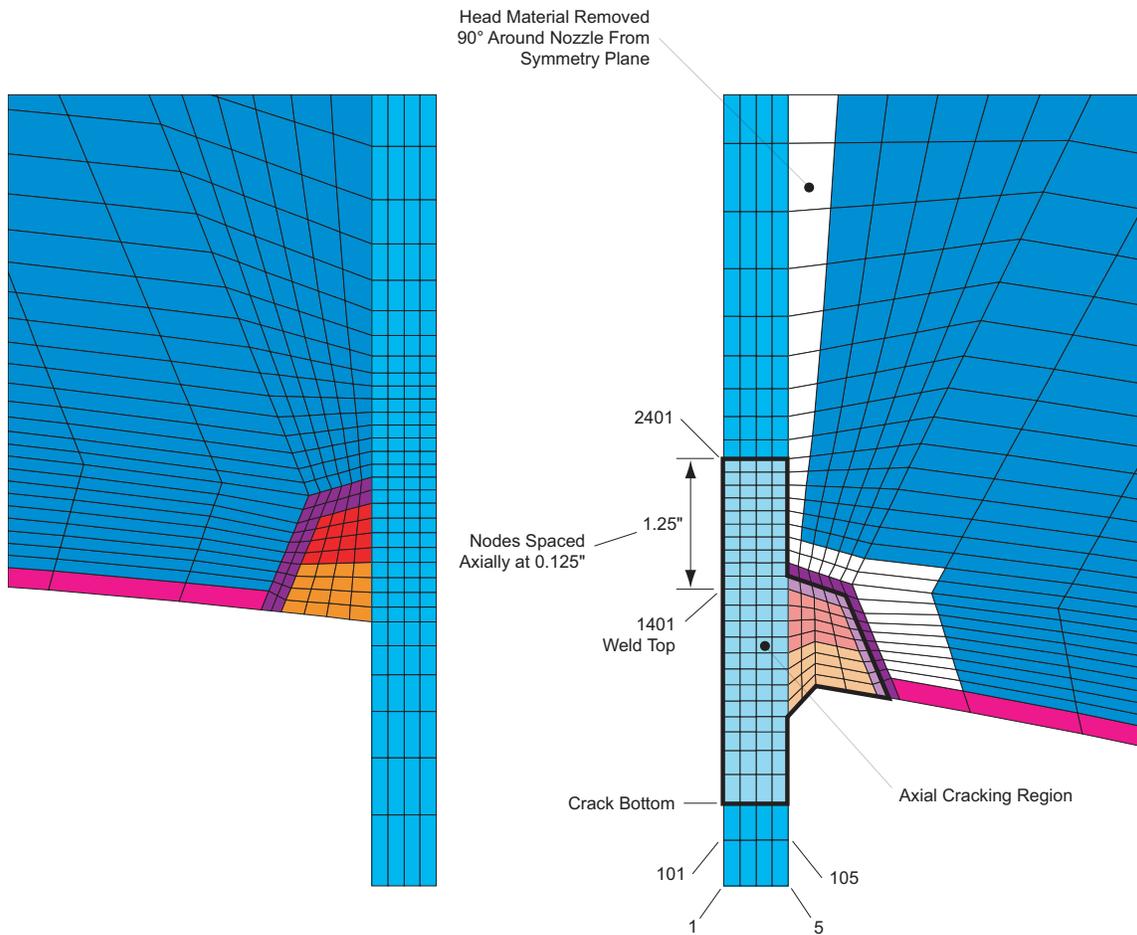
Figure 22. Finite Element Model Boundary Conditions to Simulate Axial Crack

The finite element model shown in Figure 15 was modified by releasing the nodes on the plane of symmetry in the area of the axial crack as shown in Figure 22 and described in Dominion Engineering, Inc. Calculation No. C-5509-00-7 (reference 8.2.5). The resultant crack opening displacements shown in Figure 23 result in a predicted leak rate of over 1 gpm for the 1.2" long crack at nozzle 3.

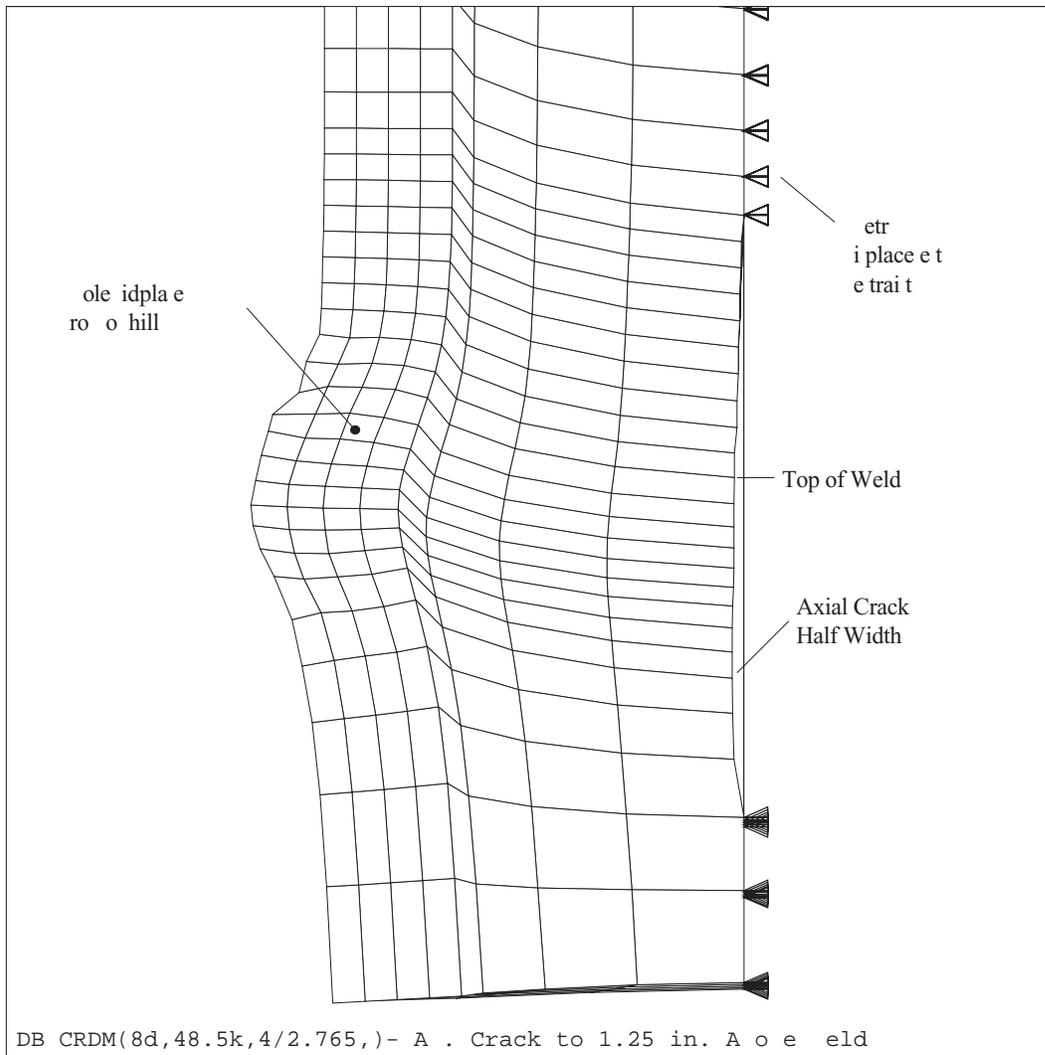
Figure 23. Crack Opening Displacement with the Crack Surface Nodes Released

An additional load step was added to the model to simulate the loss of low-alloy steel from behind the J-groove weld. Removal of the constraint provided by this material resulted in the crack closing up somewhat and a predicted leak rate of about 0.8 gpm for the 1.2" long crack in nozzle 3.

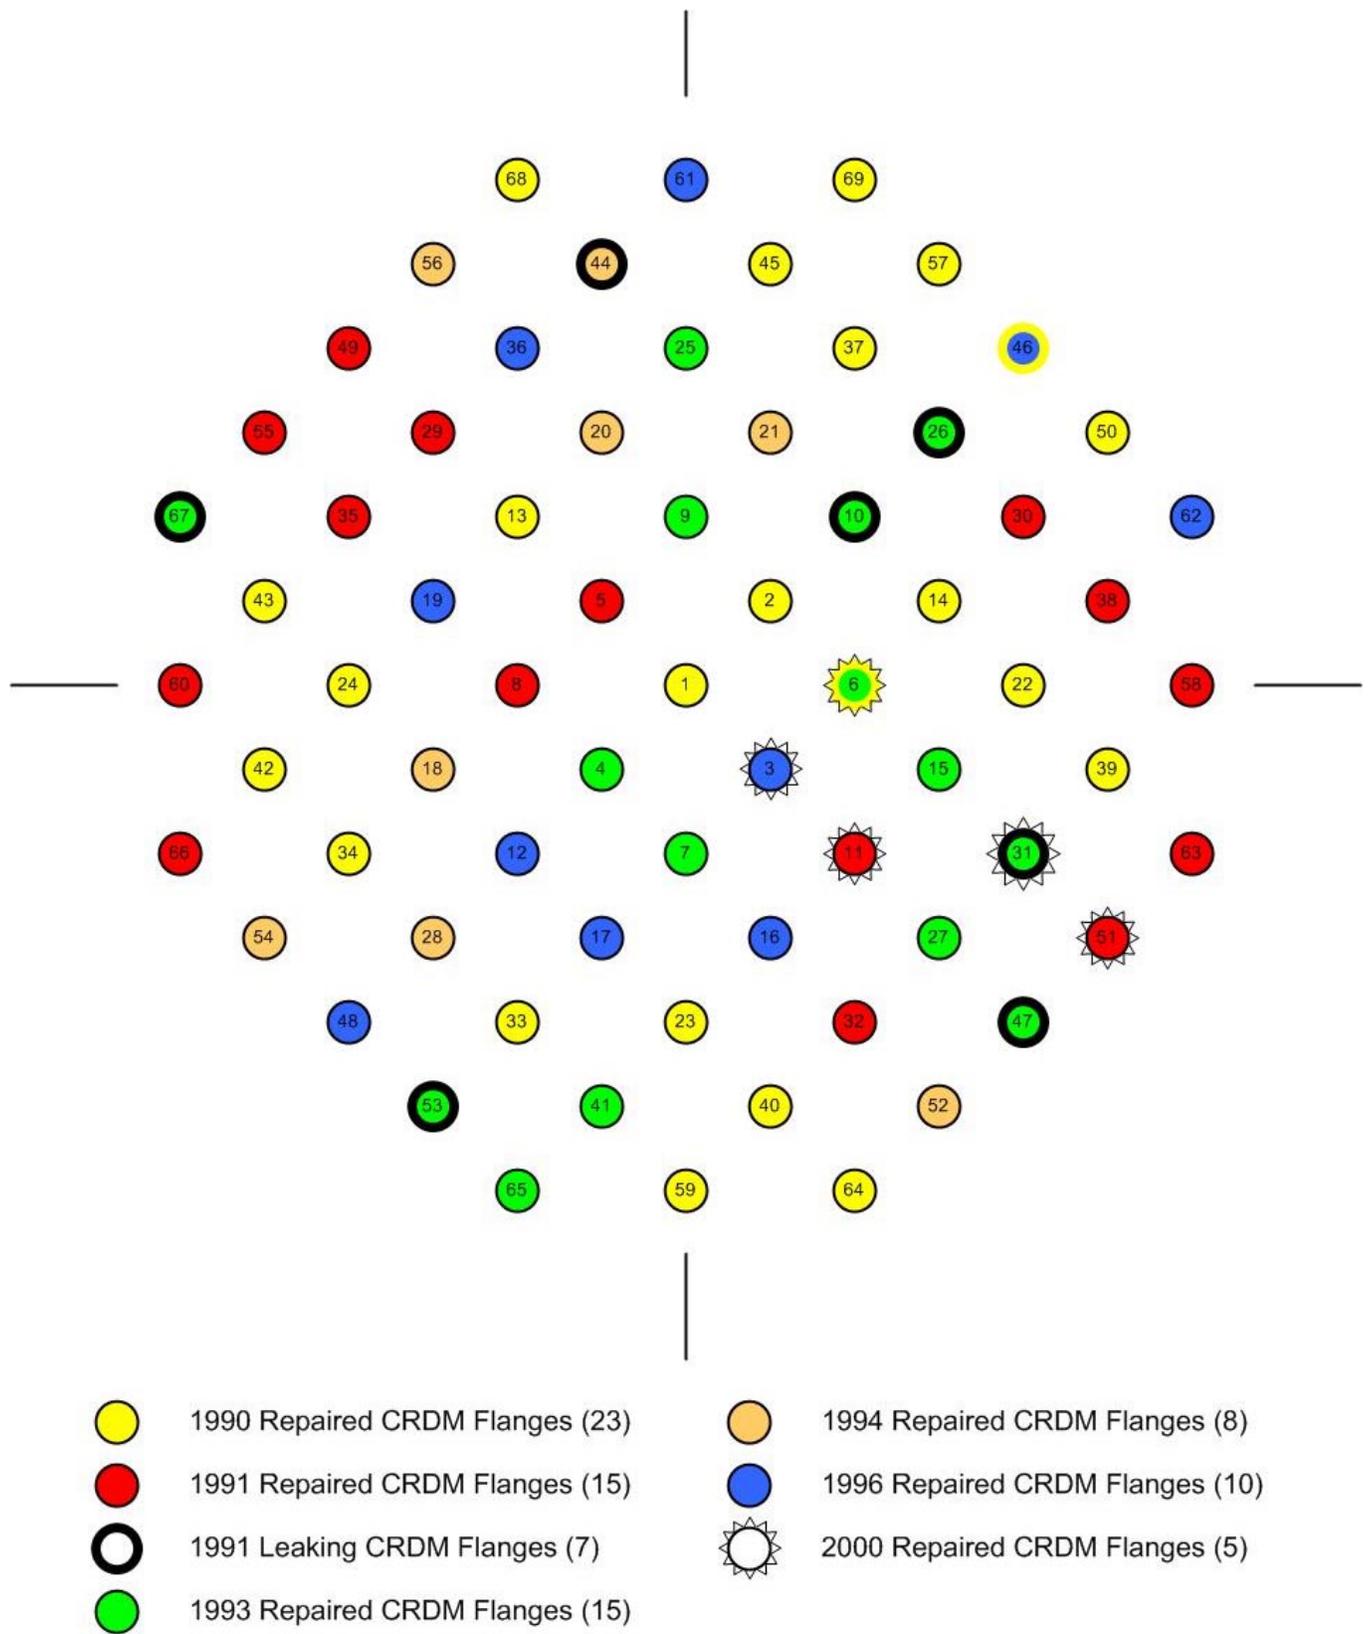
Figure 28. Leaking Flanges Found and Repaired During Each Outage

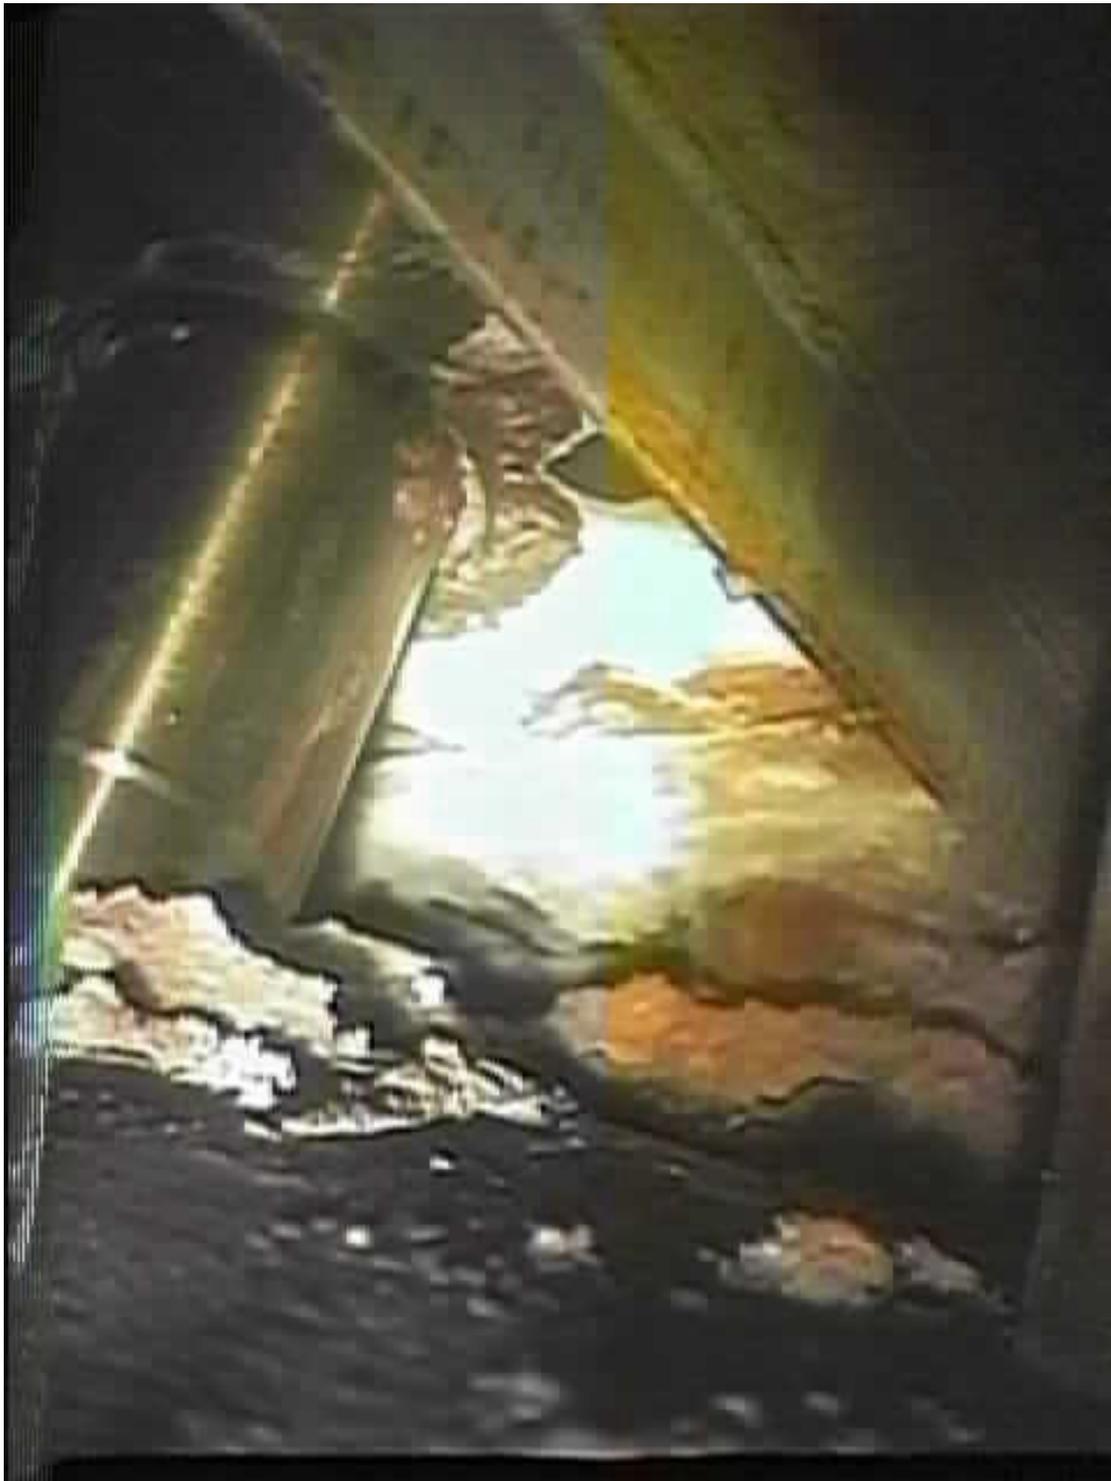
Figure 32. Boron Deposits – Source Unclear (8RFO)

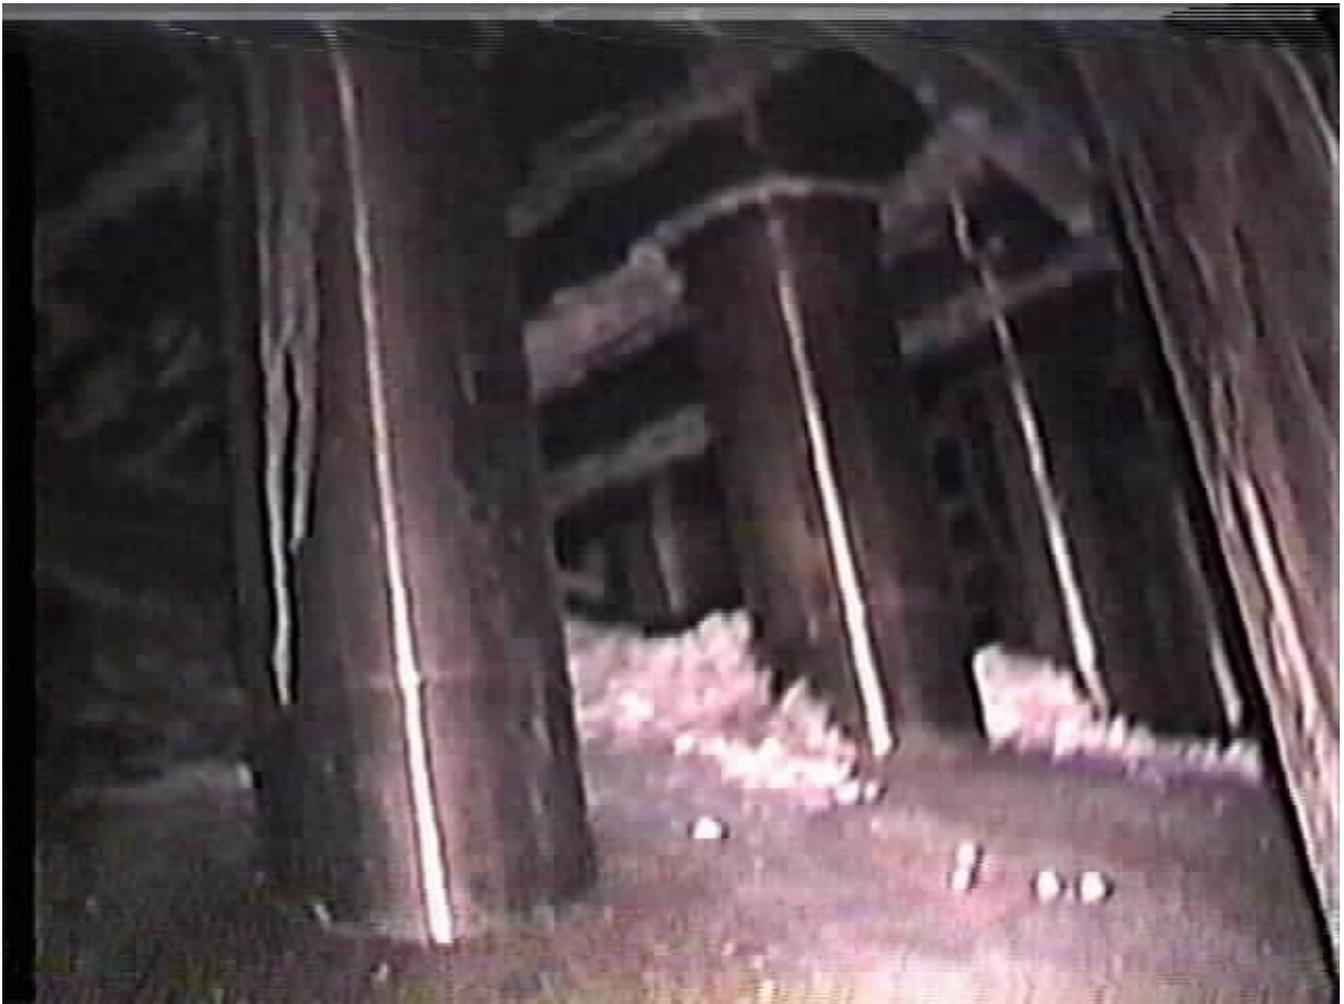
Figure 33. North Side of Reactor Vessel Head (10RFO)

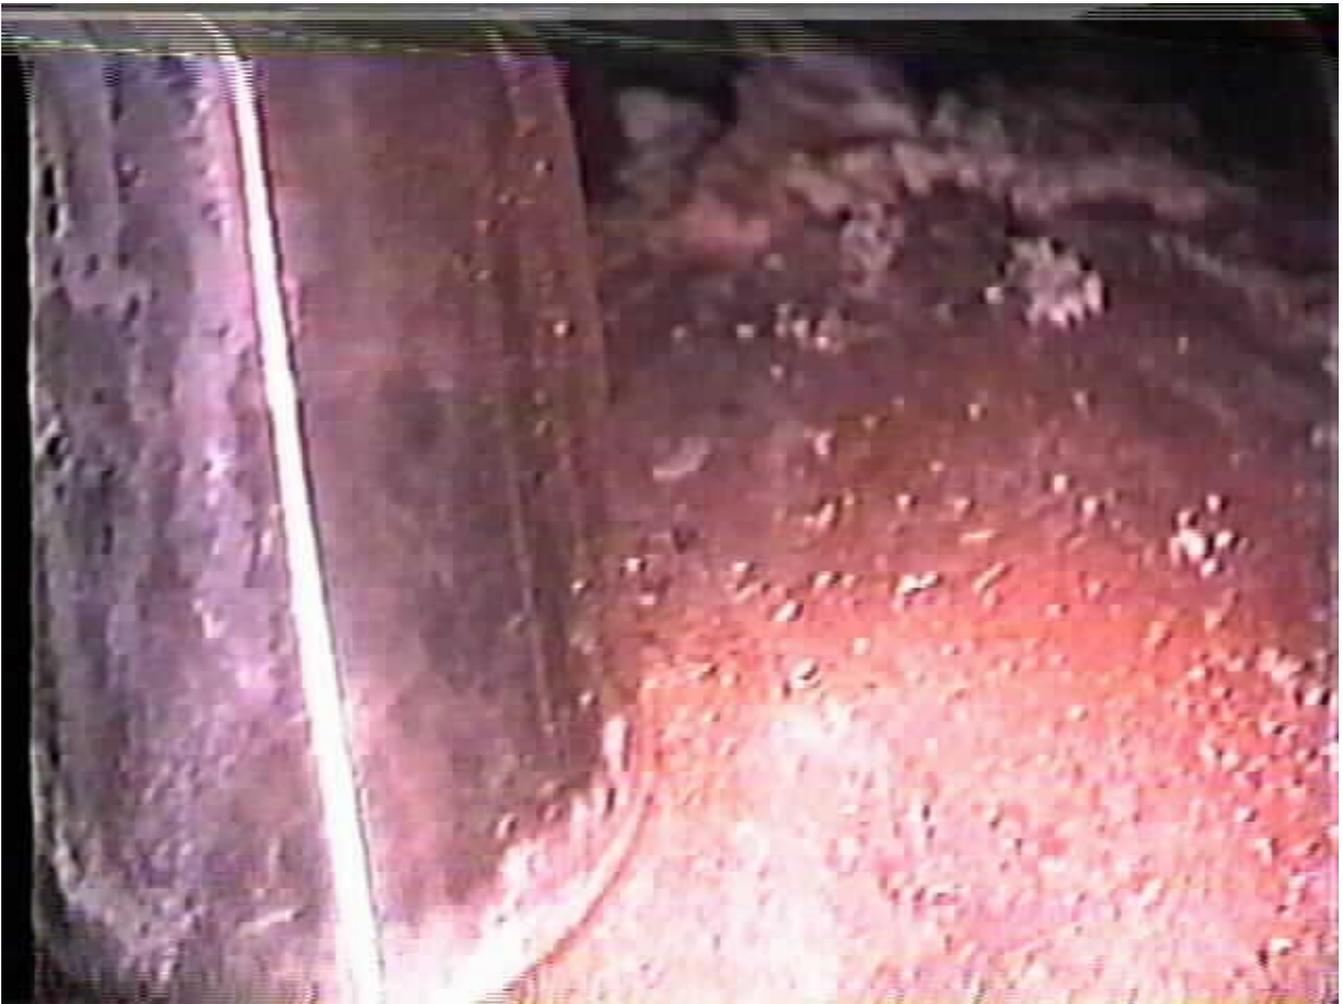
Figure 34. Boron Deposits Near Top of Reactor Vessel Head (10RFO)

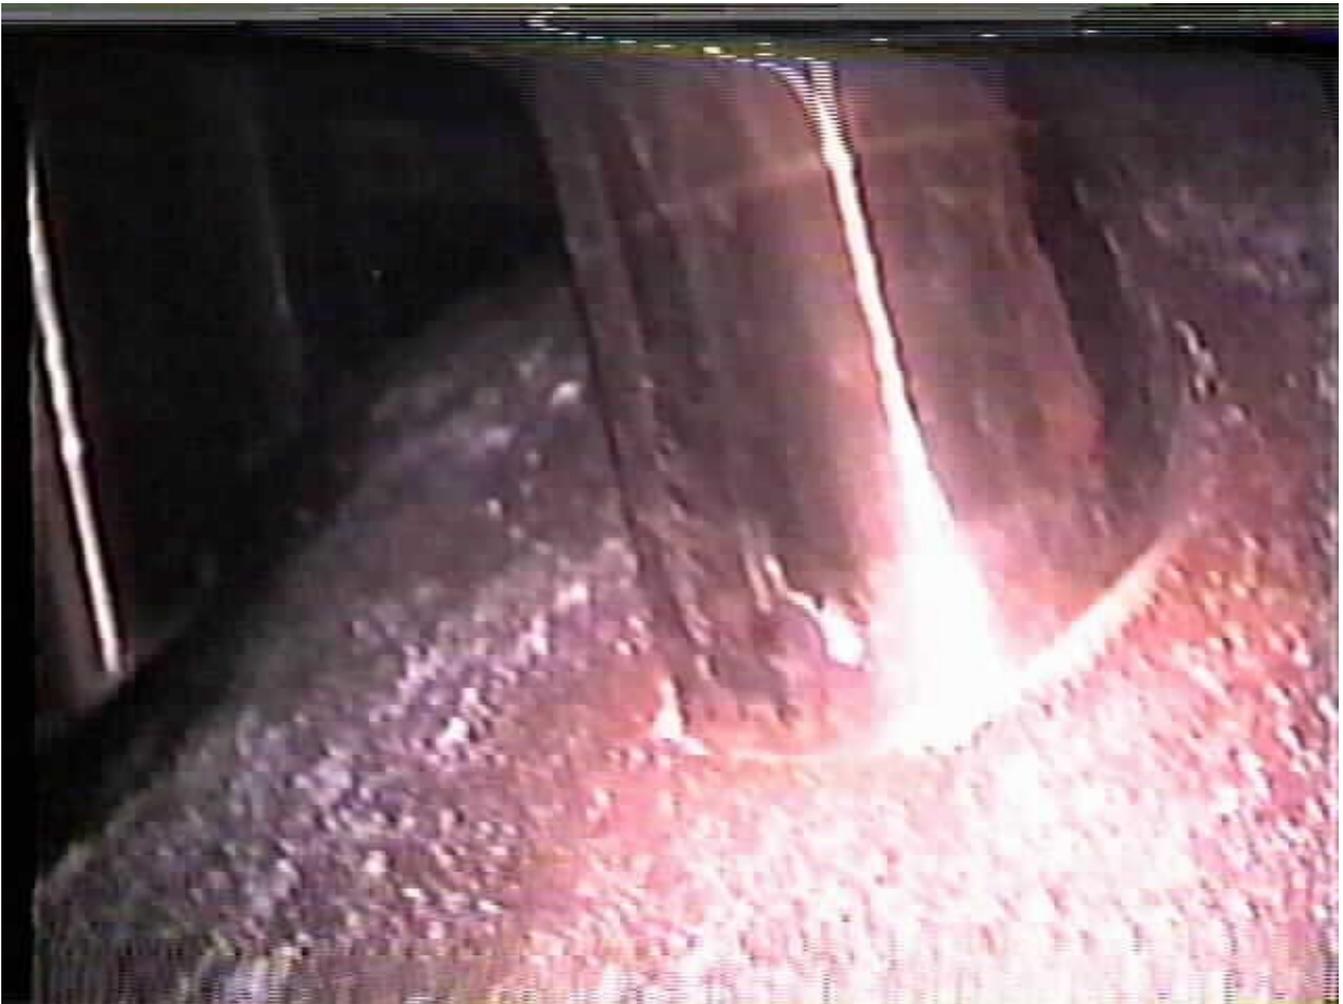
Figure 35: Typical Deposits for Periphery (10RFO)

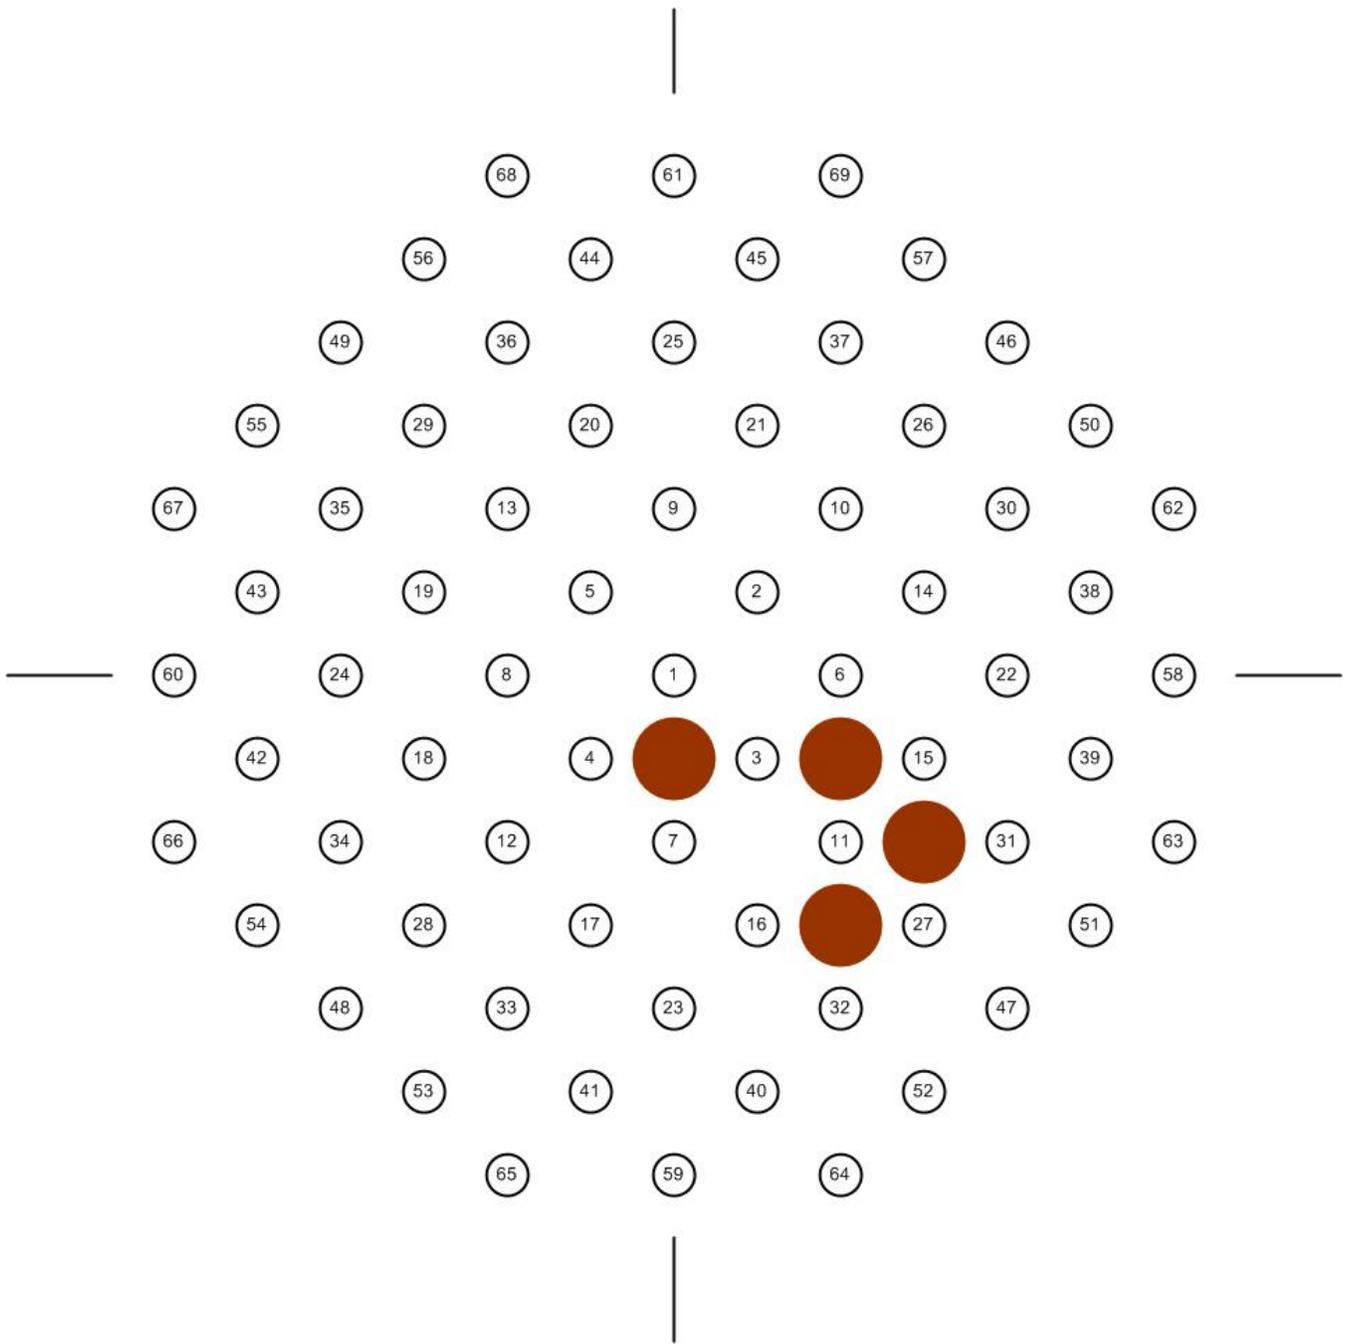
Figure 39. 2000 Interferences with CRDM Flange Inspection

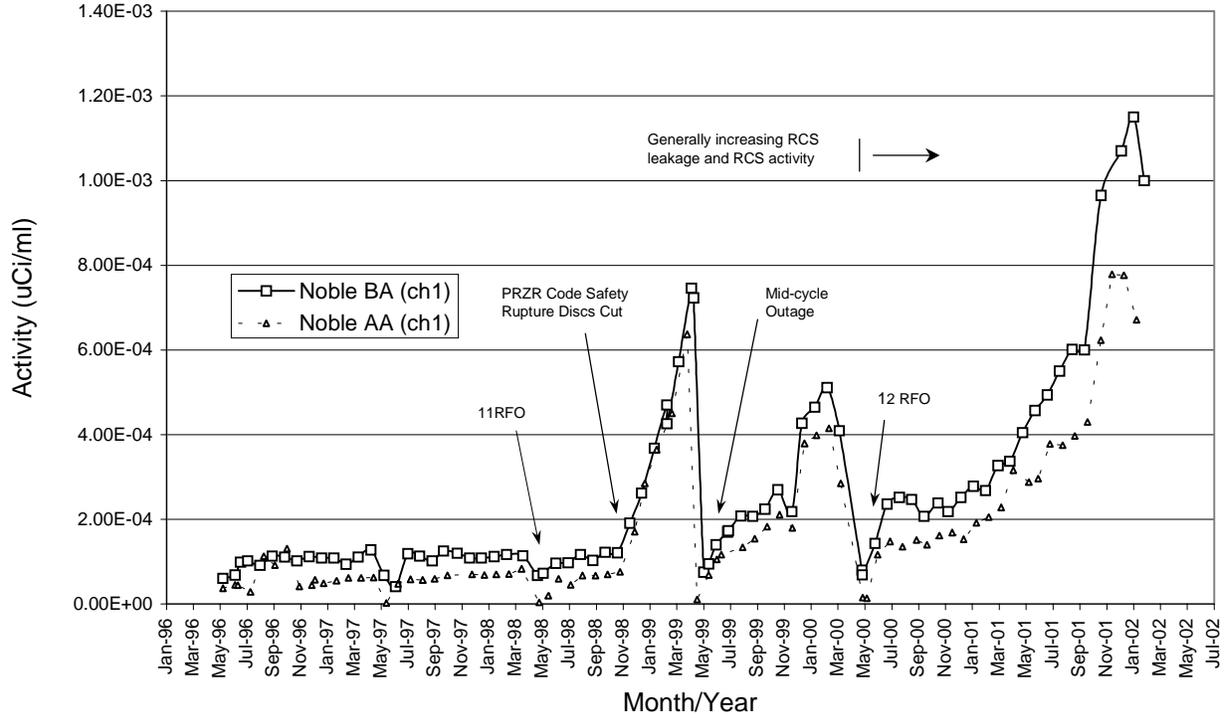
Figure 42. CTMT Radiation Monitors RE4597AA & BA (Both Noble Gas Channels)

with half lives of 9.2 hours to 5.2 days. For a constant RCS leakage rate and coolant activity, these isotopes will also reach a stable equilibrium value in containment and would thus theoretically provide a direct and valid indication of a slowly evolving RCS leakage trend. Trend data from these monitors is presented in Figure 42.
