Subject: Confirmatory Action Letter Response – Revision 1 to Root Cause Analysis  
Report Regarding Reactor Pressure Vessel Head Degradation

# Root Cause Analysis Report

Significant Degradation of the Reactor  
Pressure Vessel Head

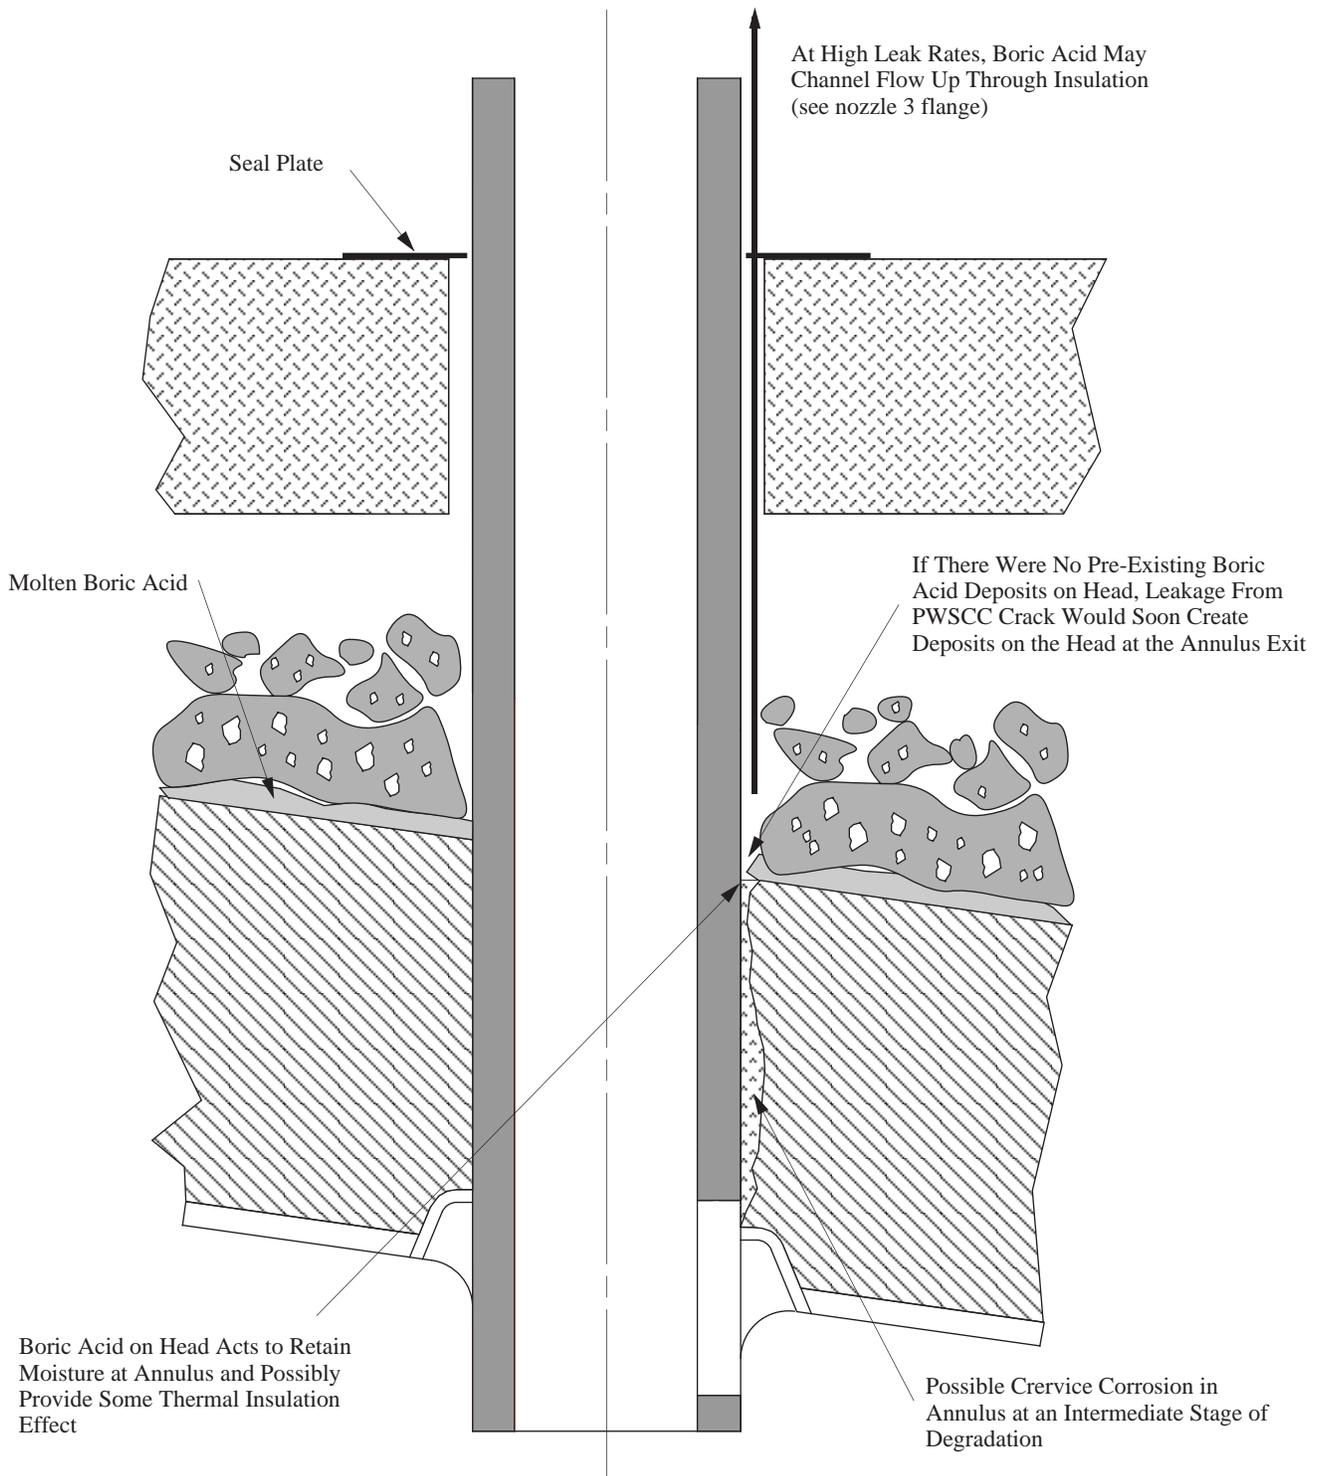
Figure 43. Potential Effects of Boric Acid Deposits on Vessel Top Head Surface.

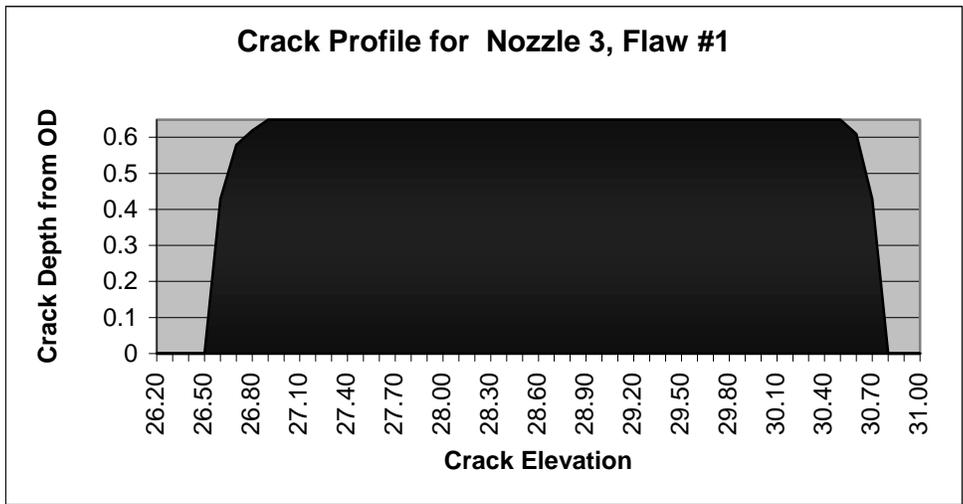
Figure 44. Crack Profile for Nozzle 3, Flaw #1
