Subject: Confirmatory Action Letter Response – Revision 1 to Root Cause Analysis
Report Regarding Reactor Pressure Vessel Head Degradation

Root Cause Analysis Report

Significant Degradation of the Reactor Pressure Vessel Head

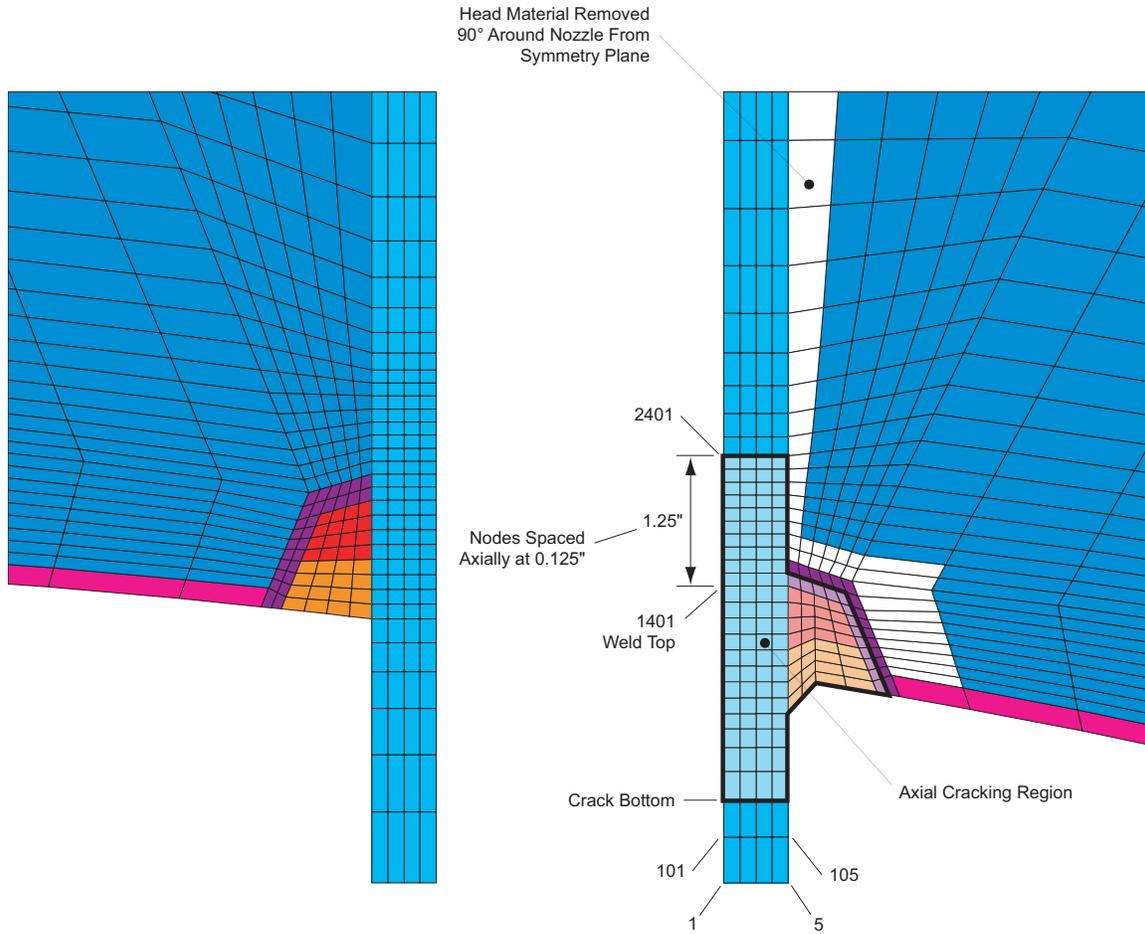
Figure 22. Finite Element Model Boundary Conditions to Simulate Axial Crack

The finite element model shown in Figure 15 was modified by releasing the nodes on the plane of symmetry in the area of the axial crack as shown in Figure 22 and described in Dominion Engineering, Inc. Calculation No. C-5509-00-7 (reference 8.2.5). The resultant crack opening displacements shown in Figure 23 result in a predicted leak rate of over 1 gpm for the 1.2" long crack at nozzle 3.
