# 1991 Annual Prelicensing Inspection of the Burrell, Pennsylvania, UMTRA Vicinity Property Disposal Site

September 1992

U. S. Department of Energy  
Albuquerque Field Office  
Grand Junction Projects Office  
Grand Junction, Colorado

**Prepared by  
Chem-Nuclear Geotech, Inc.  
Under DOE Contract No. DE-AC04-86ID12584  
U.S. Department of Energy  
Grand Junction Projects Office  
Grand Junction, Colorado**

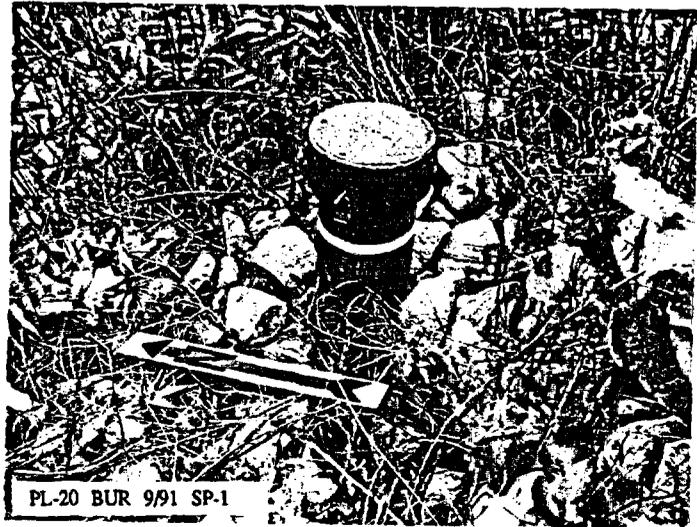
PL-20 BUR 991 SP-1

Twenty settlement plates are located on the tailings embankment and are referred to as SP-1 through SP-20. Fifteen of the settlement plates are cased, similar to the cap-and-pin monitoring well system. The remaining five (SP-2, SP-6, SP-7, SP-17, and SP-18) are of a different construction and appear as a piece of rebar anchored in concrete. All 20 were inspected and photographed (PL-20 through PL-39). There was no evidence of tampering or disturbance and all casings were in good condition, although the locks and casings are quite rusty.
