1991 Annual Prelicensing Inspection of the Green River, Utah, UMTRA Project Disposal Site

September 1992

U. S. Department of Energy
Albuquerque Field Office
Grand Junction Projects Office
Grand Junction, Colorado

**Prepared by
Chem-Nuclear Geotech, Inc.
Under DOE Contract No. DE-AC04-86ID12584
U. S. Department of Energy
Grand Junction Projects Office
Grand Junction, Colorado**

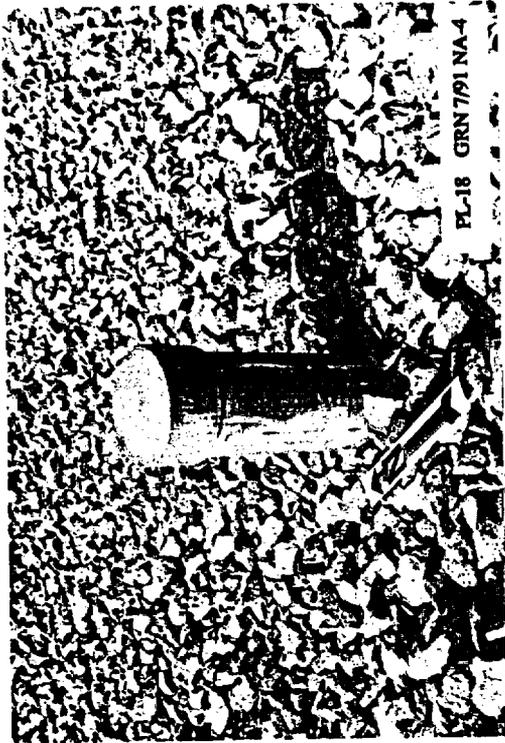
PL-18 GRN 7/91 NA-4

deterioration or evidence of tampering was observed. The positions of the neutron access holes are shown on Plate 1, the inspection drawing.

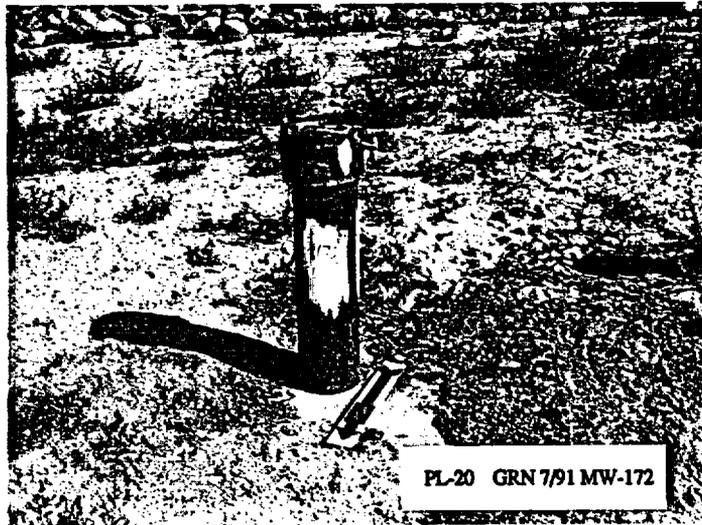
PL-20 GRN 7/91 MW-172

Twenty-one monitoring wells were inspected and photographed (PL-19 through PL-39). The positions of the wells are shown on Plate 1, the inspection drawing. Monitoring well 817 (MW-817) was found unlocked (PL-39). All other wells were locked and in good condition. All well casings are of the cap and pin variety. MW-582 was found to have a small artesian flow (PL-29). Two holes had been drilled in the casing of this well to allow the water to escape. A list of all wells and padlock key numbers is included as Table 2-3.
