# **1991 Annual Prelicensing Inspection of the Salt Lake City (South Clive), Utah, UMTRA Project Disposal Site**

**September 1992**

**U. S. Department of Energy  
Albuquerque Field Office  
Grand Junction Projects Office  
Grand Junction, Colorado**

**Prepared by  
Chem-Nuclear Geotech, Inc.  
Under DOE Contract No. DE-AC04-86ID12584  
U. S. Department of Energy  
Grand Junction Projects Office  
Grand Junction, Colorado**

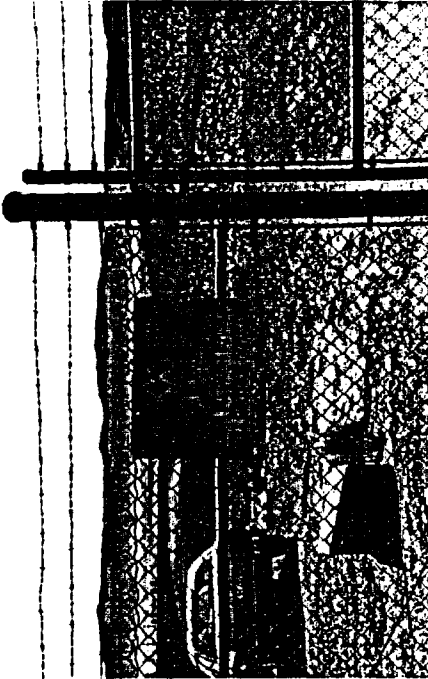
PL-1 SLC 7/91 ENTRANCE SIGN

The South Clive site has one entrance sign and 15 perimeter signs. The entrance sign is in place and it is not damaged (PL-1). All 15 perimeter signs are in their designated locations; none of the signs are damaged. The locations of the signs are shown on Plate 1, the inspection drawing. The entrance sign is designated with an "E." The perimeter signs are designated by a "P" followed by a number, such as P6. The perimeter signs were numbered to provide useful reference points for observation and to allow the inspector to specify a particular sign requiring replacement if required.

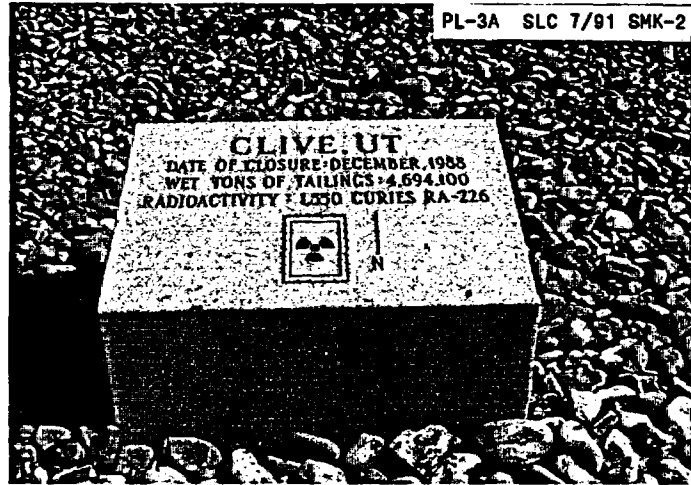
PL-3A SLC 7/91 SMK-2

Two site markers are in place at the South Clive site—SMK-1 and SMK-2. SMK-1 is located just inside the entrance gate (PL-2). SMK-2 is centrally located on top of the covering over the tailings (embankment) (PL-3). Both site markers are in excellent condition and show no sign of deterioration. There are, however, two problems.

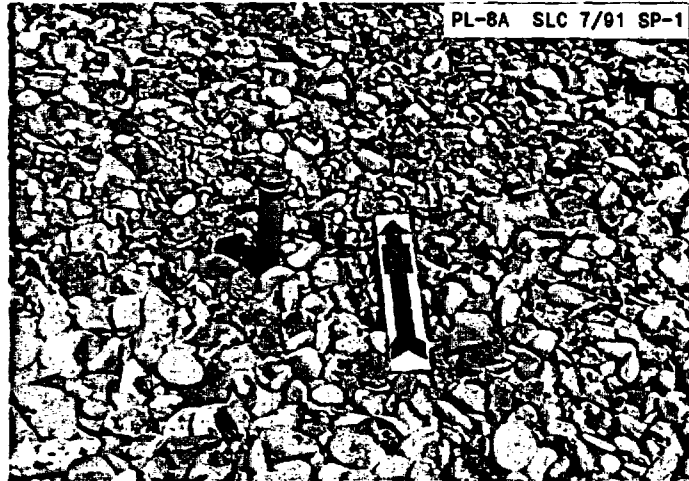
PL-8A SLC 7/91 SP-1

Nine settlement plates are in place at the site: SP-1, SP-2 NW, SP-2 SE, SP-3, SP-7, SP-8, SP-10, SP-11, and SP-12. The numbers were difficult to read. All nine settlement plates are on top of the embankment and noted on Plate 1. All are identified by orange-colored threaded caps with numbers stamped on the caps. The numbering of the plates is random with two plates numbered "2." For purposes of this report the plates numbered "2" have been labeled SP-2 NW and SP-2 SE. SP-2 NW, SP-1, and SP-10 are located along the northern edge of the top transect (PL-7, PL-8, and PL-9). SP-3, SP-7, and SP-12 are located across the middle of the top transect, west to east (PL-10, PL-11, and PL-12). SP-11, SP-8, and SP-2 SE are located along the southern edge of the top transect (PL-13, PL-14, and PL-15). All settlement plate casings are in good condition except that the die-stamped numbers on the casing caps were difficult to discern and two caps are stamped with the same number "2."

first-order levels using the northwest corner of Section 32 as the reference bench mark (DOE, 1987). During the resurvey, the existing caps should be replaced with caps which have numbers that are readable and are in sequential order. For first-order accuracy, the caps should be welded to each respective casing.
