**TECHNICAL REPORT  
TR-3270-9-90**

**AN OPERATIONAL ASSESSMENT OF THE  
BABCOCK & WILCOX AND COMBUSTION ENGINEERING  
CONTROL ROD DRIVES**

**September 1990**

**E. Grove and W. Gunther  
Engineering Technology Division**

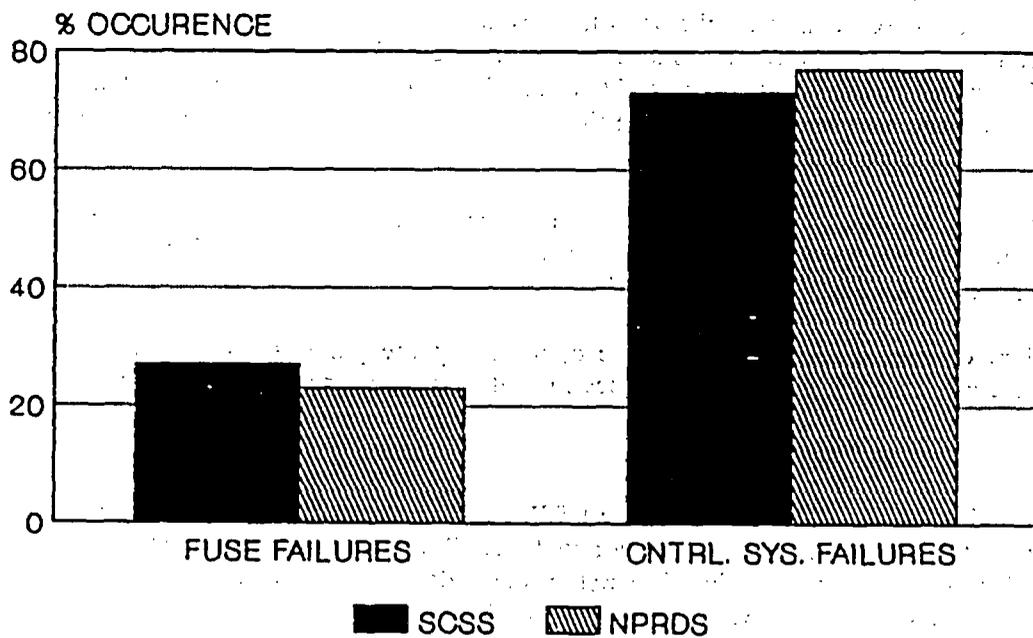
Figure 4.12. B&W control system failures 1980-1989.

As shown on Figure 4.2, control system failures accounted for approximately 25% of the reported events. However, with the exception of blown fuses, no other component accounted for any significant majority as shown on Figure 4.12.

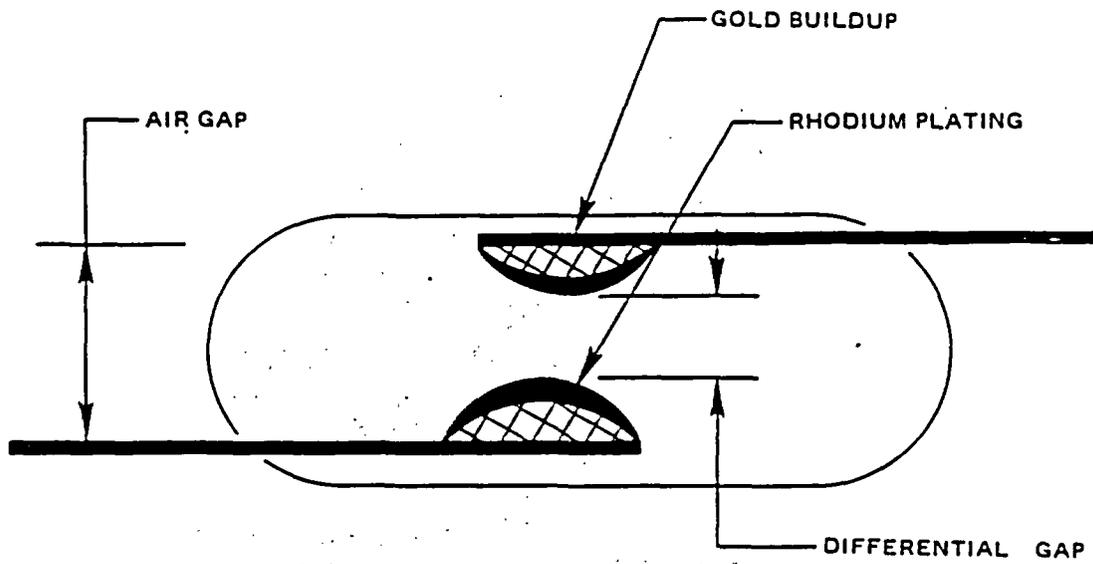
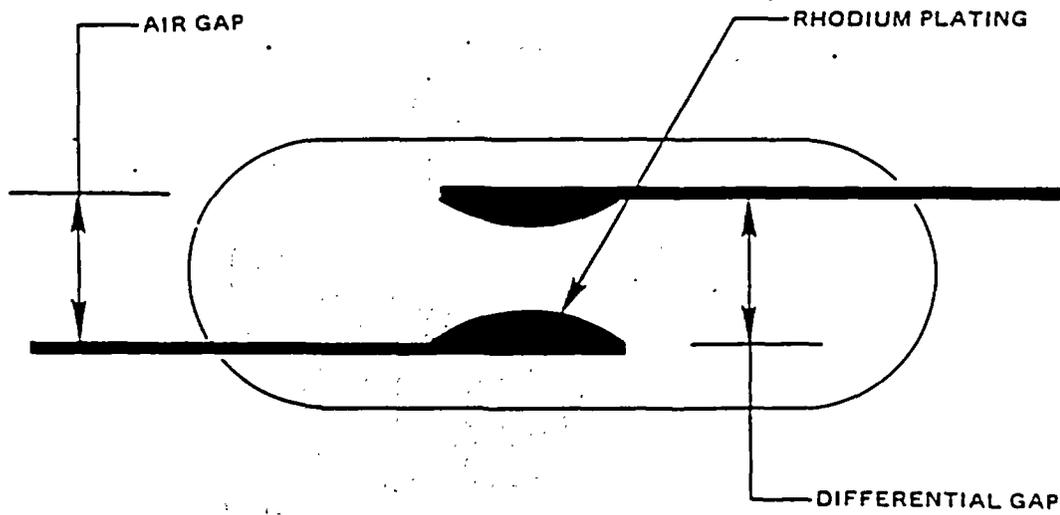
Figure 4.14. Babcock & Wilcox reed switch comparison.

Also, a new reed switch design, designated R4C was utilized. These new reed switches were more reliable and allowed the system to continue to operate with one failed reed switch. These switches were completely encased in glass, with rhodium contact points. Previous designs used a low differential reed switch with gold plating on top of the rhodium plating as shown in Figure 4.14. The change was necessitated by the failure rate and erratic operation of the previous design. The previous design had a tendency to build up a surface film on the contacts, which in conjunction with a small closing force resulting from the small gap, led to switch failures. The R4C reed switch provides a more positive contact because of the higher closing force, thus reducing surface film buildup.

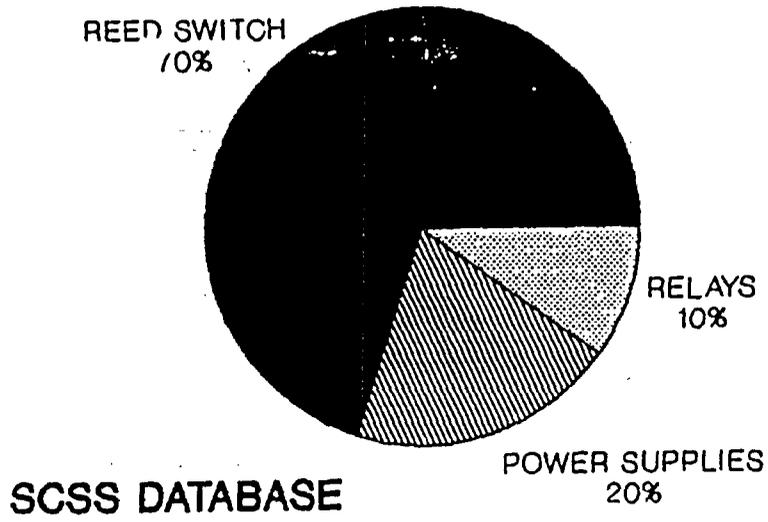
Figure 4.15. B&W rod position indication failures 1980-1989.

As shown on Figure 4.15, no other major component failure caused the system to fail, and the occurrence of system failures since 1985 has decreased markedly.

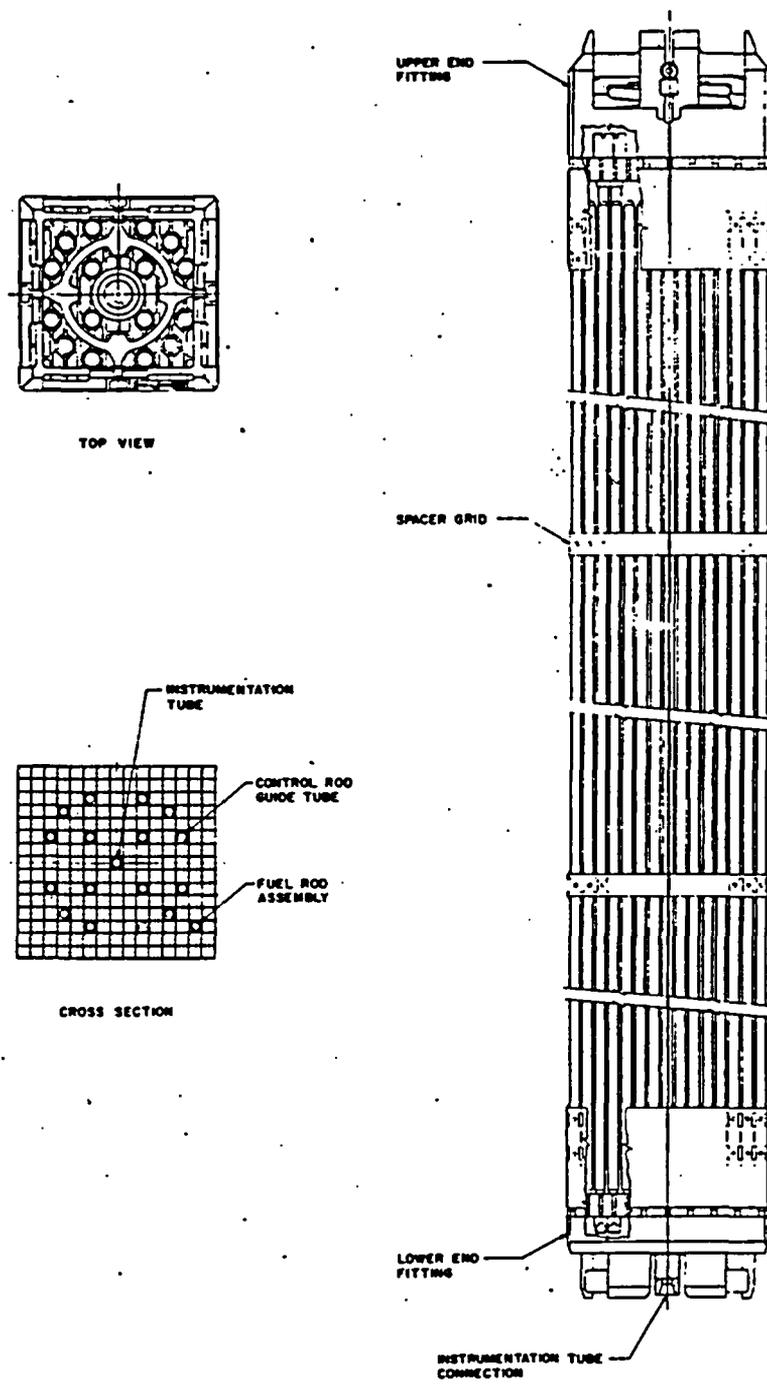
Figure 4.17. Babcock & Wilcox fuel assembly.<sup>(17)</sup>

Broken fuel assembly holddown springs were identified at Crystal River, Davis Besse and in Oconee 1 and 3. The Mark B fuel assembly design, as shown on Figure 4.17, utilized one large helical coil spring, which is positioned on top of the upper end fitting and held in place by a spring retainer. Inspection of this spring revealed cracks, conclude that it was caused by low stress high cycle fatigue and stress corrosion cracking. Of all the broken spring identified, none actually interfered with control rod insertion or withdrawal.
