Subject: 2003 Annual Site Inspection and Monitoring Report for UMTRCA Title I  
Disposal Sites

# 2003 Annual Site Inspection and Monitoring Report for Uranium Mill Tailings Radiation Control Act Title I Disposal Sites

January 2004

GJO-2003-528-TAC

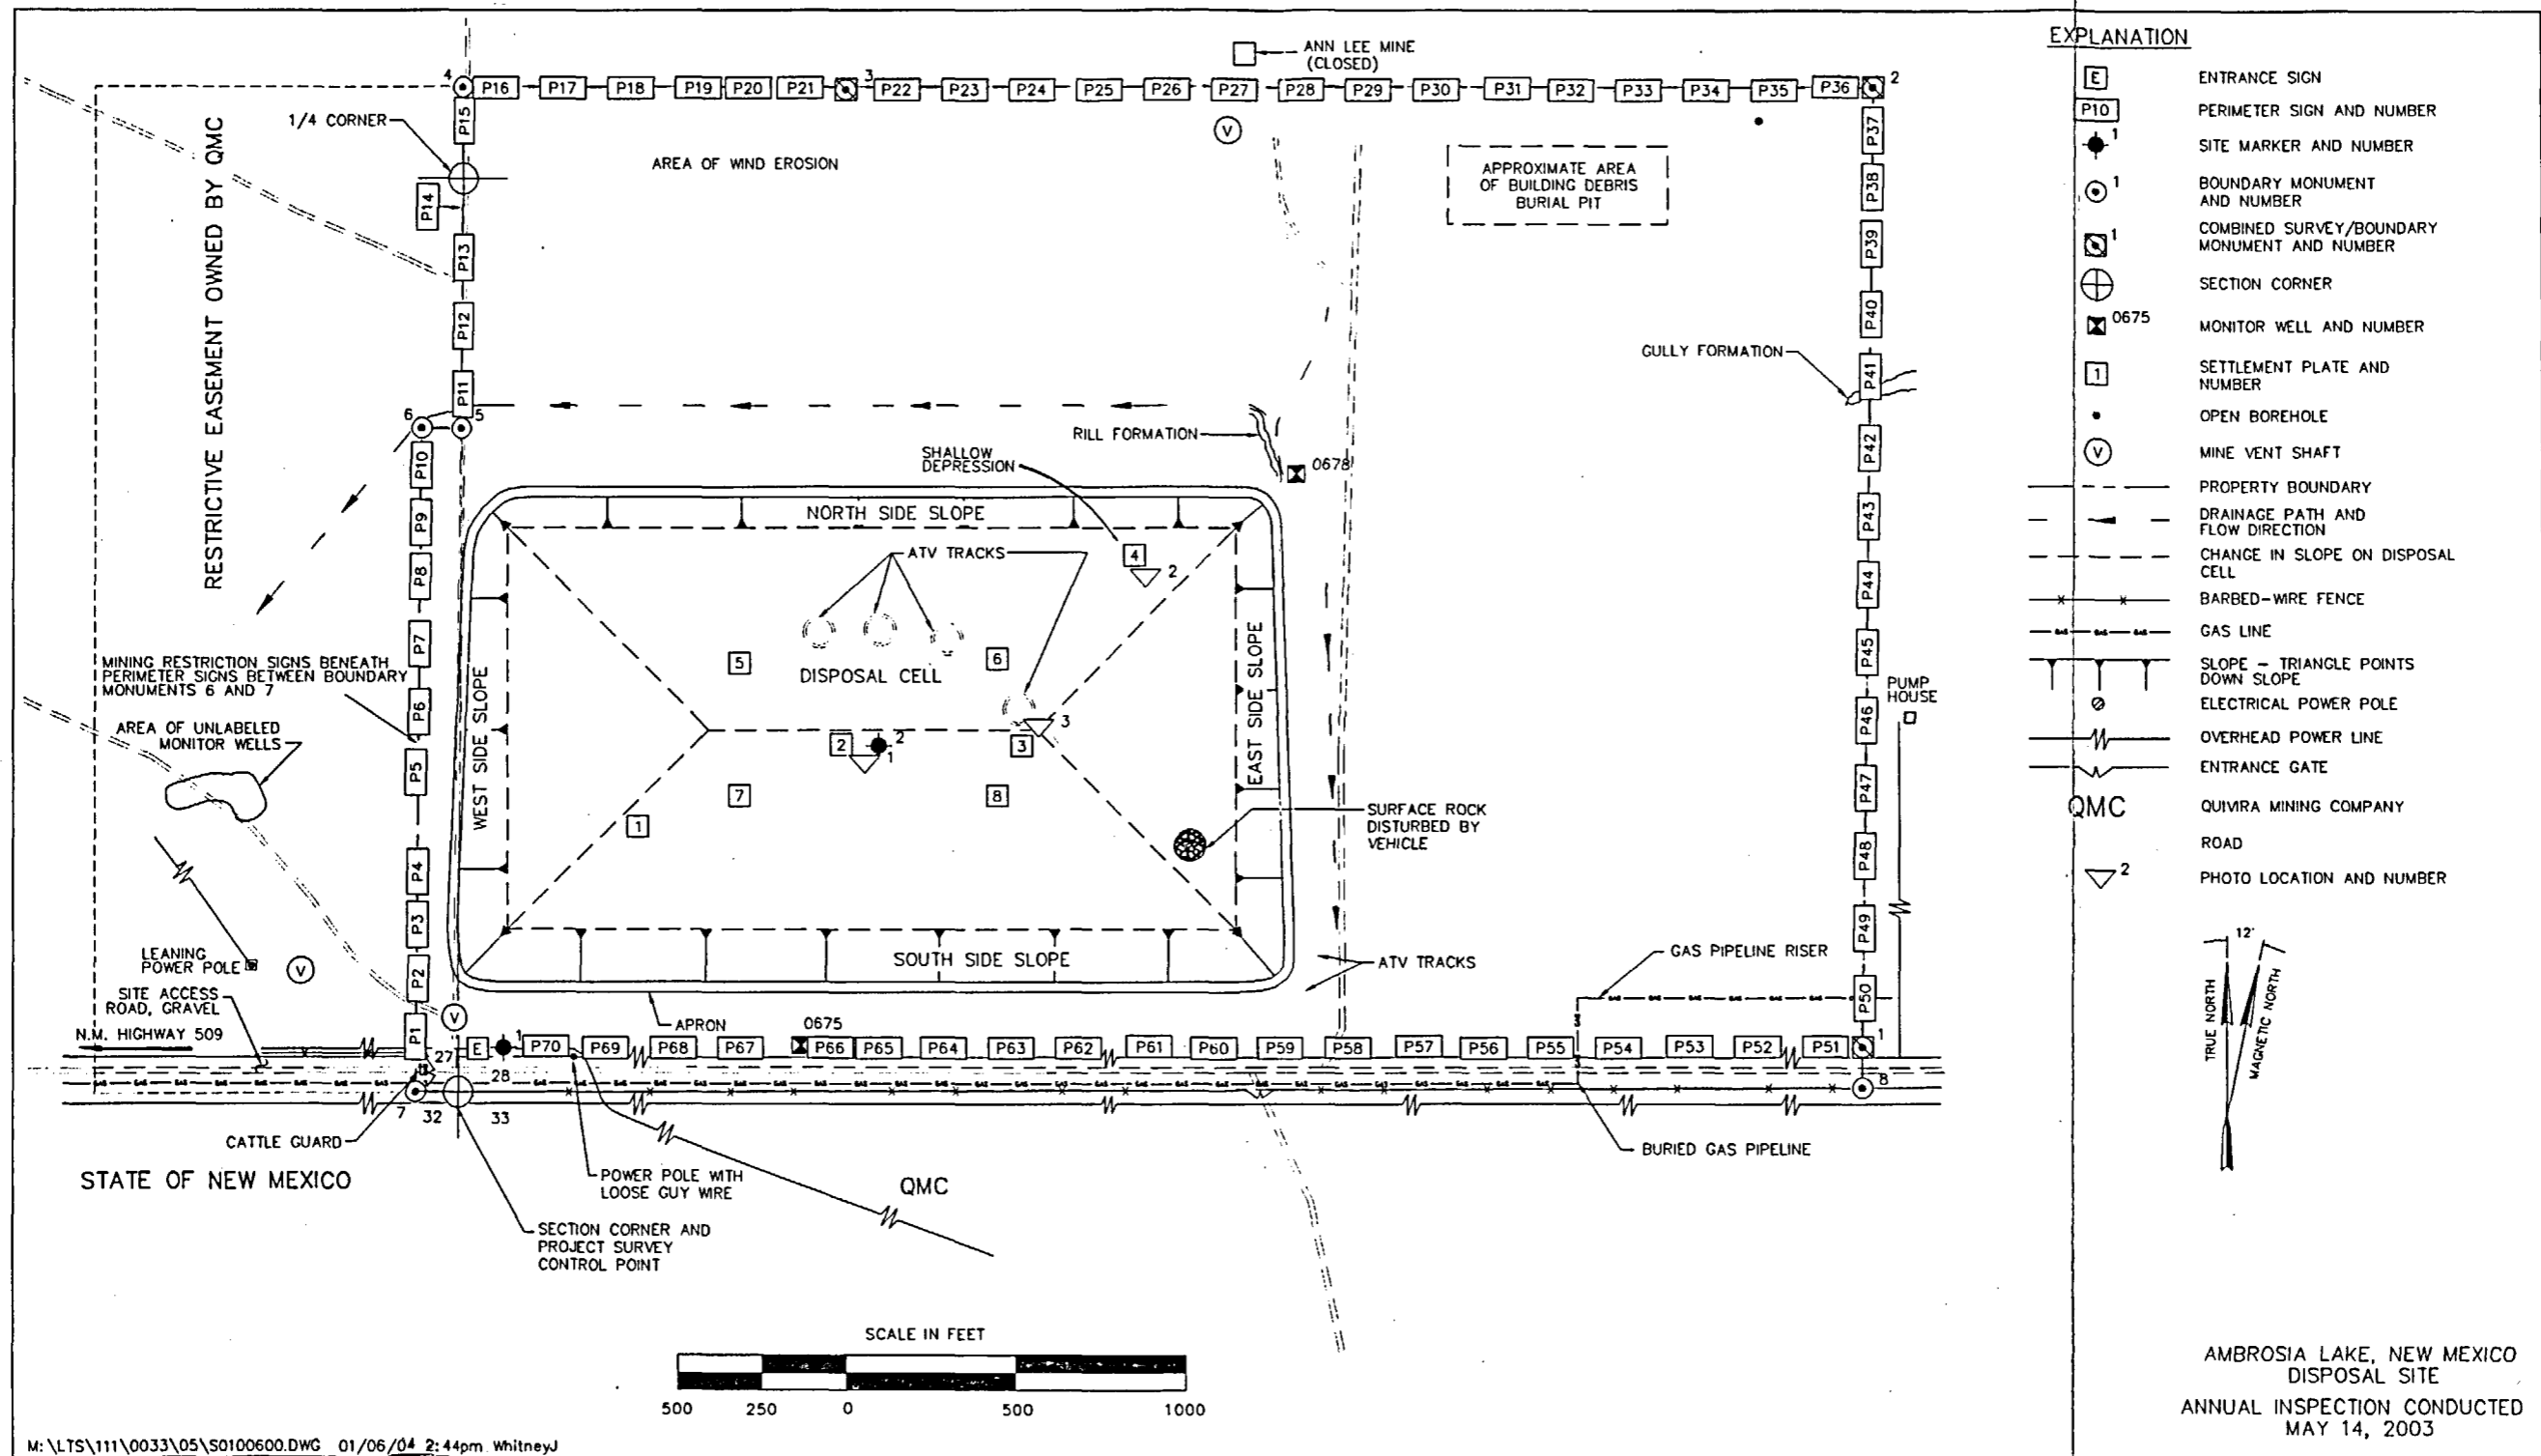
Figure 1-1. 2003 Annual Compliance Drawing for the Ambrosia Lake, New Mexico, Disposal Site

Trespassing was evident on top of the disposal cell. An all-terrain vehicle (ATV) had been driven to the top of the cell and used to mark four circles with diameters between 40 and 60 feet (PL-3). Another area of surface disturbance was noted near the southeast corner of the cell top. The tracks were very shallow and do not impair the integrity or performance of the cover.

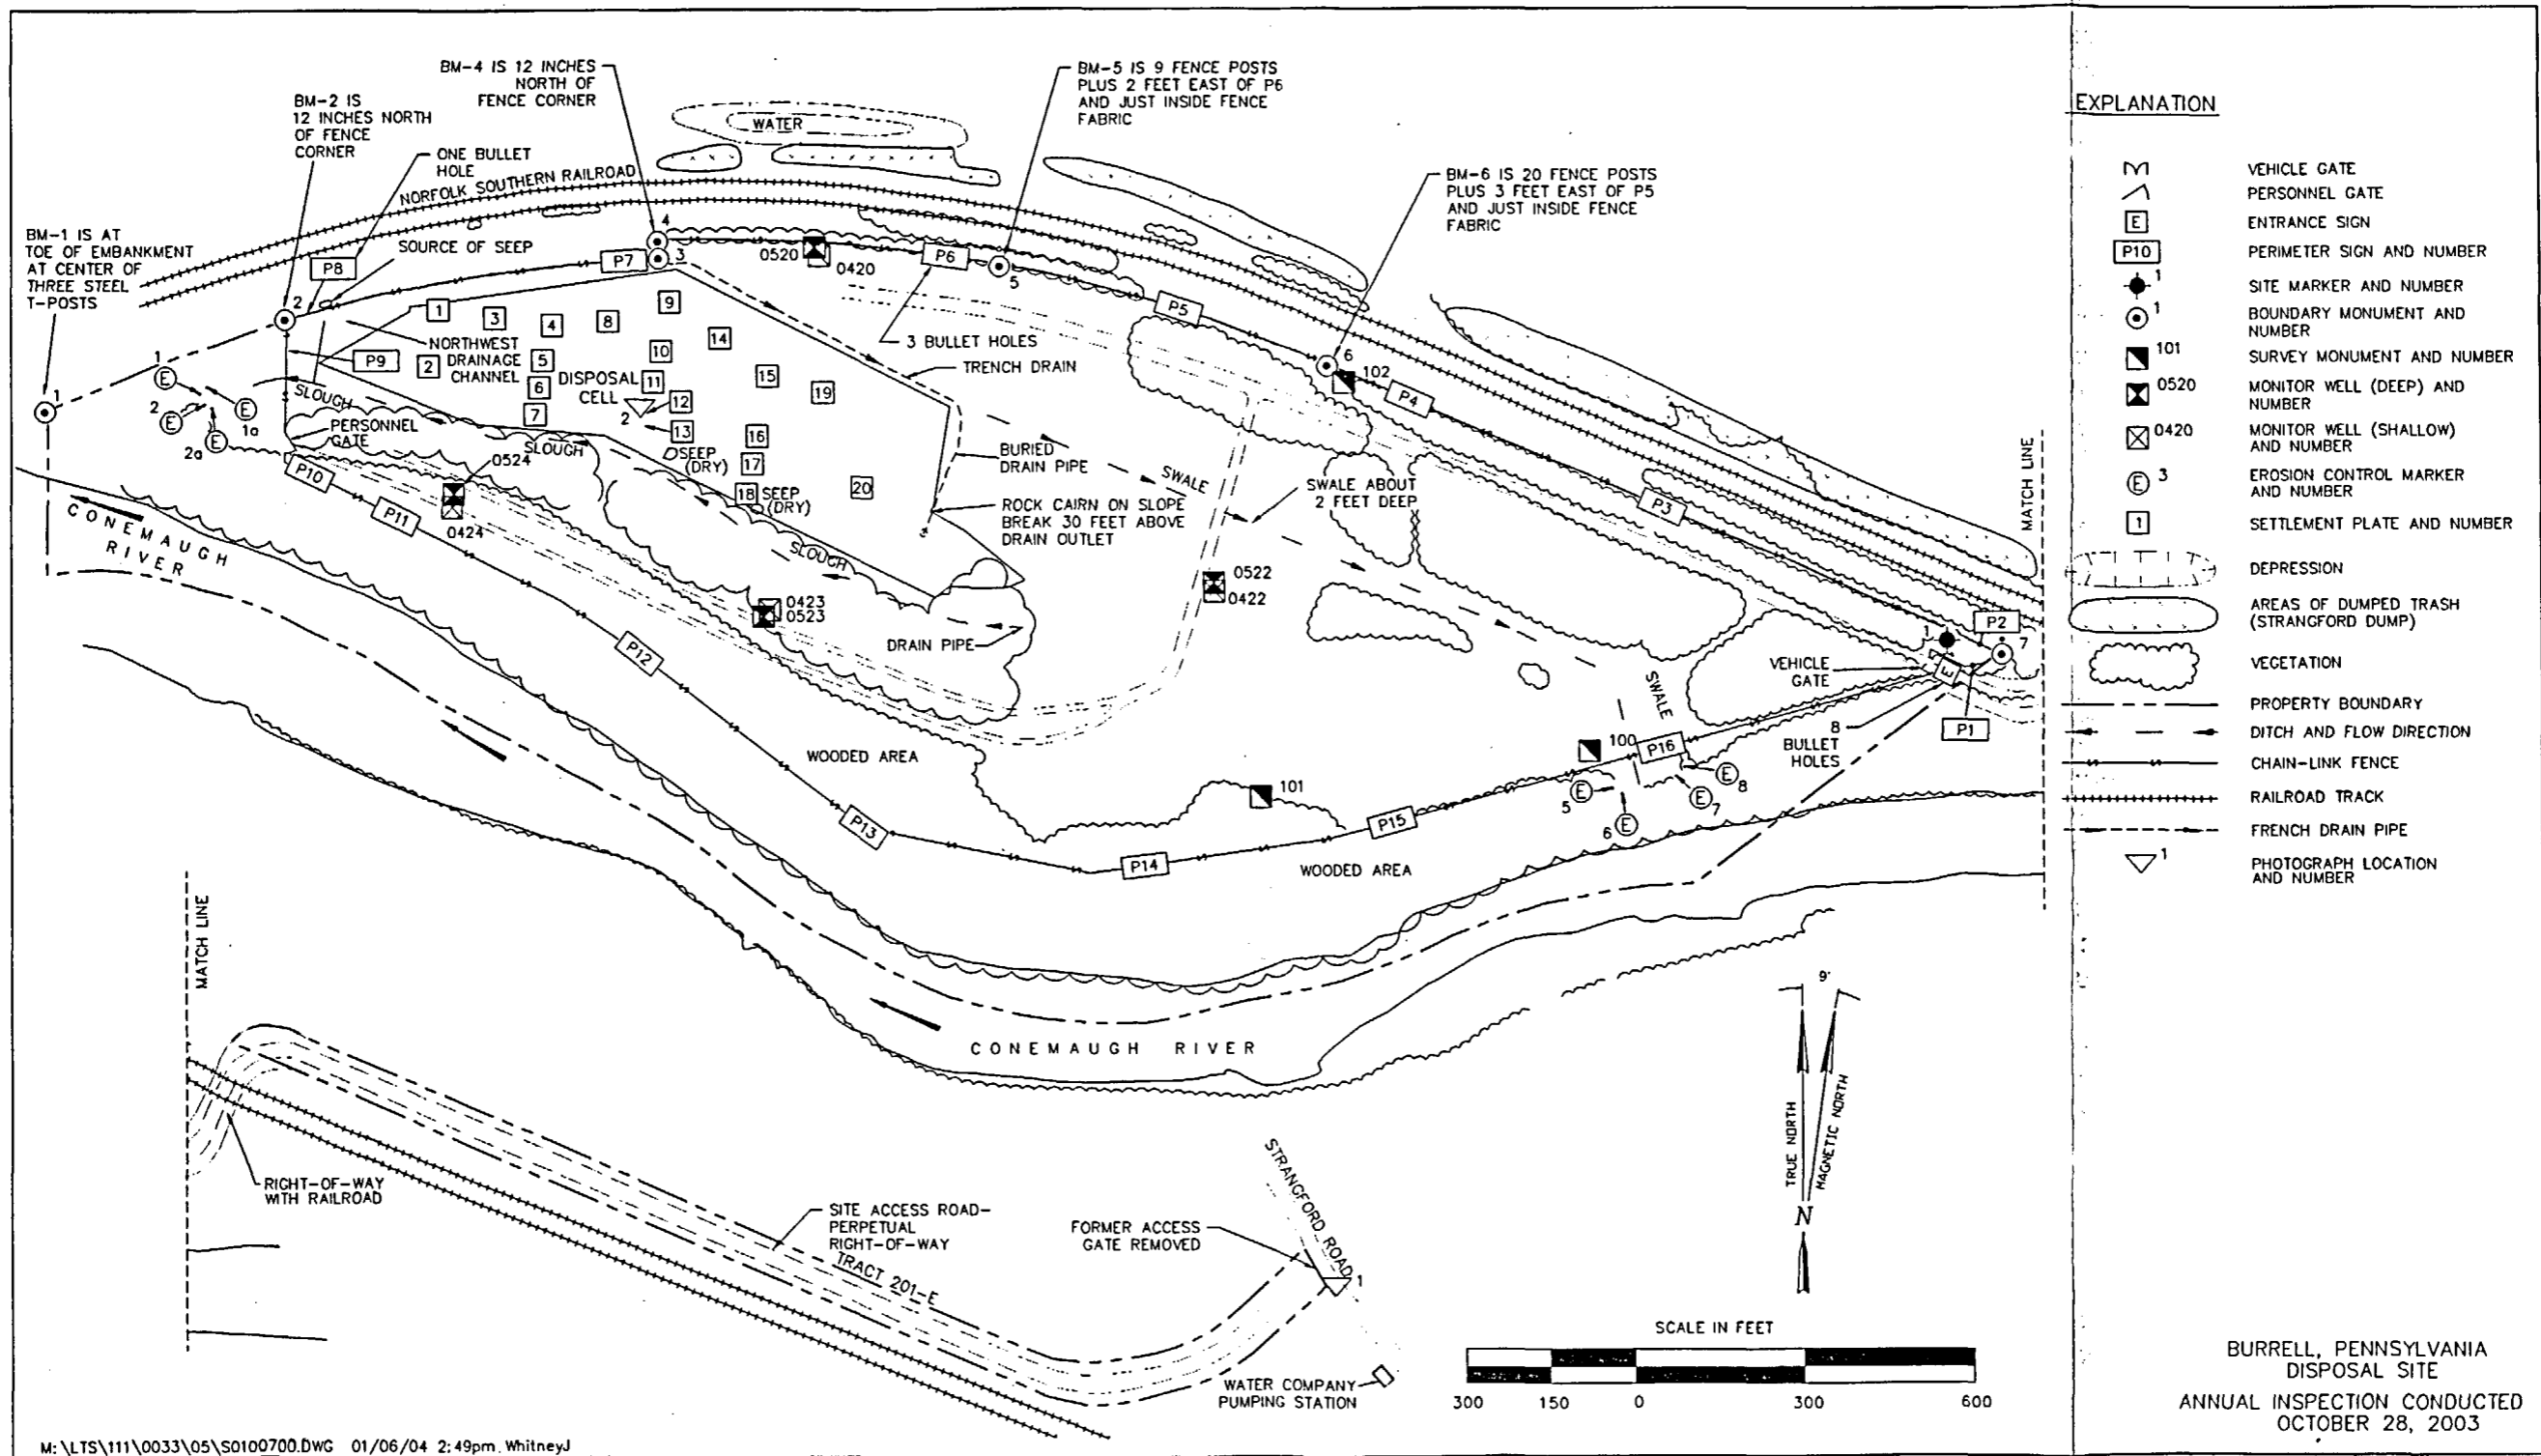
Figure 2-1. 2003 Annual Compliance Drawing for the Burrell, Pennsylvania, Disposal Site

Trees and shrubs continue to establish in the riprap (PL-2). In the past, this vegetation was aggressively controlled with massive applications of herbicide. A study that evaluated risks posed by encroachment of plants on the disposal cell demonstrated that the plants will not degrade the long-term performance of the cell and may improve performance by reducing moisture in the cover through evapotranspiration.

The revised Long-Term Surveillance Plan allows the vegetation to grow on the disposal cell without further intervention; such growth will not increase risk to public health, safety, or the environment. In their concurrence in the revised Long-Term Surveillance Plan, the U.S. Nuclear Regulatory Commission suggested that DOE reevaluate the effects of vegetation on cover performance in 10 or 20 years to confirm performance parameters and predictions.

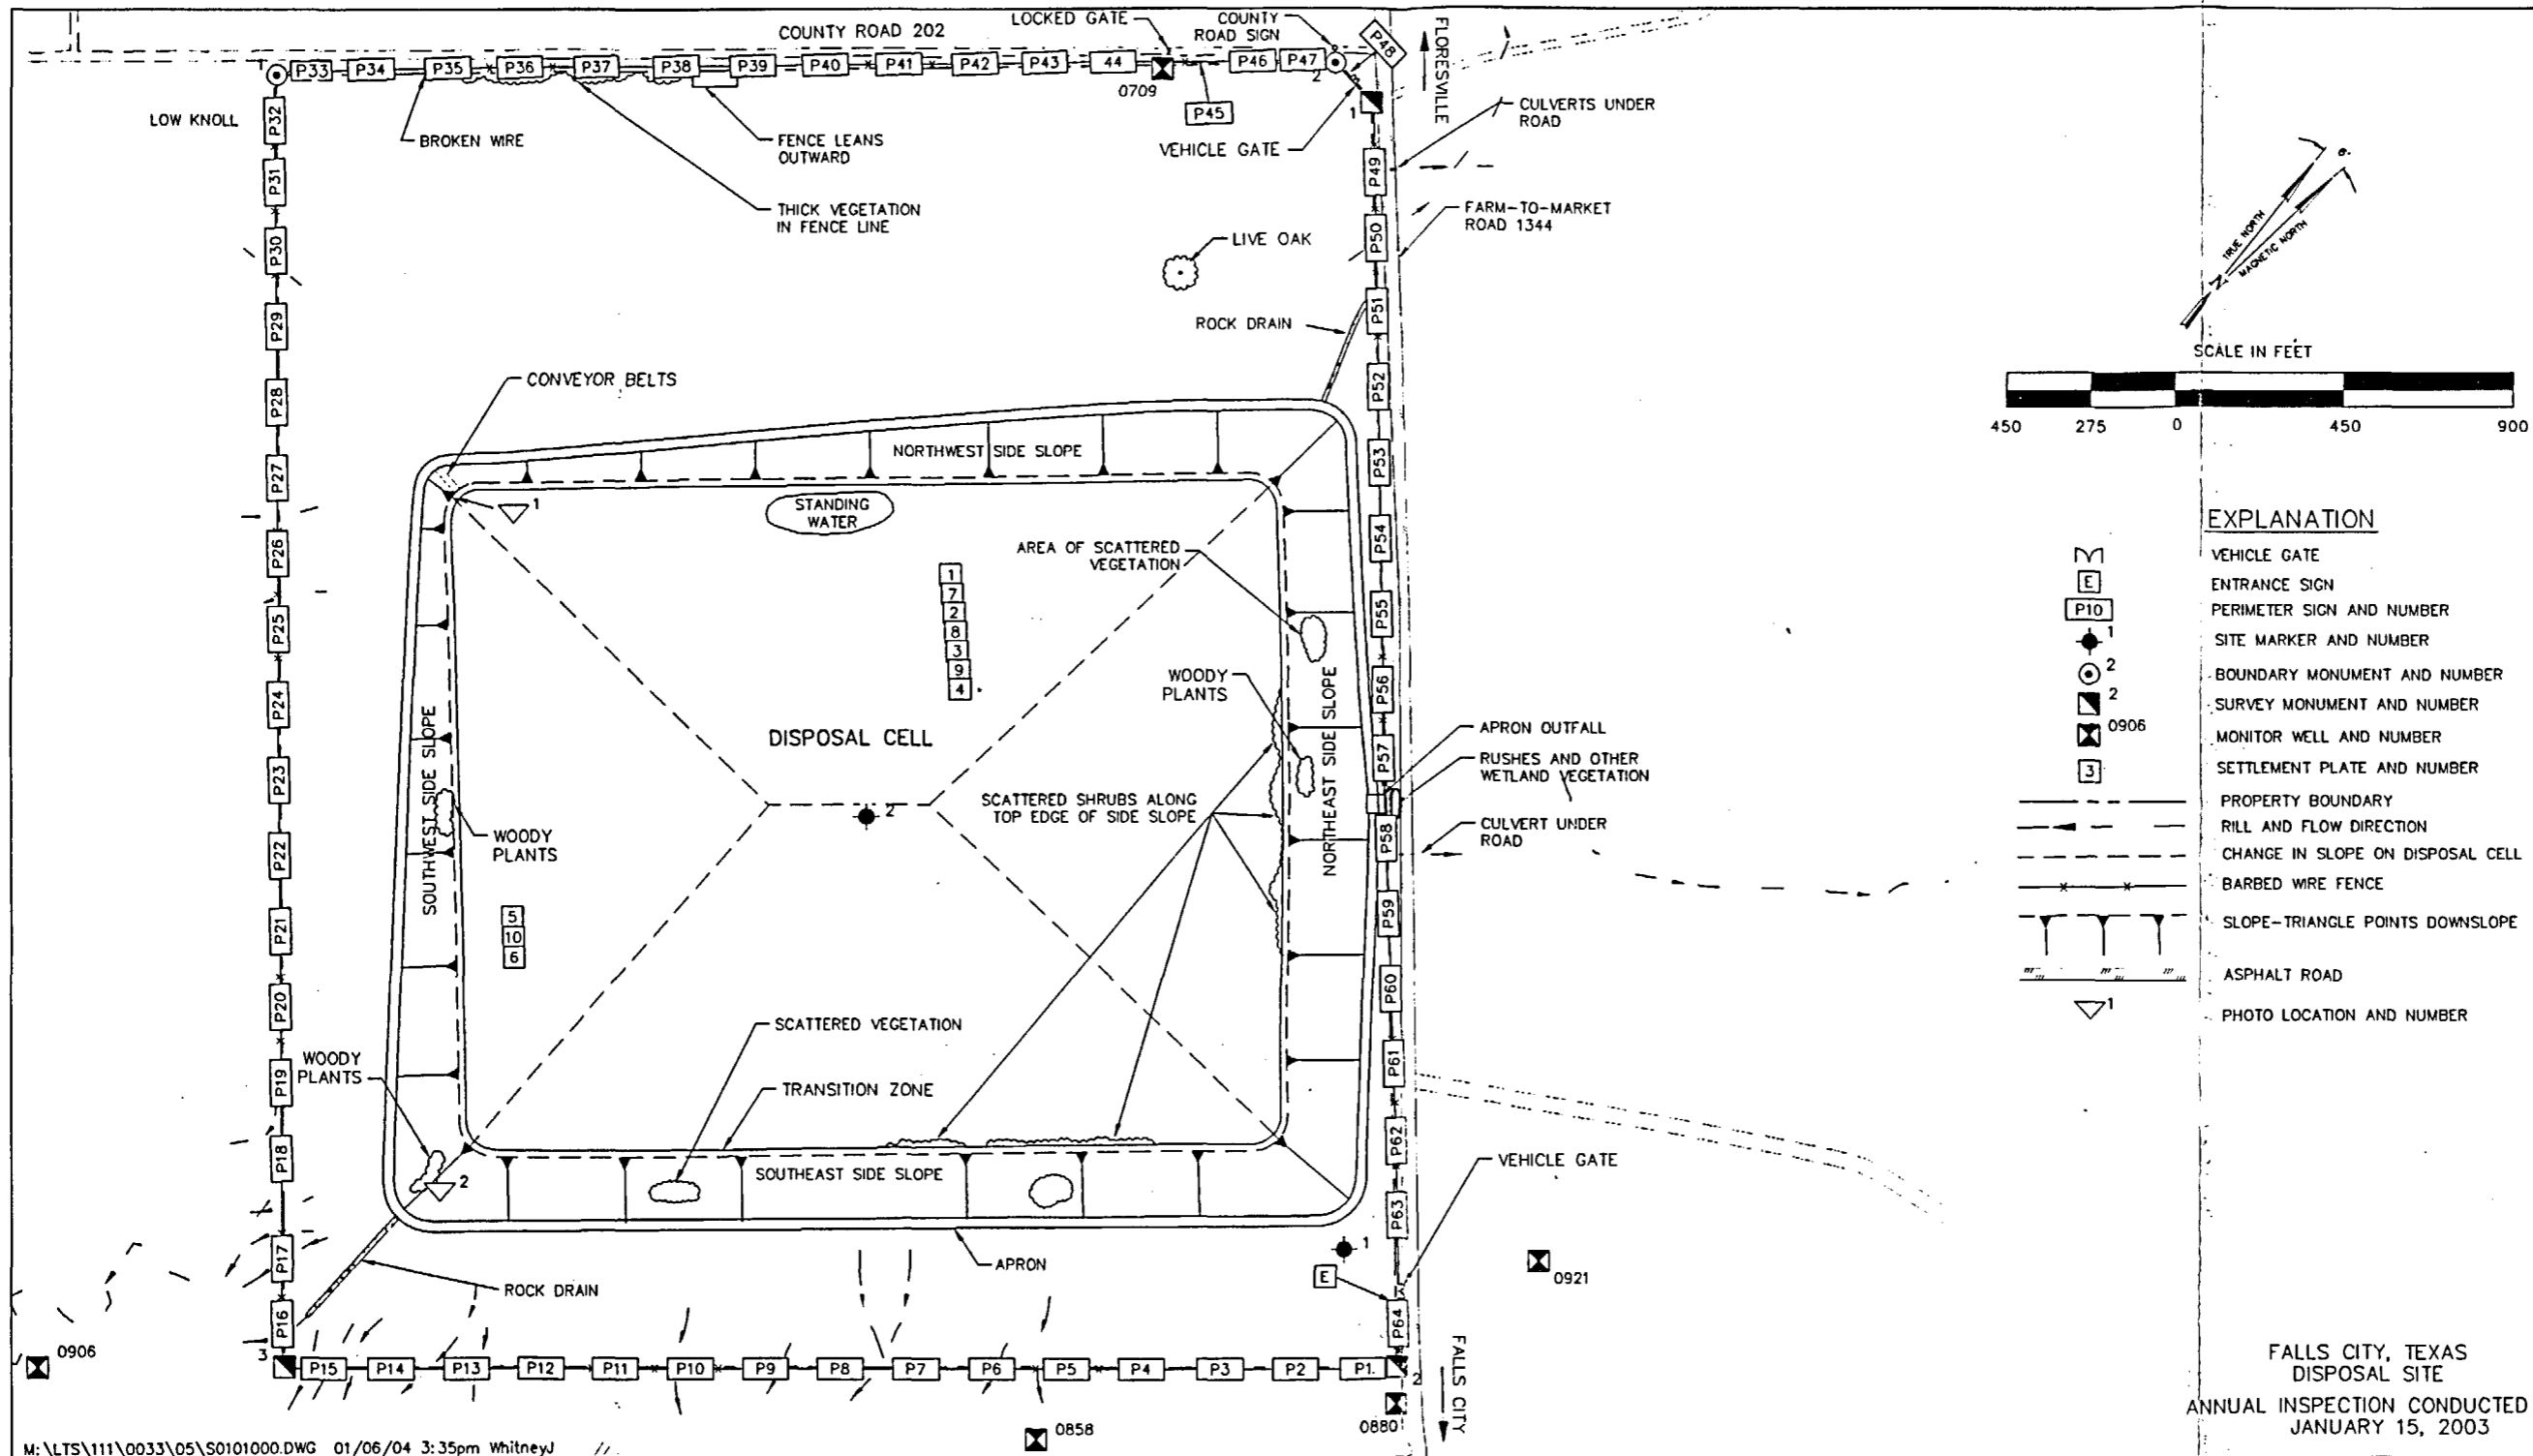
Figure 5-1. 2003 Annual Compliance Drawing for the Falls City, Texas, Disposal Site

Locally heavy precipitation received in the week prior to the inspection saturated the ground in the region. The soil on the cell top was saturated with water, and standing water (up to 2 inches deep) was noted at one location along the northwest edge of the cell top. Water was actively draining from the cell cover and the accumulation was not considered to be a problem. However, the location of the standing water will continue to be inspected to ensure the cover sheds water as designed.

The side slopes are covered with riprap and were in excellent condition. As noted during previous inspections, small amounts of fractured riprap were observed along the side slopes. The fractured riprap apparently is an artifact of quarrying and placement of the rock and does not appear to be degrading. However, DOE continues to visually monitor the riprap for indications of rock degradation.

Two tracks of steel-belted rubber conveyor belt material were placed on the west corner of the disposal cell by the hay farmer (PL-1). The conveyor belt material appears to keep the rocks from being overturned as farm equipment is driven up and down the side slope, and does not adversely affect the function of the disposal cell. The material may be left in place as long as it does not fragment into smaller pieces and become distributed as litter.

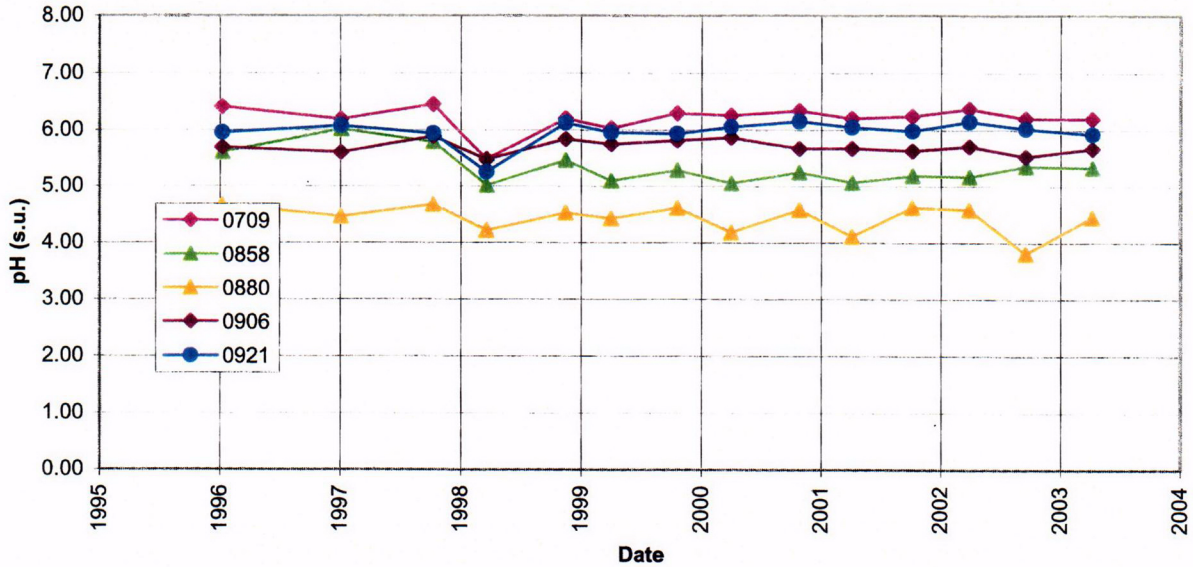
Figure 5-3. pH in Ground Water at Cell Performance Monitoring Locations at the Falls City, Texas, Disposal Site

Analytical results from 2003 generally are consistent with previous results and what would be expected of ground water conditions in a naturally mineralized area that has been impacted by uranium exploration and mining activities. Levels of pH have not varied significantly in recent years (Figures 5-3 and 5-4) and it does not appear that pH is a good indicator for what is occurring with concentrations of uranium or other select constituents in ground water. There is no statistical correlation between changes in pH and changes with the select constituents.

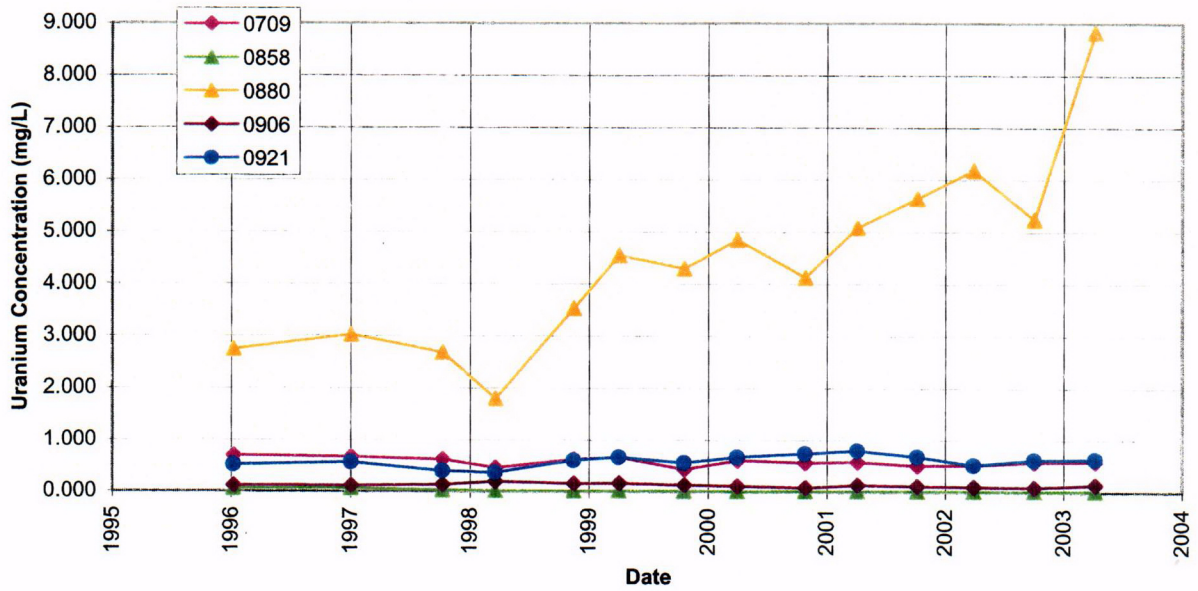
Figure 5-5. Uranium in Ground Water at Cell Performance Monitoring Locations at the Falls City, Texas, Disposal Site

Uranium concentrations in ground water in the vicinity of the disposal cell are consistent with previous results with the exception of monitor well MW-0880, where concentrations continue to increase (Figure 5-5). This increase may be an indication of seepage from the disposal cell, as expected; there is no risk however, because ground water is not used in the area. Uranium in ground water in the compliance monitoring network has varied substantially in two wells (MW-0891 and 0924) since 1997 and exceeded the maximum concentration limit of 0.044 mg/L in three wells (MW-0891, 0924, and 0963) in 2003 (Figure 5-6). Concentrations of other analytes in ground water are similar to previous results.

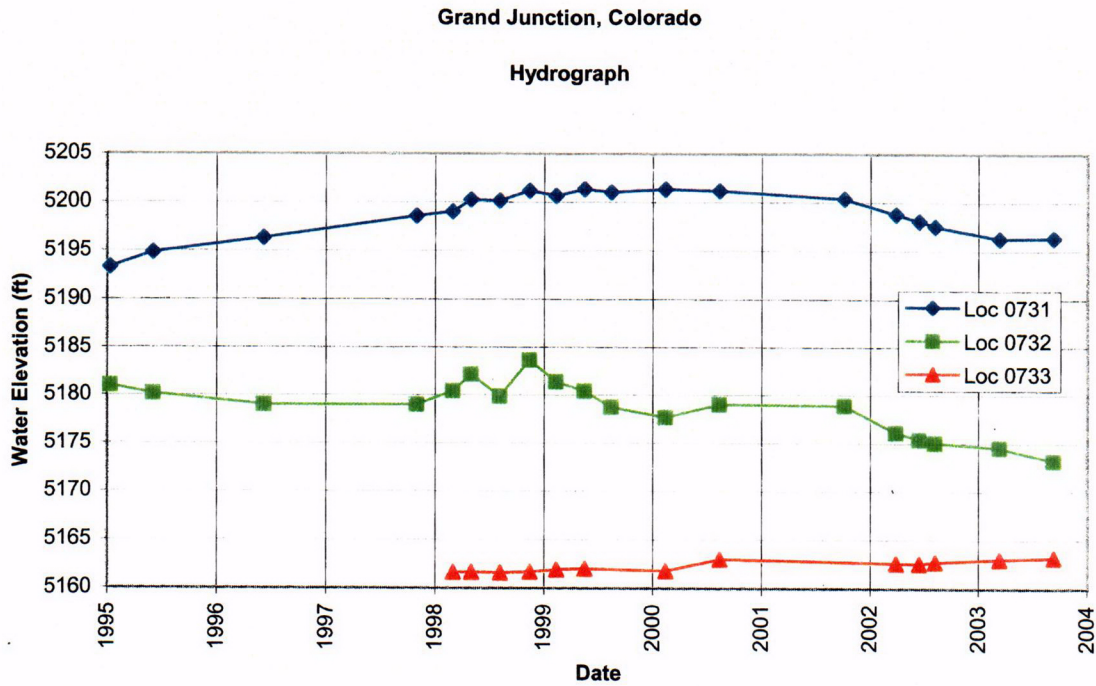
Figure 6-2. Water Level Measurements at the Grand Junction, Colorado, Disposal Site

In lieu of monitoring ground water in the uppermost aquifer, ground water in two monitor wells in or very near buried alluvial paleochannels adjacent to the disposal cell (MW-0731 and MW-0732) and one monitor well in the disposal cell (MW-0733) is monitored to assess performance of the disposal cell and to ensure that any water in the paleochannels is not impacted by seepage (transient drainage) from the disposal cell (Figure 6-1). The paleochannel wells are along the west (downgradient) edge of the disposal cell and are screened at the interface between the alluvium and shallow Mancos Shale. The third well is in the southwest corner of the open portion of the disposal cell and is used primarily for measurement of water levels in the deepest part of the disposal cell to demonstrate that intracell water will not rise high enough to move laterally into the paleochannels. The water level in the disposal cell well is approximately 35 and 10 feet lower (deeper) than water levels in the paleochannels at MW-0731 and MW-0732, respectively (Figure 6-2). This indicates that ground water cannot seep from the disposal cell to the paleochannels.

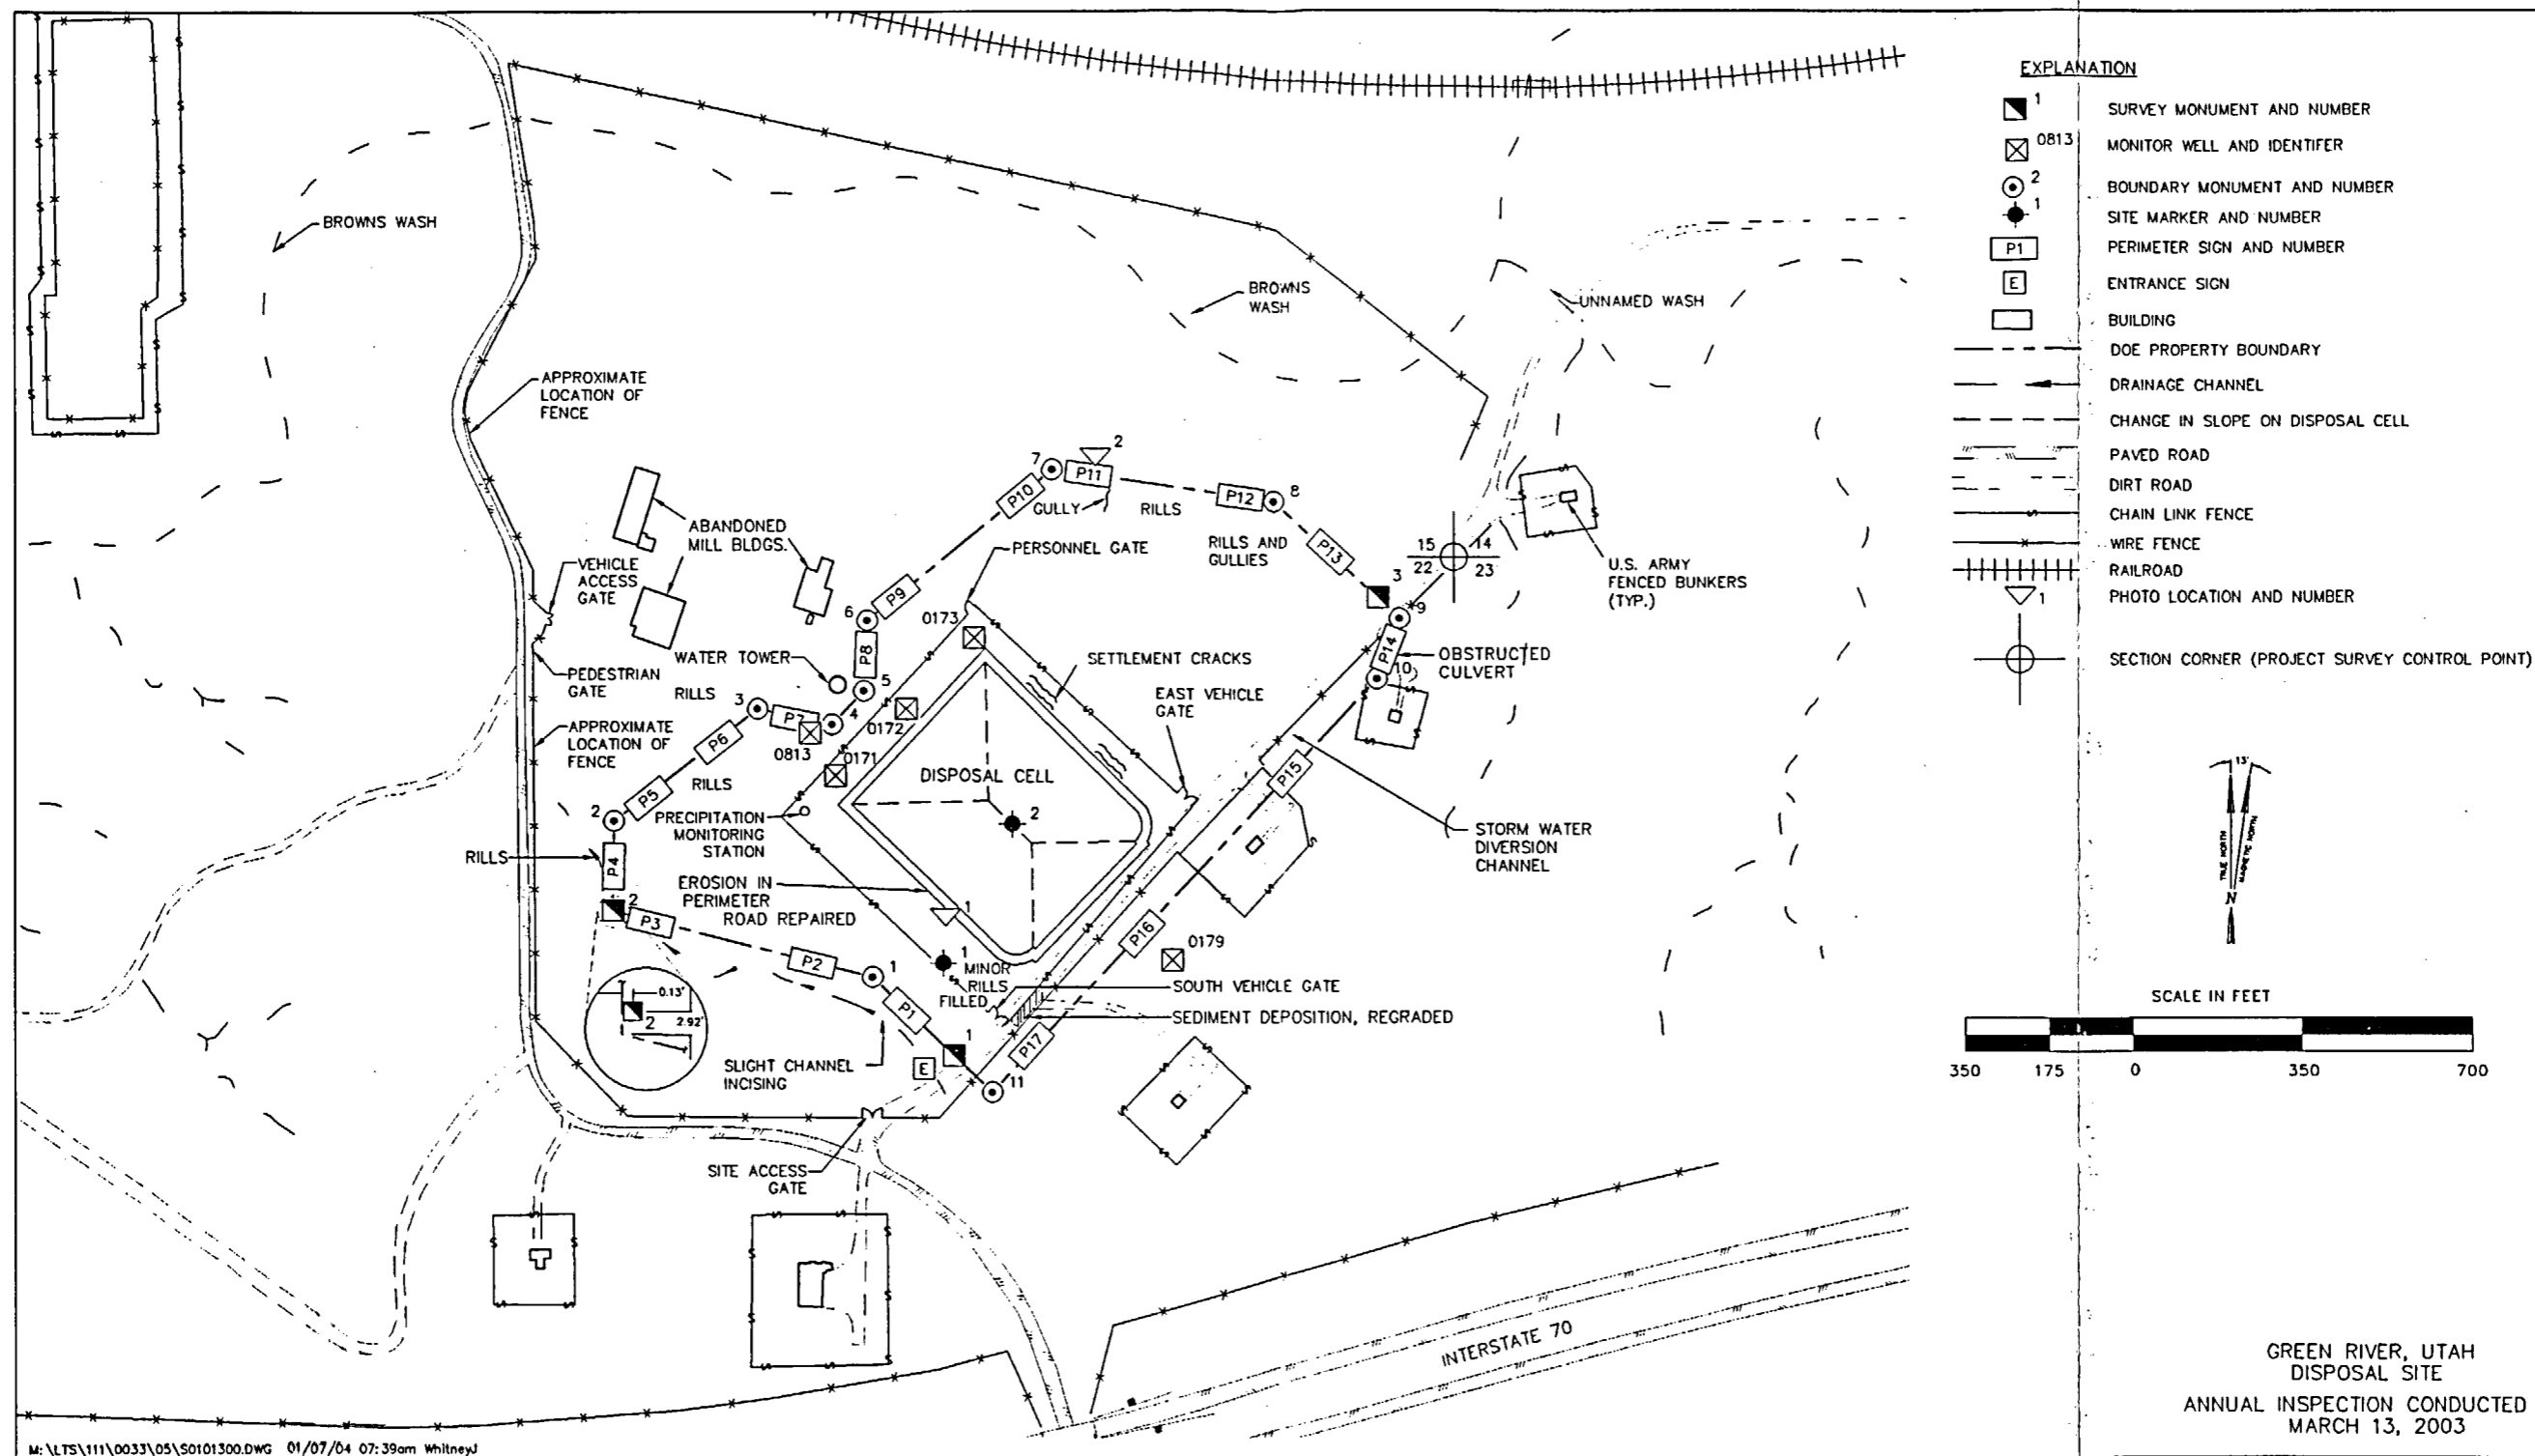
Figure 7-1. 2003 Annual Compliance Drawing for the Green River, Utah, Disposal Site

**Site Perimeter Between the Security Fence and the Site Boundary**—Graded areas were reseeded with grasses soon after construction was completed. Establishment of seeded and natural vegetation has been a slow process. Vegetation in these areas continues to be sparse, especially in the graded areas northeast and southwest of the disposal cell. However, natural and seeded plants appear to have reached abundances comparable to the sparsely vegetated surrounding areas and revegetation is considered to be successful.

7B Rill erosion on the west side of the property appears to have increased but does not pose a threat to the integrity of the cell. Site grading was performed to repair erosion damage and to divert runoff away from perimeter sign P4 and boundary monument BM-3.

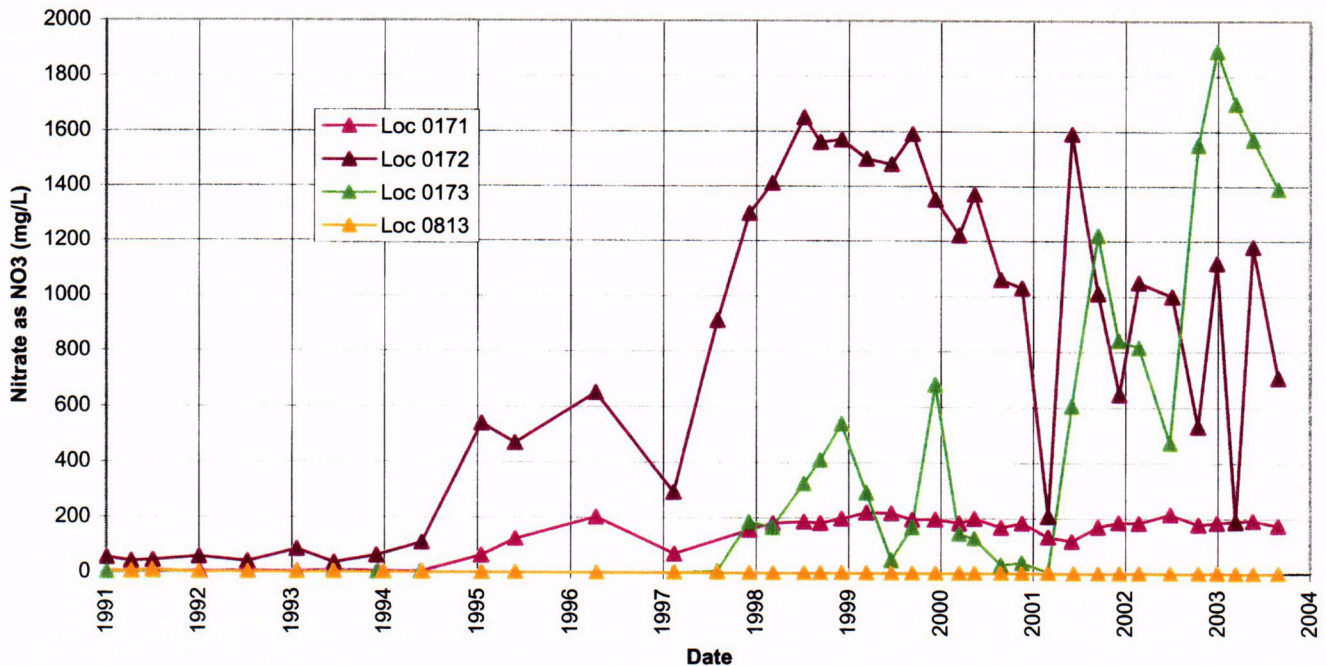
Figure 7-2. Time-Concentration Plots of Nitrate (as NO<sub>3</sub>) in Ground Water at the Green River, Utah, Disposal Site

**Ground Water Quality Monitoring**—Concentrations of nitrate in ground water continued above the proposed concentration limits (Table 7-2) except in well MW-0813, where values were very near the laboratory detection limit (Figure 7-2). Nitrate concentrations fluctuated slightly in well MW-0171, but there was considerable variation in the values for wells MW-0172 and MW-0173.

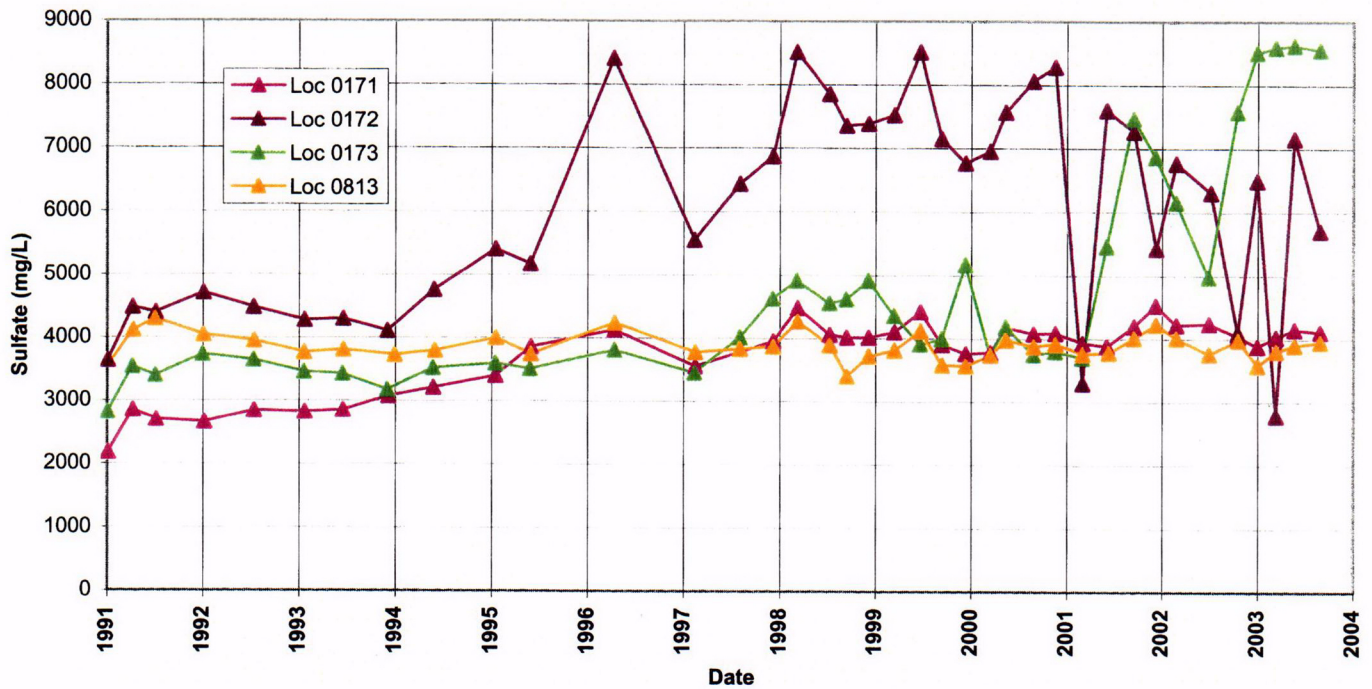
Figure 7-3. Time-Concentration Plots of Sulfate in Ground Water at the Green River, Utah, Disposal Site

Sulfate concentrations in ground water have remained relatively constant in wells MW-0171 and MW-0813 since the disposal cell was constructed (Figure 7-3). Concentrations in wells MW-0172 and MW-0173 have fluctuated substantially since 1996. Concentrations in 2003 continued above the proposed concentration limits (Table 7-2) in wells MW-0171, MW-0172, and MW-0173. Sulfate concentration was below the proposed limit in well MW-0813.

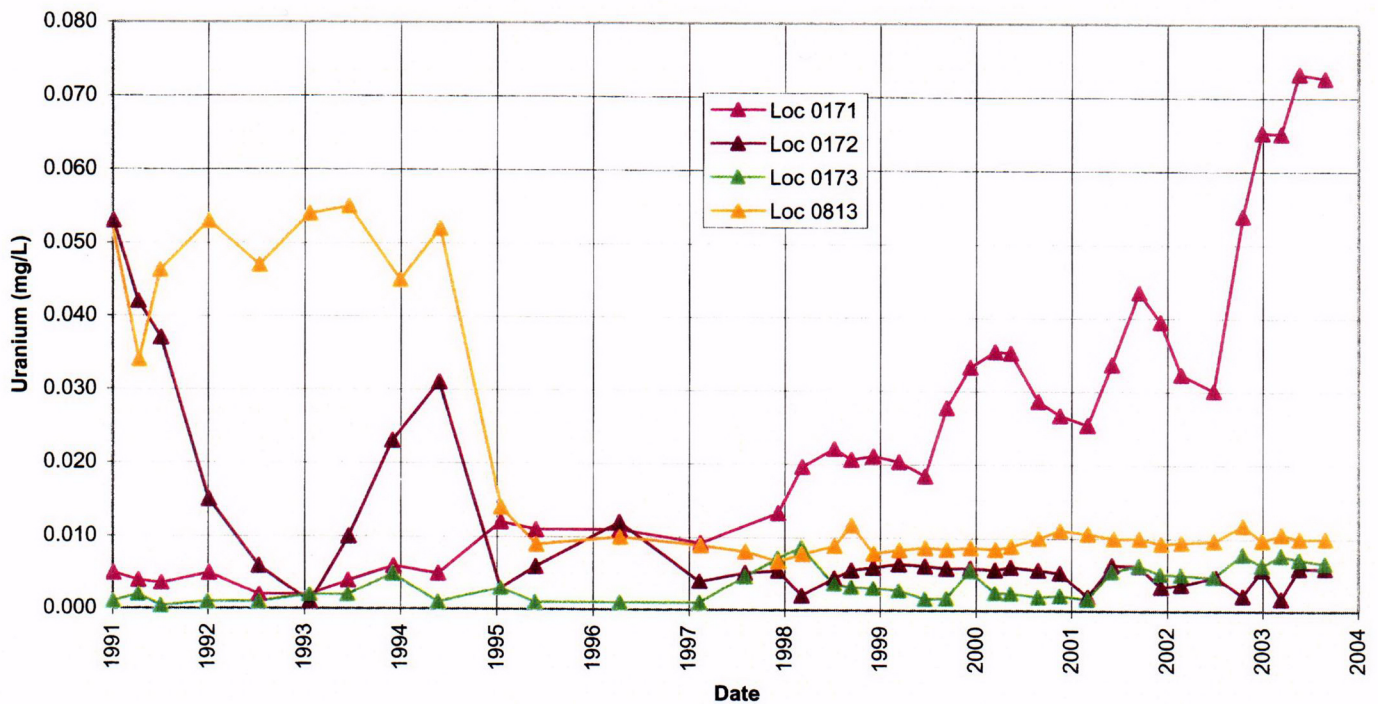
Figure 7-4. Time-Concentration Plots of Uranium in Ground Water at the Green River, Utah, Disposal Site

Uranium concentrations in ground water were below the proposed concentration limits (Table 7-2) in all four point-of-compliance wells from 1995 until October 2002, when levels exceeded the maximum concentration limit in well MW-0171 (Figure 7-4). The increasing uranium concentration in MW-0171 may be an indication of seepage from the disposal cell, as expected on the basis of the cell design and construction. Concentrations in the other wells remain fairly constant and at or below 0.010 milligrams per liter.
