Subject: 2003 Annual Site Inspection and Monitoring Report for UMTRCA Title I  
Disposal Sites

# 2003 Annual Site Inspection and Monitoring Report for Uranium Mill Tailings Radiation Control Act Title I Disposal Sites

January 2004

GJO-2003-528-TAC

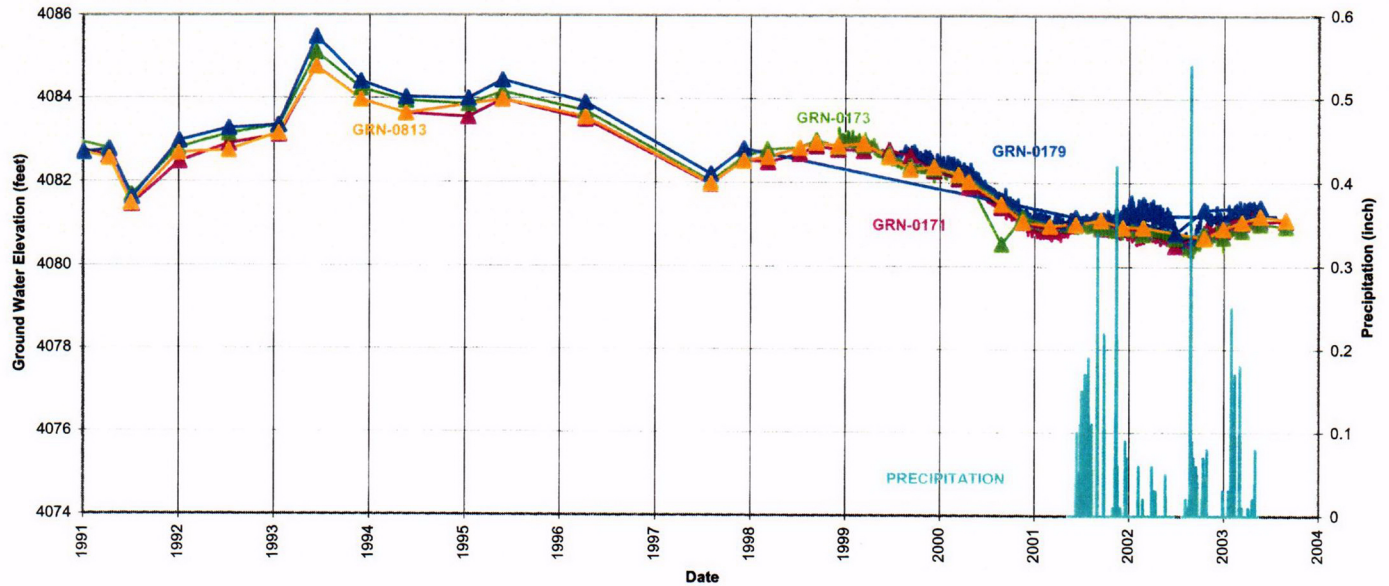
Figure 7-5. Ground Water Elevations and Precipitation at the Green River, Utah, Disposal Site

**Ground Water Level Monitoring**—Ground water levels in several monitor wells adjacent to the disposal cell have been measured manually since 1991, and continually with down-hole dataloggers for the past 5 years. Well hydrographs indicate an overall decrease in the ground water elevation of approximately 4 feet since 1993 (Figure 7-5).

A precipitation monitoring station was installed in the west corner of the secured site in 2001. DOE is evaluating the relationship between precipitation and ground water elevations near the disposal cell to determine if runoff from the cell has an impact on ground water flow at the site, which affects contaminant migration. Based on information collected to date, precipitation has been minimal, and there is no obvious correlation with ground water elevations measured by dataloggers in the wells adjacent to the disposal cell (Figure 7-5).

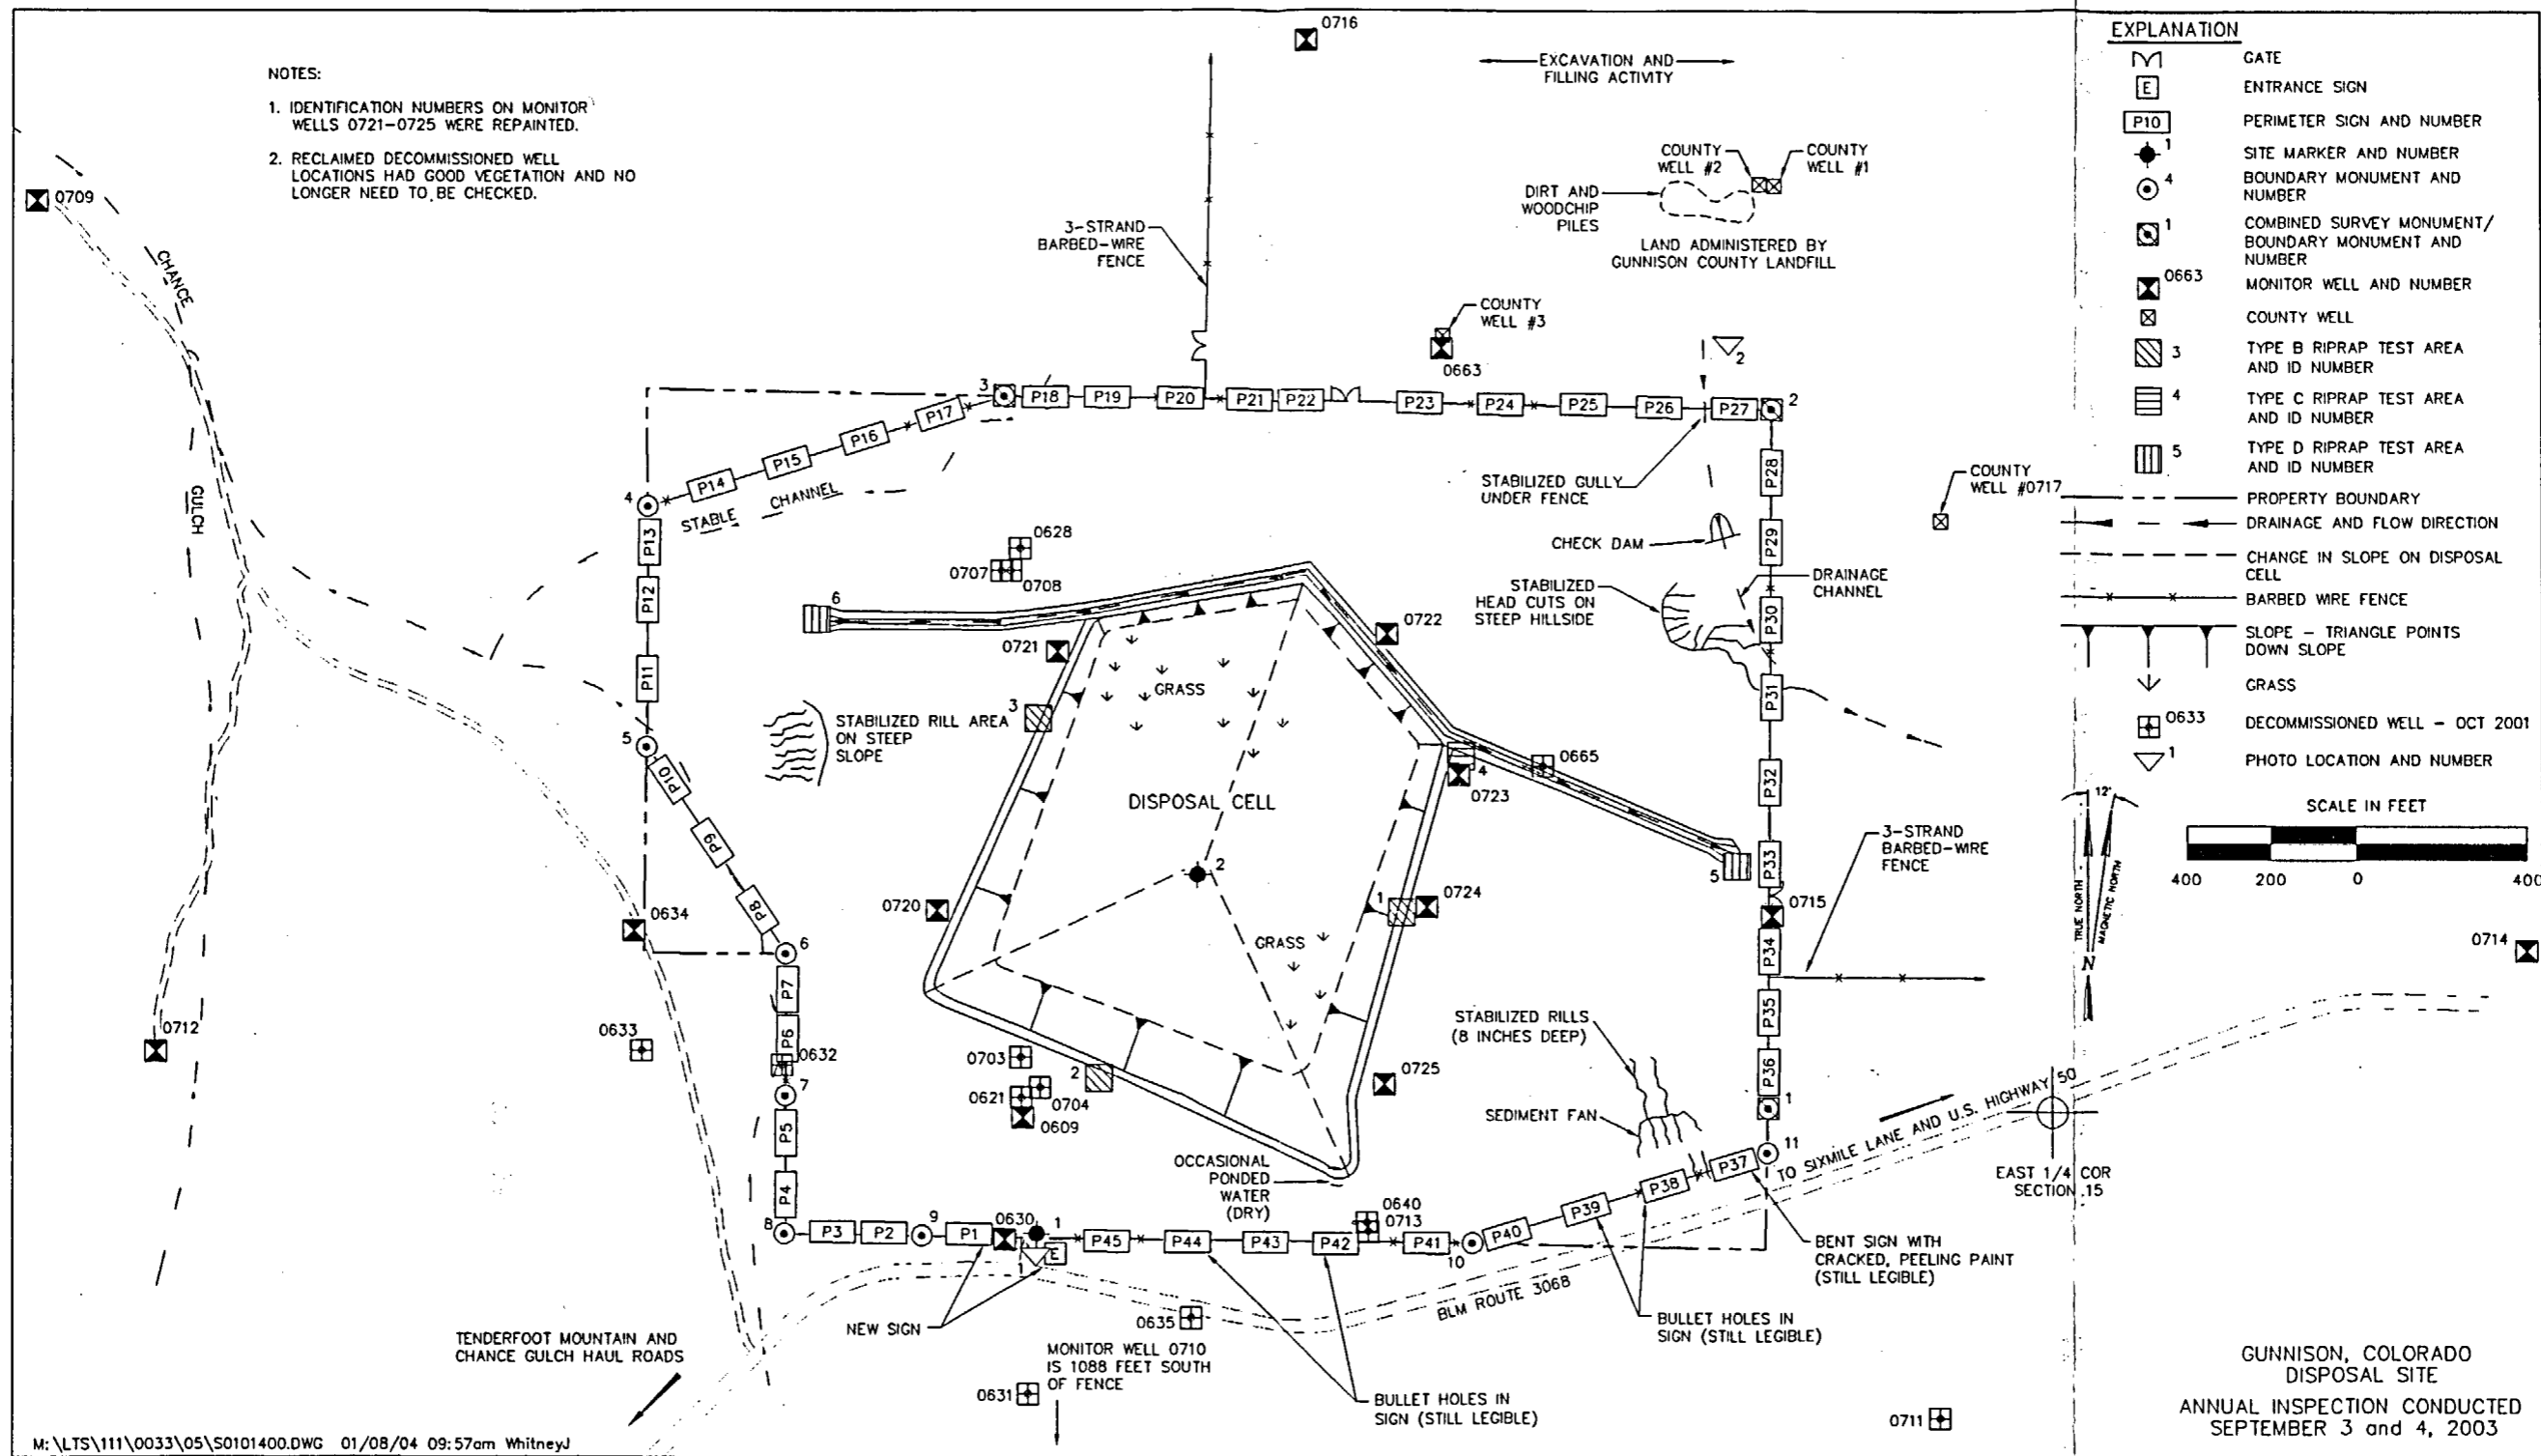
Figure 8-1. 2003 Annual Compliance Drawing for the Gunnison, Colorado, Disposal Site

At the southeast corner of the cell apron, water draining from the cell occasionally ponds in a low-lying area along the edge of the riprap. The riparian-type vegetation that has established indicates this area retains moisture much of the time. Water collection in this area does not pose a problem because the cell is designed to drain to the southeast, and any water that ponds is below the elevation of the tailings. This area was dry at the time of the inspection.

- In the southeast erosional area, several 8-inch-deep rills had formed in the steeper portion of the slope, and a fan-like accumulation of eroded sediments had formed just below the rills. The area was found to be in stable condition. Vegetation is becoming well established on the steeper portions of the eroded slopes.

- In the northeast portion of the property, a series of deep gullies and headcuts had formed at a natural slope break in the terrain. As noted in previous inspection reports, these gullies appear to be stabilizing with the successful establishment of sagebrush and various grasses. The drainage channel between perimeter signs P30 and P31 does not appear to be worsening.

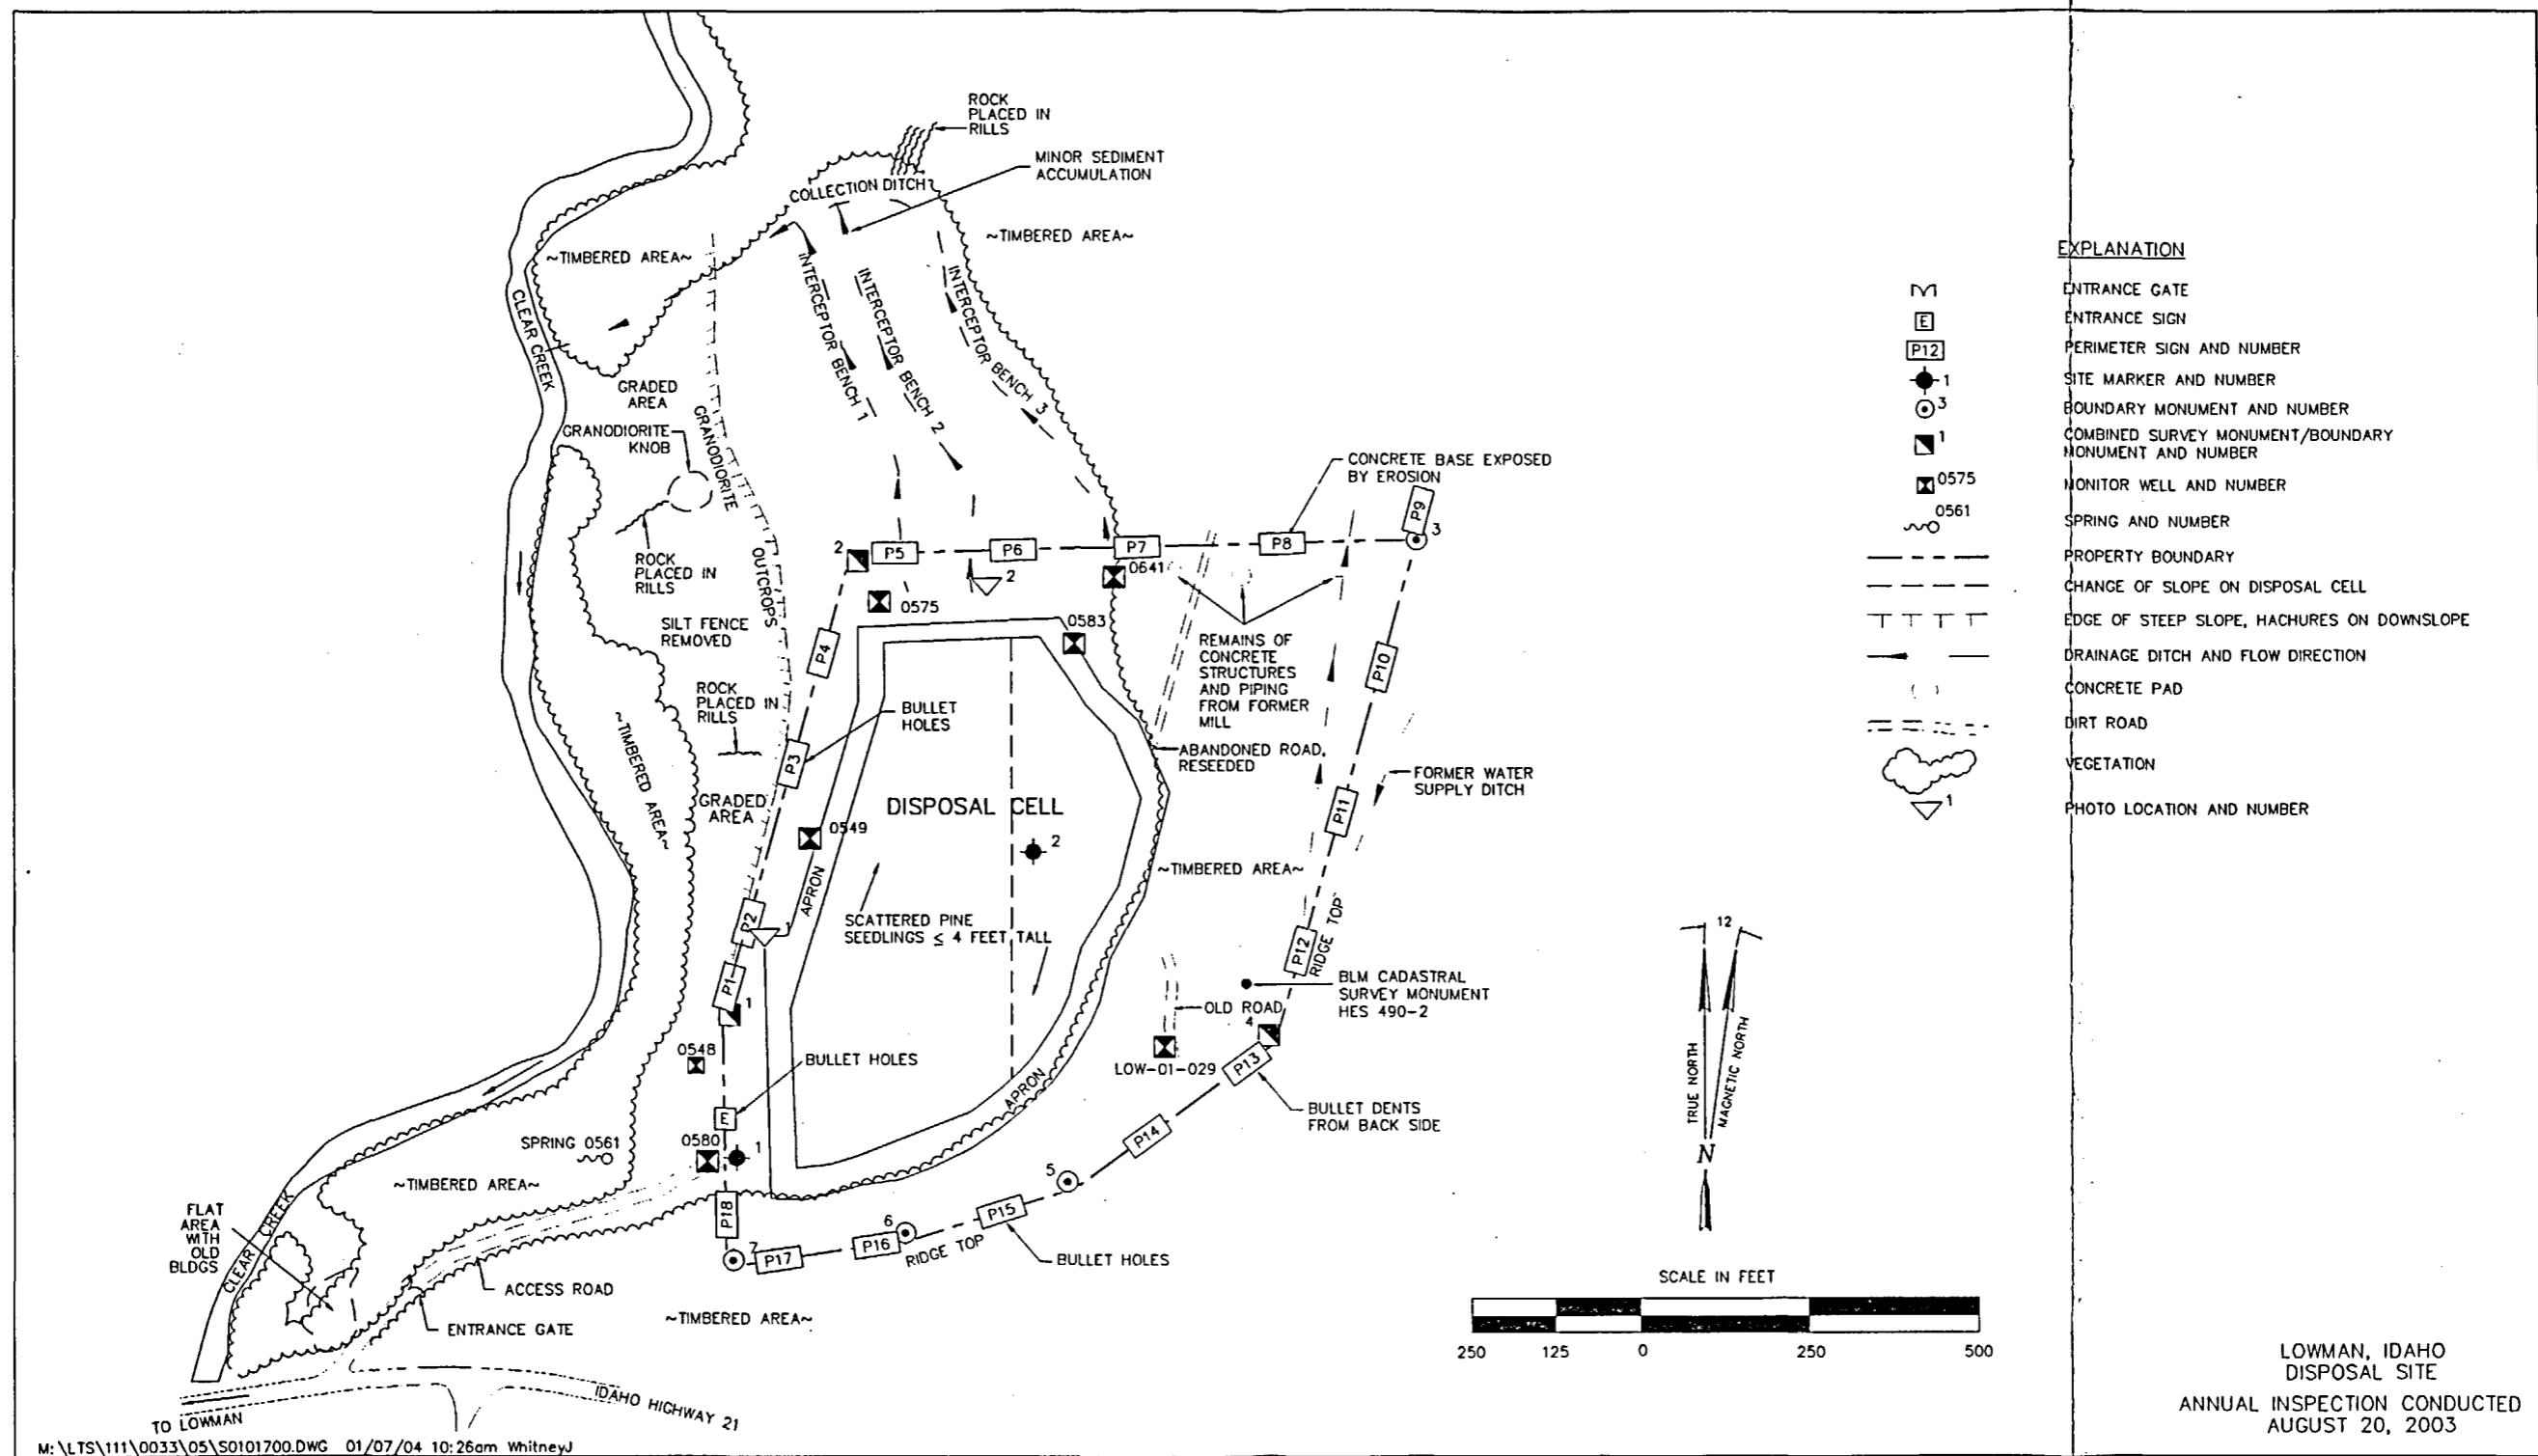
Figure 10-1. 2003 Annual Compliance Drawing for the Lowman, Idaho, Disposal Site

**Area Between the Disposal Cell and the Site Boundary**—The steep slopes east and south of the site were stable with well-established ponderosa pine and grasses. The rills on the slopes immediately north and west of the cell were stable or gone as a result of erosion control and maintenance activities. DOE will continue to monitor this area for erosion.

10B Infestations of several species of noxious weeds continue to be a concern for DOE on and adjacent to the site. Two applications of herbicide were made in 2003, and the success of these treatments will be evaluated in 2004.

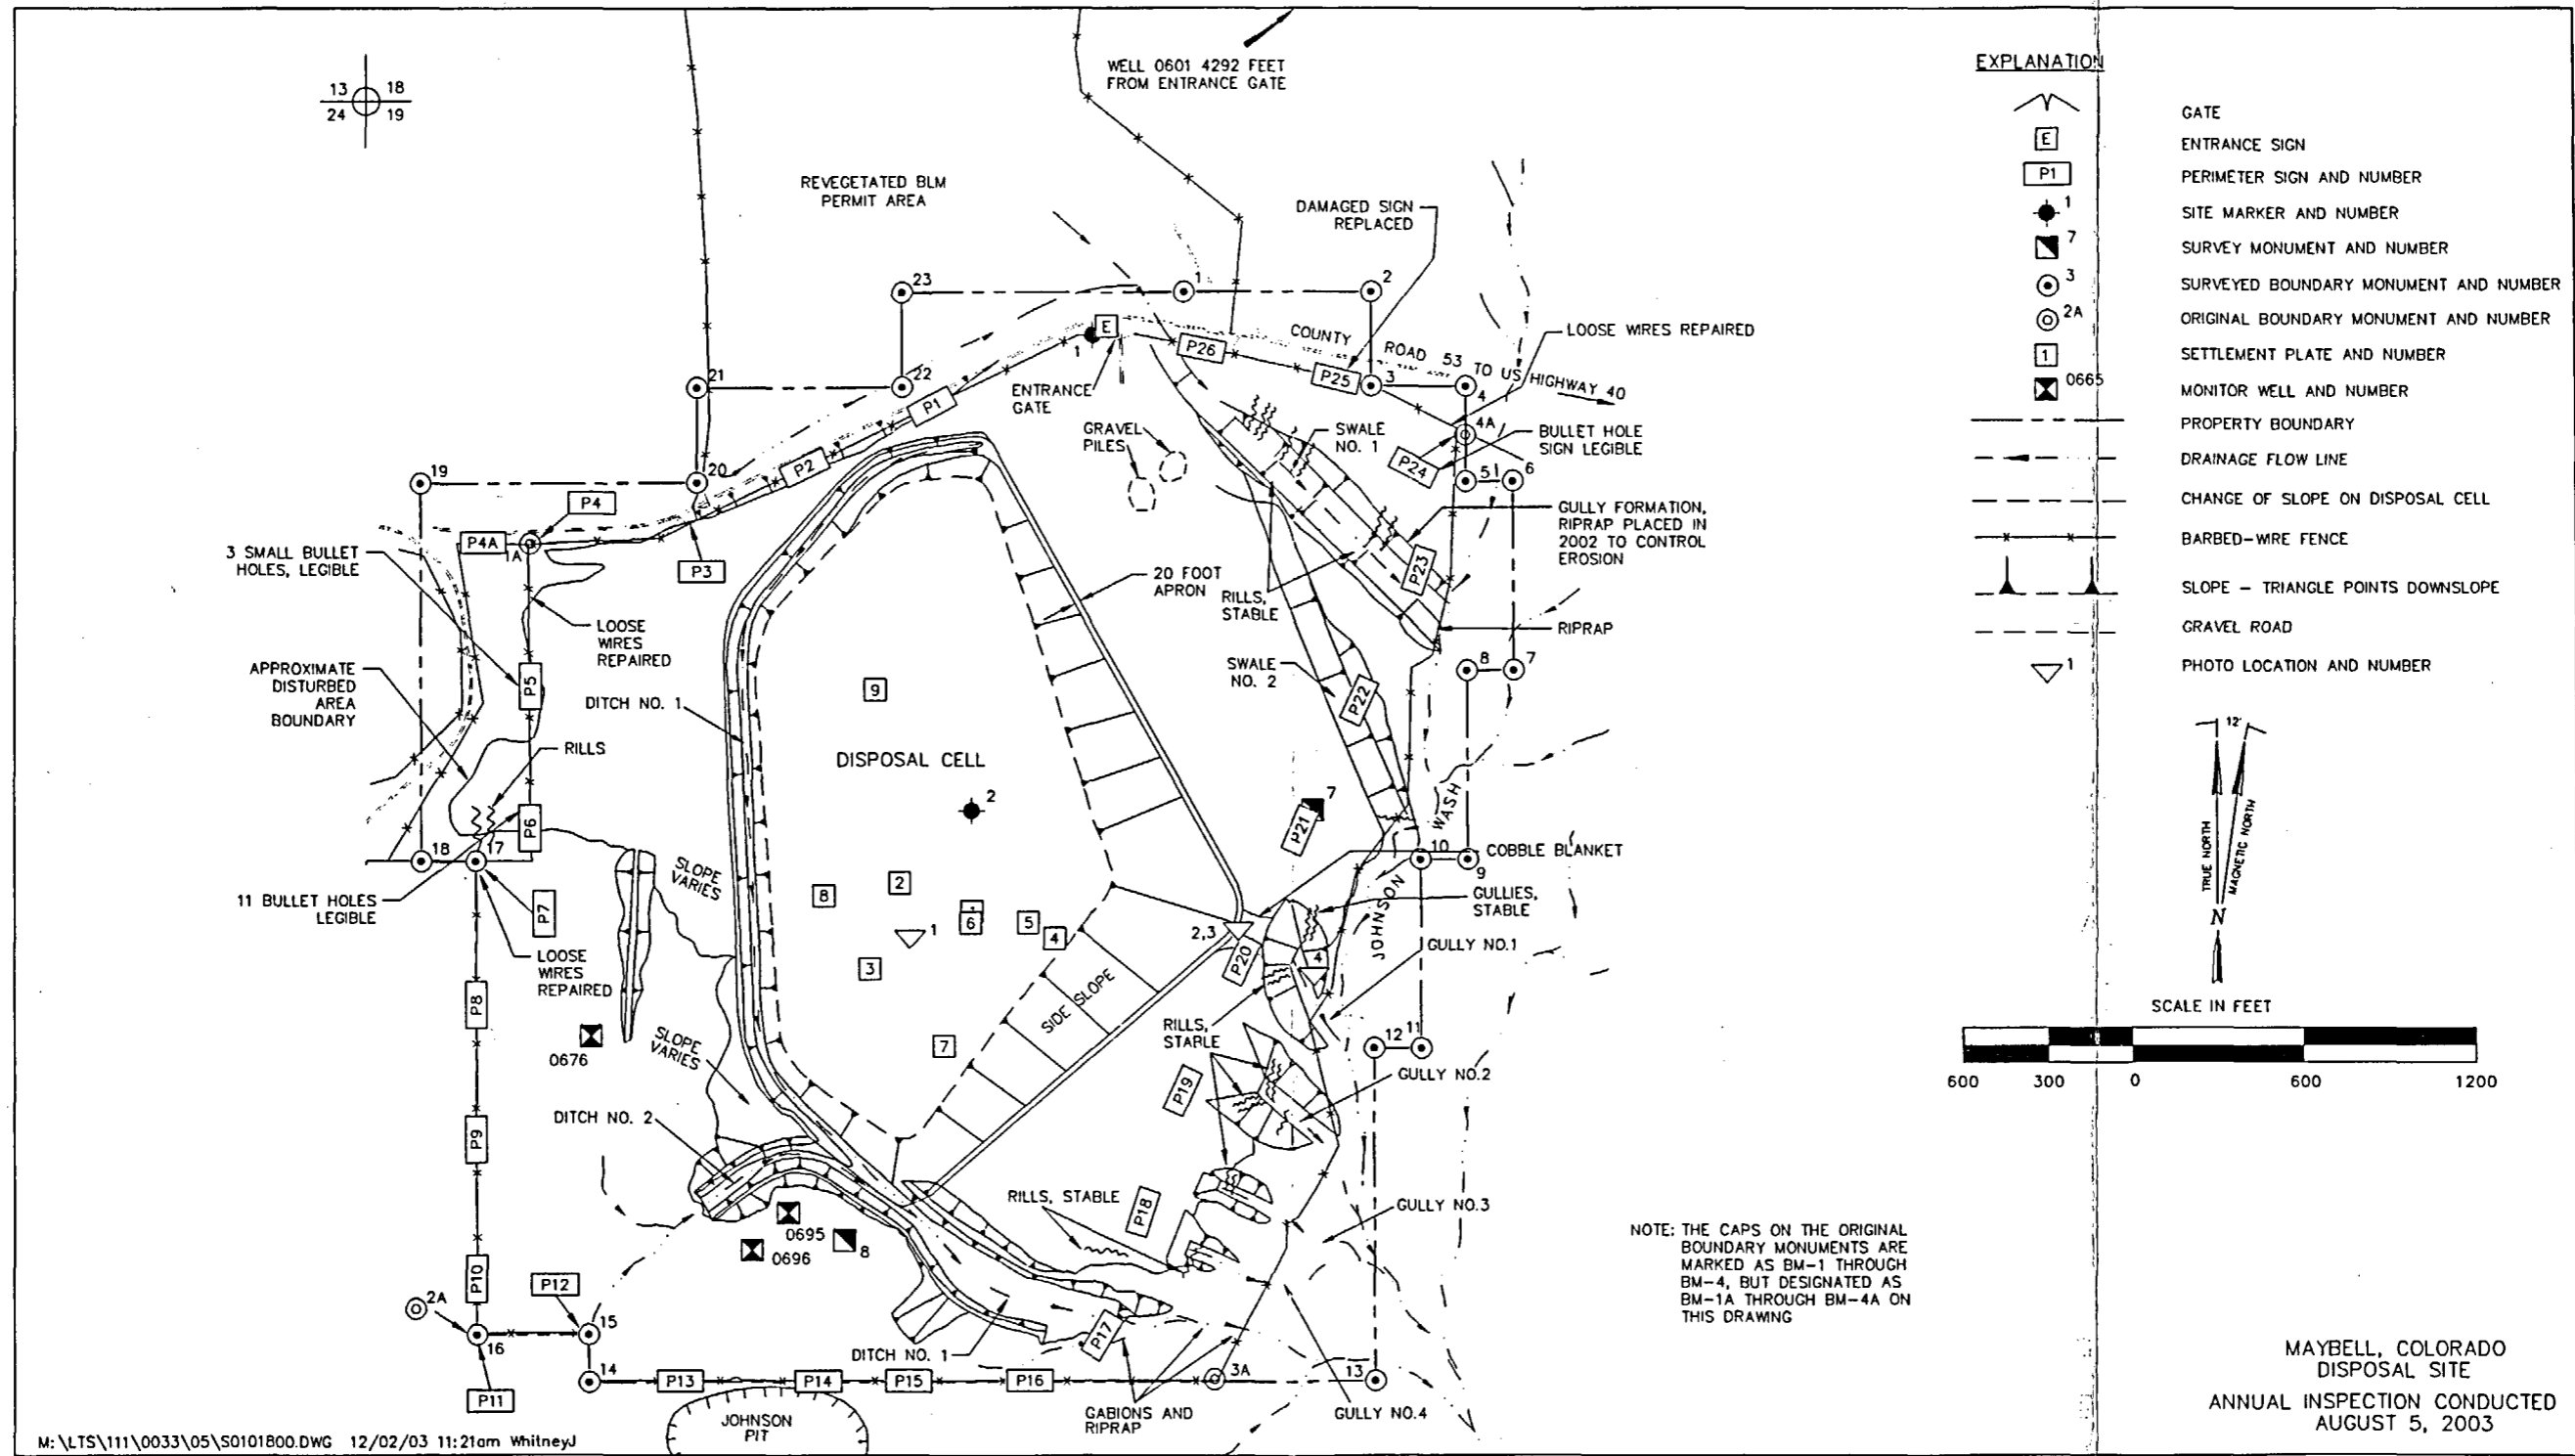
Figure 11-1. 2003 Annual Compliance Drawing for the Maybell, Colorado, Disposal Site

11C Occasional plants consisting of deep-rooted species, grasses, and annual weeds were observed on the cell top and side slopes. Deep-rooted plants (tamarisk and rabbitbrush) were cut and their stems were treated with herbicide (PL-1), and patches of unidentified thistle were sprayed with herbicide.

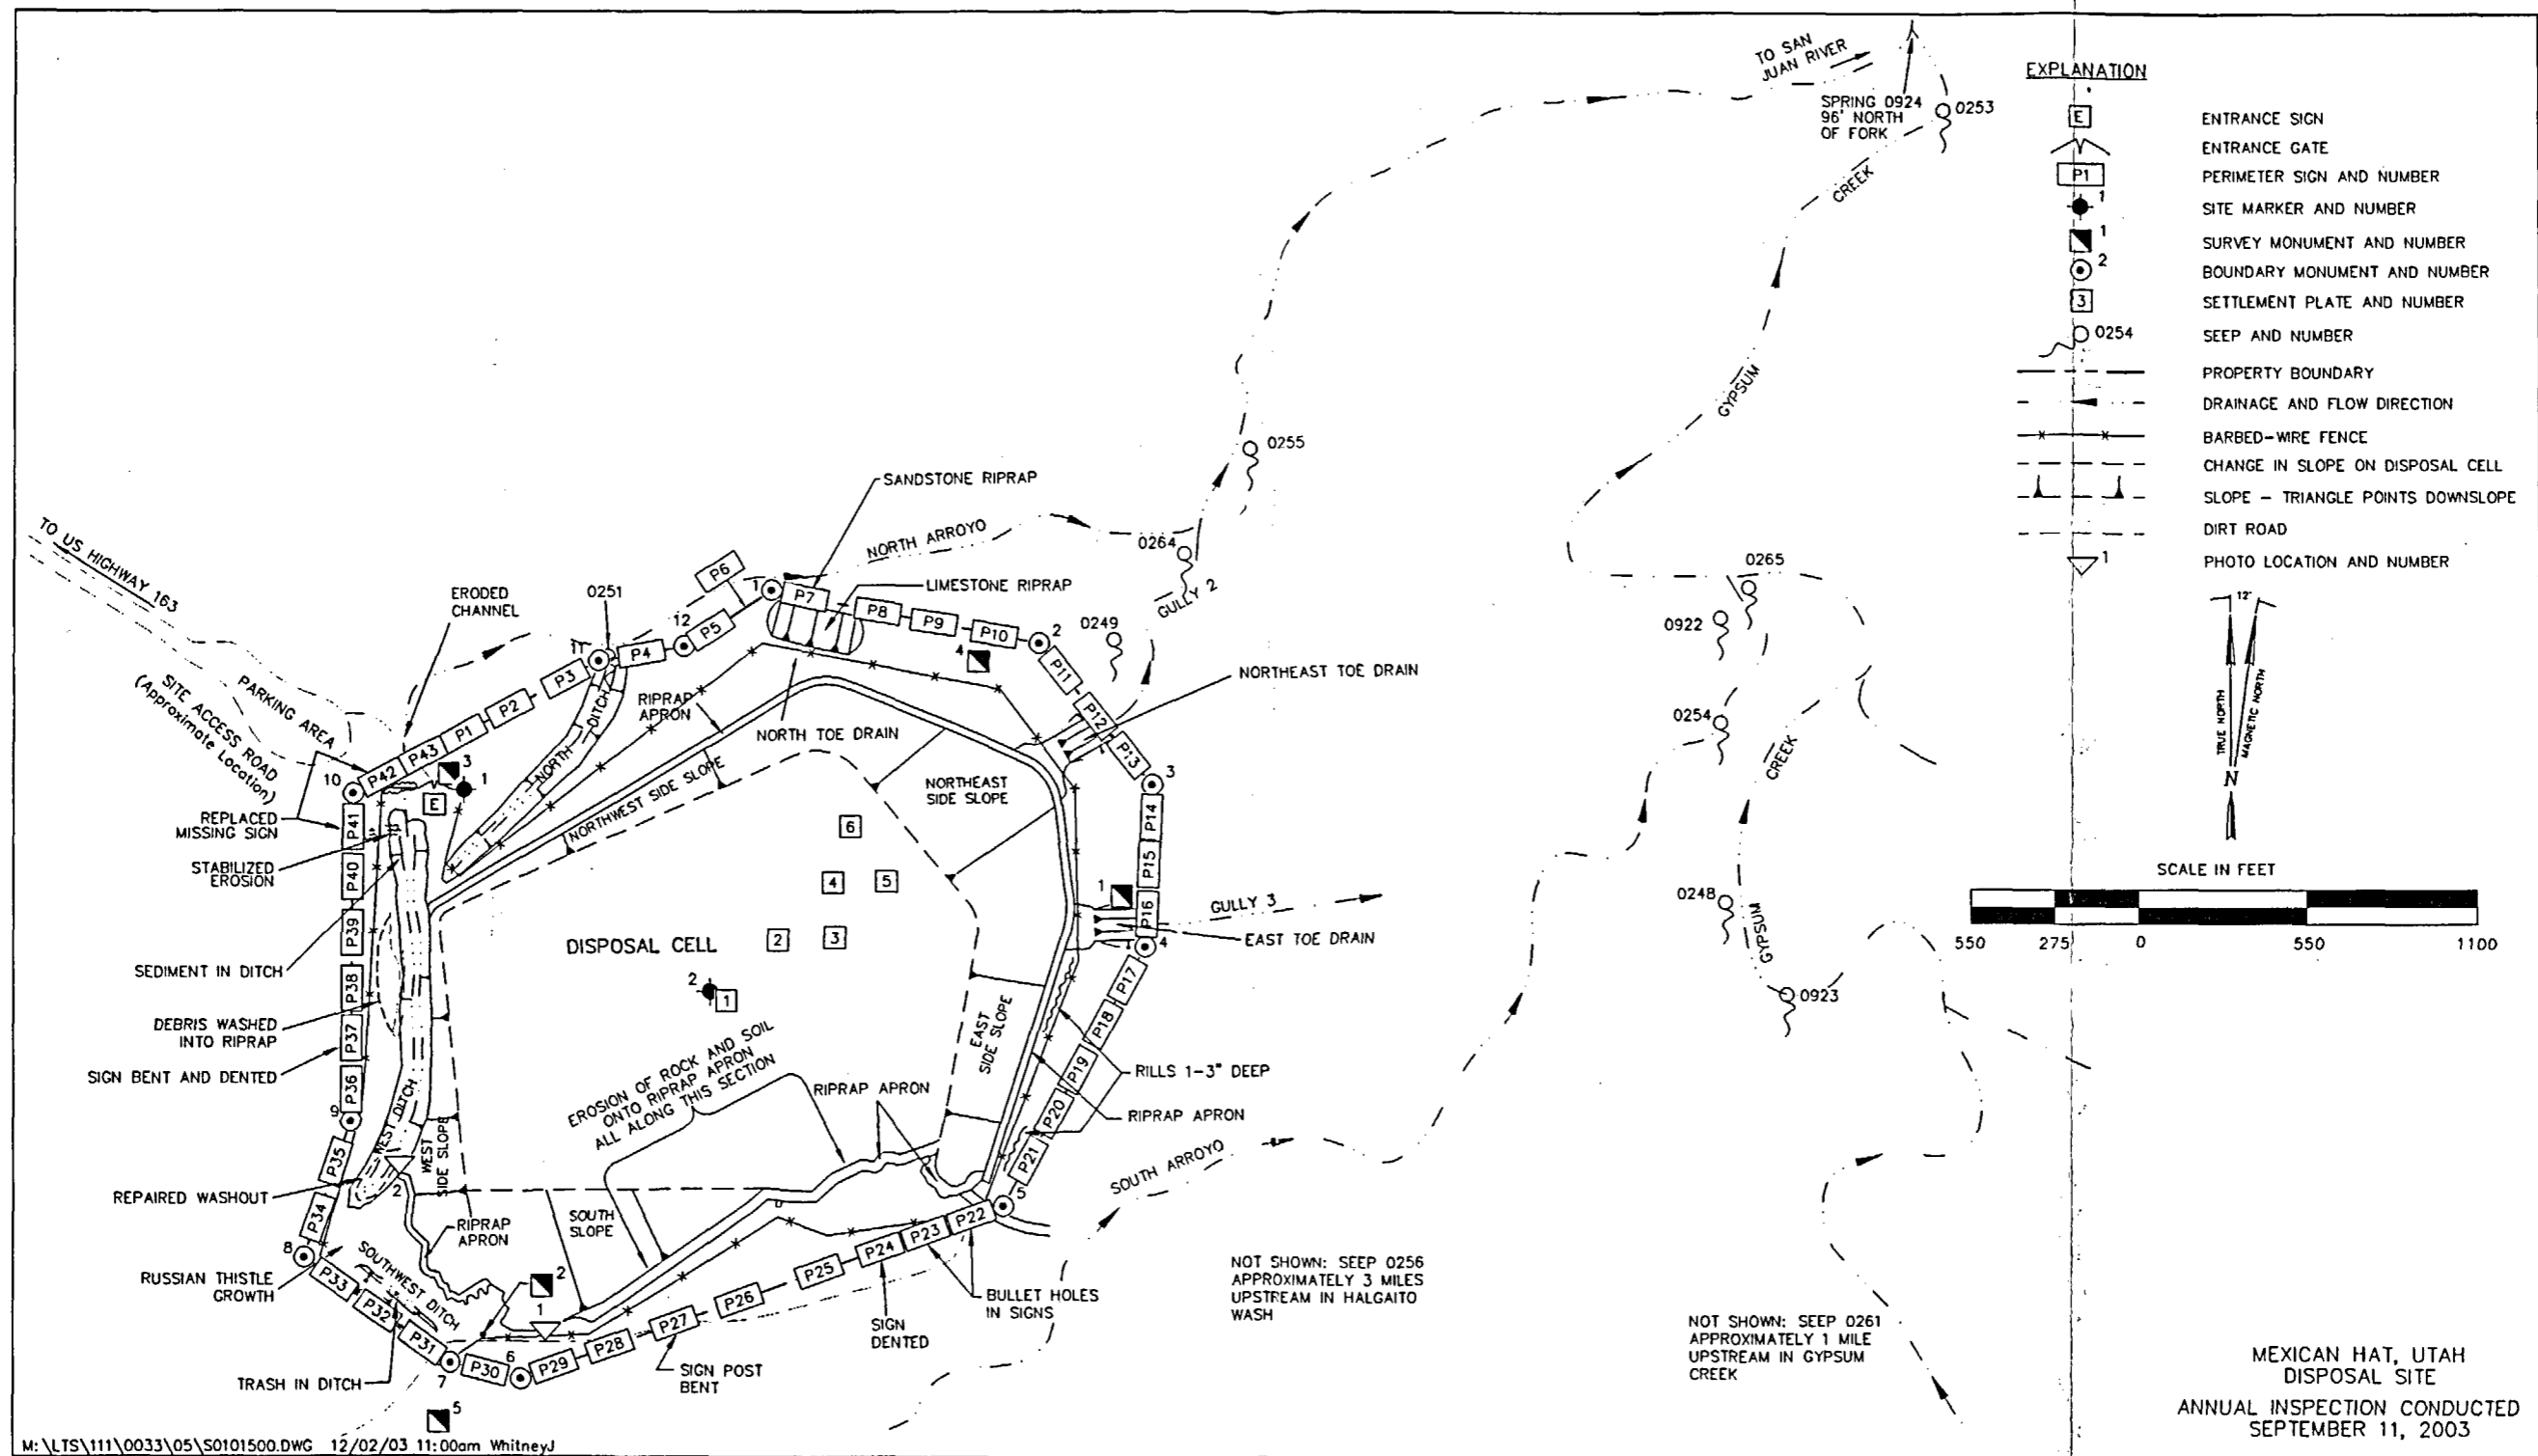
Figure 12-1. 2003 Annual Compliance Drawing for the Mexican Hat, Utah, Disposal Site

The sloughing of red country rock and soil along the south apron did not increase significantly during the past year; the accumulation remains approximately 18- to 24-inches high against the base of the adjacent hill slope (PL-1). As in previous years, inspectors did not find evidence of channel erosion in this area, and the sloughed material does not appear to have filled the void spaces in the riprap beyond the toe of the hill slope. A photograph will be taken for the record annually until conditions stabilize.

12C Substantial erosional damage to the upper section of the West Ditch caused by a severe storm in 2002 was repaired following a geotechnical evaluation of the damage. Another severe storm totaling 1.25 inches of rainfall in the town of Mexican Hat occurred on September 9, 2003. The repaired washout area of the West Ditch was intact (PL-2), and no evidence of erosion, settling, or slumping was observed on the side slopes or in the diversion ditches. Some sediment and weeds were present in the lower end of West Ditch but do not affect the performance of the diversion ditch.

**Area Between the Disposal Cell and the Site Boundary**—Minor rills were present upstream of West Ditch and along the east side slope. Trash (primarily cans and bottles) had washed onto the site in the vicinity of West Ditch. Hill slopes around the disposal cell remain stable with only minor accumulations of loose material at the toe of the slopes.

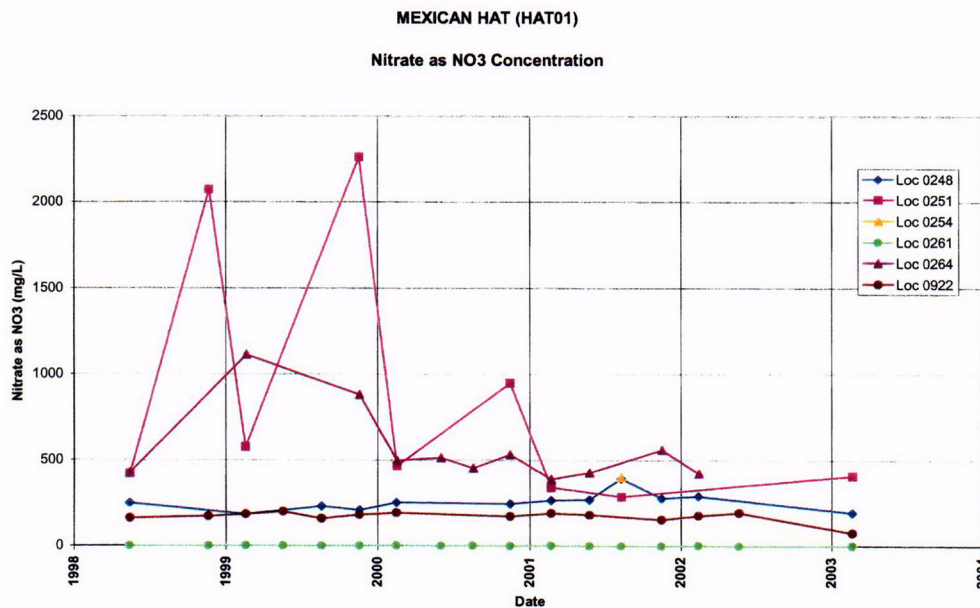
Figure 12–2. Time-Concentration Plots of Nitrate (as NO<sub>3</sub>) in Seep Water at the Mexican Hat, Utah, Disposal Site

Concentrations of nitrate have been variable in the two North Arroyo seeps for the past several years and have declined substantially from greater than 2,000 mg/L to less than 500 mg/L in the past 3 years (Figure 12–2). Nitrate concentrations have remained relatively stable in the Gypsum Creek seeps for the past 5 years ranging from 150 to 400 mg/L. Concentrations in the background seep remain below 1 mg/L.

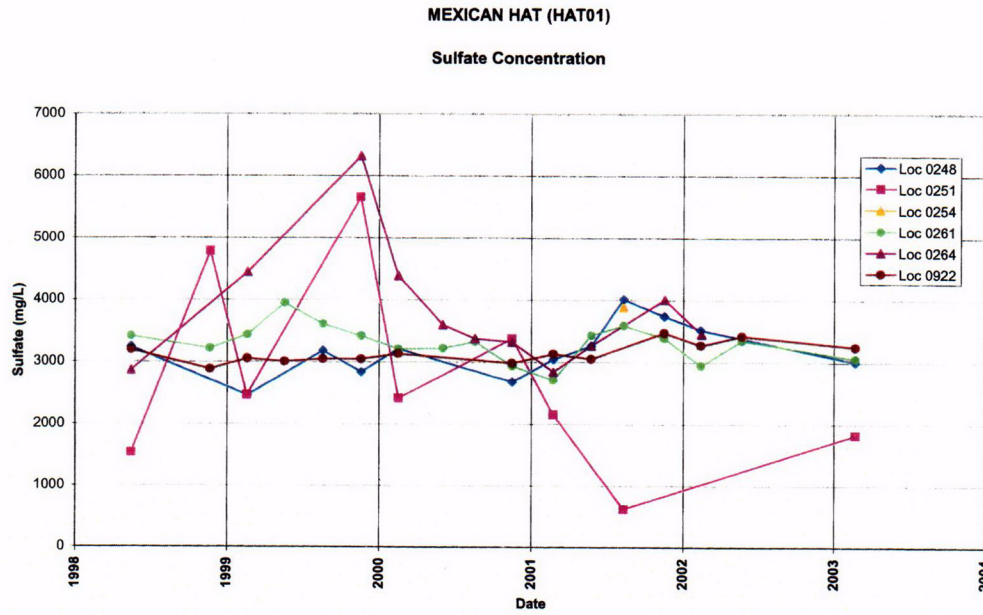
Figure 12-3. Time-Concentration Plots of Sulfate in Seep Water at the Mexican Hat, Utah, Disposal Site

Sulfate concentrations similarly have decreased in the two North Arroyo seeps from greater than 6,000 mg/L to less than 4,000 mg/L since early 2000 (Figure 12–3). Concentrations in the Gypsum Creek seeps and the background seep have remained relatively steady between 3,000 and 4,000 mg/L during this time.

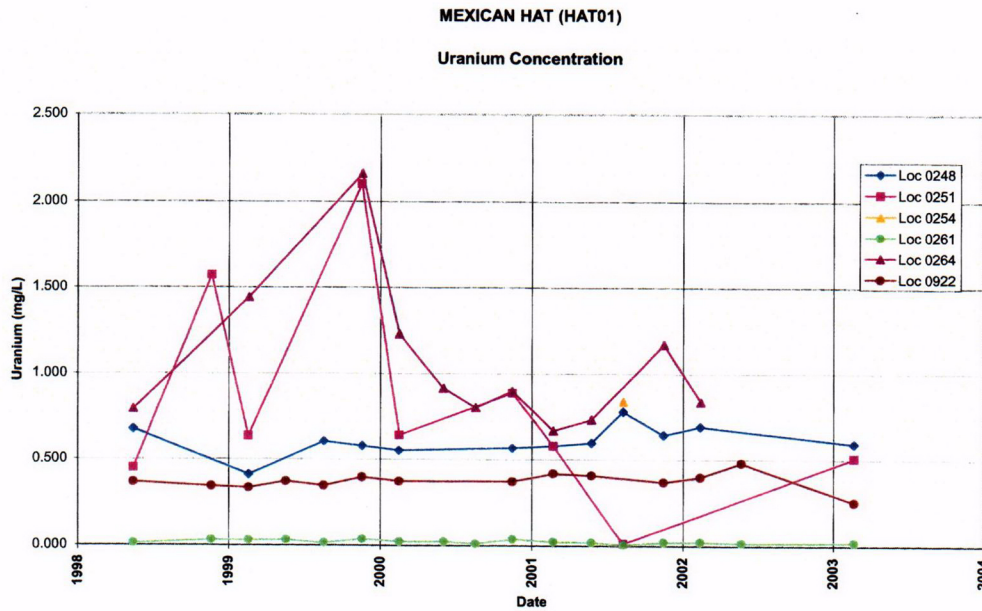
Figure 12-4. Time-Concentration Plots of Uranium in Seep Water at the Mexican Hat, Utah, Disposal Site

Concentrations of uranium in the North Arroyo seeps have decreased from greater than 2.0 mg/L to less than 1.0 mg/L since November 1999 (Figure 12–4). Concentrations remain relatively constant in the Gypsum Creek seeps at approximately 0.5 mg/L. Background levels at seep 0261 averaged 0.024 mg/L for the past several years.
