Subject: 2003 Annual Site Inspection and Monitoring Report for UMTRCA Title I  
Disposal Sites

# 2003 Annual Site Inspection and Monitoring Report for Uranium Mill Tailings Radiation Control Act Title I Disposal Sites

January 2004

GJO-2003-528-TAC

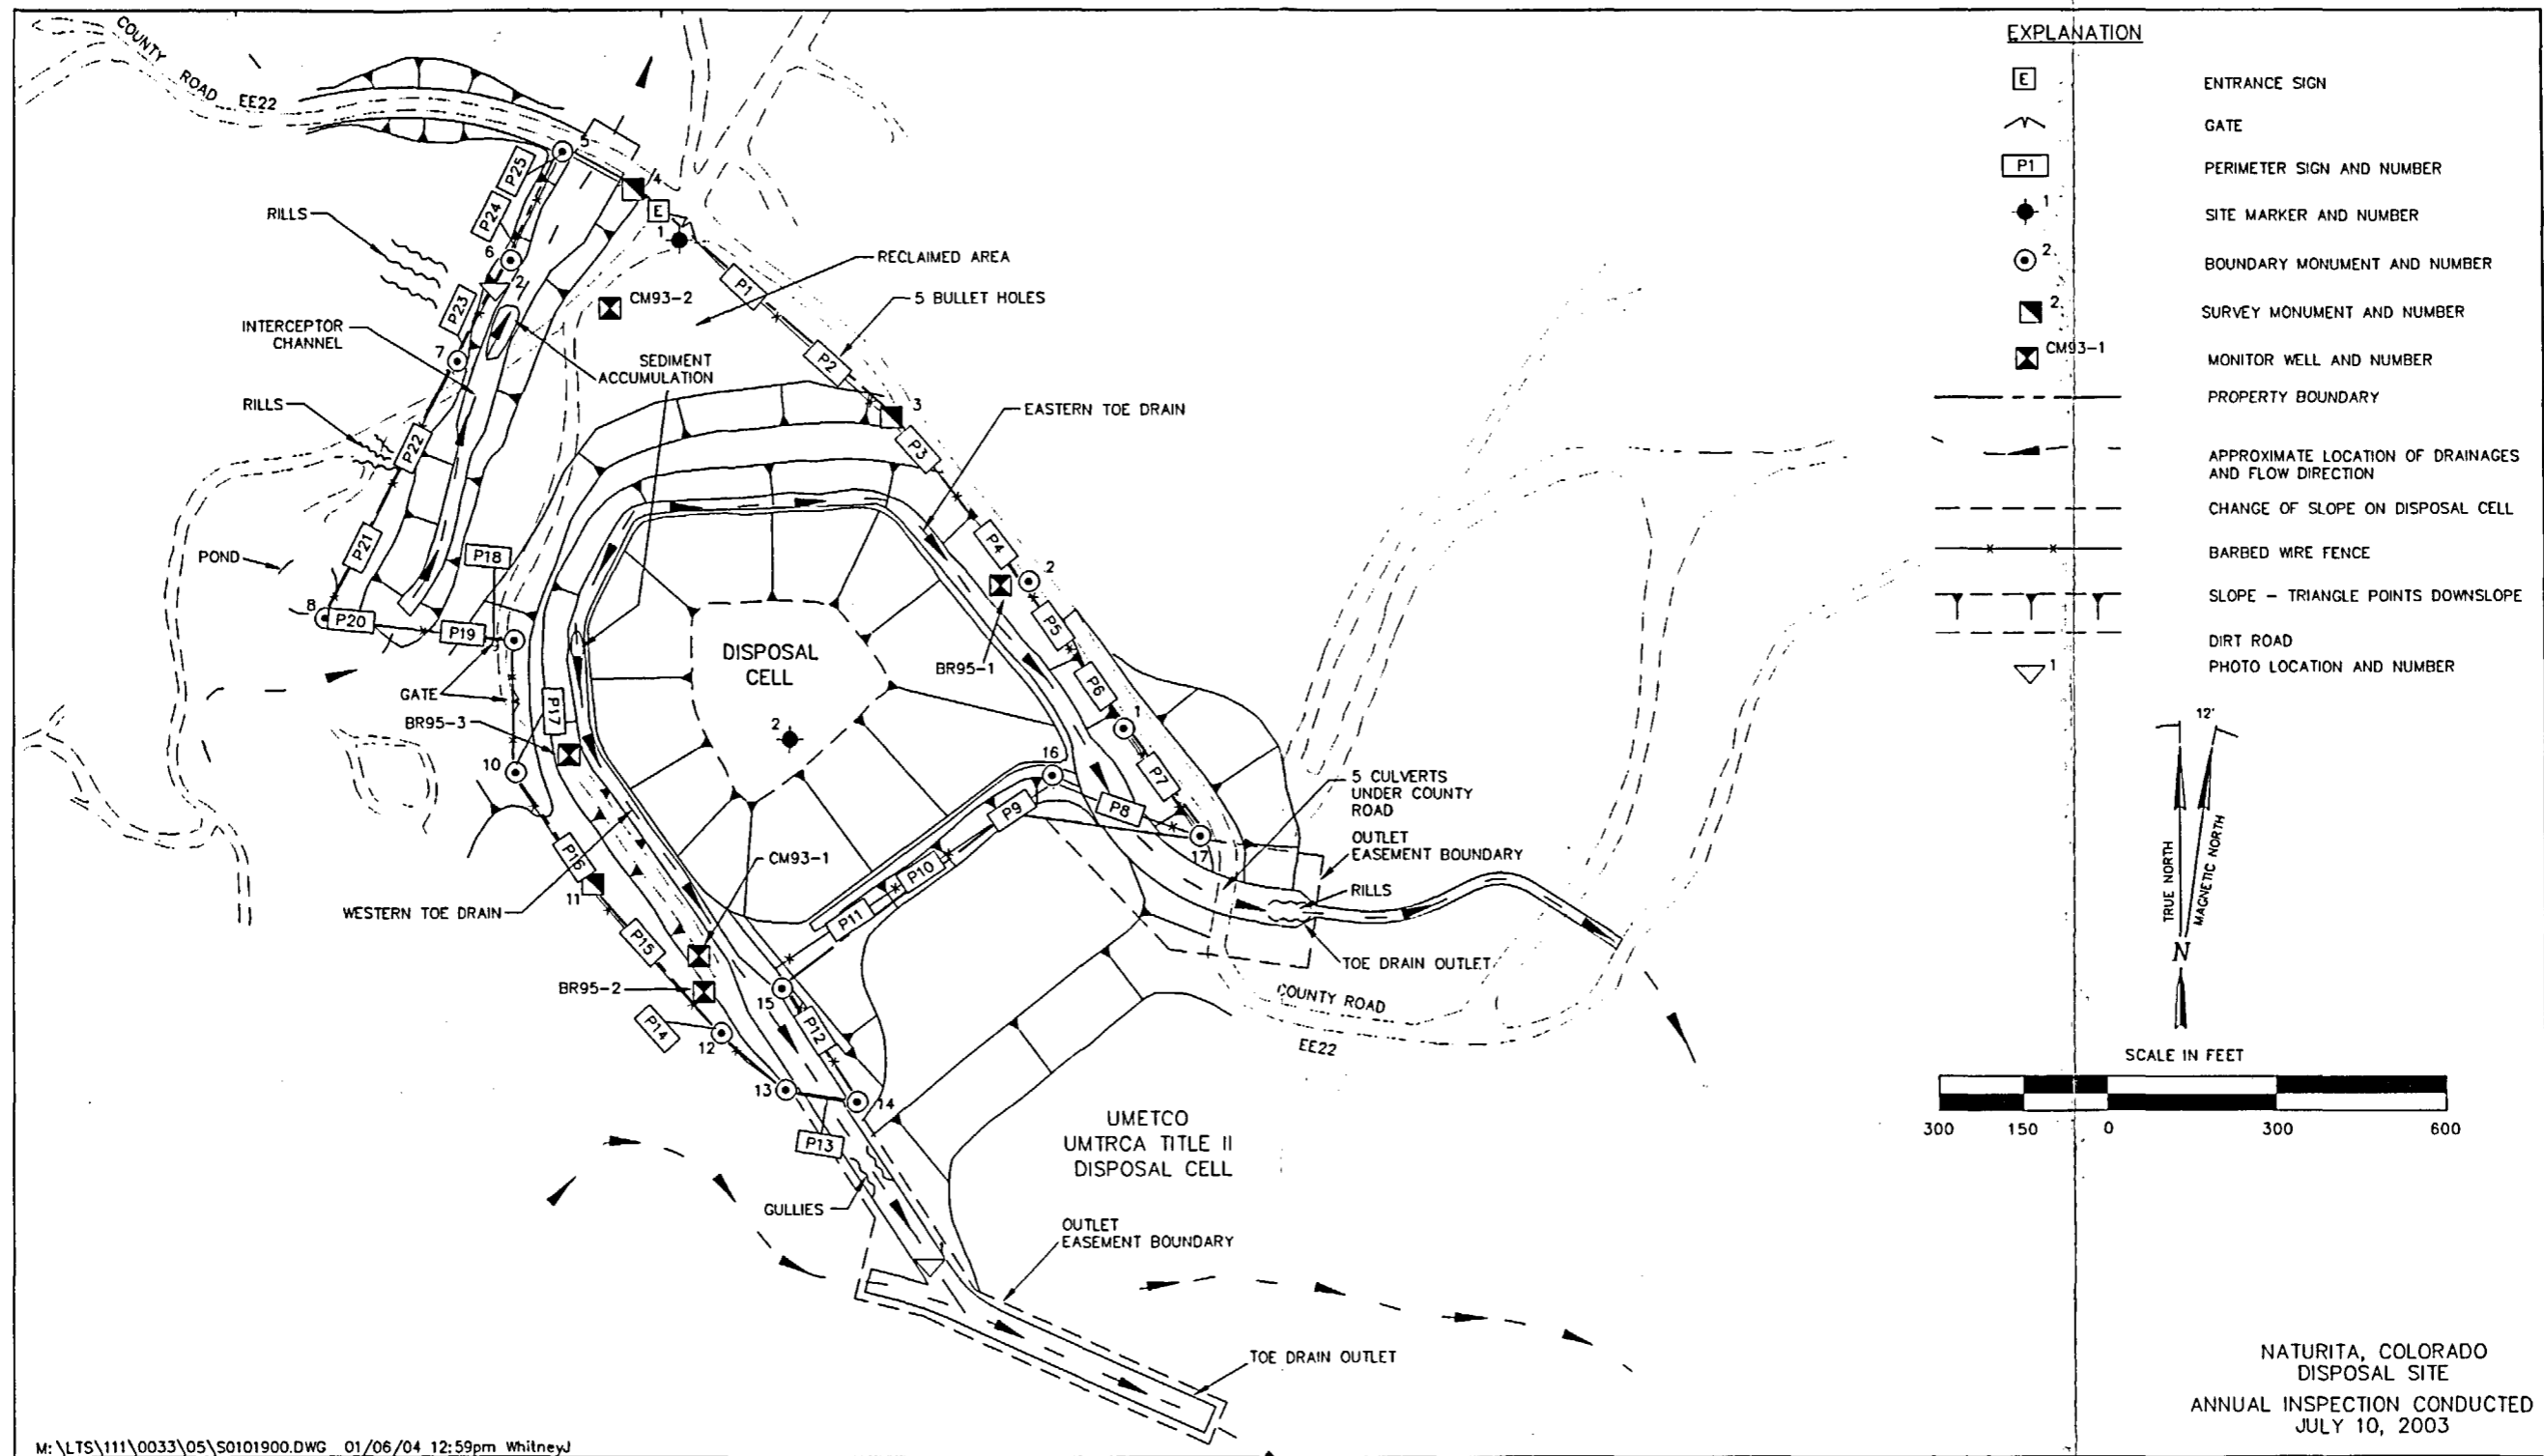
Figure 13-1. 2003 Annual Compliance Drawing for the Naturita, Colorado, Disposal Site

**Toe Drains and Outlets**—Two riprap-filled toe drains collect water from the cell side slopes and divert it to the southeast. The toe drain on the western side of the cell exits through a channel quarried through the wall of the Burbank Pit and into a deep canyon leading to the San Miguel River. Some sediment has accumulated in the upper end of the western toe drain. The eastern toe drain exits through the adjacent UMETCO UMRCA Title II disposal site and crosses beneath County Road EE22 through five culverts. Some erosion of loose material has occurred in the toe drain outlets, but the underlying sandstone bedrock (PL-1) limits further erosion. Patches of noxious weeds (halogeton and Russian knapweed) were found adjacent to the toe drain outlets; the weeds will be sprayed with herbicide in 2004.

13A The U.S. Bureau of Land Management right-of-way permits for the toe drain outlets (the drains extend beyond the property boundary), originally set to expire in 2004, were modified as perpetual easements in 2003. The surveyed easement boundaries are shown on Figure 13-1.

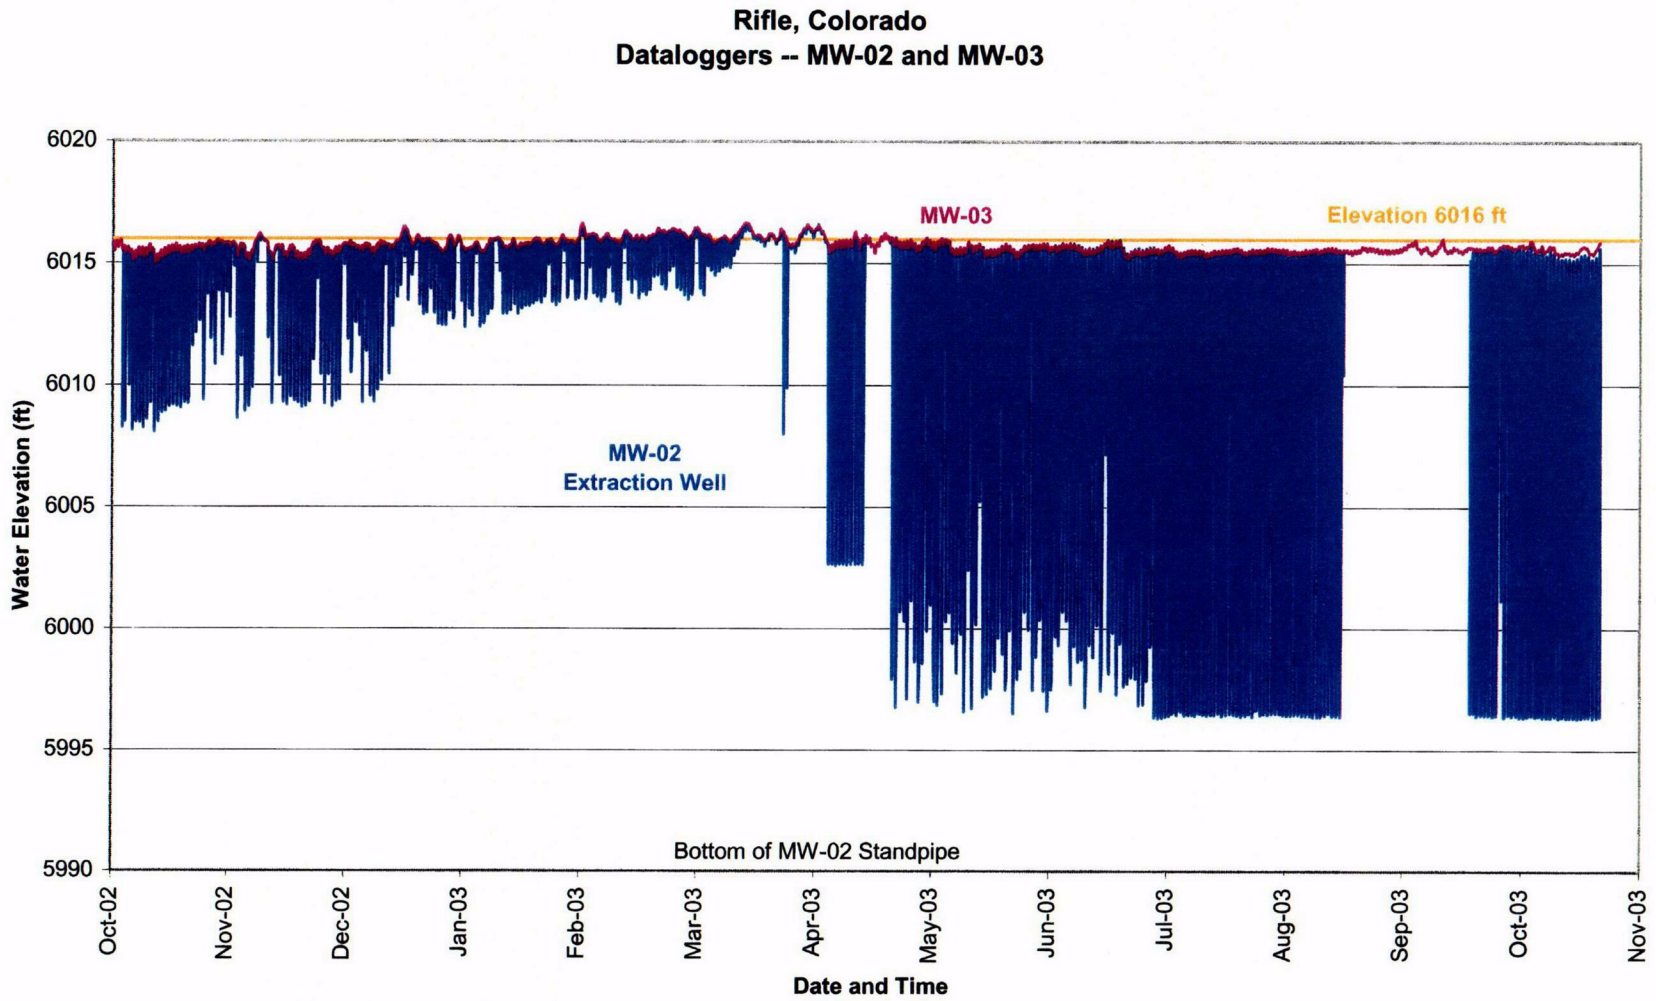
Figure 14-2. Water Levels in Standpipes MW-02 and MW-03 at the Rifle, Colorado, Disposal Site

14F Average water levels (as calculated using linear regression) in MW-02 approached the action level in August 2001. DOE subsequently installed a pump in this standpipe, constructed an evaporation pond, and began pumping from the standpipe to the pond. Since then, a total of approximately 830,000 gallons of water have been extracted from the disposal cell, and water levels have slowly decreased as shown by datalogger measurements (Figure 14-2).

The discharge rate from the solar-powered pump currently averages less than 3 gallons per minute during periods of operation. The oscillation in the datalogger trace for MW-02 in Figure 14-2 represents drawdown in the standpipe during pumping, and recovery of the water level when pumping ceases. The normal recording interval for the dataloggers is every 4 hours. However, to better track activities in the extraction well (MW-02), the interval was changed to every 5 minutes in July 2003. Gaps in the plot for MW-02 reflect periods of datalogger shutdown.

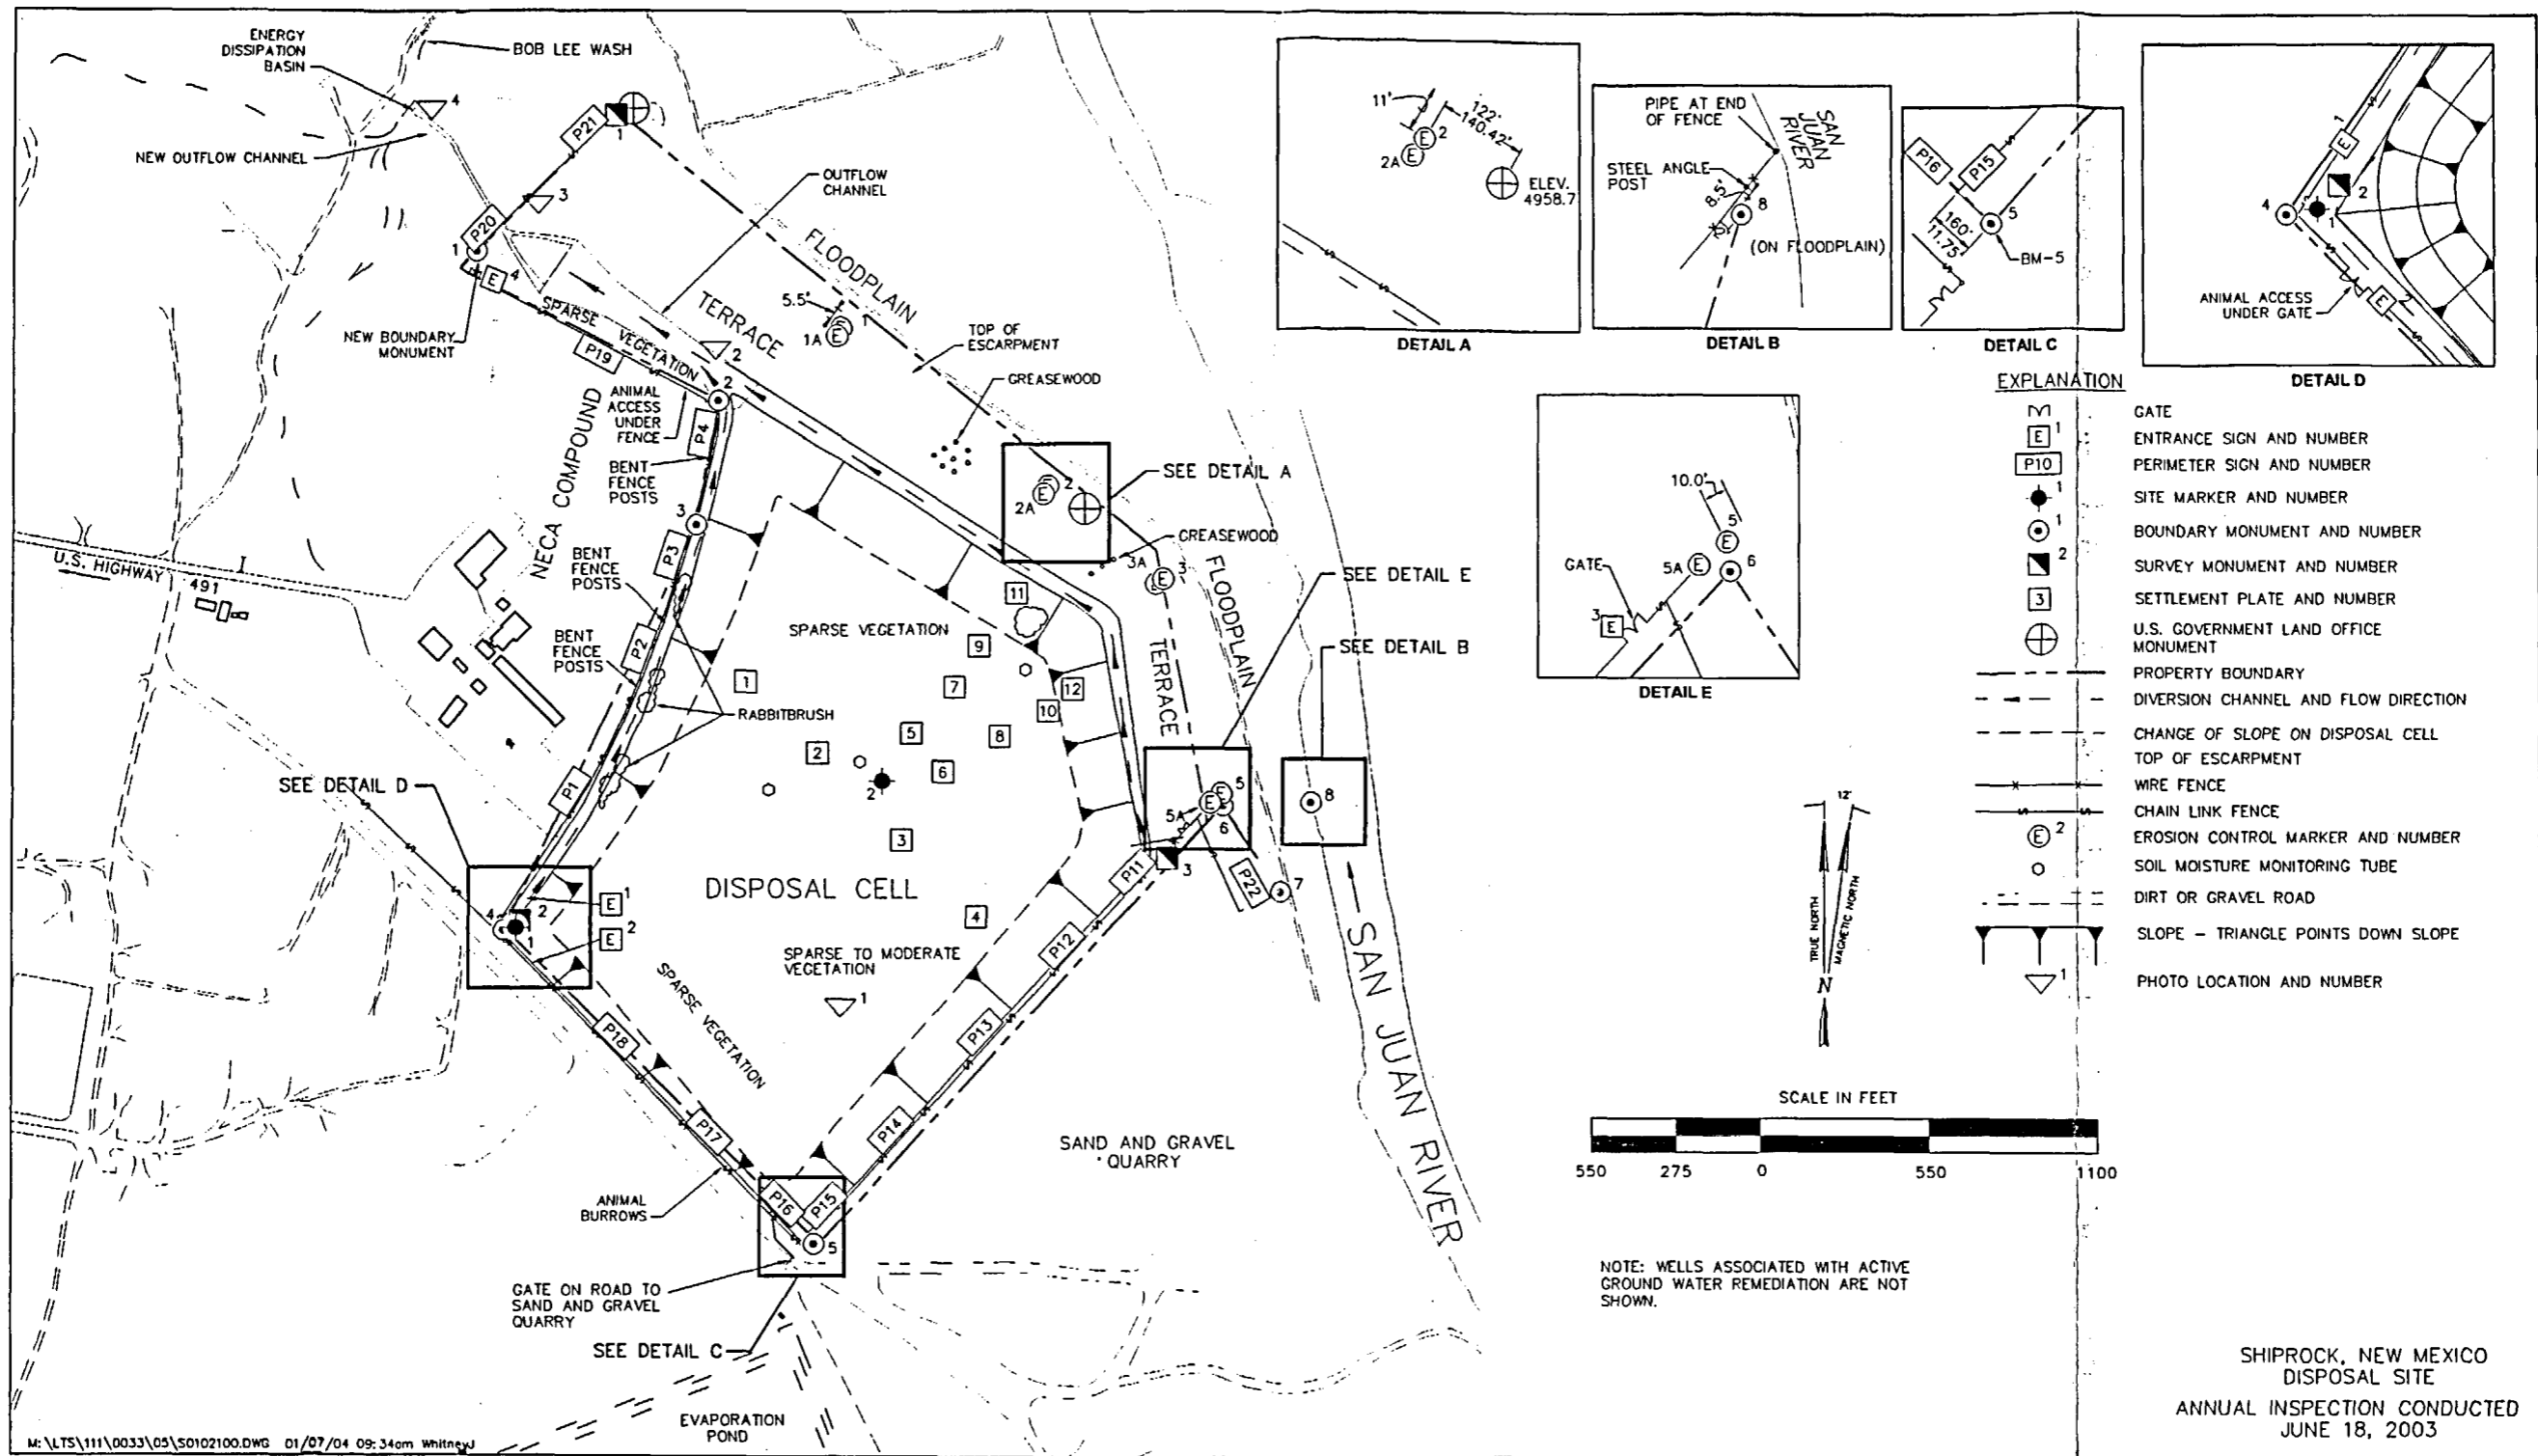
Figure 16-1. 2003 Annual Compliance Drawing for the Shiprock, New Mexico, Disposal Site

16C Significant vegetation growth has been noted during past inspections on the cell top and the east, northeast, and northwest side slopes. These areas were sprayed in June 2001 in a continuing effort to reduce the seed source and control future plant encroachment on the disposal cell. Numerous patches of annual grasses and weeds were present on the cell top and the side slopes in 2003. Several deep-rooted woody shrubs were found on the cell top and were cut and treated with herbicide (PL-1). The population of woody shrubs growing on the cell side slopes continues to increase. The DOE will continue to monitor and control vegetation growth to maintain the performance of the cell.

Diversion channels around the base of the disposal cell were in good condition. Site drainage is ultimately directed toward the outflow channel at the northwest corner of the site. Rock cover in the outflow channel was in good condition. Vegetation is increasing in the diversion and outflow channels (PL-2); however, the performance of the channels is not impaired.

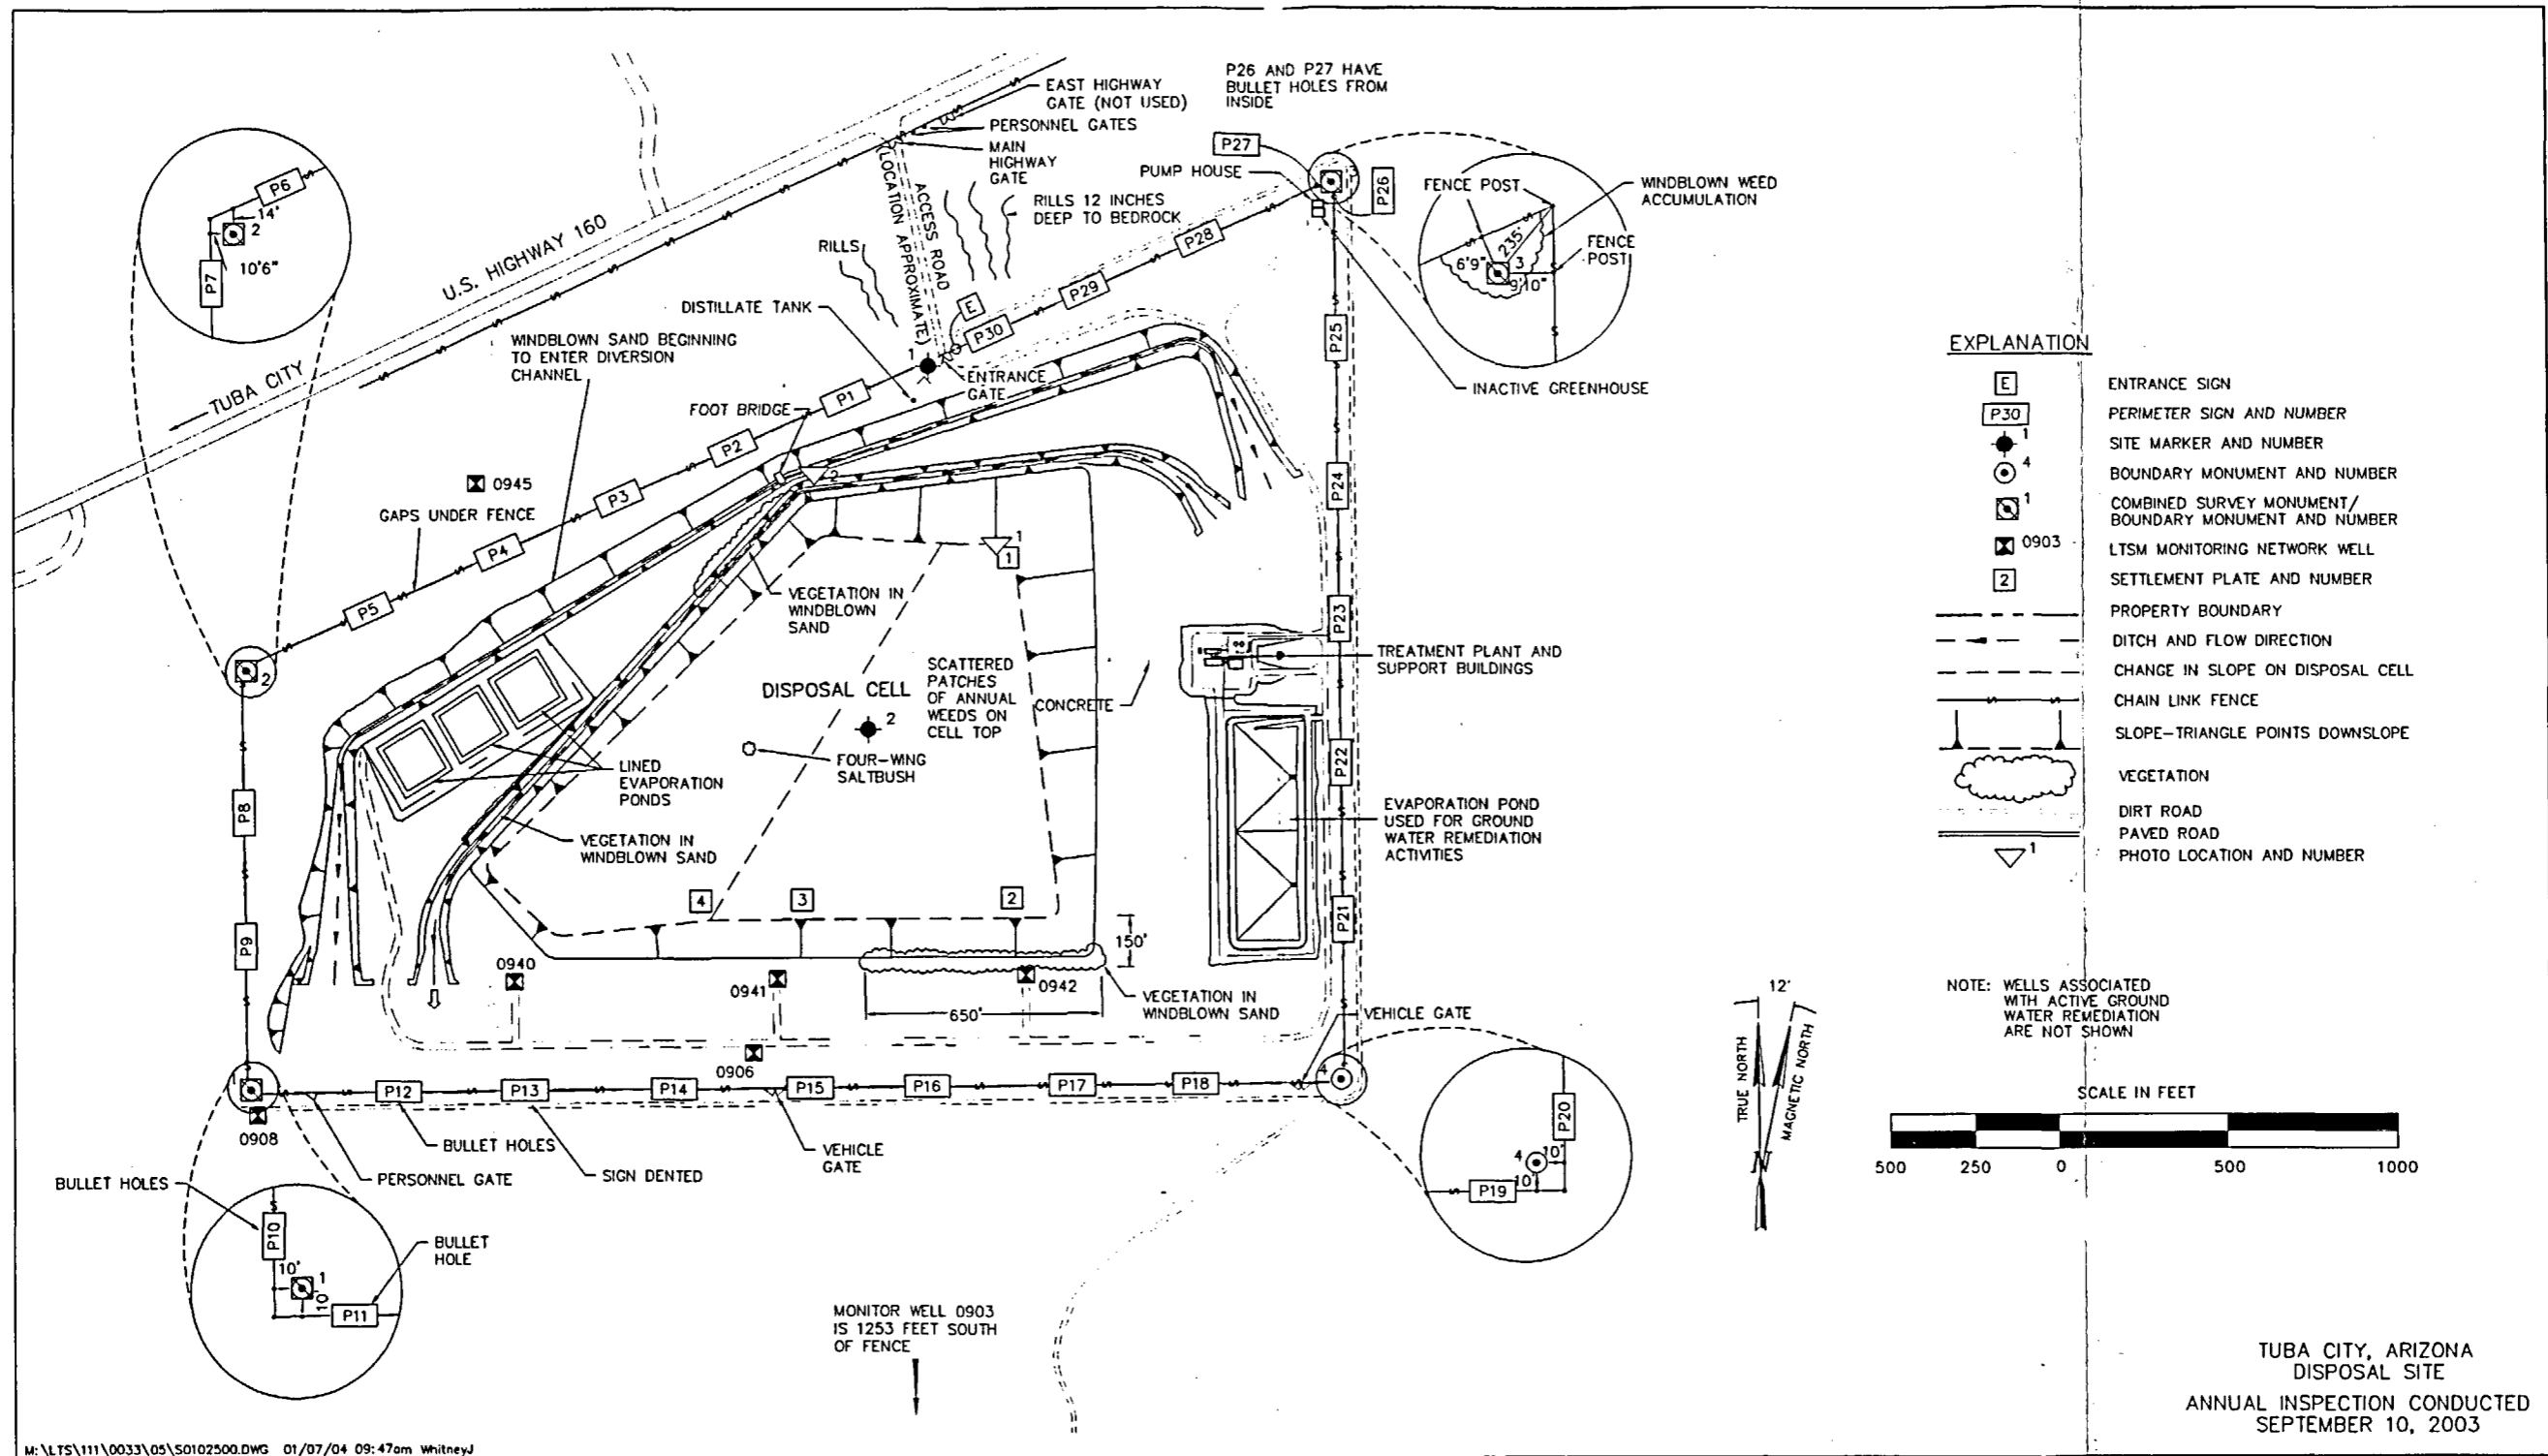
Figure 19-1. 2003 Annual Compliance Drawing for the Tuba City, Arizona, Disposal Site

The site, located east of Tuba City, Arizona, was inspected on September 10, 2003. Results of the inspection are described below. Features and photograph locations (PLs) mentioned in this report are shown on Figure 19-1. Numbers in the left margin of this report refer to items summarized in the Executive Summary table.

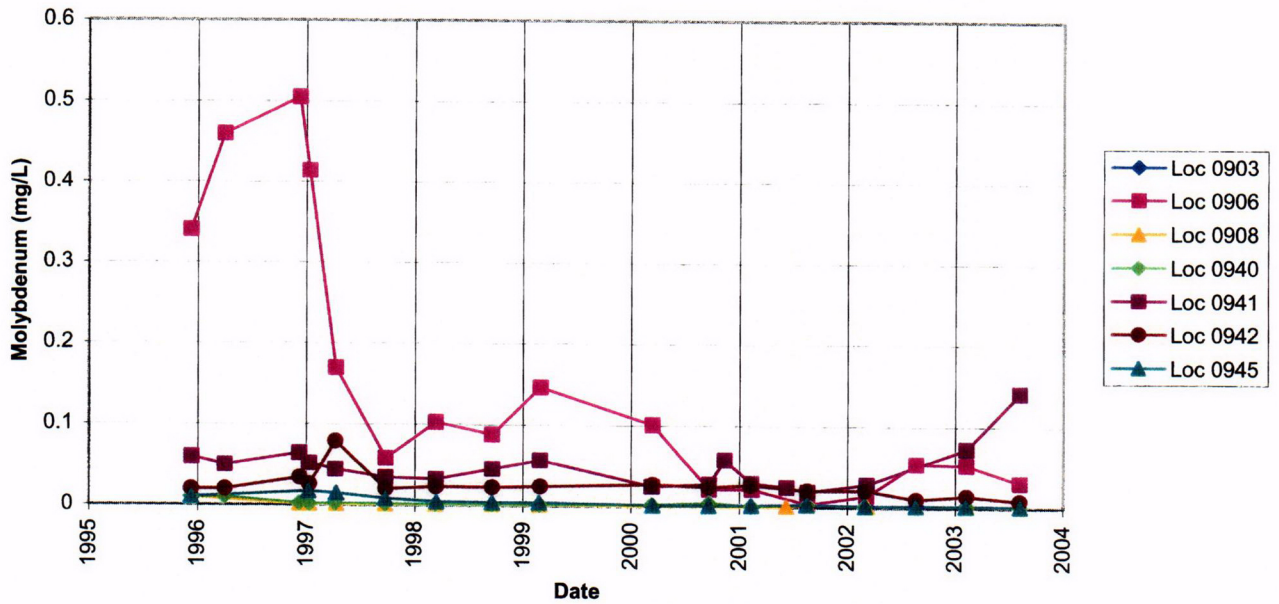
Figure 19-2. Time-Concentration Plots of Molybdenum in Ground Water at the Tuba City, Arizona, Disposal Site

Molybdenum concentrations exceeded the 0.1 milligram per liter (mg/L) standard in the sample from monitor well MW-0941 in 2003. Except at MW-0906, molybdenum concentrations have not varied significantly in the last 8 years (Figure 19-2). Samples from MW-0906 typically have had higher and more variable molybdenum concentrations in the past than samples from other wells.

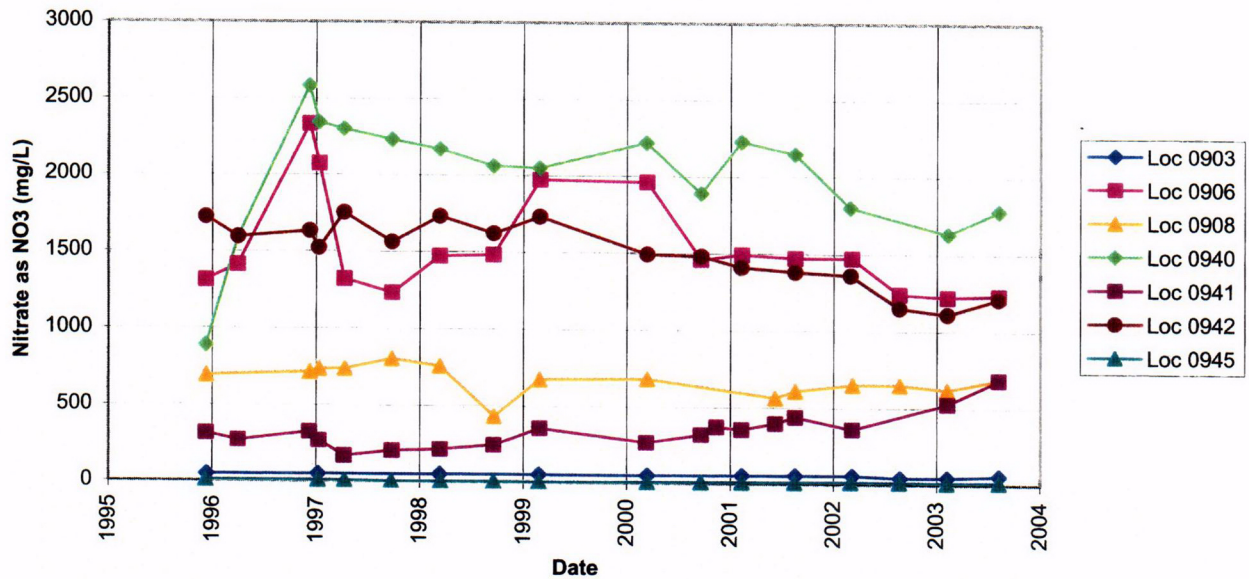
Figure 19-3. Time-Concentration Plots of Nitrate (as NO<sub>3</sub>) in Ground Water at the Tuba City, Arizona, Disposal Site

In 2003, concentrations of nitrate (as  $\text{NO}_3$ ) exceeded the 44 mg/L standard in samples from all monitor wells except background well MW-0945. Between 2002 and 2003, no significant increases or decreases in concentrations were observed in samples from any well, although concentrations varied considerably—by more than two orders of magnitude—from well to well (Figure 19-3).

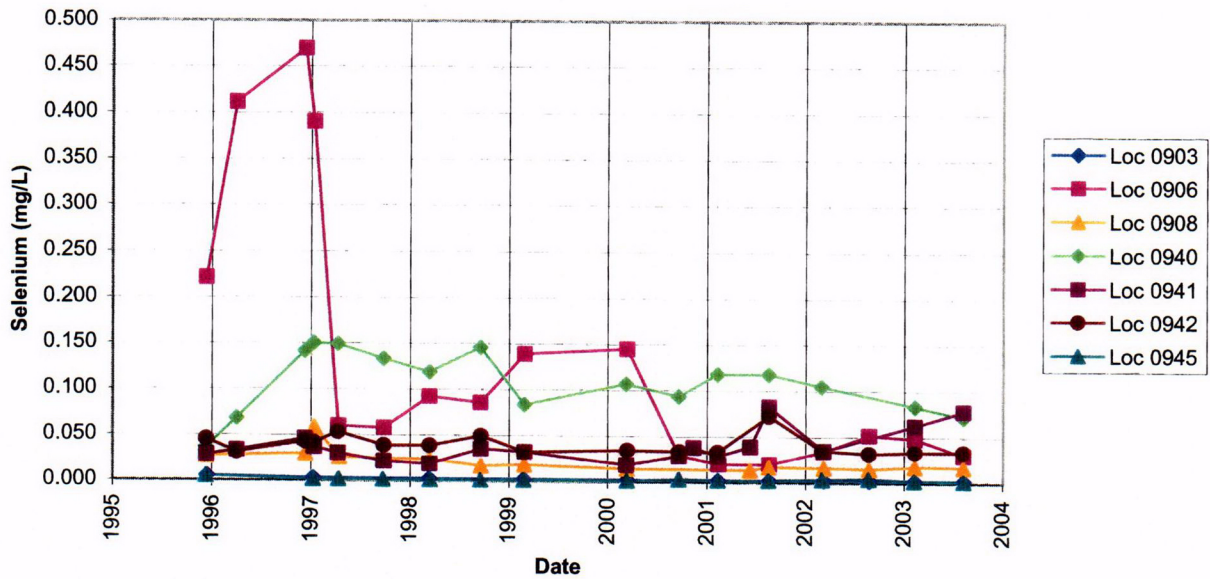
Figure 19-4. Time-Concentration Plots of Selenium in Ground Water at the Tuba City, Arizona, Disposal Site

Consistent with historical data, selenium concentrations exceeded the 0.01 mg/L standard in 2003 in samples from all wells except background well MW-0945 and off-site, downgradient well MW-0903. Selenium values have remained fairly consistent in samples from all wells except MW-0906 and MW-0940 (Figure 19-4).

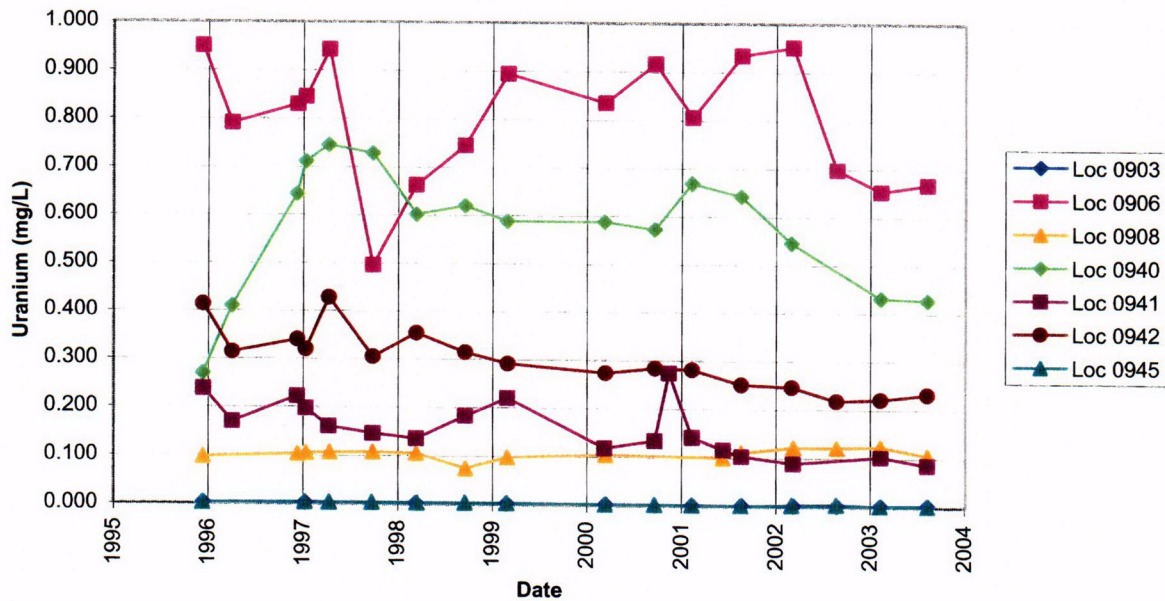
Figure 19-5. Time-Concentration Plots of Uranium in Ground Water at the Tuba City, Arizona, Disposal Site

Uranium concentrations exceeded the 0.044 mg/L standard in 2003 samples from all wells except background well MW-0945 and off-site, downgradient well MW-0903. Concentrations have remained fairly constant over time in samples from all wells except MW-0906 and MW-0940 (Figure 19-5).
