NUREG/CR-4939
BNL-NUREG-52031
VOLUME 3

IMPROVING MOTOR RELIABILITY IN NUCLEAR POWER PLANTS

VOLUME 3: FAILURE ANALYSIS AND DIAGNOSTIC TESTS
ON A NATURALLY AGED LARGE ELECTRIC MOTOR

ENGINEERING TECHNOLOGY DIVISION
DEPARTMENT OF NUCLEAR ENERGY, BROOKHAVEN NATIONAL LABORATORY
UPTON, LONG ISLAND, NEW YORK 11973

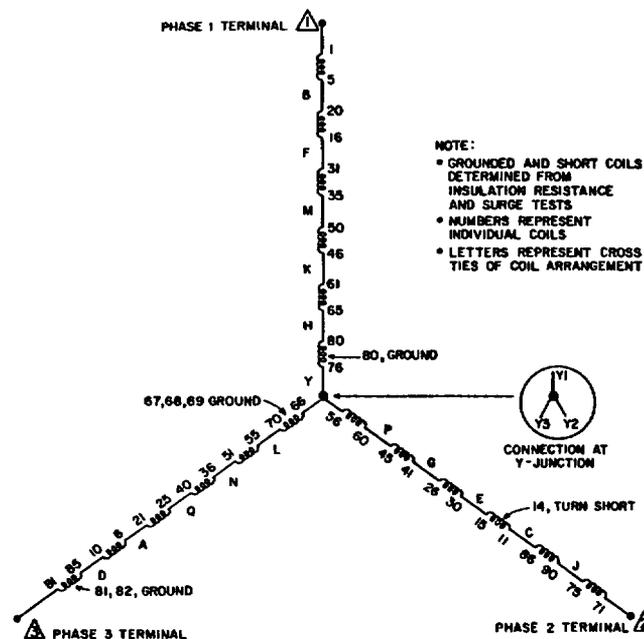
Figure 2.1 - Stator winding arrangement showing coil numbers.

Before cutting the connections for individual and group testing of the coils, all connections and coils were identified by letters or numbers. Letters were used on inner group connections representing the cross ties of each phase coil connection and numbers were used on individual coils. The coil and connection identifications are shown on Figures 2.1 and 2.2. By connecting all the same letters in the winding arrangements in Figure 2.2 (also shown in Figure 2.1) one can develop the Y-connected stator windings. This figure illustrates the stator winding arrangement after it was spread out on a flat sheet. Figure 2.3 shows the pictorial view of the stator after all connections were cut, marked, and ready for other dielectric tests.

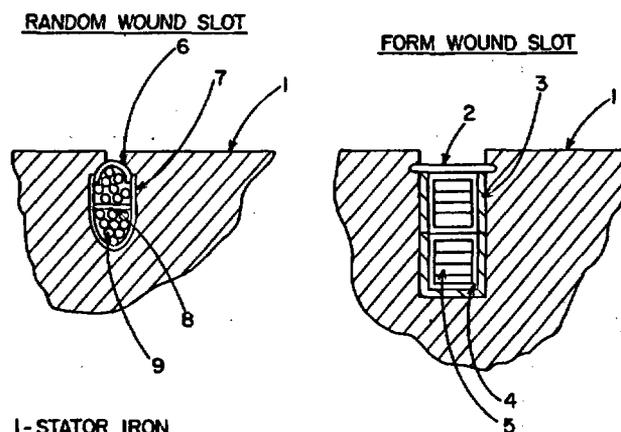
Figure 4.1 - Coil arrangements in random and form wound stators.

Figure 4.1 presents the formula for capacitance⁶ showing its relationship with reduced wall thickness. From the formula it is apparent that where the thickness of the insulation is reduced, the capacitance is increased. An increase in capacitance value could, therefore, be an indication of a reduction in insulation thickness in the slots. This could be due to insulation deterioration accompanied by deposition of additional conducting material which is a typical problem when a coil is over heated and carbon from the burning process replaces the insulation.

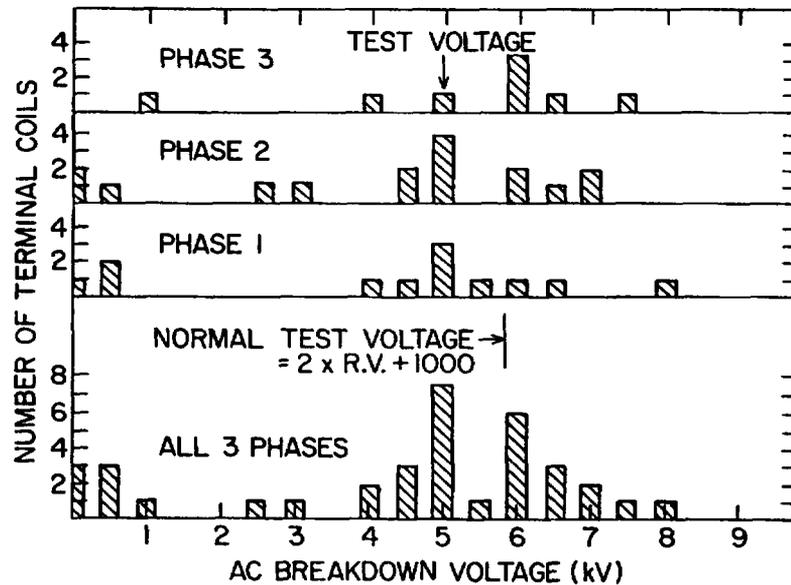
Figure 4.6 - Ac high potential test.

Figure 4.6 shows the distribution of ac breakdown voltage test results for coils considered in the other dielectric tests. The coils with high capacitance, dissipation factor or leakage current had different breakdown voltages ranging from instant ground to 6000 volts. Many of them failed prior to reaching the 5000 volt level. Some coils indicated instant ground. This may be due to damage done to coils resulting from difficulties in separating the cut series connection leads.
