Aging and Qualification Research on Solenoid Operated Valves

Prepared by V. P. Bacanskas, G. J. Toman, S. P. Carfagno

Franklin Research Center

Prepared for
U.S. Nuclear Regulatory
Commission

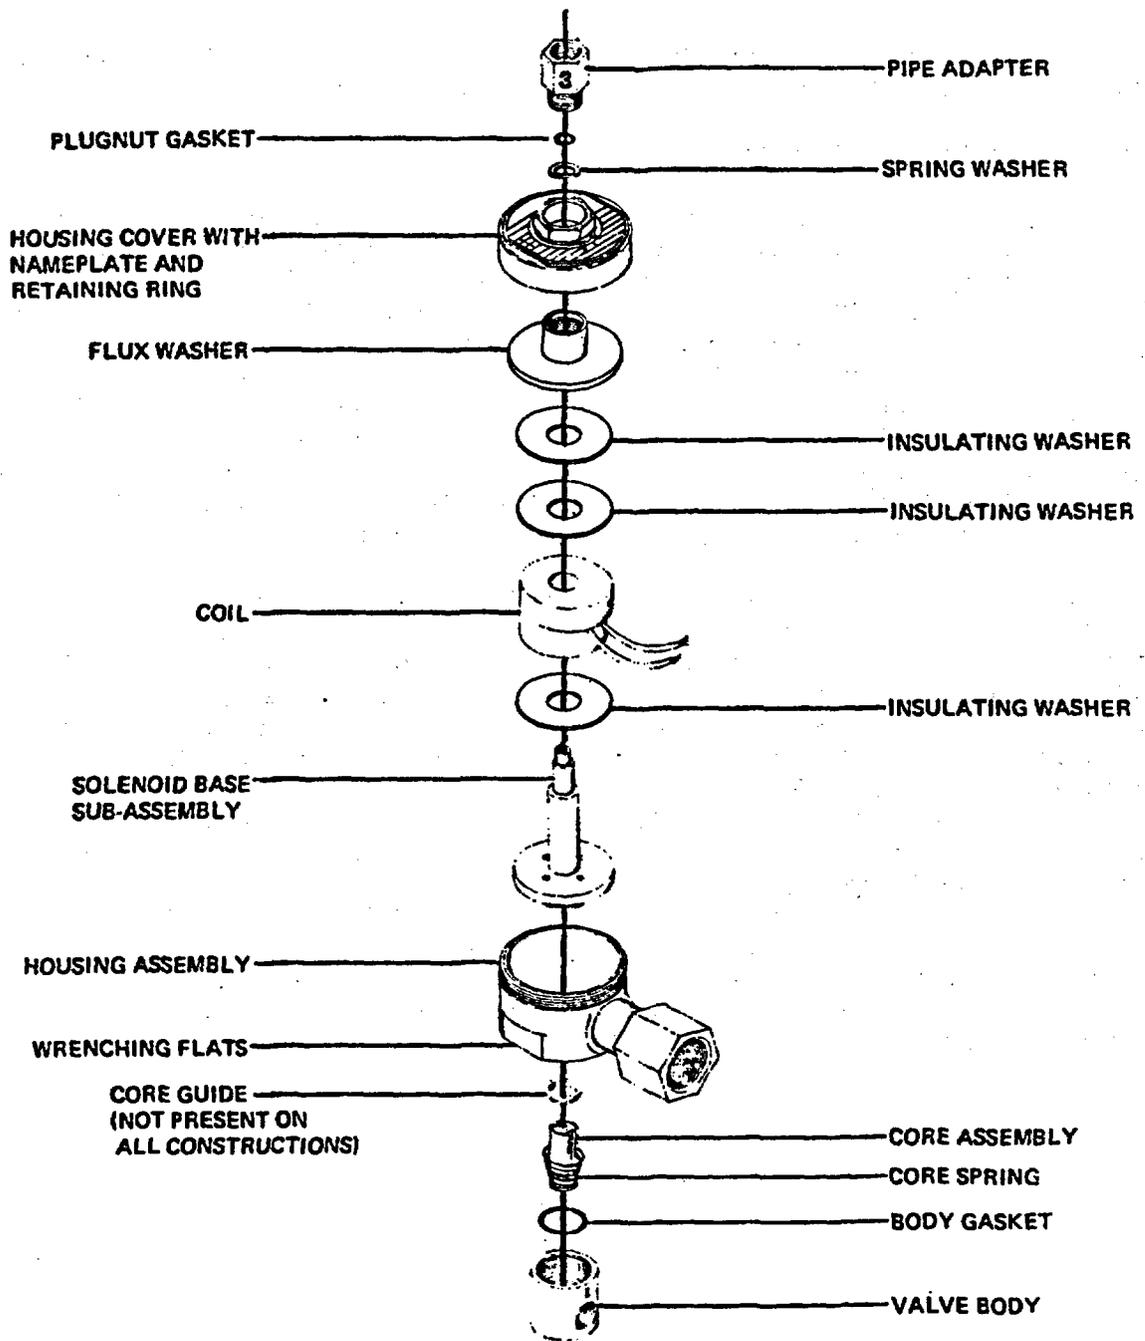
Figure 1. Exploded View of ASCO NP8314 SOV

During thermal aging of the ASCO valves, sticking was observed (see Section 6.3.2) that required cleaning the vicinity of the metal-to-metal interface (at the top of the core assembly) prior to resumption of the thermal aging program. Ultimately, thermal aging was completed on the ASCO SOVs.

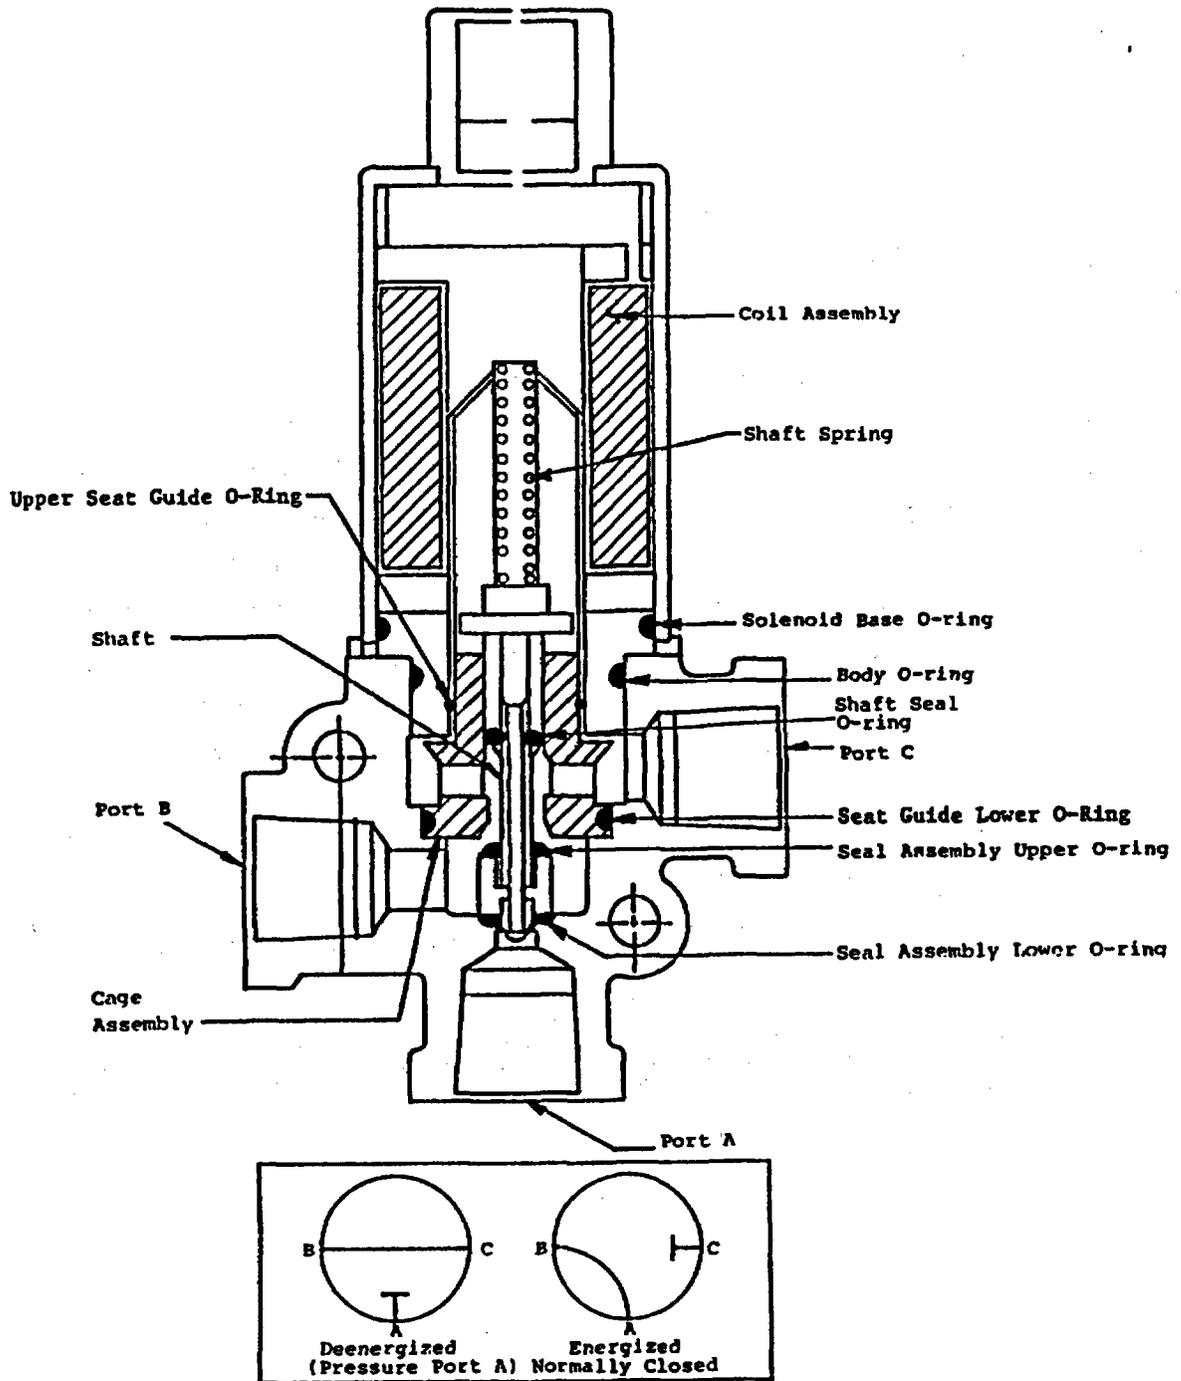
Figure 2. Section View of Valcor V-70900-21 SOV

Two of the three Valcor SOVs (6096-22 and -23) failed to return to their deenergized position upon deenergization of their coils. A failure analysis showed that the failure to transfer was caused by sticking of the shaft seal O-ring to its guide tube. Using a spare Valcor* SOV, the temperature of the shaft seal O-ring was measured as 278°F (137°C) at the thermal aging temperature of 230°F (110°C). The temperature measurement confirmed that the temperature at the shaft seal O-ring had not exceeded the manufacturer's suggested limit of 300°F (149°C).

Further evaluation of the failure indicated that the observed failure could have been the result of peculiarities of the accelerated thermal aging procedure which would not occur in a plant environment. Two possible causes were hypothesized.** The first hypothesis was that the physical and chemical changes of the EPDM O-ring that occurred at the elevated aging temperature and caused it to adhere to the guide tube, rather than slide in it, are different from the changes that occur under service conditions. The second hypothesis was that creep of the O-ring at the aging temperature under the stress of the process pressure far exceeded the creep that could occur under the same pressure at service temperatures. At the aging temperature (278°C [137°C]), the O-ring tends to soften; therefore, the 150-psig process pressure would tend to compress the O-ring between the shaft it rides on and the shaft guide tube (see Figure 7). When the oven temperature was reduced to room temperature with the SOV energized, the O-ring returned to a less pliable state and prevented movement of the shaft.

To allow completion of the thermal aging simulation and continuation of the research program, the accelerated thermal aging analysis was revised in an attempt to preclude further Valcor SOV failures that appeared to be nonrepresentative of normal aging. The objective was to reduce the accelerated aging temperature and correspondingly increase the aging time. As a result of the observed failure mode, the shaft seal O-ring was chosen to be the critical component, since its failure could prevent the seats from transferring from the energized position to the deenergized position. Previously, failure of the lower seal assembly O-ring with subsequent high leakage had been considered the critical failure mode.

In view of the new failure mode observed, the critical component was identified as the shaft seal O-ring. With the knowledge that 300°F (149°C) was considered a limiting temperature for the O-ring material, and that the failure of the lower O-ring seal had occurred at 278°F (137°C) during the thermal aging simulation, the O-ring was examined for evidence of stickiness on its surface. Since no stickiness was observed on the lower O-ring seal, it was concluded that by keeping the temperature of the shaft seal O-ring at or below 278°F (137°C), the tendency for the EPDM O-ring to become sticky would be reduced.

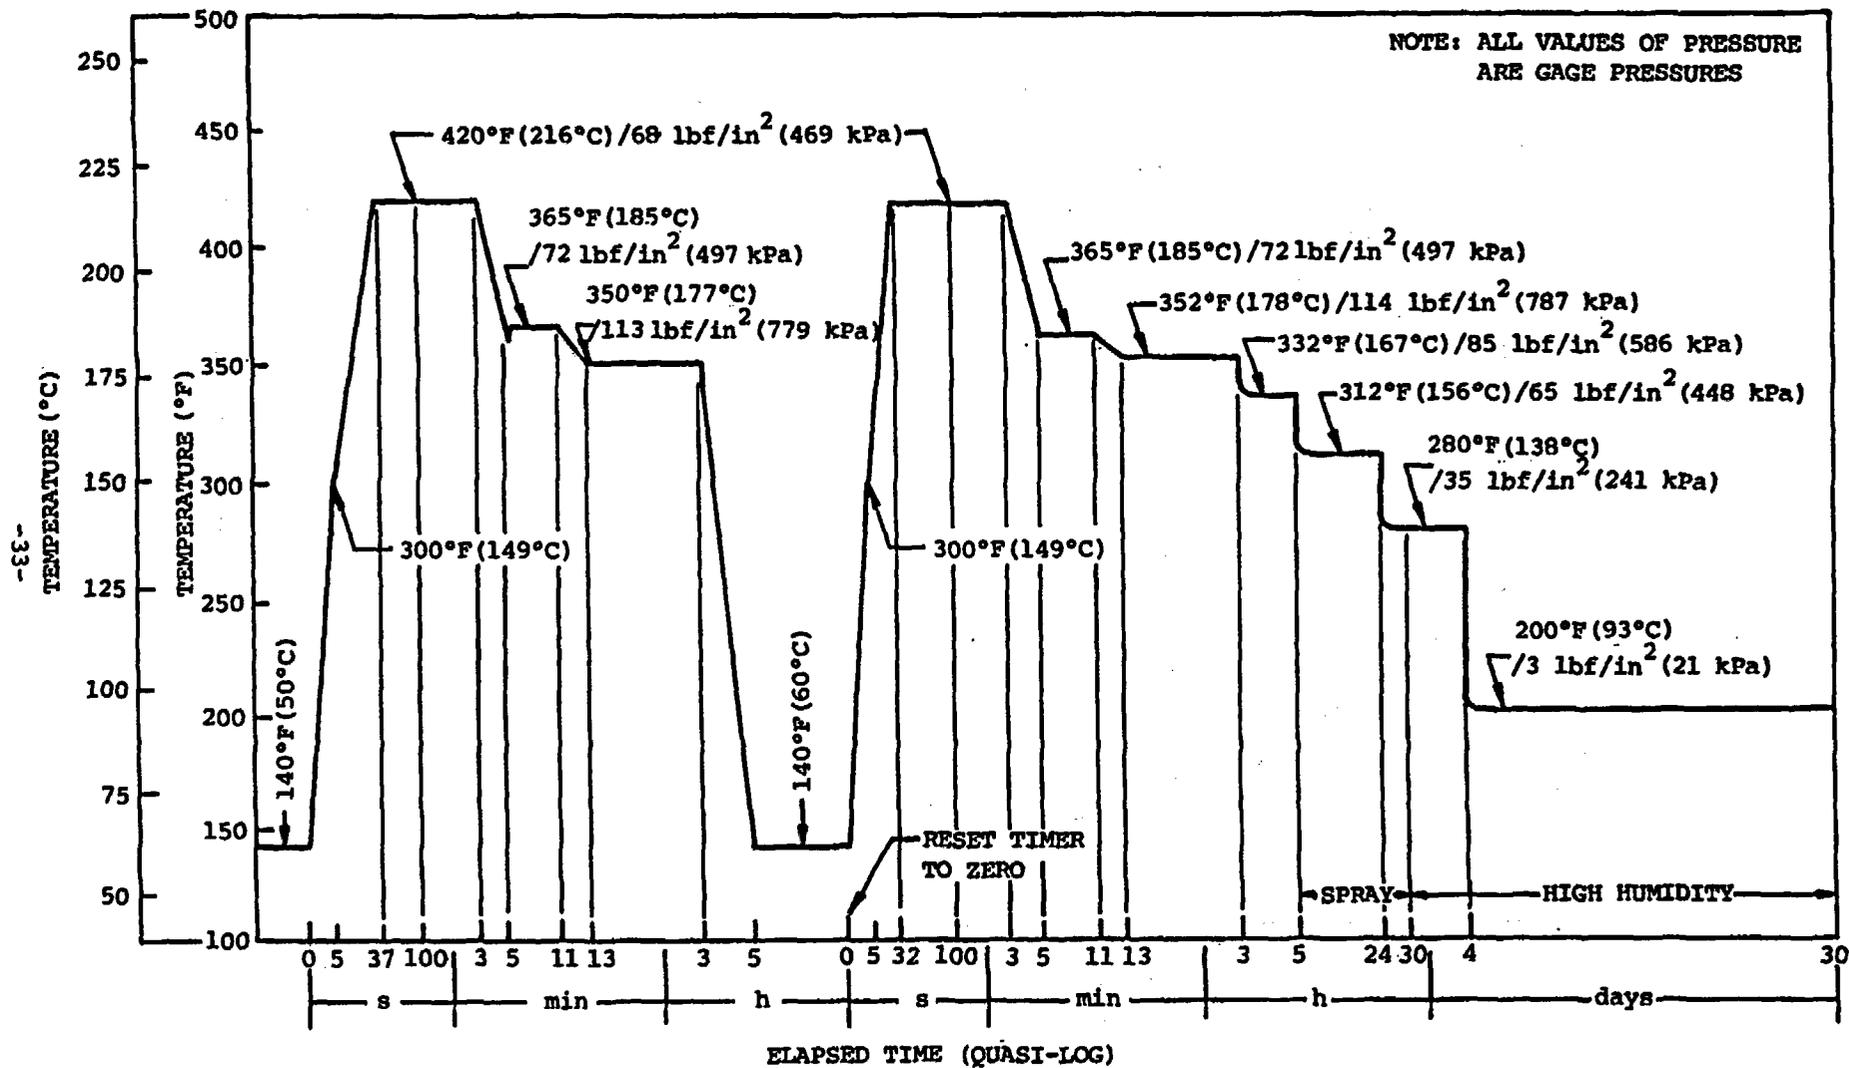
Figure 8. Actual Temperature and Pressure Profile of Simulated MSLB/LOCA Exposure

1. During the drop in temperature/pressure from 420°F (216°C)/68 lbf/in² (469 kPa) to 365°F (185°C)/68 lbf/in² (469 kPa) of the first transient, the temperature inadvertently decreased to a minimum of 335°F, as shown in Figure 8. The total period of this deviation was less than 2 minutes and is not considered to have a significant effect on the program. The temperature deviation is shown on an expanded time scale in Figure 9.

The actual temperature/pressures recorded throughout the first and second transients to the peak temperatures are shown in an expanded time scale in Figures 10 and 11, respectively. Aside from the minor deviation mentioned in Item 1 above, the actual temperature profile (Figure 8) was practically identical to the specified profile (Figure 6, Appendix A).

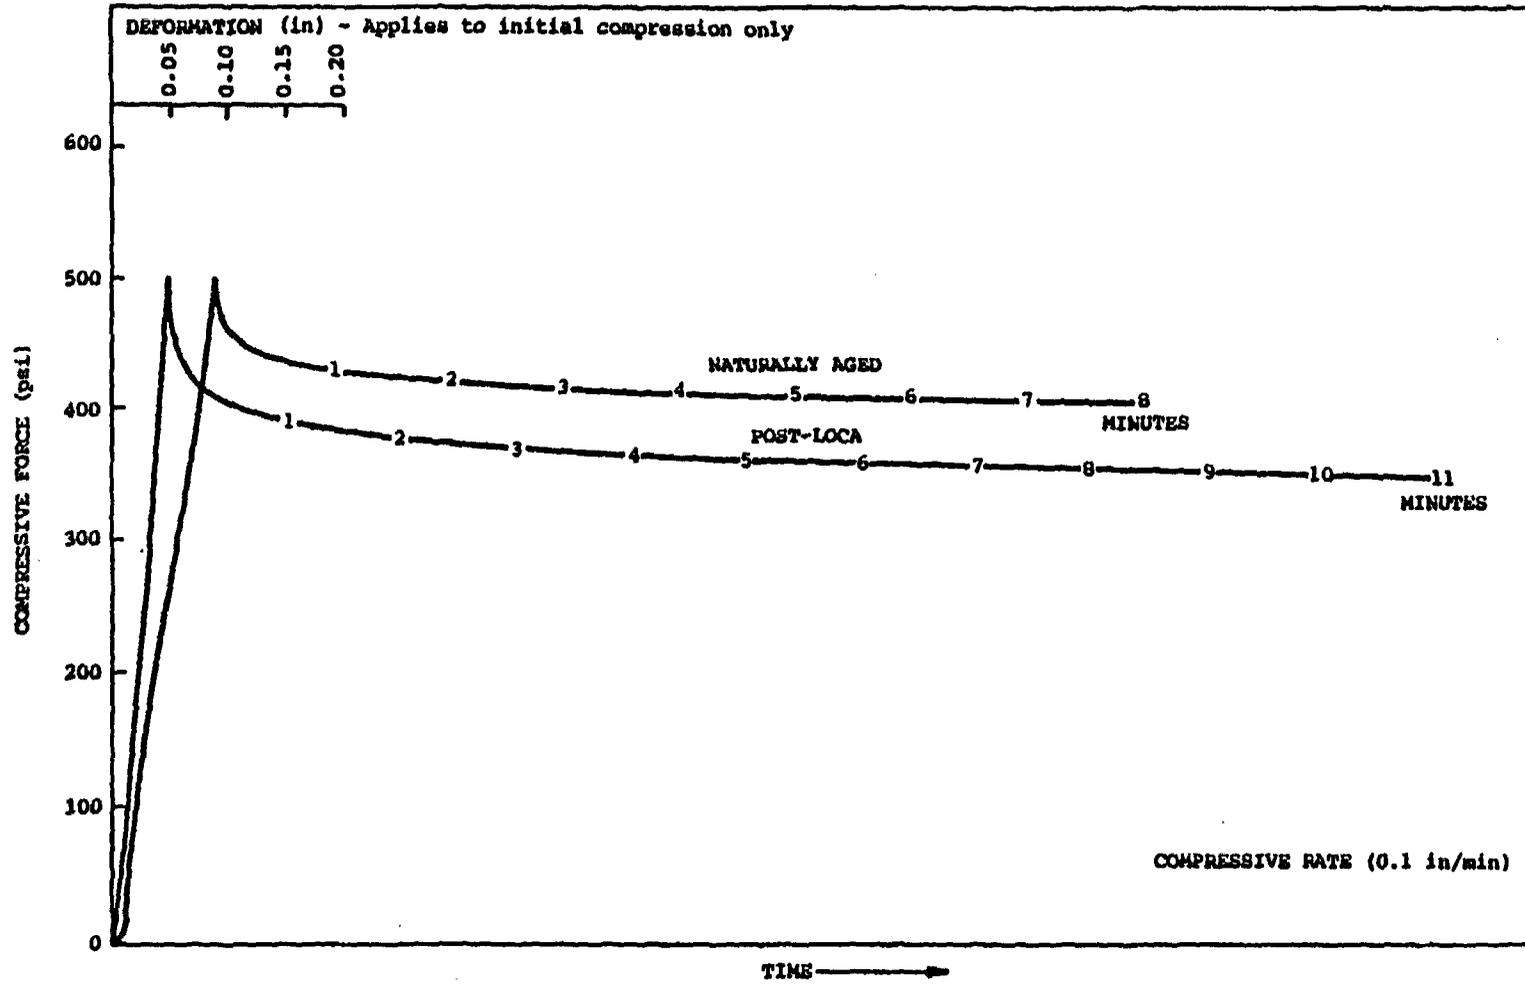
Figure 9. Compression and Relaxation Test Curves for ASCO Core Disc Seats

the upper left corner of the graph shows the total compression of the core disc seat at 500 psi. For the naturally aged core disc, the deformation was 0.10 in, and for the post-LOCA specimen, the deformation was 0.05 in. The difference in the deformation at equal compressive loadings shows a substantial hardening of the post-LOCA core disc resulting from the environmental stresses. During this test program, materials that were exposed to equivalent environmental stresses (e.g., natural vs artificial aging) will be tested and compared.
