NUREG/CR-5762
WYLE 60101

Comprehensive Aging Assessment of Circuit Breakers and Relays

Prepared by
J. F. Gleason

Wyle Laboratories

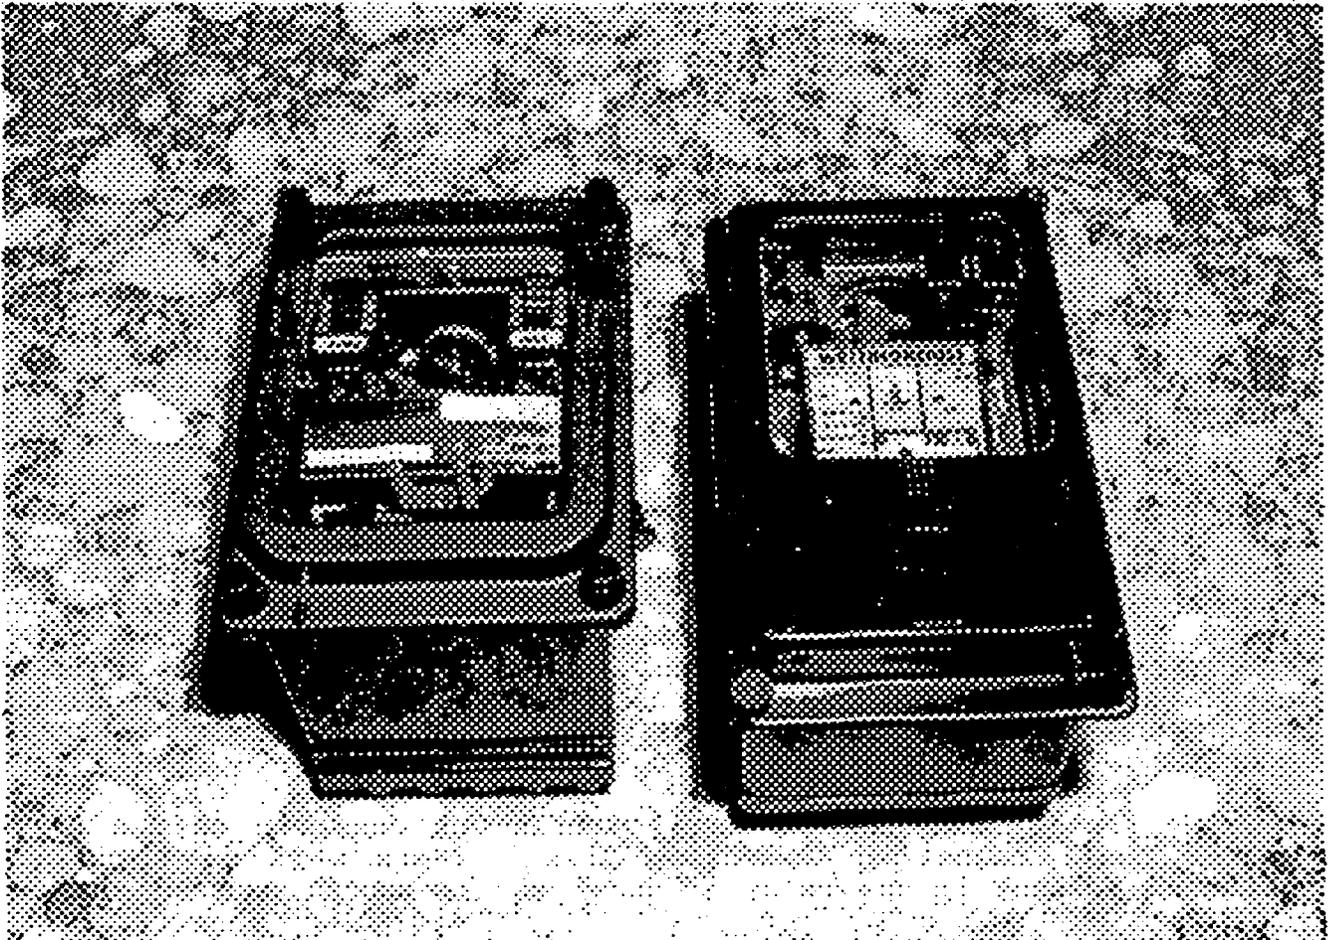
Figure 3-1. Protective Relays
General Electric 12TAC53B101A and
Westinghouse Model CC

A GE Type IAC53 and a Westinghouse Model CO protective relay are shown in Figure 3-1.

All three GE specimens had calibration tags which indicated that they were last calibrated on November 21, 1985. Calibration was due November, 1986. The 24 year relay was extremely clean and appeared to have seen little service.

The moving contacts of the seal-in and instantaneous unit were open and operated freely on all specimens. The instantaneous and seal-in contact surfaces of the 10 year and 24 year specimens were slightly worn. The metal surfaces on the connecting plug of all three specimens exhibited brown discoloration. The connecting plug of the 24 year specimen had three connections that were highly discolored with areas of brown and blue. The auxiliary brushes inside the case of all three specimens were discolored similarly to the connecting plug metal surfaces. The metal brushes on the connecting block underneath each of the relays were highly oxidized.

The induction disk, instantaneous and seal-in contacts, which were silver or silver alloy, of the 10 year specimen showed no signs of unusual wear or contact pitting. However, the contacts on the 13 year and 24 year specimens were lightly discolored and worn. The insulation of tap lead wires 4 & 5 on the 10 year specimen were discolored and appeared overheated. The 13 year and 24 year specimens showed no evidence of tap or coil lead wire insulation damage. The coil and drag magnets of each specimen were checked for debris and metal filings. The coil magnet of the 10 year and 13 year specimens were lightly covered with metal filings. The coil magnet of the 24 year specimen was clean. The drag magnet on all three specimens had a slight amount of metal filings attached to its surface. Each specimen was checked for evidence of loose connections or parts and none were found.

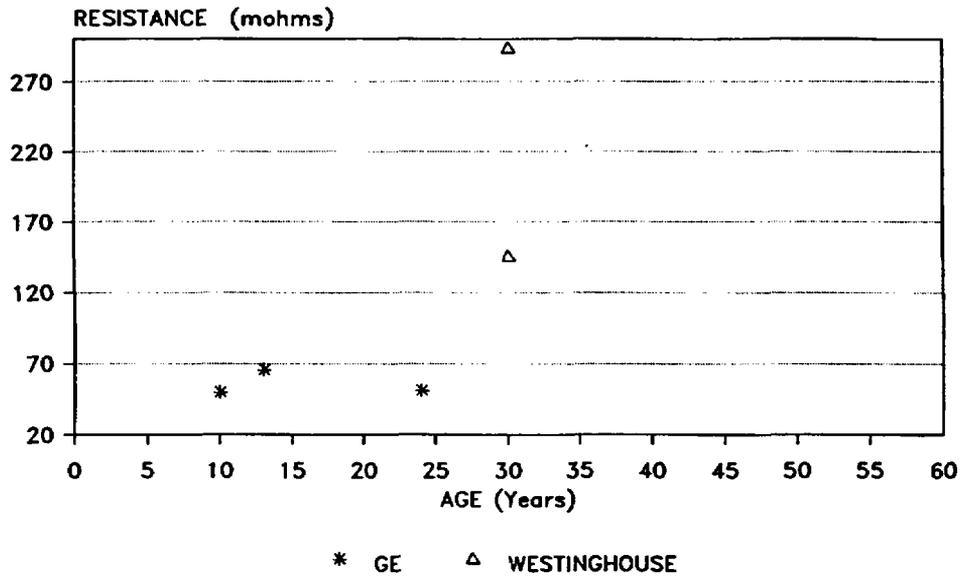
Figure 3-2. Coil Resistance Comparison Protective Relays

Coil resistance is plotted against specimen age in Figure 3-2. The 10, 13 and 24 year specimens had resistances of 49.8, 65.5 and 50.9 milliohms respectively. The 13 year specimen had the highest resistance value and may have been a contributing factor to the significant percent change in induction unit pick-up, noted later. The Westinghouse specimens even though the same age, had

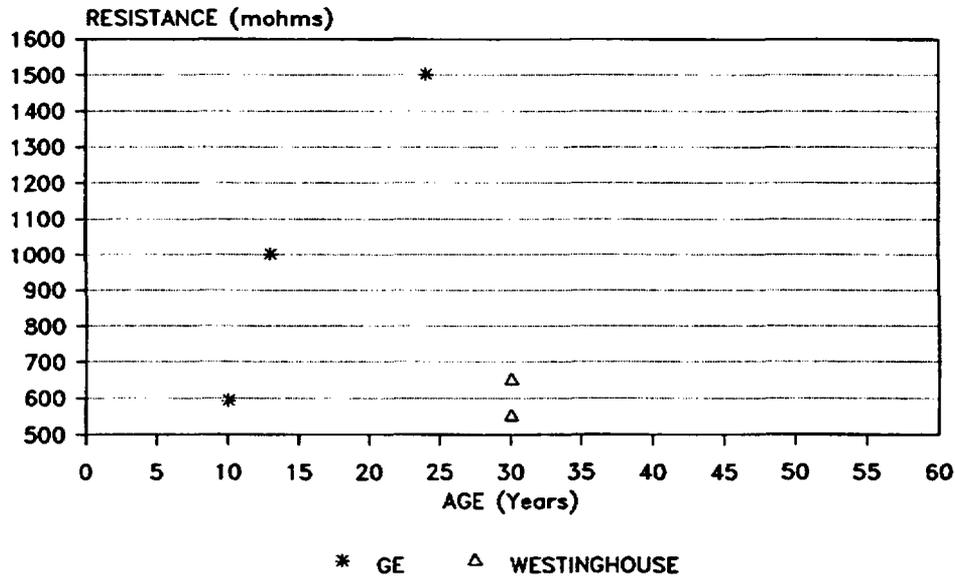
Figure 3-3. Contact Resistance Comparison Protective Relays

The contact resistance exhibited a definite trend with age. Figure 3-3 shows this increase in resistance with age and the relative difference in magnitude when compared to the Westinghouse specimens. The high resistance values obtained with the 13 and 24 year specimens may have been due to the high oxidation observed on the stationary contacts and on the metal surfaces of the contact blocks. The higher contact resistance values obtained with the GE specimens may also have contributed to the slight variation shown in the time/current characteristic, discussed later. The Westinghouse specimens had resistance values of 551 and 649 milliohms respectively. The resistance difference, 98 milliohms, between the two specimens may have been a contributing factor to the large variance in timing ranges obtained in time/current characteristic.

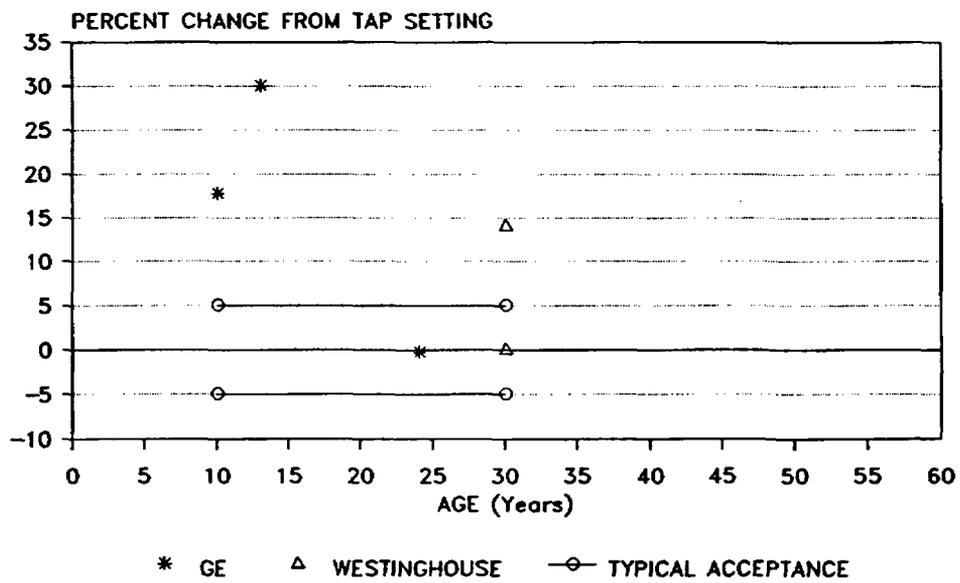
Figure 3-5. Induction Unit Pickup Comparison Protective Relays

Since the relays were from different manufactures and were not of the same model type, the percent change between the tap setting of the unit and the induction unit pickup current was calculated and compared along with the typical $\pm 5\%$ acceptance criteria, Figure 3-5. Three of the five specimens were outside of the typical acceptance criteria. The 24 year GE and one of the 30 year Westinghouse specimens had a percent change of zero. The reason for the 24 year GE being in specification, when last calibrated at the same time as the other GE specimens, as noted on the calibration tag, may be due to its cleanliness and suggestion that it had seen little use.

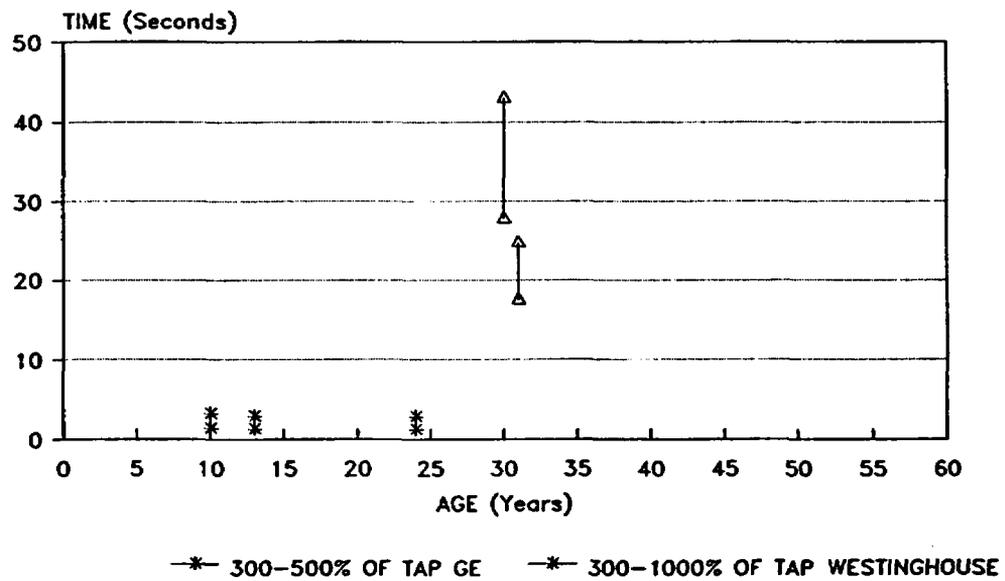
Figure 3-6. Induction Unit Timing Comparison Protective Relays

The time-current characteristics were measured at 300%, 400% and 500% of tap value current for the GE specimens and 300%, 500% and 1000% of tap value current for the Westinghouse specimens. Figure 3-6 shows the time range for contact closure for the range of values measured. The timing ranges for the GE 10 year, 13 year and 24 year were 3.2-1.4, 2.9-1.3 and 2.8-1.2 seconds respectively. The times obtained for the GE specimens were compared to the

manufactures time/current characteristic curves and were all found to be within the specifications. Although the change was very slight, a 0.1 to 0.2 second decrease in time occurred with the increasing age of each device. This appears to be correlated with the increase in contact resistance with age, observed in the contact resistance method.

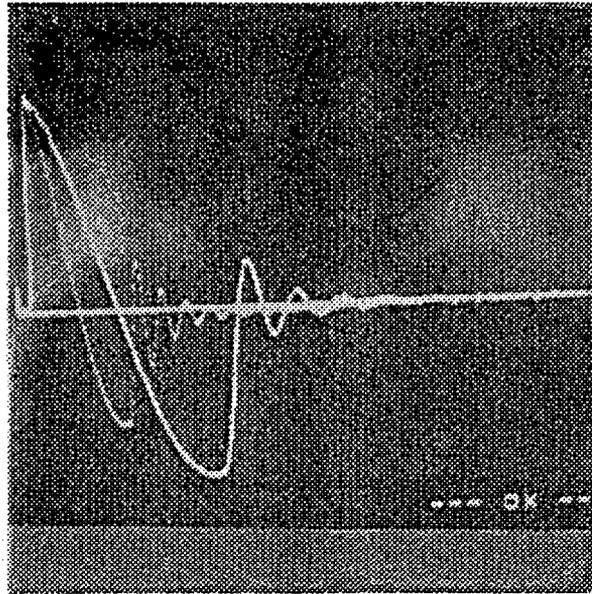
Figure 3-13. Current Surge Comparison
on GE 13-year-old Protective Relay

The GE 10 and 13 year specimens had similar waveforms measured with the test set as shown in Figure 3-12, with the combined signature pattern leading the master and small ringing at the tops of the waveform. The ringing of the 13 year specimen, Figure 3-13, was observed to be slightly larger than the 10 year specimen. The 24 year specimen differed significantly from the other two, Figure 3-14, with the signature pattern ringing very close to that of the current transformer (large ringing on the tops of the waveforms).

The variations in waveforms between the GE specimens was most likely caused by changes in the magnetic circuit of each specimen which may be due to aging of the coil insulation, but could be due to differences in the manufacturing process. The current surge comparison on protective relays may indicate a trend with age.

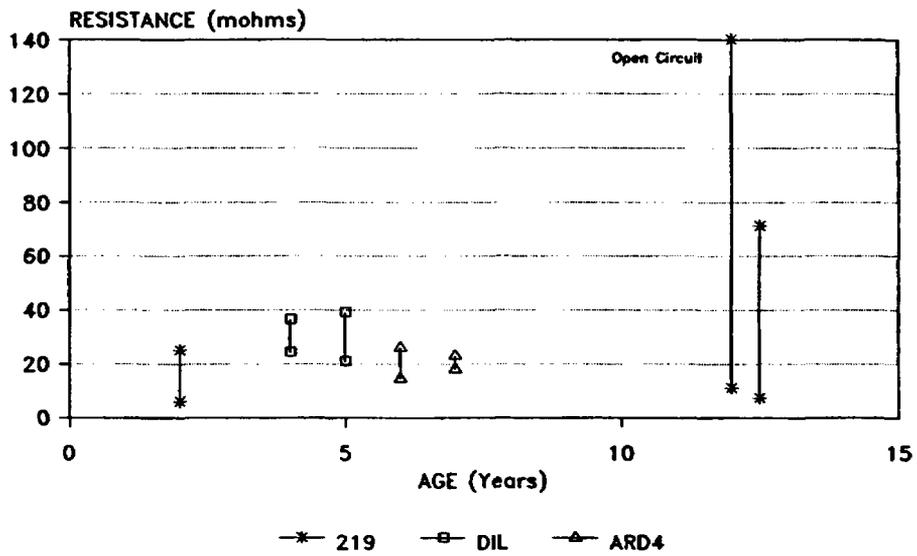
Figure 3-18. Initial Contact Resistance Comparison Control Relays

The contact resistance was measured in the as received condition for each specimen and after testing the other ISM methods. The lowest to highest resistances measured for the contact sets of each relay were summarized in Figure 3-18 for the as received initial condition and in Figure 3-19 for the post test condition. The contact resistance of the SD219 relays increased with specimen age. The initial contact resistance of the two year old specimen ranged from a low on one contact set of 5.9 milliohms to a high on another contact set of 25.2 milliohms. Contact resistance for one 12 year old specimen ranged from a low on one contact set of 11 milliohms to an open circuit on another contact set. The open circuit was reduced to 15 milliohms after relay operation. The contact resistance of the other 12 year specimen ranged from a low on one contact set of 7.3 milliohms to a high of 71.3 milliohms.

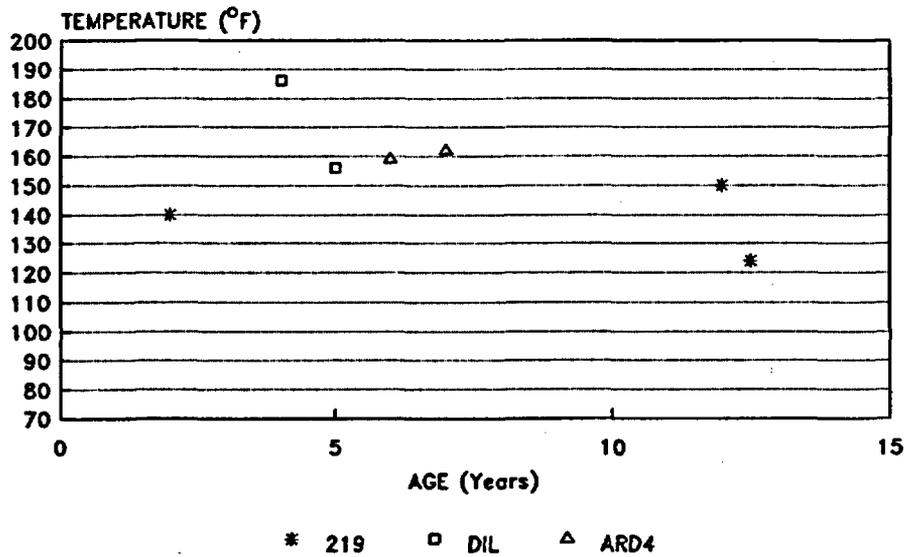
Figure 3-25. Infrared Pyrometry Comparison Control Relays

The maximum temperature measured is shown in Figure 3-25. The one 12 year SD219 relay was cooler than the 2 and other 12 year specimens and correlates with the holding current which was less for this specimen. One of the Klockner-Moeller DIL relays was considerably hotter than the other by 30 °F. This style of control relay has no cover and connections and portions of the coil were visible in the three views (normal, right 45° and left 45°). On one specimen, the maximum temperature was 156°F on the left side of the coil. The other specimen had a reading of 148°F in this same area. The hottest spot of 186°F was in the area of a connection on the right side of the relay.

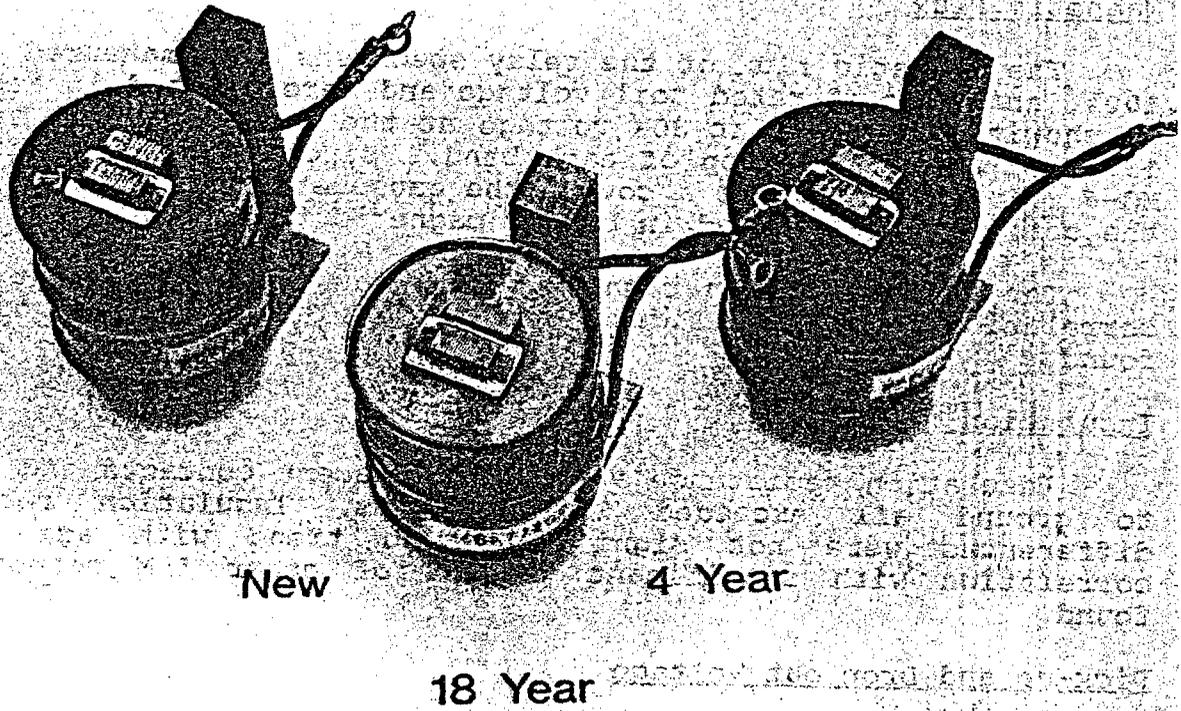
Figure 3-31. GE HFA Auxiliary Relay Coils

been recommended by IE Bulletin 76-02. All bobbins were in good condition and had no noticeable damaged or broken parts, Figure 3-31.

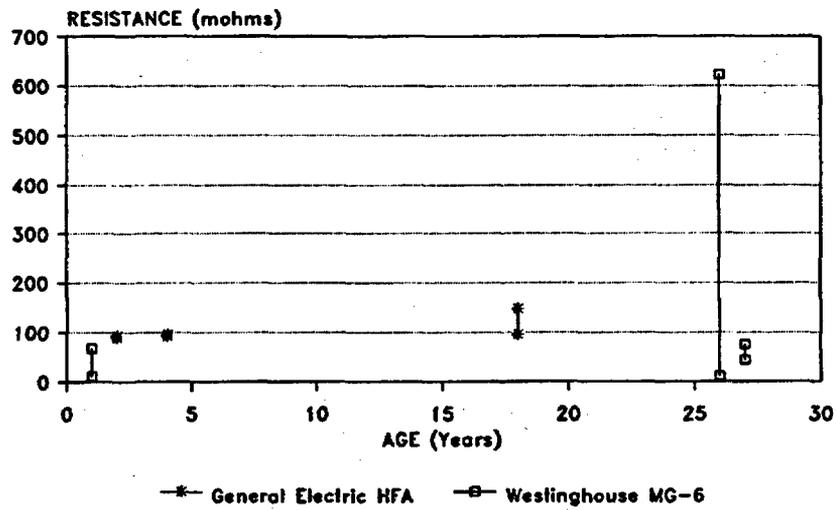
Figure 3-33. Post Test Contact Resistance Comparison Auxiliary Relays

The MG-6 relays were within the manufacturers acceptance criteria, did not change after energization and did not exhibit a trend with age.

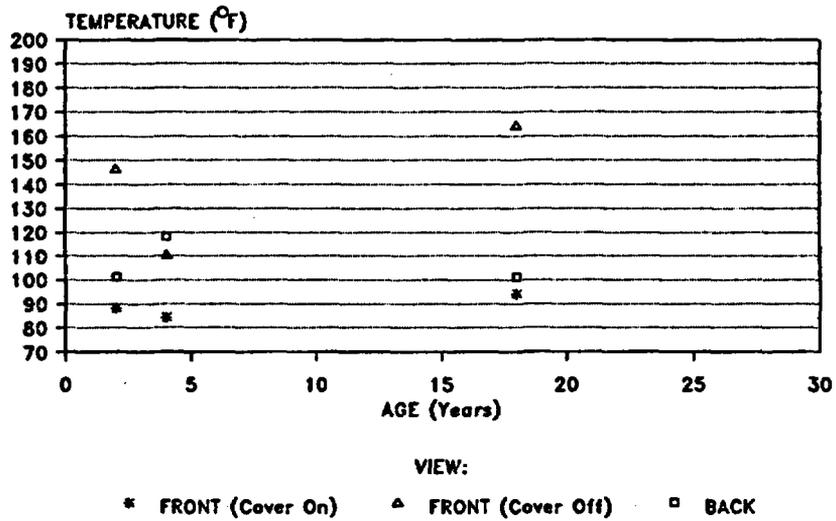
Figure 3-36. Infrared Pyrometry
Comparison Auxiliary Relay GE HFA

The maximum temperatures measured for the HFA and MG-6 relays are shown, respectively, in Figures 3-36 and 3-37 for the front of the relay with the cover on, front with cover off and the back of the relay for those which were door mounted.

Infrared pyrometry showed some significant differences among the devices. The auxiliary relays exhibited a trend towards increased temperature with age which was observable when the cover was removed. For the 4 year HFA, the hottest spot, which was obtained by the scanner and on-contact temperature measurement from around the coil, was missed with the pyrometer. It was apparently overlooked since the pyrometer requires focusing a 0.25 inch spot on the specimen. Figure 3-36 shows the maximum temperature to be 110°F, which should have been approximately 150°F. Also, for the 18 year HFA relay, pyrometry and on-contact methods missed the hottest spot on the back of the relay, which was shown to be 100°F hotter with the scanner.

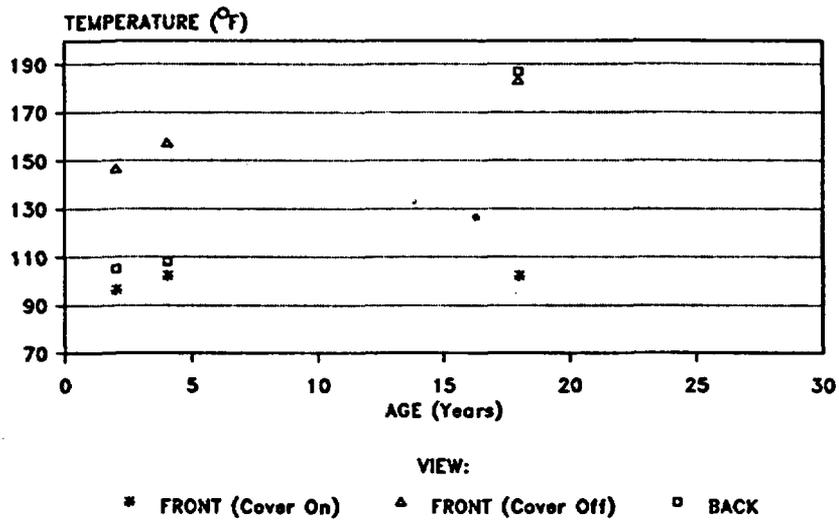
Figure 3-38. Infrared Scanning Comparison Auxiliary Relay GE HFA

The maximum temperatures measured are shown in Figures 3-38 and 3-39 for the HFA and MG-6 relays, respectively. Infrared scanning showed the same trends as infrared pyrometry. The maximum temperature was measured to be slightly hotter with scanning than pyrometry in five out of six relays. The clear bobbin on the 18 year HFA coil made the magnetic wire visible and this coil exhibited a higher temperature of approximately 30°F than the other coils. The scanner showed that the back of the 18 year HFA relay, opposite the coil, was 100°F hotter than obtained with the pyrometer and on-contact methods.

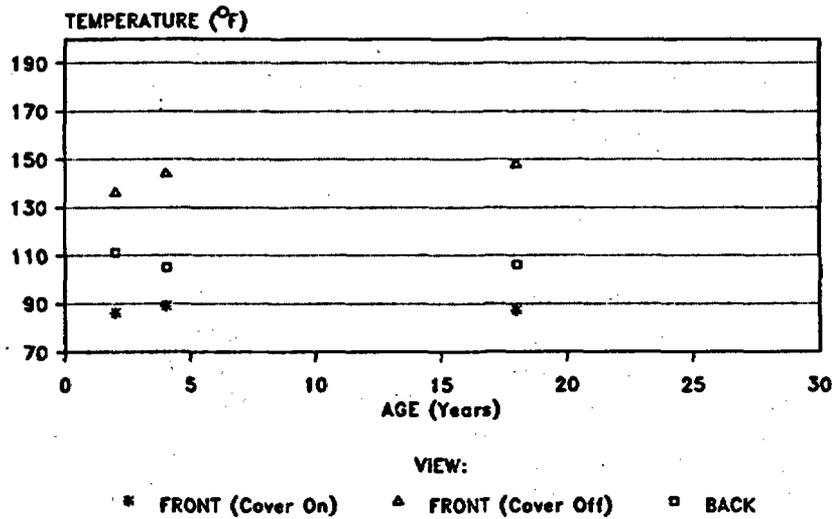
Figure 3-40. On-Contact Temperature Comparison Auxiliary Relay GE HFA

The maximum temperatures measured are shown in Figures 3-40 and 3-41 for the HFA and MG-6 relays, respectively. For the MG-6 relays, on-contact measured significantly hotter temperatures, with the cover off, since the actual hottest spot was accessible with the on-contact probe for this model of relay. For the HFA relays, on-contact measured the hot spots at approximately 10°F less than the scanner and approximately the same as the pyrometer, with two exceptions. For the 18 year HFA, the on-contact measurement on the coil was 35°F less than the scanner. The on-contact measurements were less because the hottest spots, the coil, was inaccessible by the probe. Also, for the 18 year HFA relay, pyrometry and on-contact missed the hottest spot on the back of the relay, which was shown to be 100°F hotter with the scanner. The on-contact method

pinpoints a spot, therefore the location of the hottest spot was overlooked because it was on the case in a location not near the contacts, which were suspected to contain the hottest spot.

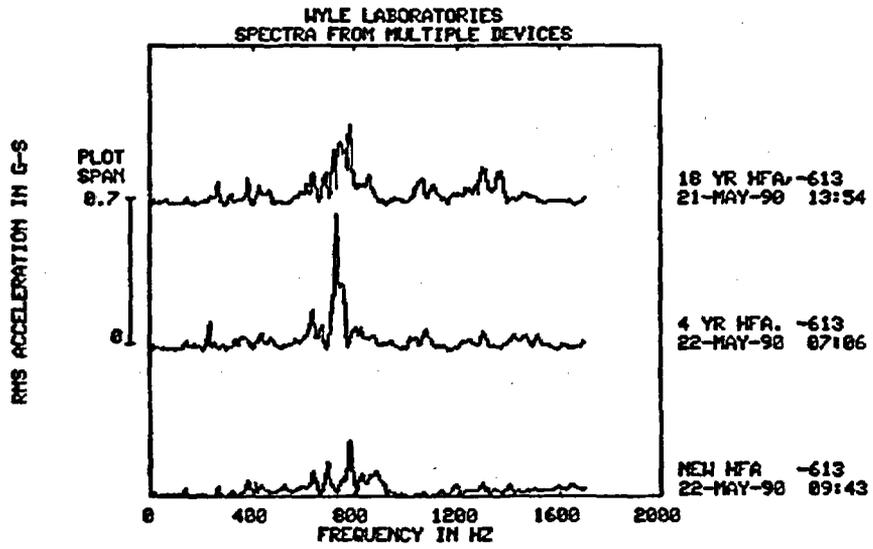
Figure 3-42. Vibration Signatures of GE HFA Auxiliary Relays

Vibration signatures were obtained during the pick-up tests. The vibration signatures were repeatable and differences noted among the different aged specimens for both the HFA and MG-6 auxiliary relays. The vibration signatures for the HFA relays are shown in Figure 3-42. Differences in the vibration signatures were mainly in the range from 636 Hz to 800 Hz although several additional peaks were noted on the 18 year HFA.

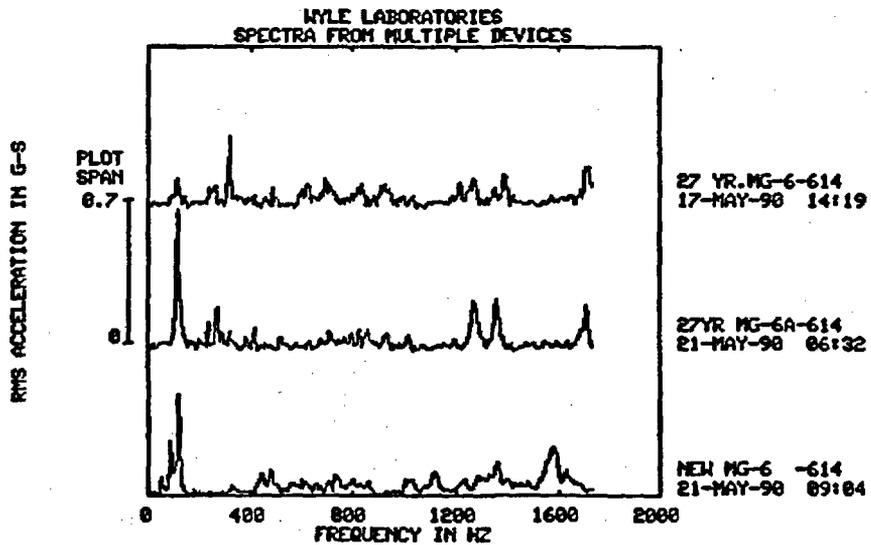
Figure 3-43. Vibration Signatures of Westinghouse MG-6 Auxiliary Relays

For the MG-6 relays, Figure 3-43 shows the differences among the three relay specimens. Changes were noted in the peaks at approximately 110 Hz, the addition of peaks at 1272, 1358 and 1800 Hz and loss of peak at approximately 1600 Hz in the 27 year specimens.

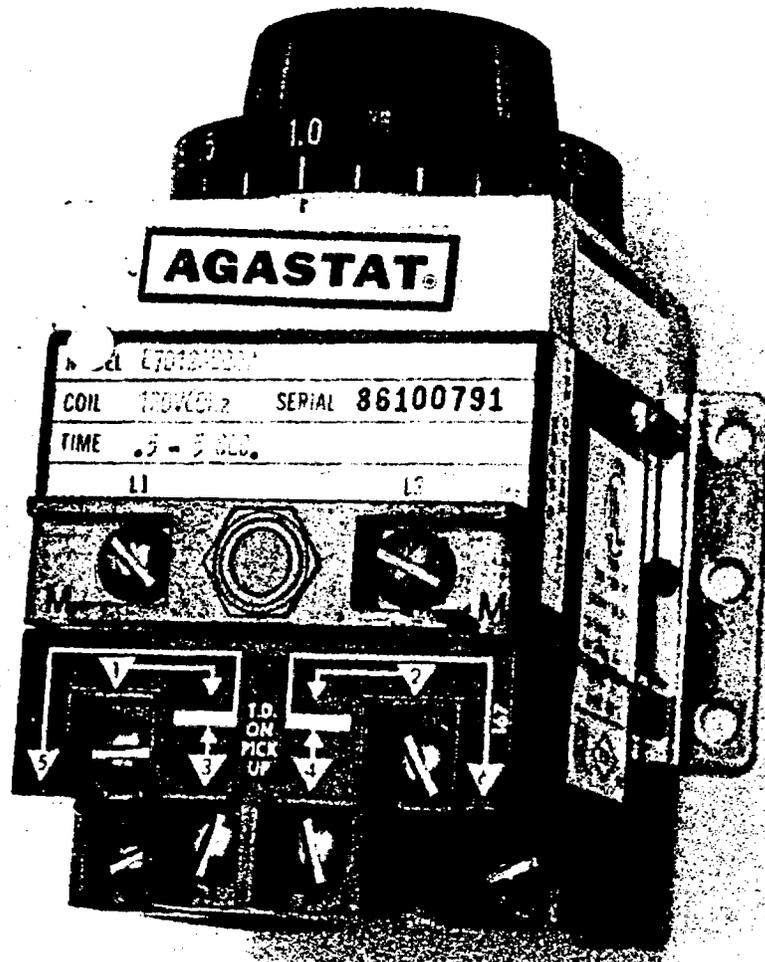
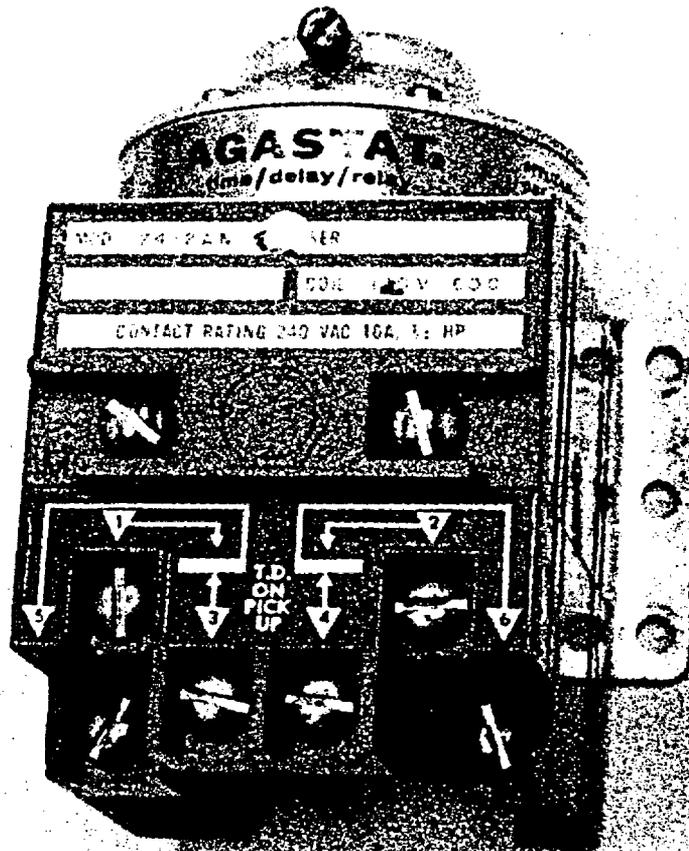
The visual inspections on the timing relays showed no obvious problems existed and all appeared to be in good condition. Figures 3-44 and 3-45 show the 4 year E7012AB and 23 year 2412AN, respectively.

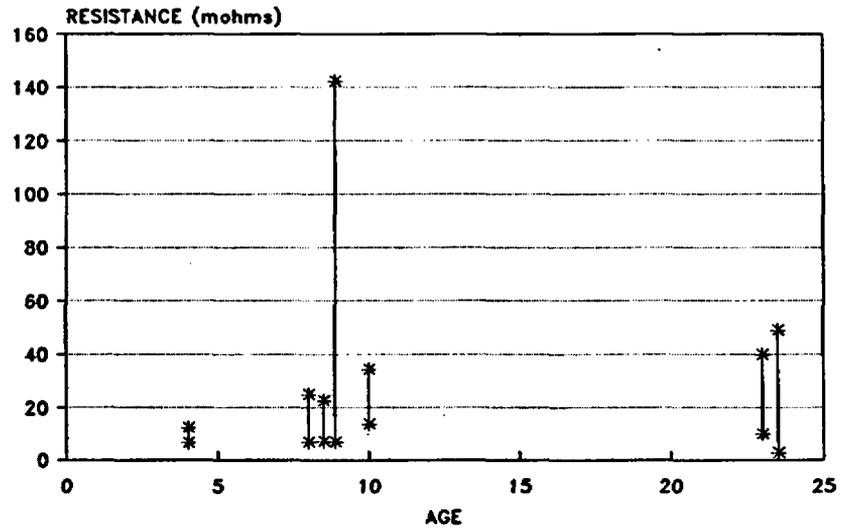
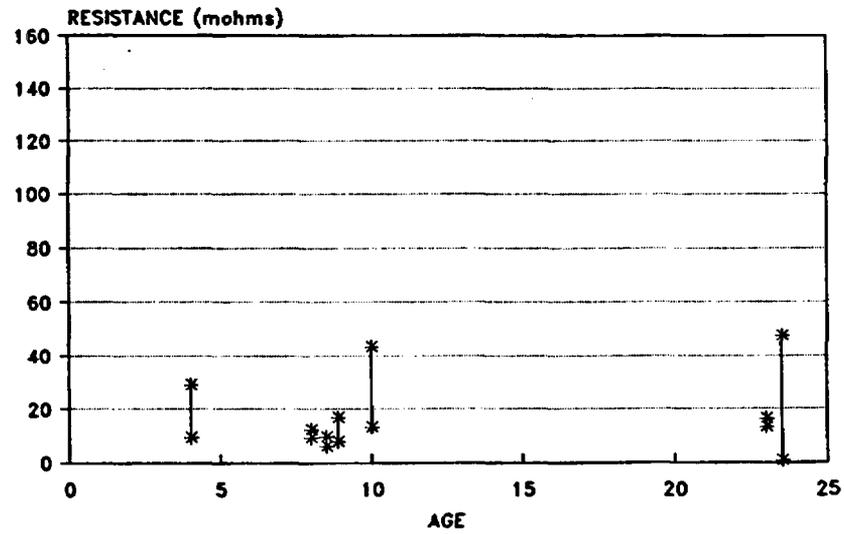
The contact resistance was measured in the as received condition for each specimen and after testing the other ISM methods. The lowest to highest resistances measured for the contact sets of each relay were summarized in Figure 3-46 for the as received initial condition and in Figure 3-47 for the post test condition. The contact resistance did not change significantly with age.

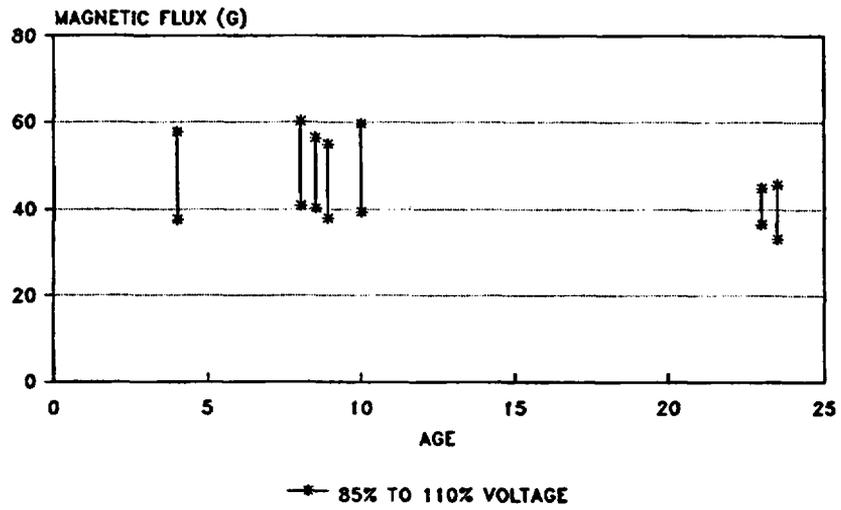
Figure 3-48. Magnetic Field Comparison Timing Relays

The relay specimens were measured at 85%, 100%, and 110% of rated coil voltage and were plotted in Figure 3-48 showing the value at 80% voltage at the bottom and the value at 110% voltage at the top of each band. The differences in magnetic flux were not considered to be significant and no correlation with significant results of other ISM methods were found.

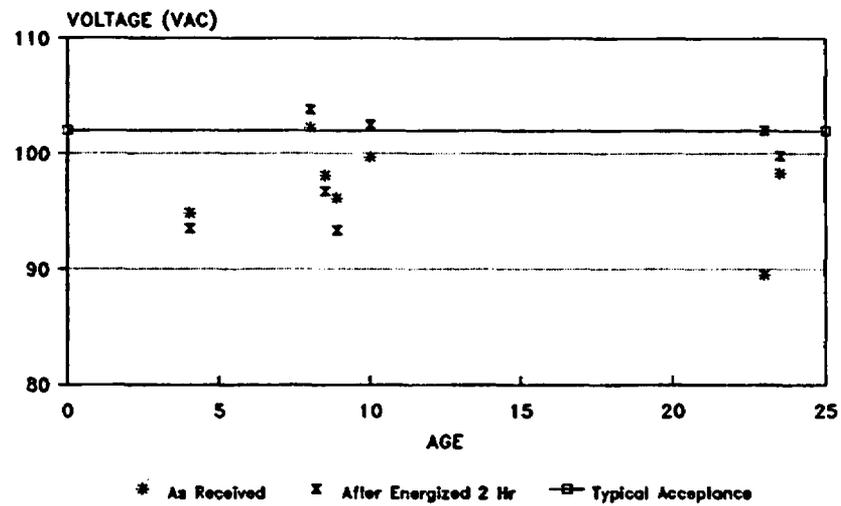
Figure 3-49. Pick-up Voltage Comparison Timing Relays

The pick-up voltages for the timing relays were taken three times when the relay was at ambient conditions in the as received condition and three more times after it had been energized for 2 hours, Figure 3-49. The pick-up voltage on the 8 year 7012AC timing relay was out of the typical acceptance criteria of 102 volts in the as received condition. After energization for 2 hours, the pick-up voltage increased for four out of the seven timing relays. The pick-up voltages on the 8 year 7012AC, 10 year 7012AC and 23 year 2412AN relays exceeded the typical acceptance criteria.

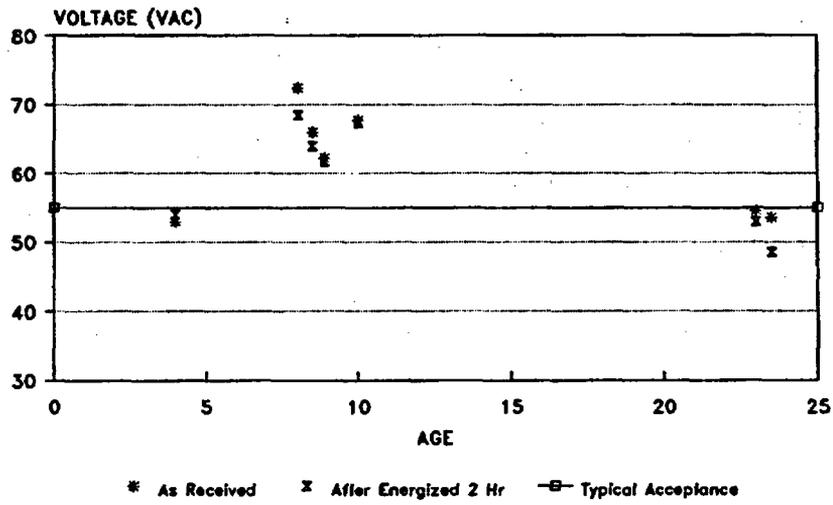
Figure 3-50. Drop Out Voltage Comparison Timing Relays

The drop out voltages for the 4 year E7012AB, 23 year 2412AN and 2412AD exceeded the typical acceptance criteria of 50% rating, Figure 3-50.

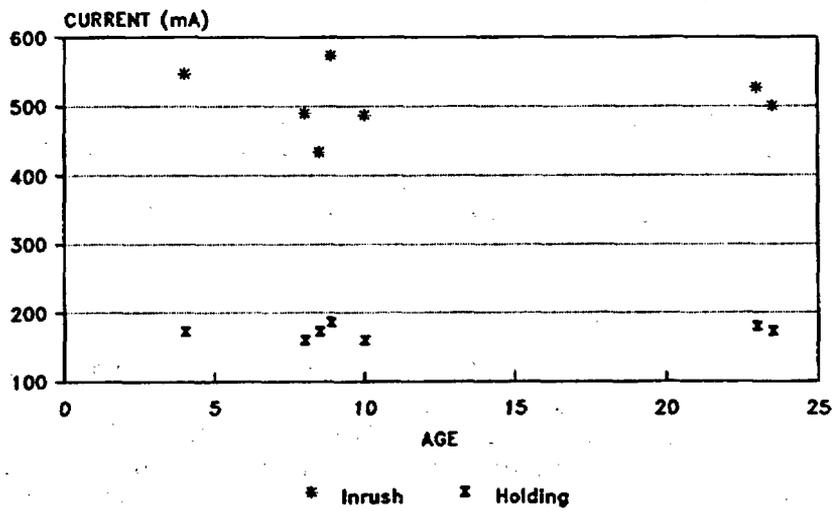
Figure 3-51. Inrush and Holding Current Comparison Timing Relays

Differences in inrush and holding current for the timing relays were not significant, Figure 3-51. No trend with age and no correlation with significant results of other ISM methods were found.

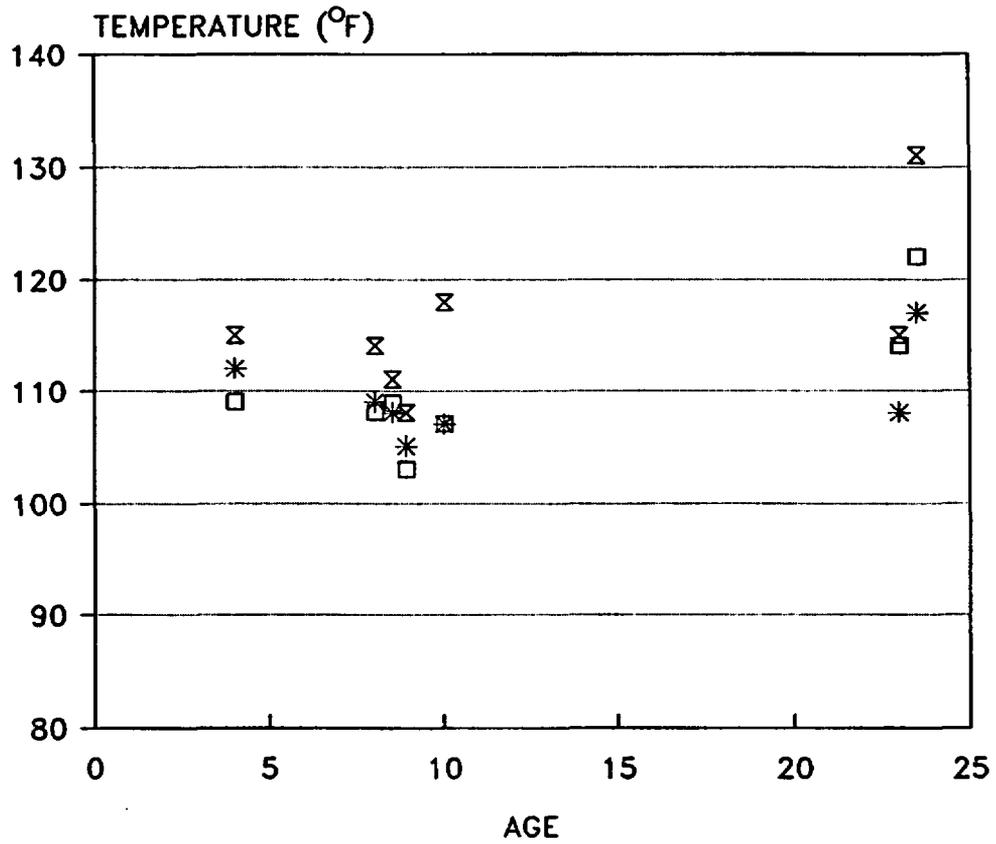
Figure 3-53. Temperature Comparison Timing Relays

The scanner showed the maximum temperatures, Figure 3-53, to be hotter than the pyrometer and on-contact methods for all seven relays. A trend towards increased temperature with age was noted with the scanner. The 23 year 2412AD relay was the hottest relay.

The maximum temperatures obtained are shown in Figure 3-53. The on-contact method pinpoints a spot, therefore the area of the hottest spot was overlooked on the 8 year 7012AC, 10 year 7012AC and 23 year 2412AD, because it was on the case in an area not near the contacts, which were suspected to contain the hottest spot. Thus the on-contact method did not show the trend towards increased temperatures with age that was noted with the scanner.

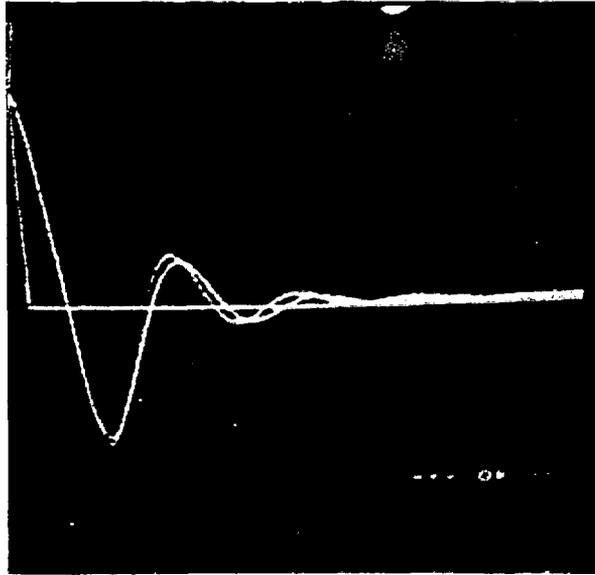
**Figure 3-54. Current Surge Comparison
on 23 Year Old 2412AD Timing Relay**

Ringling was noticeable on the two 23 year timing relays, which may be due to aging of the coil insulation, but could be due to differences in the manufacturing process. The waveform comparison is shown in Figure 3-54 for the 23 year 2412AD, which had the most noticeable ringing. The current surge comparison on timing relays may indicate a trend with age.

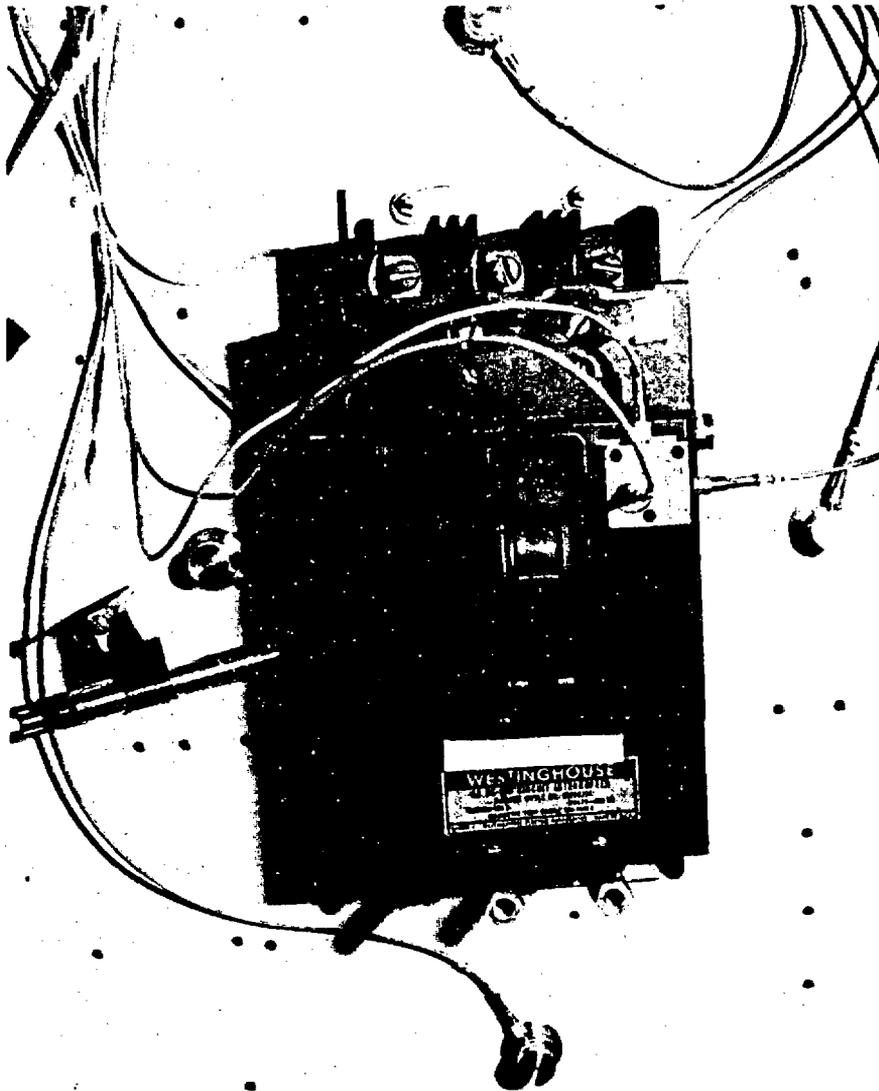
**Figure 3-55. Westinghouse AB DE-ION Style
1222077A Molded Case Circuit Breaker
Showing Location of Vibration Accelerometers
and Acoustic Microphone**

The Westinghouse AB DE-ION circuit breakers were 100 amp, 600 VAC adjustable magnetic trip only. The magnetic adjustment range was 500 amps to 1500 amps. The specimens were extremely dusty but showed no signs of physical damage or missing parts. There were no signs of electrical damage such as melting insulation or discolored terminal lugs and the closing and opening actions were crisp. The sealing compound covering the back screws of the circuit breaker was present and undamaged. Figure 3-55 shows a 30 year Westinghouse AB DE-ION, Style Number 1222077A mounted for testing.

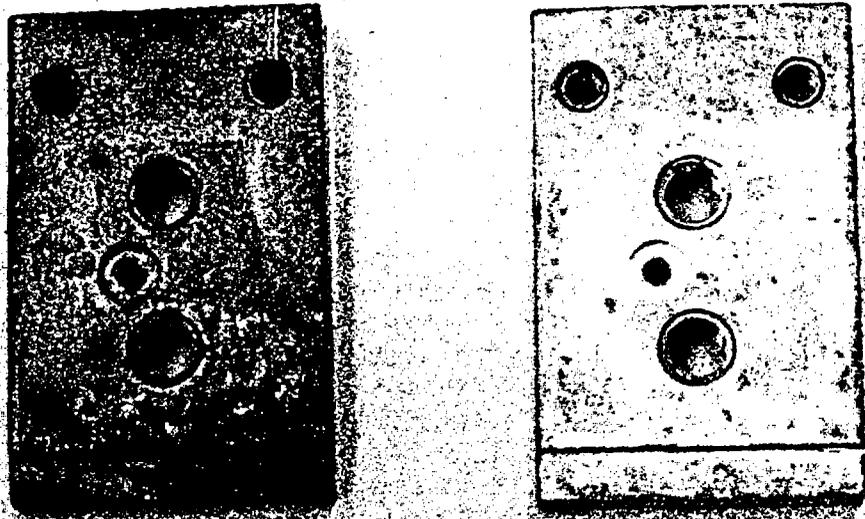
**Figure 3-57. Overheated Pole 1 Compared to Pole 2
of ITE KMB2F800 Molded Case Circuit Breaker
(Pole 1 on Left)**

- o Evidence of discoloration and overheating on pole 1 of the ITE KMB2F800,
- o Overheating on the ITE KMB2F800 had caused distortion and damage to the thermal element of pole 1, which caused it to conduct overcurrent longer than specified before tripping in the 300% overcurrent trip method,

connection on the incoming bus, after the breaker had been replaced. Figure 3-56 shows the KMB2F800 and Figure 3-57 shows the differences in color between the overheated pole 1 and normal pole 2.

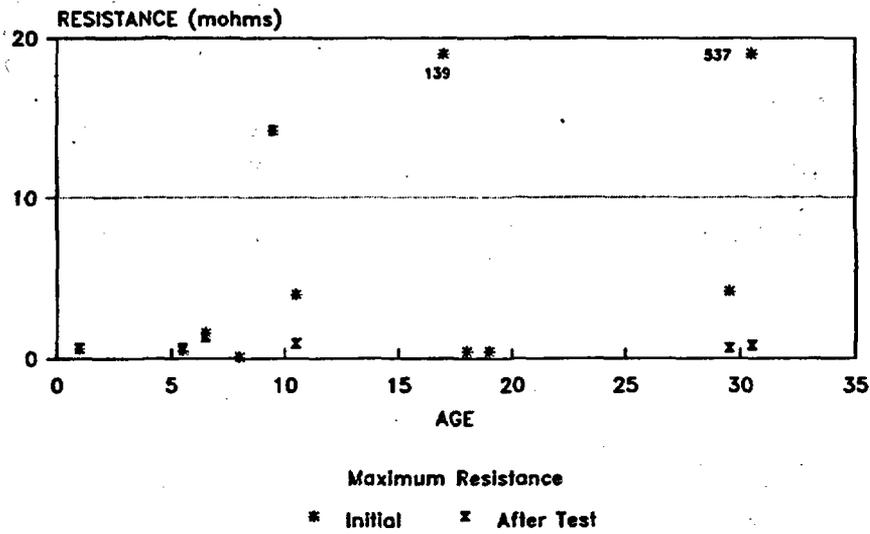
Figure 3-58. Pole Resistance Comparison Molded Case Circuit Breakers

The pole resistance was measured in the as received condition for each specimen and after testing the other ISM methods. The highest resistances measured for the poles of each circuit breaker were summarized in Figure 3-58 for the as received initial condition and for the post test condition. The pole resistance of one of the HFB breakers was 139 mohms and one of the poles of a 30 year breaker was 537 mohms. The pole resistance showed a trend towards increased resistance with age. Lack of operation appears to contribute to this increase in pole resistance since the initial values were higher than the value obtained after the ISM methods had been performed. Pole resistance in general did not correlate with problems noted in the other ISM techniques except for the temperatures noted on the 30 year breaker with high resistance.

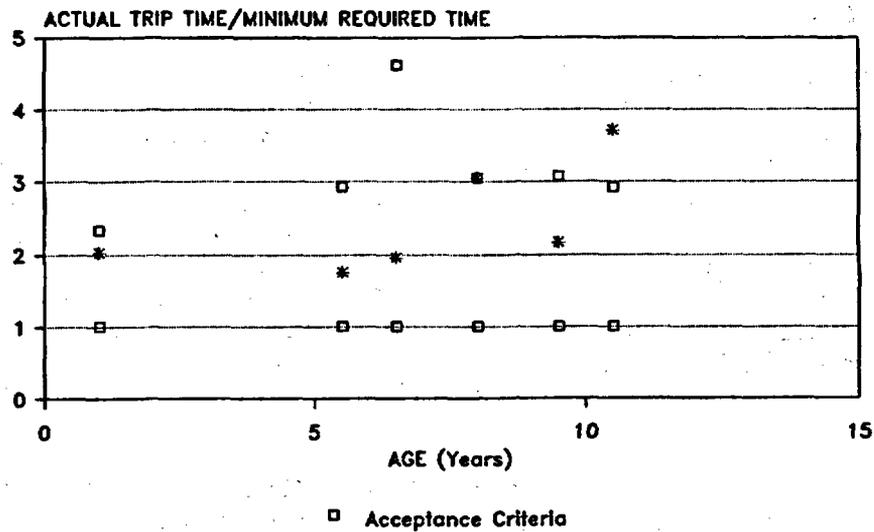
Figure 3-59. 300% Overcurrent Comparison Molded Case Circuit Breakers

The results of the 300% overcurrent method were summarized for the circuit breaker specimens in Figure 3-59 and the performance of each pole of each breaker were compared in Table 3-1.

The 300% overcurrent method detected a trend with age and identified age related failure mechanisms in the thermal trip elements of molded case circuit breakers. In each instance, the failure of the molded case circuit breaker was in a non-conservative manner.

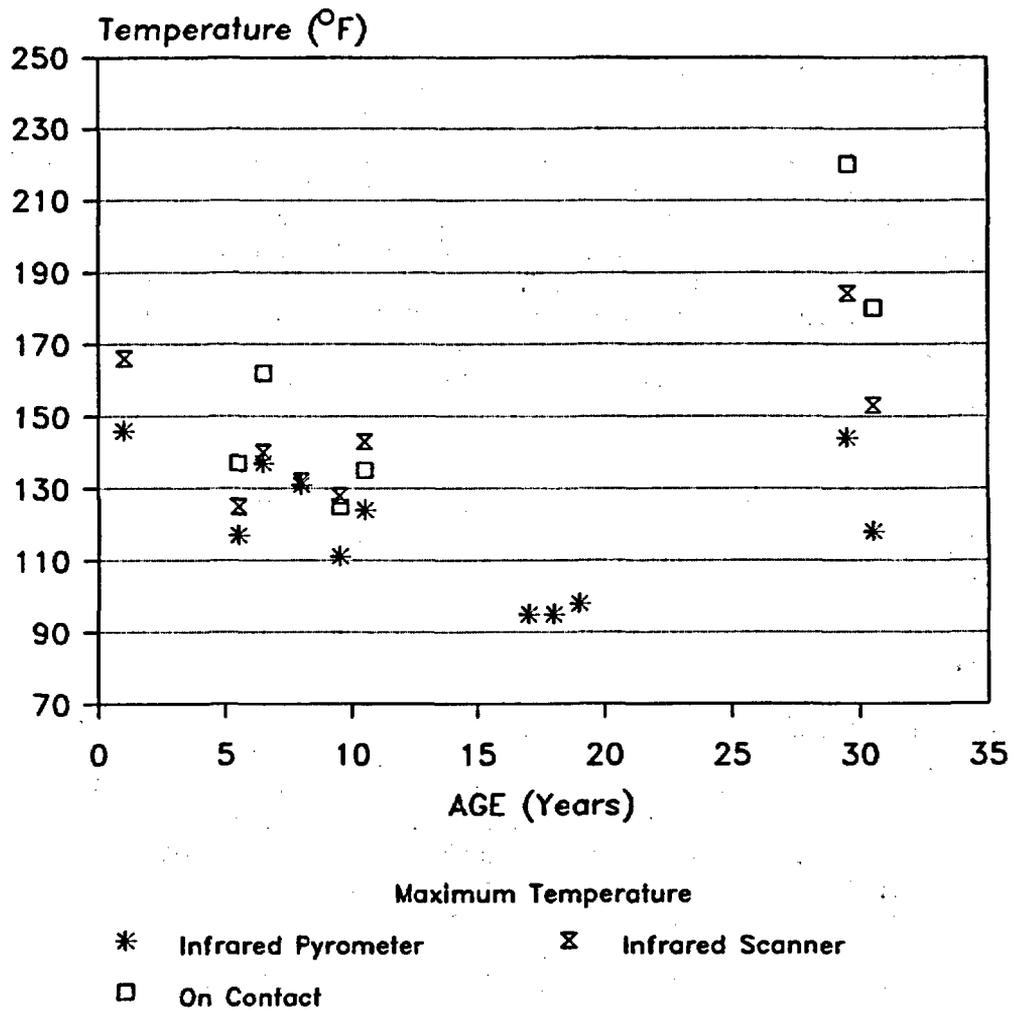
Figure 3-68. Temperature Comparison Molded Case Circuit Breakers at 100% Rated Current

The scanner showed the maximum temperatures, Figure 3-68, to be hotter than the pyrometer for all eight circuit breakers measured. No trend with age was noted with the scanner although the highest temperatures were measured on one of the 30 year breakers.

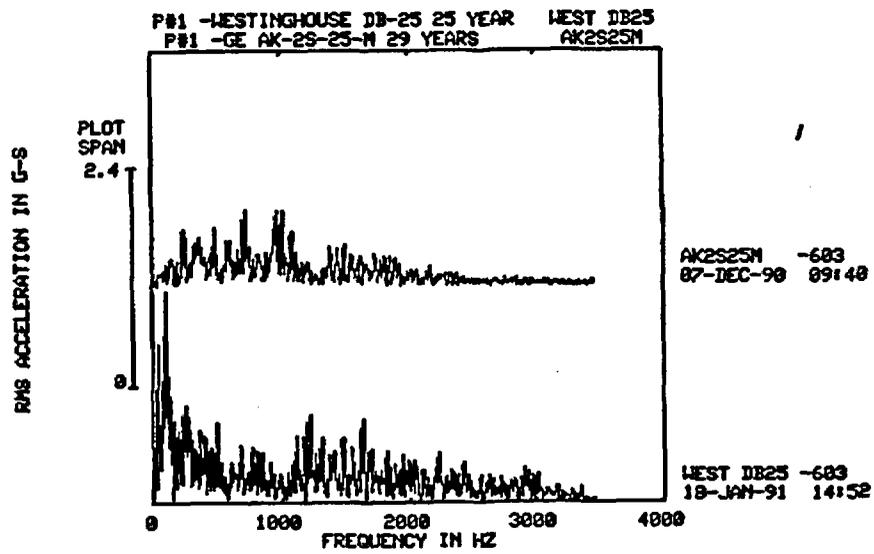
**Figure 3-71. Vibration Signatures of
 Metal Clad Circuit Breakers**

Vibration signatures were obtained during manual actuation, the long time delay and short time delay overcurrent tests. The vibration signatures were repeatable for each breaker. Differences were noted between the metal clad circuit breakers. The vibration signatures were analyzed in the frequency domain, Figure 3-71. The specimens had different trip mechanisms and therefore the differences in the vibration signatures could not solely, be attributed to age but were a reflection of the different breaker styles and their trip mechanisms.
