NUREG/CR-5762
WYLE 60101

Comprehensive Aging Assessment of Circuit Breakers and Relays

Prepared by
J. F. Gleason

Wyle Laboratories

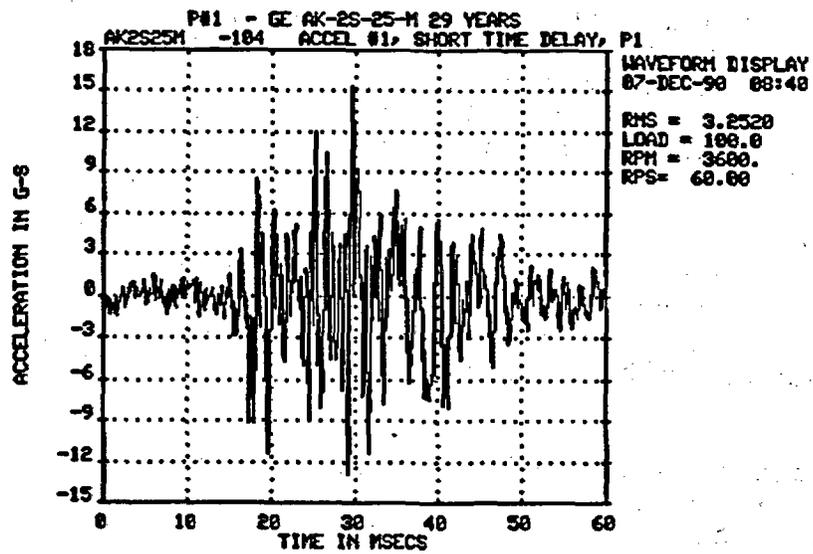
**Figure 3-72. Vibration Time History
 Signature of GE AK-2S-25-M
 Metal Clad Circuit Breaker**

The main vibration signature was caused by the tripping of the main contacts. The vibration signature was continuously monitored, before and during the manual actuation, the long time delay and short time delay overcurrent tests. When the vibration exceeded a trigger level, caused by the main breaker trip, the vibration signature and a set portion of the signature prior to the trip were captured and stored. The portion of the signature prior to the trigger event was known as pre-trigger. Figure 3-72 shows the time history of the vibration signature for the GE AK-2S-25-M, from a short time delay overcurrent trip on pole 1. The main vibration starts at approximately 18 milliseconds and lasts for approximately 30 milliseconds. The pre-trigger portion, prior to 18

milliseconds, of the time history signature contained the information on the initiating vibration from the short time delay function for the EC-1 trip device.

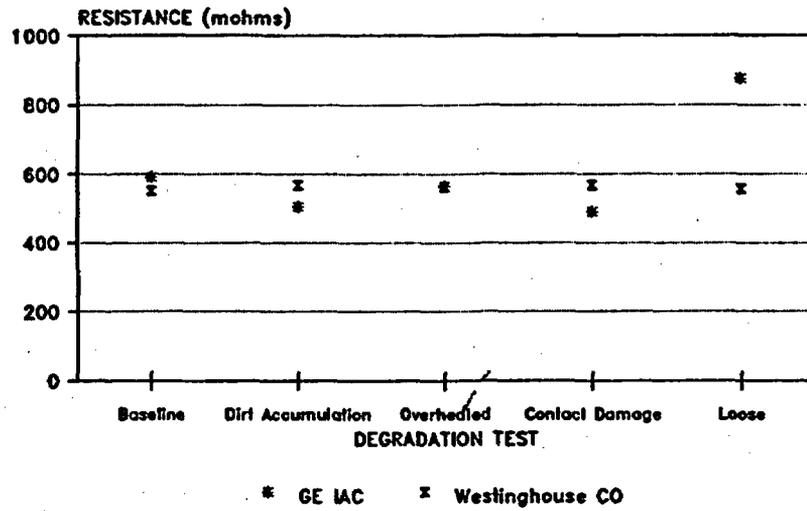
Figure 4-5. Contact Resistance Comparison Protective Relays

Contact resistance changed significantly in one out of the five degraded conditions on the GE relay, Figure 4-5, and was about the same or increased slightly on four out of five degraded conditions on the Westinghouse relay, Figure 4-5. The significant increase in contact resistance was on the GE specimen during the loose connections test. It increased 48% from baseline.

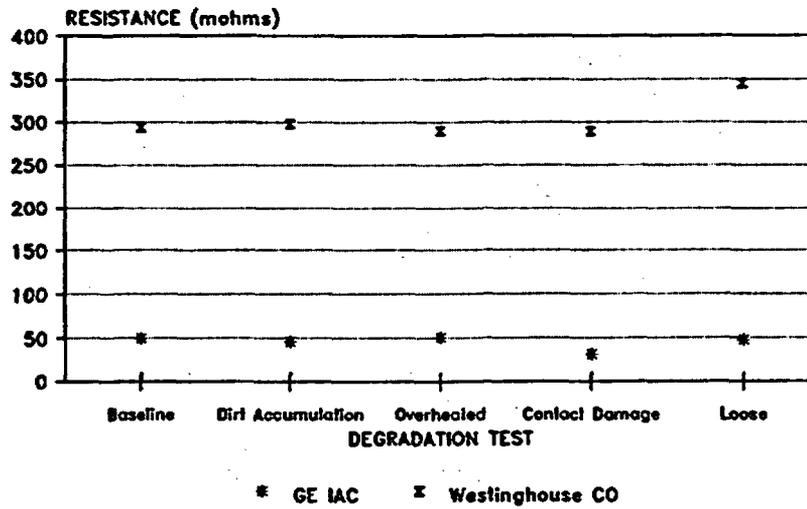
Figure 4-6. Coil Resistance Comparison Protective Relays

Coil resistance changed significantly in one out of the five degraded conditions on the Westinghouse relay and the GE relay, Figure 4-6. The loose connections test caused an increase of 17% from baseline for the Westinghouse relay. The contact damage, when the induction unit contacts of the GE specimen were soldered

together, resulted in a coil resistance decrease of 37.4% from baseline.

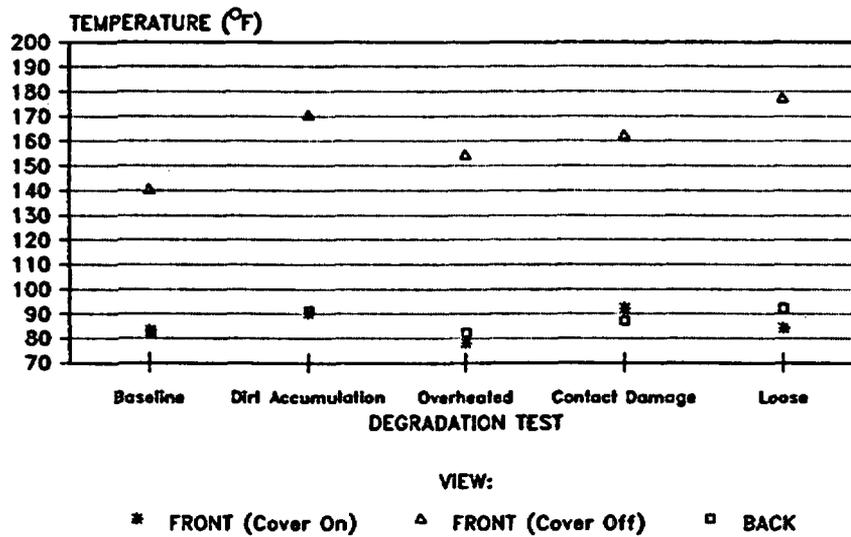
Figure 4-15. Infrared Temperature Comparison Protective Relay GE IAC

temperatures when viewed with the cover off for the GE relay, Figure 4-15.

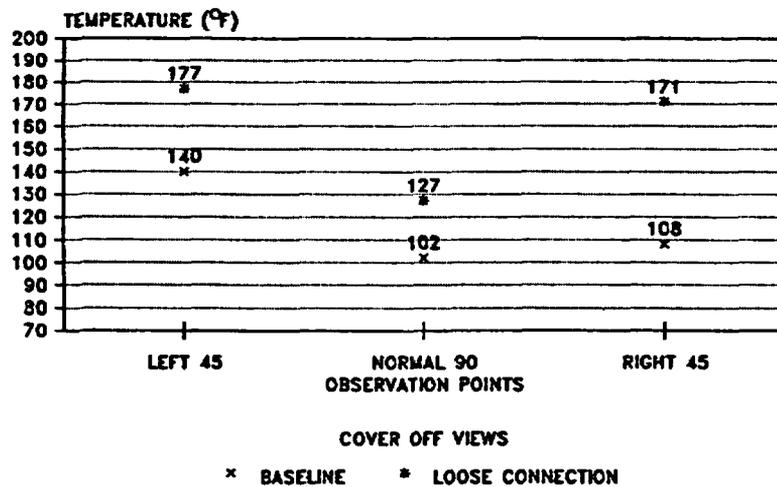
Figure 4-16. Infrared Pyrometry Comparison Protective Relay GE IAC

When viewed with the cover on and from the back of the relays, significant variations in temperature were undetectable. The angle of view was also significant for these relays. Figure 4-16 shows that the hottest temperatures were masked in normal 90° view but were detectable when viewed at 45° angles to the right or left of normal.

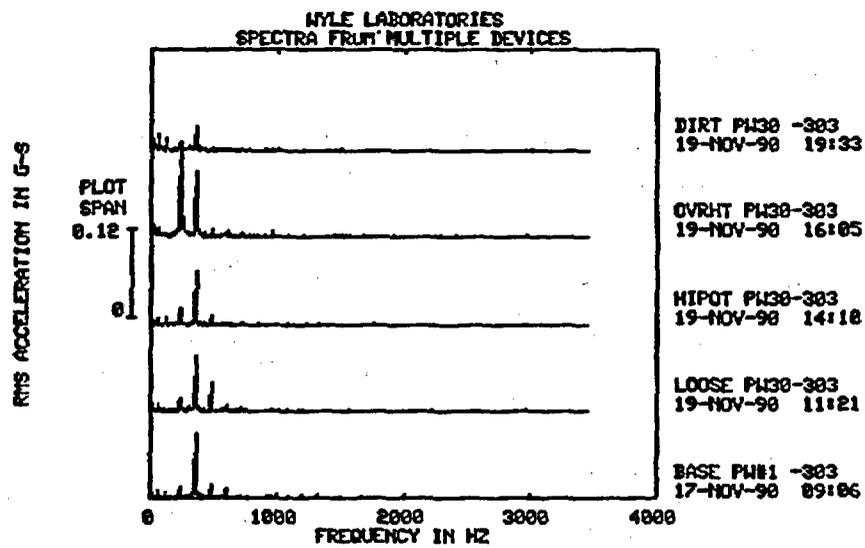
**Figure 4-17. Vibration Signature Comparison
of Westinghouse Protective Relay
Before and After Degraded Conditions**

Vibration signature differences were caused by three of the degraded conditions on the Westinghouse relay. Figure 4-17 shows that loose connections caused a peak at 480 Hz. Overheat caused a peak at 242 Hz and the characteristic peak at 359 Hz decreased to approximately one third by dirt accumulation. Acoustic signature differences were caused by the same three conditions, although not as noticeably. The vibration and acoustic signatures on the GE relay were different but the levels were too low to attribute the changes to the degraded conditions.

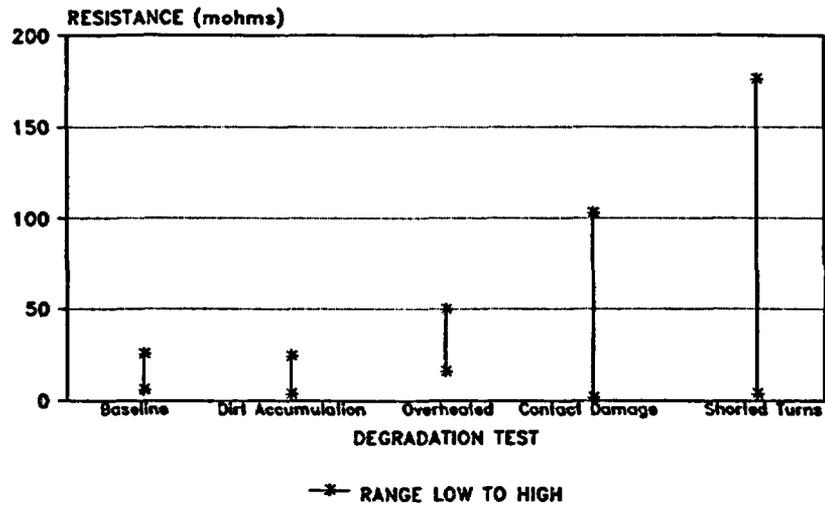
Figure 4-18. Contact Resistance Comparison Control Relay SD219

Contact resistance changed significantly in four out of the ten degraded conditions. Figure 4-18 shows the range of contact resistances for each contact set after each of the degraded conditions. Additionally, the contact resistance increased the most, to a peak of 995 mohms during the blocked armature degradation since the contacts did not fully close.

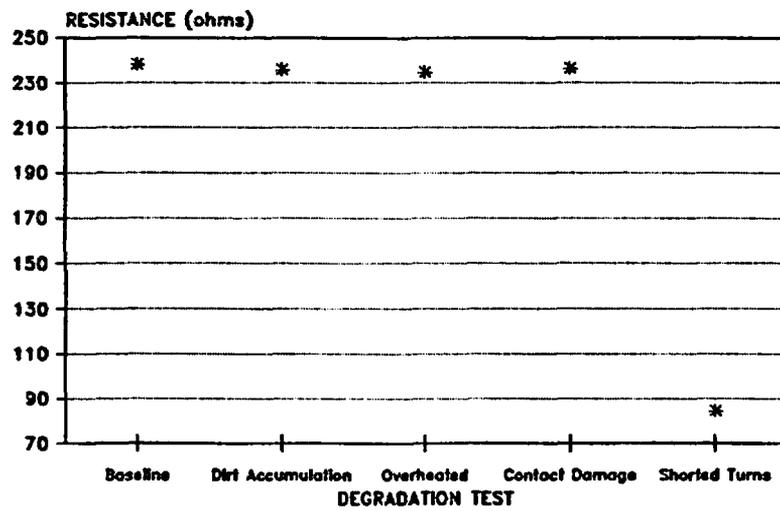
Figure 4-19. Coil Resistance Comparison Control Relay SD219

Coil resistance changed significantly in one out of the ten degraded conditions. Shorted turns caused a 60 % drop in coil resistance, Figure 4-19.

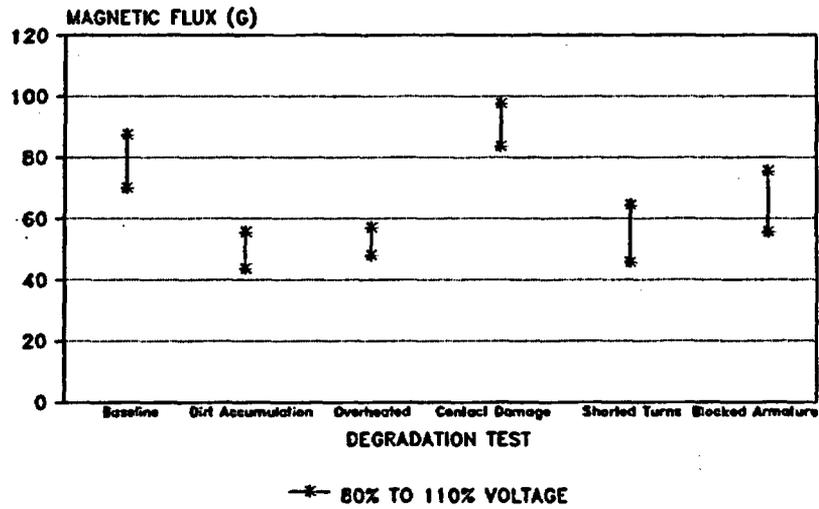
Figure 4-20. Magnetic Field Comparison Control Relay SD219

Magnetic flux changed significantly in five of the ten degraded conditions. Dirt accumulation, overheated, shorted coil turns and blocked armature all caused the magnetic flux to decrease and contact damage caused an increase, Figure 4-20.

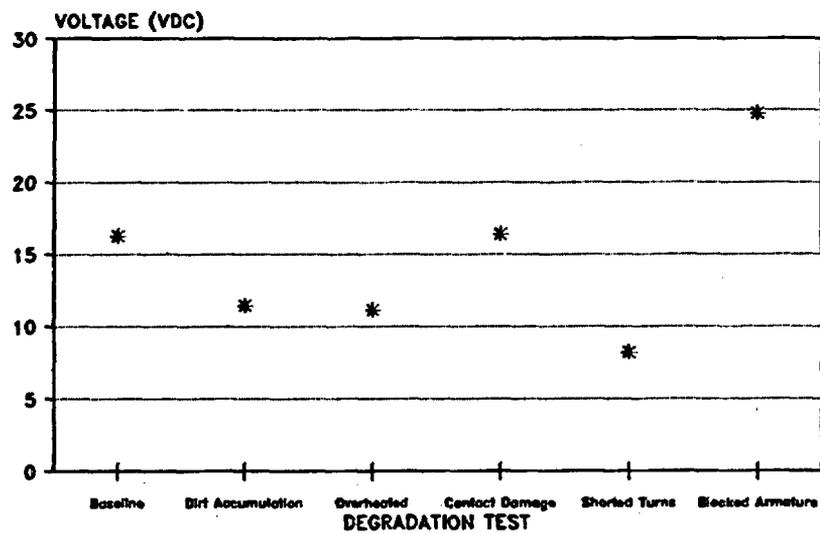
Figure 4-21. Pickup Voltage Comparison Control Relay SD219

Pick-up voltage increased in only one of the ten degraded conditions and decreased in three others. The decrease in pick-up voltage would normally be misinterpreted as an improvement, but since the relays were actually degraded, this is shown to be misleading. Blocked armature caused pick-up voltage to increase and dirt accumulation, overheated and shorted coil turns caused decreases in pick-up voltage, Figure 4-21. Blocked armature caused the pick-up voltage to exceed the specification.

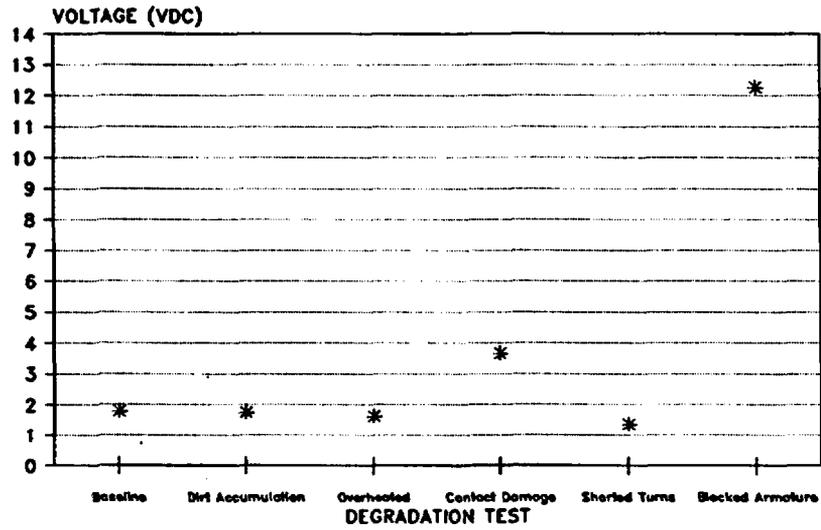
Figure 4-22. Drop-Out Voltage Comparison Control Relay SD219

Drop out voltage changed in two of the ten degraded conditions, Figure 4-22. Contact damage of a welded contact caused the drop out to increase since the moving contact bar is directly connected to the armature. Shorted coil turns caused a decrease in drop out voltage.

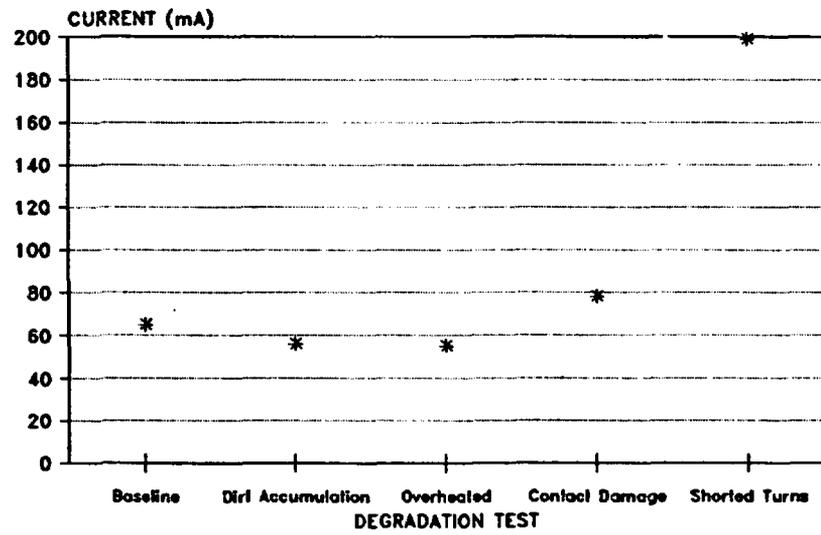
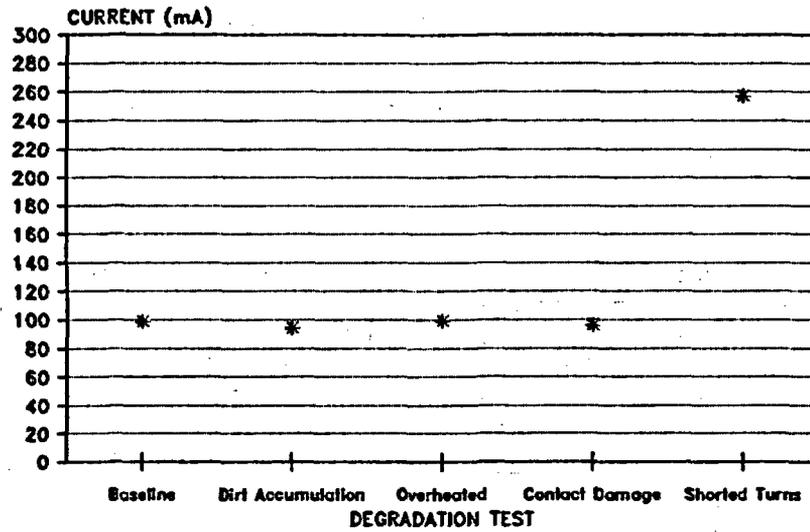
Inrush and holding current changed in one out of ten degraded conditions. Shorted coil turns caused an increase of over 200% for both inrush and holding current, Figure 4-23 and 4-24.

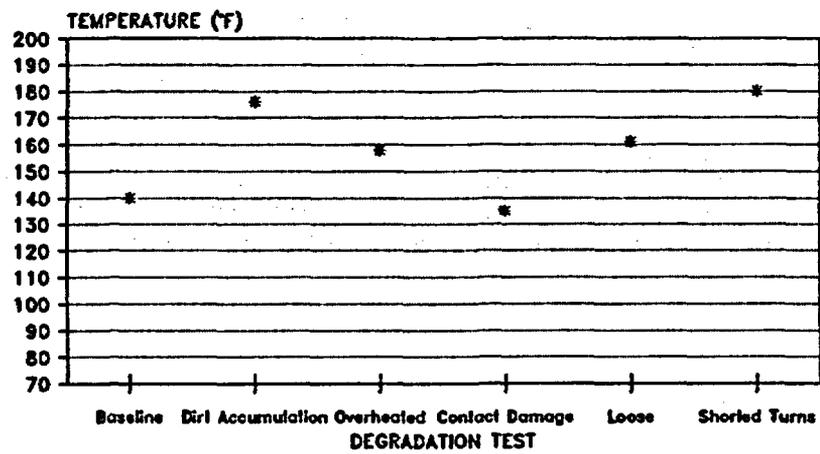
Figure 4-25. Infrared Pyrometry
Comparison Control Relay SD219

Infrared pyrometry showed temperature changes in four out of ten degraded conditions, Figure 4-25. The adverse effects of all four conditions were undetected by the pick-up voltage method. Loose connections and overheated caused an increase in maximum

temperature of approximately 20°F. Dirt accumulation and shorted coil turns caused an increase in maximum temperature of 35°F and 40°F, respectively. These temperature increases would be expected to reduce the expected life of the relays. A 40°F temperature rise would be expected to reduce the life to approximately 25% of the original expected life.

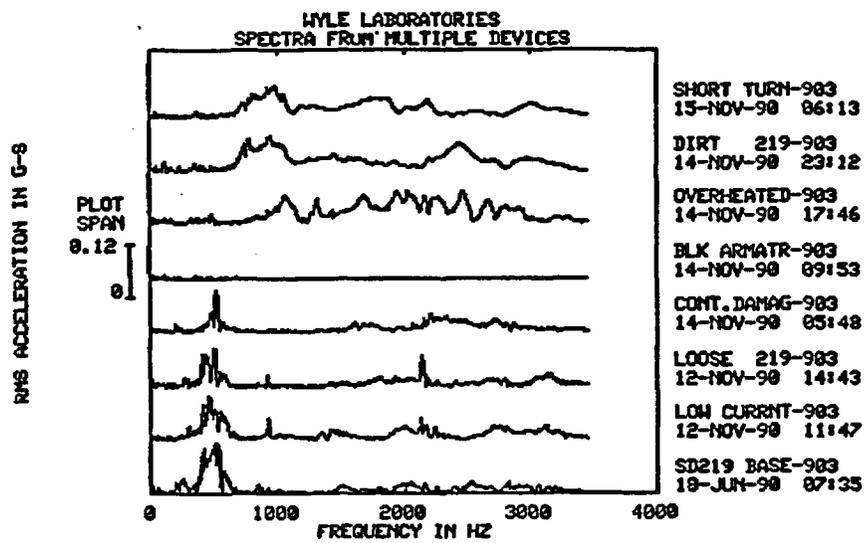
Figure 4-27. Vibration Signatures of Degraded Conditions of Struthers-Dunn 219 Control Relay

Vibration signature differences were caused by seven of the ten degraded conditions. Figure 4-27 shows that low contact current, and loose connections caused a peak at 1000 Hz. Contact damage resulted in a narrowing of the peak from 300 to 700 Hz. Blocked armature resulted in significant signal reduction. Overheat caused re-characterization of the vibration signature even though the relay continued to pick-up and drop out. Additionally, differences in the vibration signatures caused by the degradations of dirt accumulation and shorted coil turns were confounded and difficult to see since the changes from the overheated degradation were significant. The overheated degradation was performed prior to the degraded conditions of dirt accumulation and shorted coil turns.

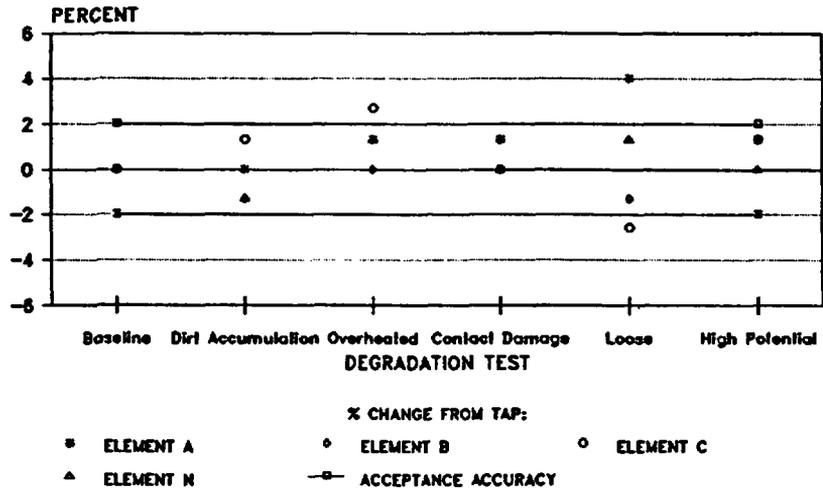
Figure 4-33. Overcurrent Sensing Pickup Comparison Electronic Relay BE1-51

Overcurrent sensing changed in two of the five degradation conditions. Loose connections and overheated caused at least one element to exceed the $\pm 2\%$ acceptance criteria, Figure 4-33.

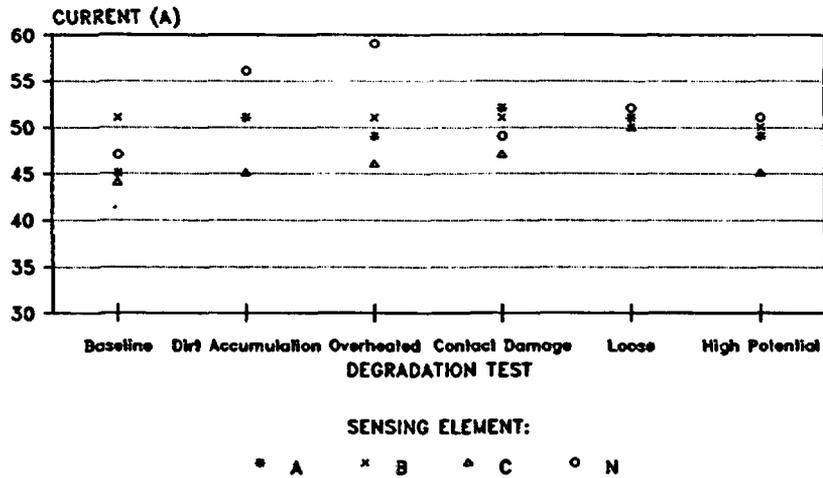
Figure 4-34. Instantaneous Current Pickup Comparison Electronic Relay BE1-51

Instantaneous overcurrent was changed in all five degraded conditions. The instantaneous overcurrent pick-up varied more than the typical acceptance criteria of $\pm 2\%$ of the pick-up values obtained during baseline testing for each degraded condition for three out of four sensing elements. Only element B changed less than $\pm 2\%$, Figure 4-34. It should be noted that the levels of change may not be totally attributed to the degraded conditions since specific manufacturer's test equipment, designed in conjunction with the electronic relay, was unavailable for this research. This special test equipment may have shown less change and shown better precision for this method. The use of manufacturer's test equipment for electronic relays is recommended.

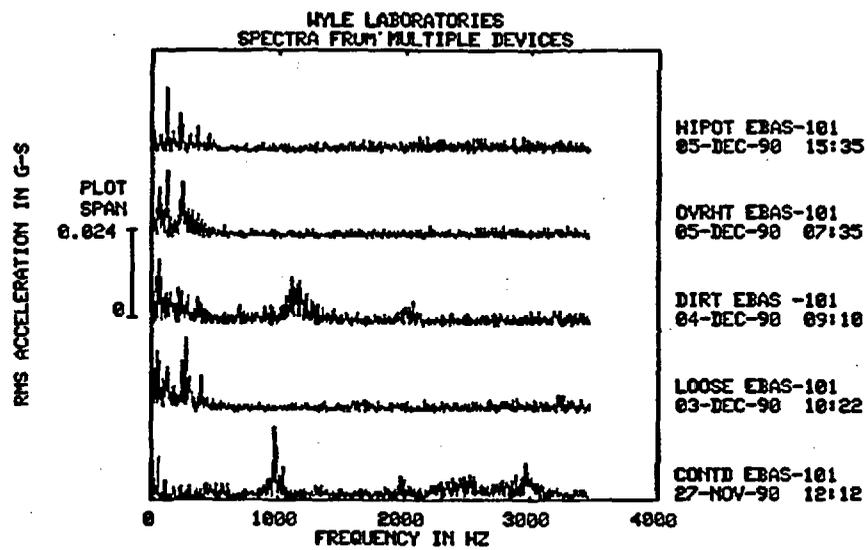
Figure 4-35. Vibration Signatures of Degraded Conditions of Basler Electronic Relay

Vibration signature differences were noted among all five degraded conditions. In Figure 4-35 the vibration signatures for the five degradation conditions were compared. Differences were most noticeable with the degraded conditions of contact damage and dirt accumulation. The vibration signatures on the electronic relay were different but the levels were too low to attribute all of the changes to the degraded conditions.

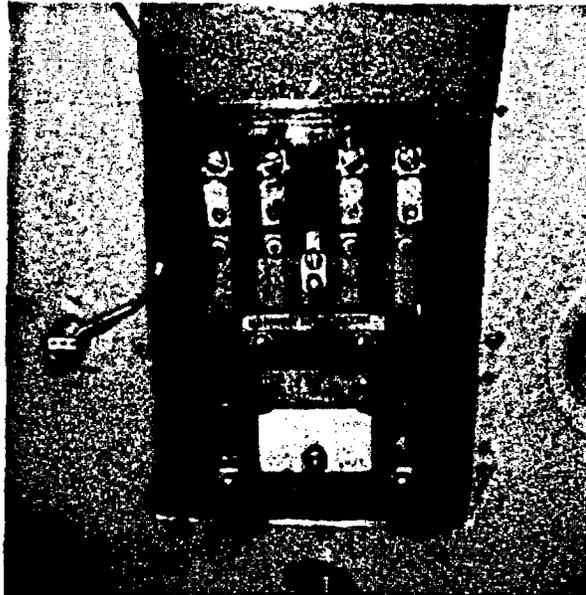
Figure 4-36 shows the blistered surface on the GE HFA caused by the overheated degradation and Figure 4-37 shows the dirt accumulation degradation on the Westinghouse MG-6. It is noted that these degradations have been purposely significant in order to constitute a worst case.

**Figure 4-37. Westinghouse MG-6 Auxiliary Relay in
Dirt Accumulation Degraded Condition**

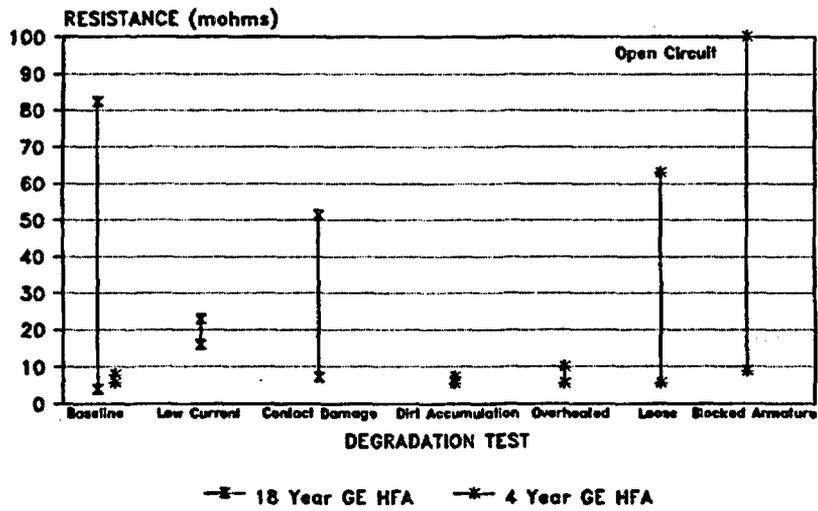
Figure 4-38. Contact Resistance Comparison Auxiliary Relay GE HFA

Contact resistance changed significantly in two out of the ten degraded conditions on the HFA and six out of ten on the MG-6 relay. For the 4 year HFA relay, loose connections and blocked armature caused significant increases in contact resistance, Figure 4-38. This figure shows the range of contact resistances for each contact set after each of the degraded conditions. Additionally, the contact resistance of the 18 year HFA relay varied considerably in the as received condition. The contact resistance improved after operation in the low contact current test and then increased because of the contact damage degradation for the 18 year relay.

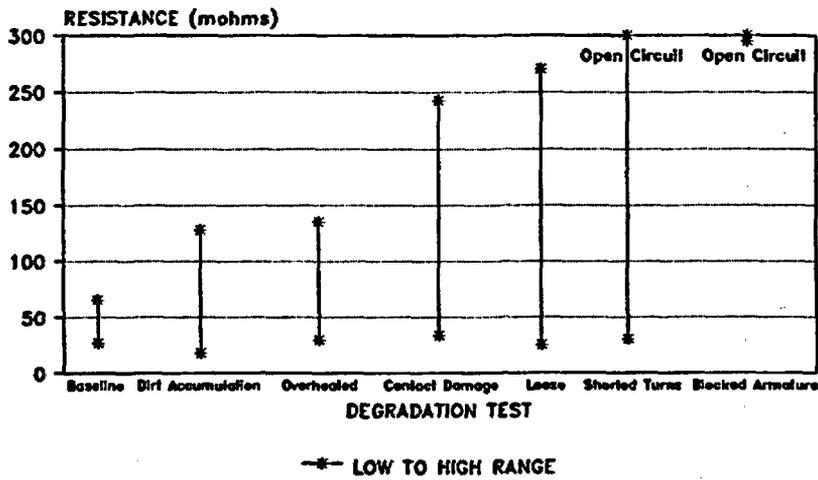
Figure 4-39. Contact Resistance Comparison Auxiliary Relay Westinghouse MG-6

For the MG-6 relay, dirt accumulation, overheated, contact damage, loose connections, shorted coil turns and blocked armature caused significant increases in contact resistance, Figure 4-39. The contact resistance increased the most during the blocked armature degradation since the contacts did not fully close.

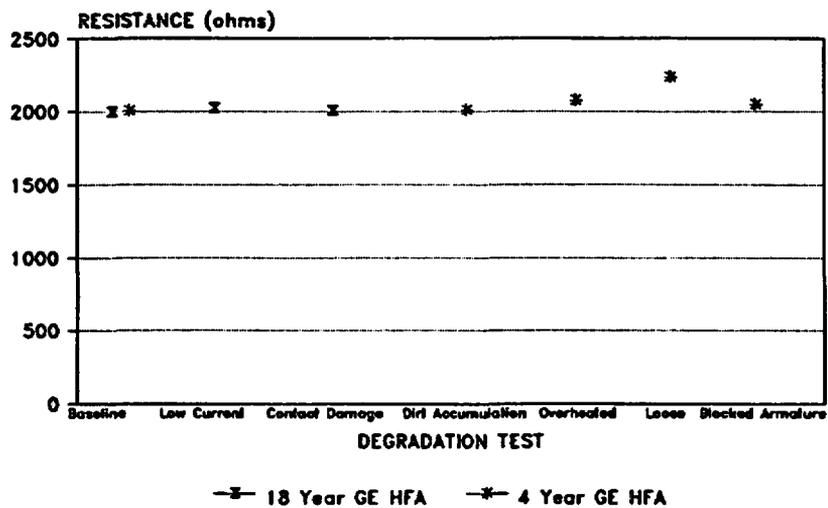
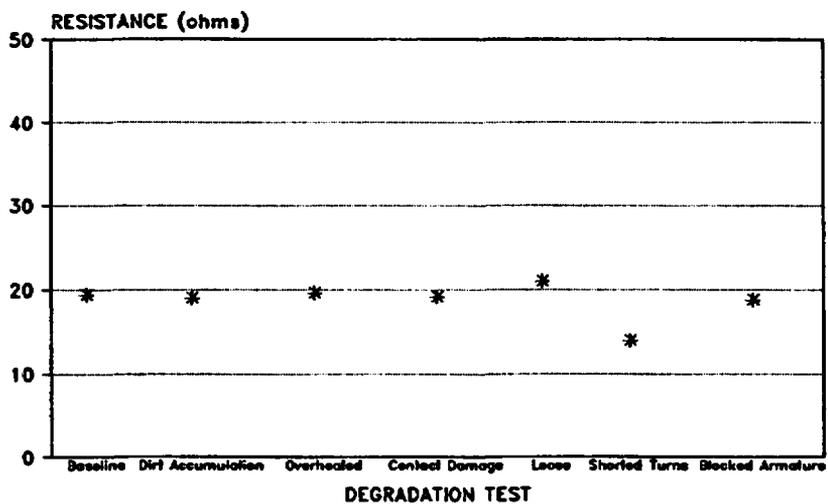
Coil resistance changed significantly in one out of the ten degraded conditions for each of the auxiliary relays. Loose connections caused an increase of 12% for the HFA relay, Figure 4-40. Shorted coil turns caused over a 25 % drop in coil resistance for the MG-6 relay, Figure 4-41.

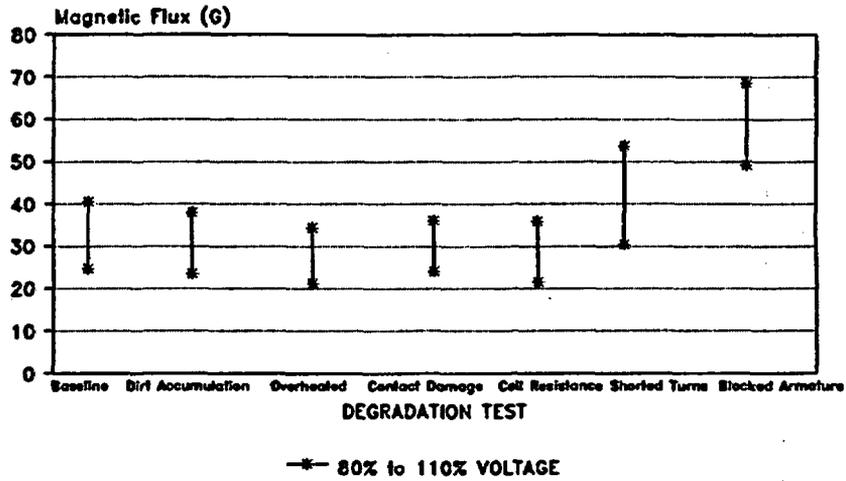
Figure 4-42. Magnetic Field Comparison Auxiliary Relay Westinghouse MG-6

Magnetic flux changed significantly in two of the seven degraded conditions in which it was measured on the MG-6. It was not measured on the HFA due to equipment unavailability. Shorted coil turns and blocked armature caused the magnetic flux to increase, Figure 4-42.

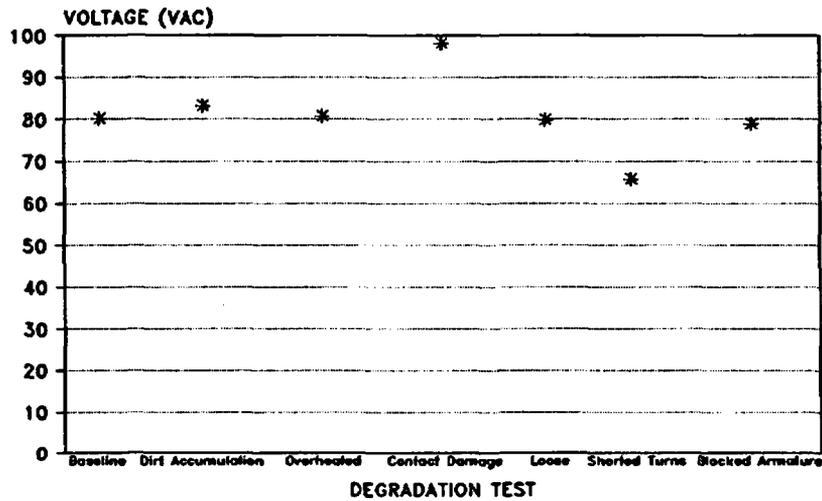
The significance of the pick-up voltage results was that for 90% of the degraded conditions, either there was no change in pick-up voltage or it decreased, which would normally be interpreted as improving. Thus it was only effective at detecting 10% of the degraded conditions. For the HFA relays, since the 18 year relay was out of specification for pick-up voltage in the as received condition, it decreased to within specification after the contact damage degradation. Additional comparisons were made on the 4 year HFA relay, which increased pick-up voltage in one out of eight degraded conditions. Loose connections caused an increase in pick-up voltage of 13%, Figure 4-43. Pick-up voltage changed in two of the ten degraded conditions for the MG-6 relay. Contact damage caused pick-up voltage to increase and shorted coil turns caused pick-up voltage to decrease, Figure 4-44.

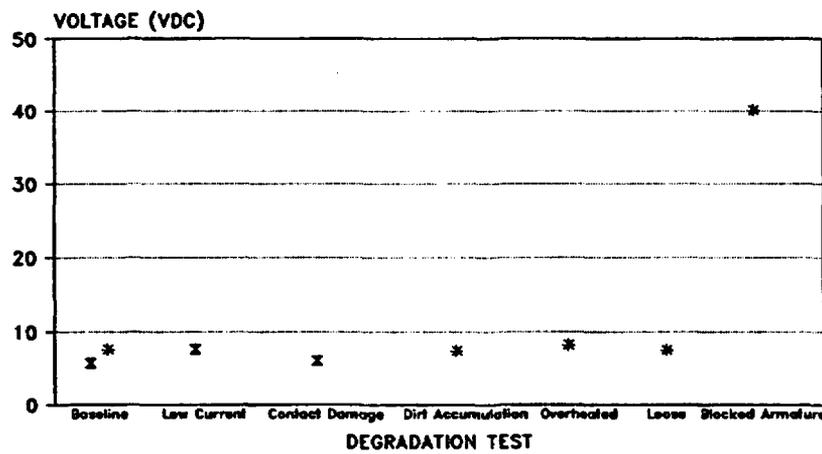
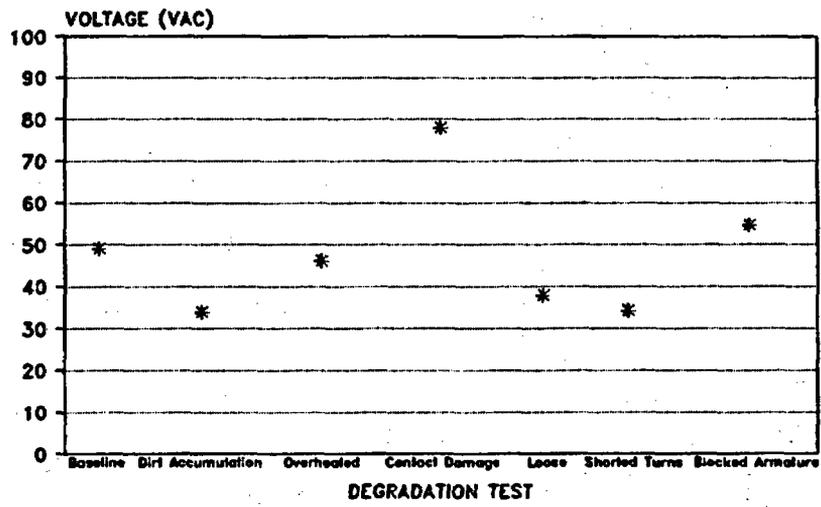
Drop out voltage changed significantly in one out of the ten degraded conditions on the HFA and five out of ten on the MG-6 relay. For the HFA relay, Figure 4-45, the blocked armature degradation caused an increase in drop out voltage of over 400%. For the MG-6 relay, the degraded conditions of dirt accumulation, loose connections and shorted coil turns caused a decrease in drop out voltage and contact damage and blocked armature caused increases in drop out voltage, Figure 4-46.

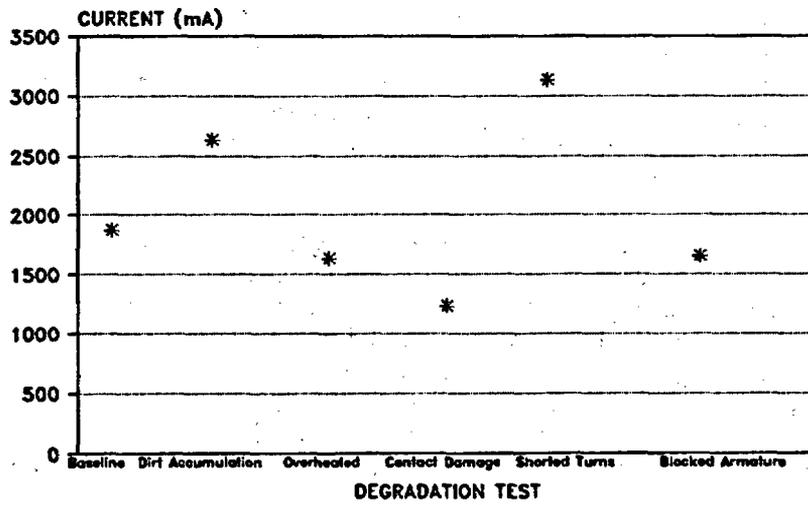
Figure 4-47. Inrush Current
Comparison Auxiliary Relay
Westinghouse MG-6

Inrush current changed significantly in three out of the ten degraded conditions for the MG-6. The degraded conditions of dirt accumulation and shorted coil turns caused increases of 40% and 68% respectively, Figure 4-47. The contact damage degradation caused a decrease of 34% in the inrush current.

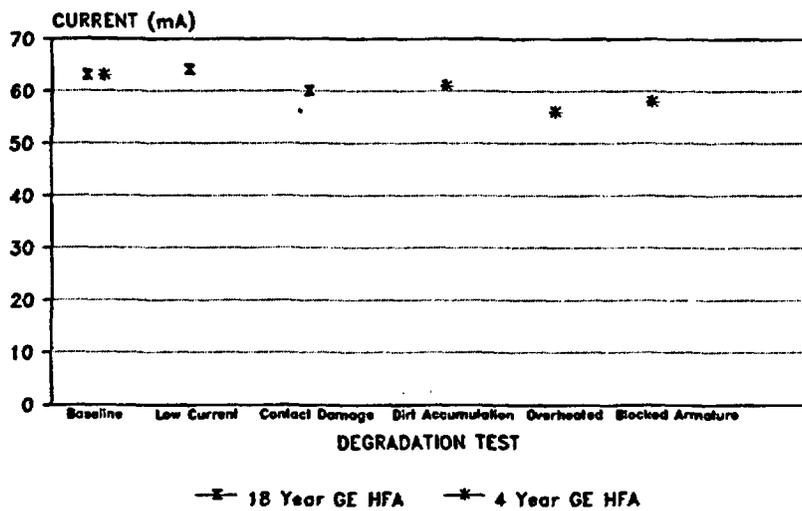
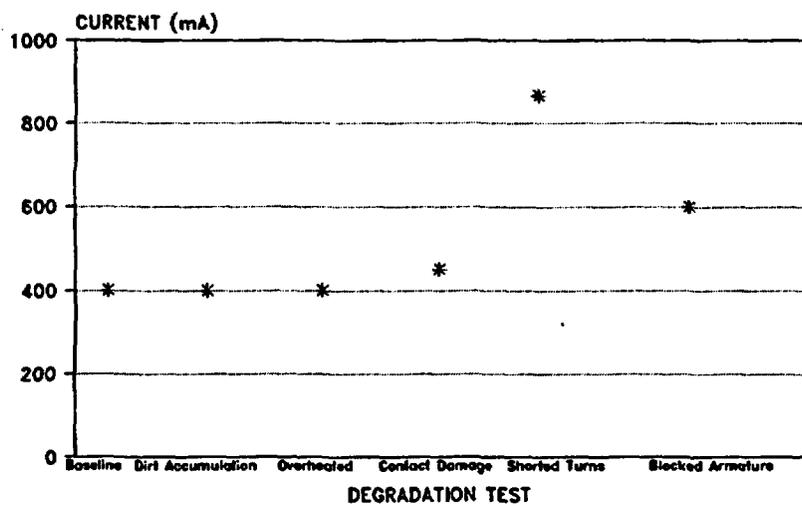
Holding current did not significantly change in the HFA relay, Figure 4-48, but did change significantly in two out of the ten degraded conditions on the MG-6 relay. Shorted coils turns caused an increase of over 100% and blocked armature caused an increase of 50% in the holding current, Figure 4-49. The excessive current drawn during the shorted coil turns test also caused significant temperature increases (over 300°F on the case) and produced smoke, visible through the glass on the case.

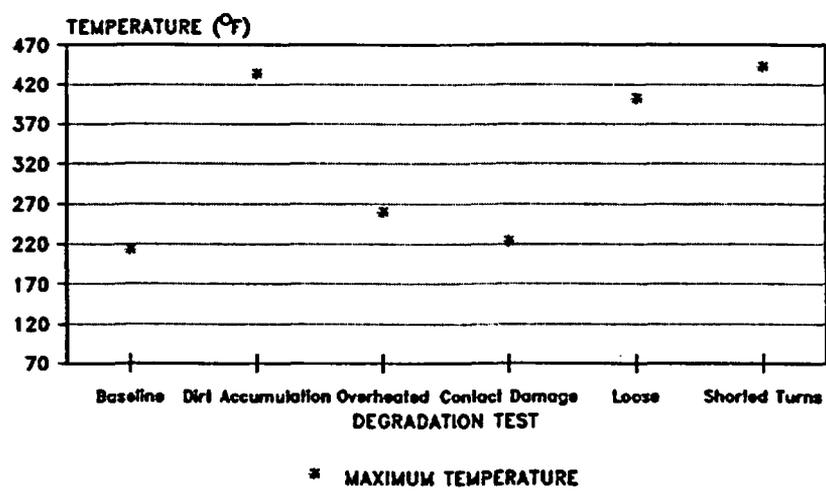
Figure 4-55. Infrared Pyrometry Comparison Auxiliary Relay MG-6 (Cover off)

With the cover off, the degraded conditions of dirt accumulation, loose connections and shorted coil turns had caused temperature increases of approximately 200°F, Figure 4-55.

During the shorted coil turns degradation, the maximum temperature, with the cover off was 442°F.

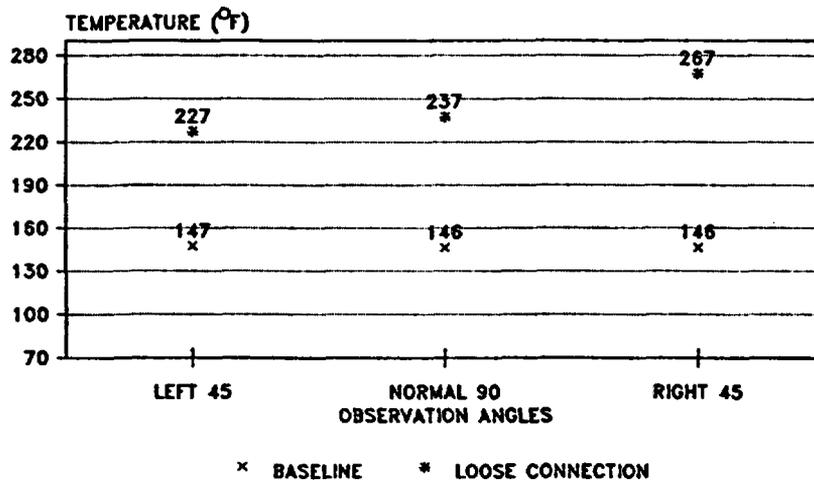
Figure 4-56. Infrared Pyrometry
Comparison of Viewing Angles for MG-6
Baseline and Loose Connection:Cover on

Also of interest on the MG-6 relay was the difference in temperature observed when different viewing angles were used. Figure 4-56 shows the three viewing angles of left 45°, normal to the relay (90°) and right 45°, with the cover on when the baseline temperatures were compared with the loose connection degradation. With the cover on, viewing angle had little effect during baseline measurements, but did show a difference of 40°F in the loose connection degradation. With the cover removed, Figure 4-57, viewing angle results in an almost 80°F difference in hot spot during baseline measurements and a 50°F difference during the loose connection degradation. Since dirt accumulation had caused a higher increase in maximum temperature, viewing angles were also compared. In Figure 4-58, viewing angle showed little difference with the cover on. With the cover off, a difference of 100°F was noted due to the viewing angle, Figure 4-59. The temperature of 472°F was found on a contact finger where the connection to the rear terminal post was made. This extreme temperature on the contact was due to the build up of foreign material on the contact surface, creating a poor electrical connection.

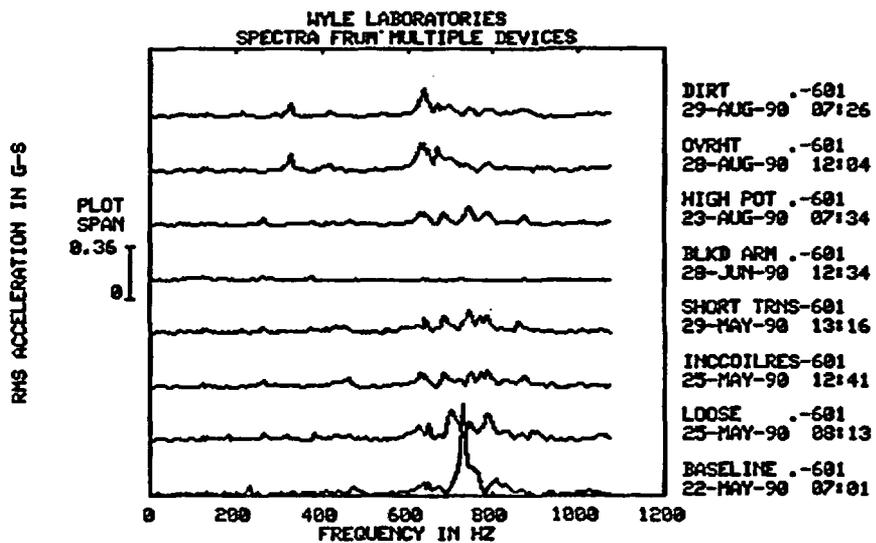
**Figure 4-60. Vibration Signatures of
GE HFA Auxiliary Relays During Degraded Conditions**

Vibration signature differences were caused by four of the ten degraded conditions for the HFA relay and six out of ten for the MG-6 relay. For the HFA relay, significant vibration signature differences were caused by loose connections, blocked armature, overheated and dirt accumulation, Figure 4-60. Loose connections caused a reduction in the peak at 731 Hz. Blocked armature resulted in significant signal reduction. Overheat caused re-characterization of the vibration signature by adding peaks at 328 and 630 Hz, even though the relay continued to pick-up and drop out. The degraded condition of dirt accumulation caused a narrowing of the peak at 630 Hz.

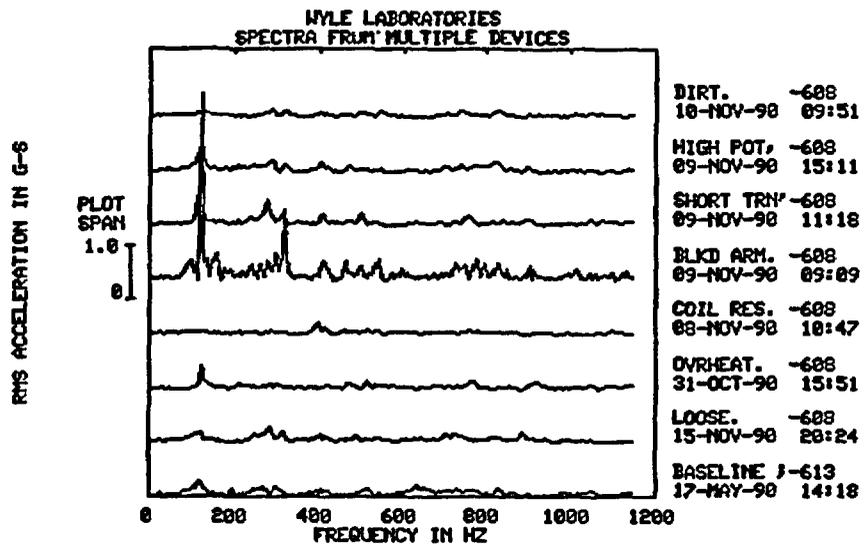
Figure 4-61. Vibration Signatures of Westinghouse MG-6 Auxiliary Relays During Degraded Conditions

For the MG-6 relay, significant vibration signature changes were caused by loose connections, overheated, increased coil resistance, blocked armature, shorted coil turns and dirt accumulation. In the blocked armature degraded condition, excessive chatter and arcing of the contacts occurred as the relay attempted to close. This caused an extremely high vibration, Figure 4-61. Additionally, increased coil resistance caused a reduction in signal; loose connections caused a peak at 285 Hz; overheated resulted in narrowing the peak at 121 Hz; shorted coil turns caused a peak at 280 Hz and dirt accumulation reduced the peak at 121 Hz.

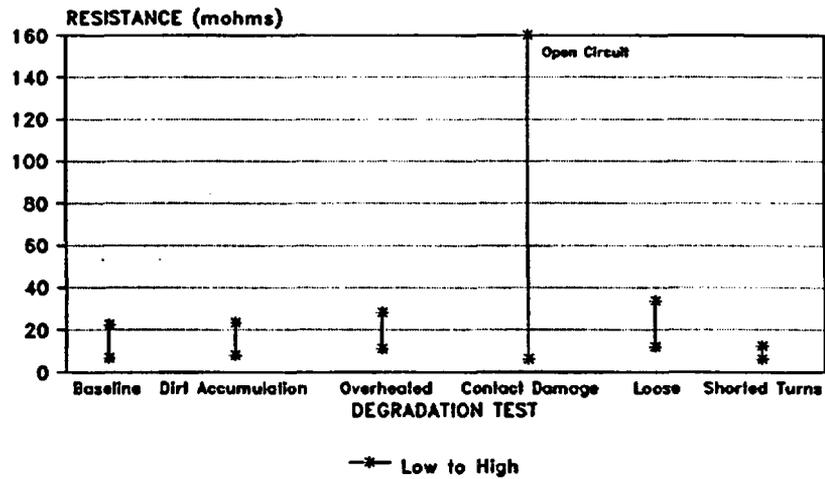
Figure 4-63. Contact Resistance Comparison Degradation Tests Timing Relays

Contact resistance changed significantly in one out of the nine degraded conditions. The contact damage of soldering two contacts together caused an open circuit. Figure 4-63 shows the range of contact resistances for each contact set after each of the degraded conditions.

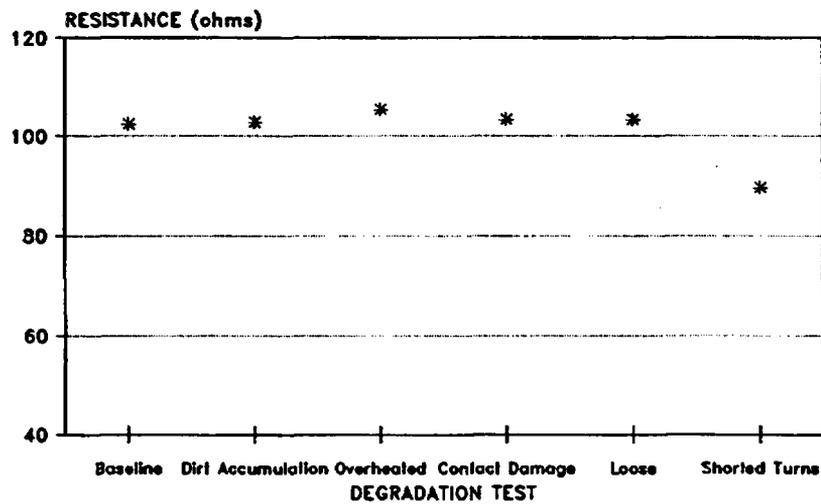
Figure 4-64. Coil Resistance Comparison Degradation Tests Timing Relays

Coil resistance changed significantly in one out of the nine degraded conditions. Shorted coil turns caused a 15 % drop in coil resistance, Figure 4-64.

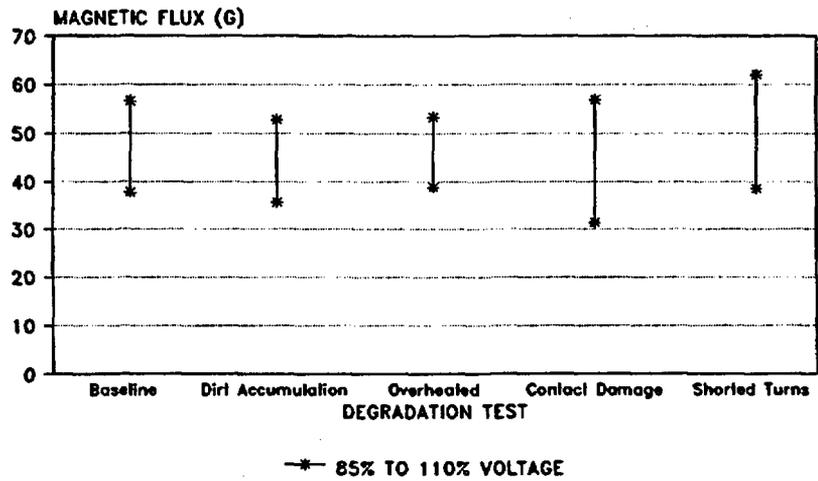
Figure 4-65. Magnetic Field Comparison Degradation Tests Timing Relays

Magnetic flux changed significantly in two of the nine degraded conditions. Shorted coil turns caused the magnetic flux to increase at 110% voltage, Figure 4-65, and the overheated degradation caused a reduction.

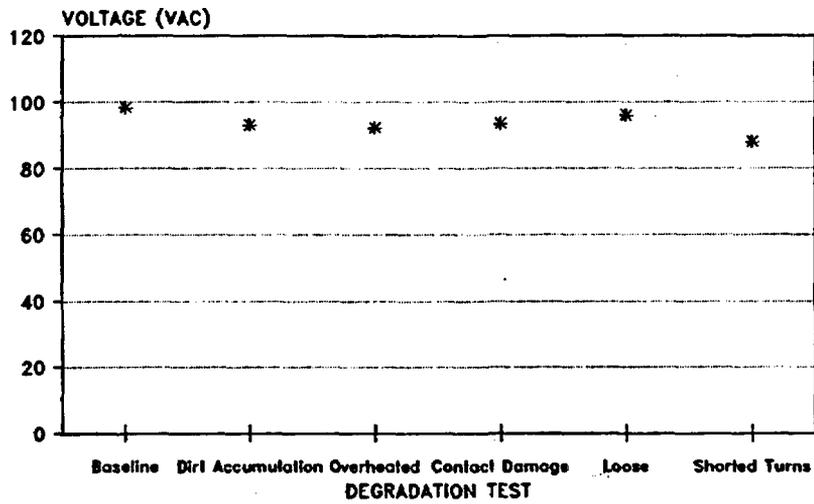
Figure 4-66. Pick-Up Voltage Comparison Degradation Tests Timing Relays

The significance of the pick-up voltage results was that none of the degraded conditions caused the pick-up voltage to increase. Thus, pick-up voltage did not indicate the presence of any of the degraded conditions. Pick-up voltage only changed, a reduction, in one out of the nine degraded conditions, and this would normally be misinterpreted as an improvement. Shorted coil turns caused a 10% reduction in pick-up voltage, Figure 4-66.

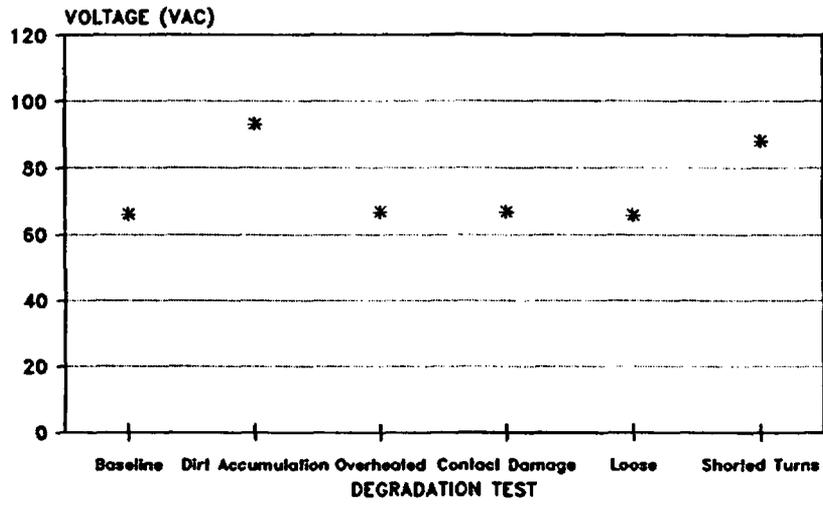
Figure 4-67. Drop Out Voltage Comparison Degradation Tests Timing Relays

Drop-out voltage changed in two of the nine degraded conditions, Figure 4-67. Both the dirt accumulation and shorted coil turns degraded conditions caused drop out voltage to increase approximately 50%.

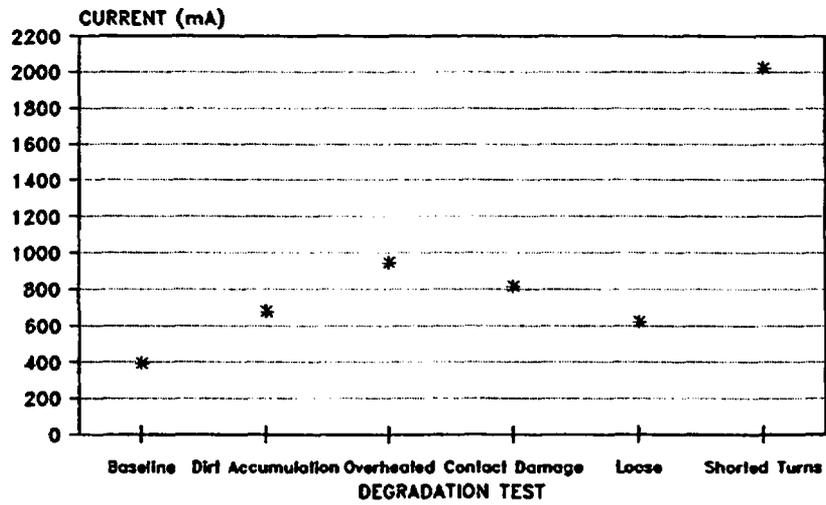
Figure 4-68. Inrush Current Comparison Degradation Test Timing Relays

Inrush current changed significantly in five of the nine degraded conditions, Figure 4-68. The degraded conditions of dirt accumulation and loose connections caused inrush increases over 50%. The degraded conditions of overheated and contact damage caused increases over 100% and shorted coil turns caused an increase of over 400%.

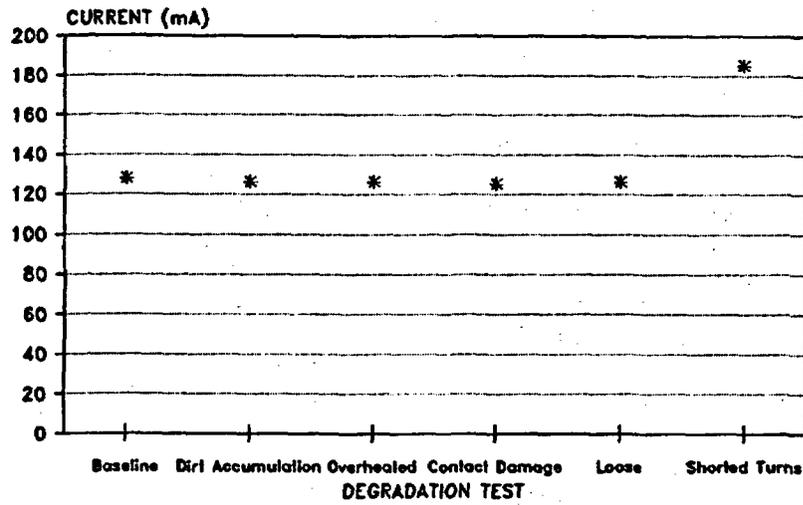
Figure 4-69. Holding Current Comparison Degradation Tests Timing Relays

Holding current changed significantly in one of the nine degraded conditions, Figure 4-69. The degraded condition of shorted coil turns caused an increase of 45% in holding current.

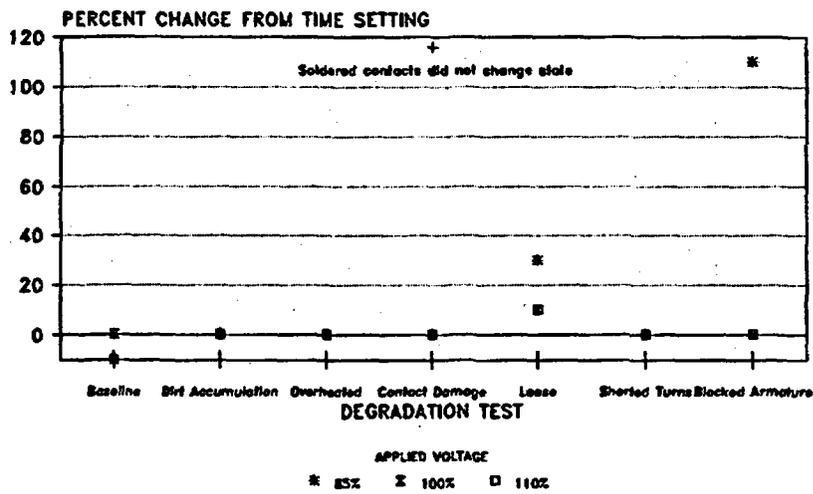
Figure 4-70. Timing Comparison Degradation Tests Timing Relays

Timing changed significantly in three of the nine degraded conditions, Figure 4-70. The degraded conditions of contact damage, loose connections and blocked armature caused changes. The

contact damage of two contacts soldered together prevented the contacts from changing state. The loose connection and blocked armature degradations caused the time delay to increase out of the typical specification of $\pm 10\%$, when tested at 85% of rated voltage.
