NUREG/CR-5762
WYLE 60101

Comprehensive Aging Assessment of Circuit Breakers and Relays

Prepared by
J. F. Gleason

Wyle Laboratories

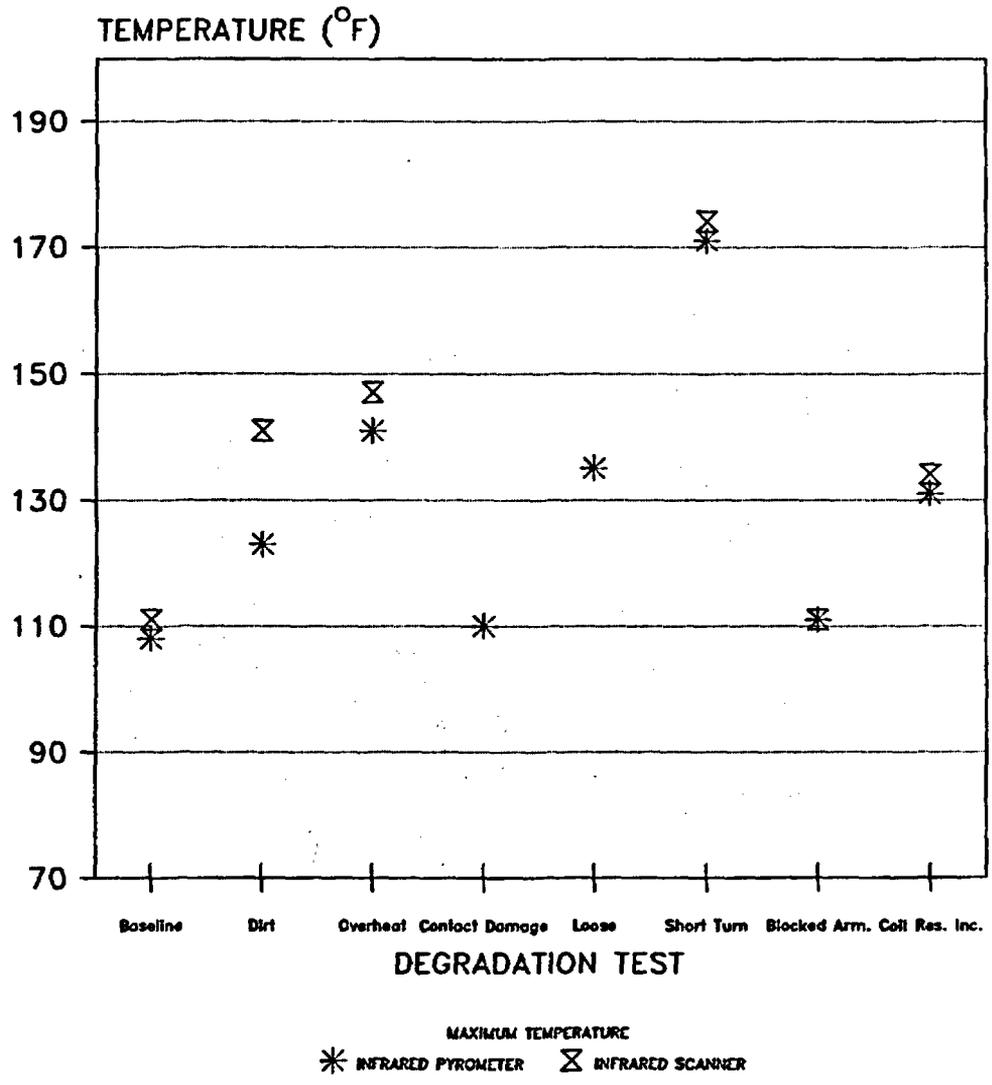
Figure 4-71. Temperature Comparison Degradation Tests Timing Relays

Infrared pyrometry showed temperature changes in five out of nine degraded conditions, Figure 4-71. An increase in temperature of 10°F was caused by the degraded condition of dirt accumulation. The degraded conditions of overheated, loose connections and increased coil resistance caused an increase in temperature of 20 to 30°F . The degraded condition of shorted coil turns caused an increase in temperature of approximately 60°F . These increased temperatures would be expected to reduce the life of the timing relays. When an Arrhenius relationship is used to calculate expected life, a temperature increase of 30°F would be expected to result in an expected life of approximately 25% of the original expected life. A temperature increase of 60°F would result in an expected life of less than 6% of the original life.

Infrared scanning showed temperature changes in four out of the seven degraded conditions in which it was measured, Figure 4-71. The equipment was unavailable for the degradations of contact damage and loose connections. Infrared scanning showed higher temperatures than the pyrometer since it could better pinpoint the hottest spot, as shown in thermograph of Figure 4-72, which was taken with the Inframetrics Thermal Imaging System 600. It showed the same trend as the infrared pyrometer.

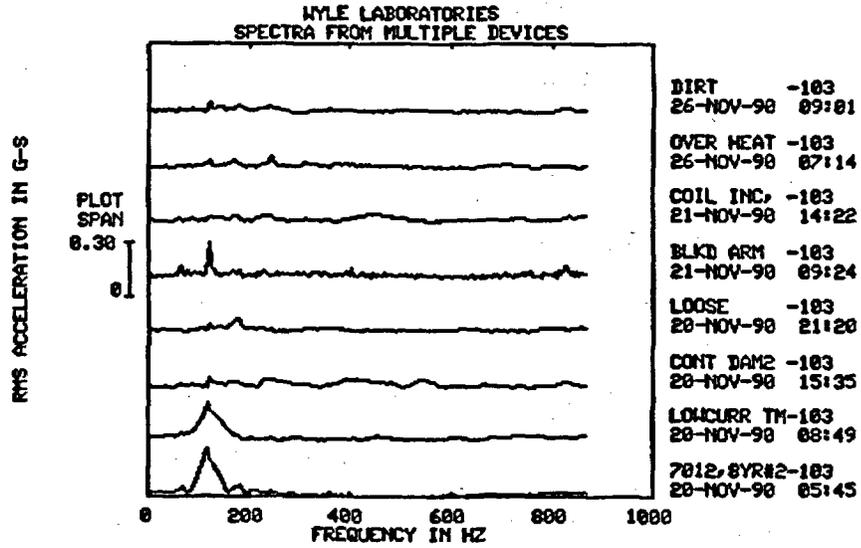
**Figure 4-73. Vibration Signatures of Timing Relay
During Degradation Condition Tests**

Vibration signature differences were caused by six of the nine degraded conditions for the timing relays. Significant vibration signature differences were caused by contact damage, loose connections, blocked armature, increased coil resistance, overheated and dirt accumulation, Figure 4-73.

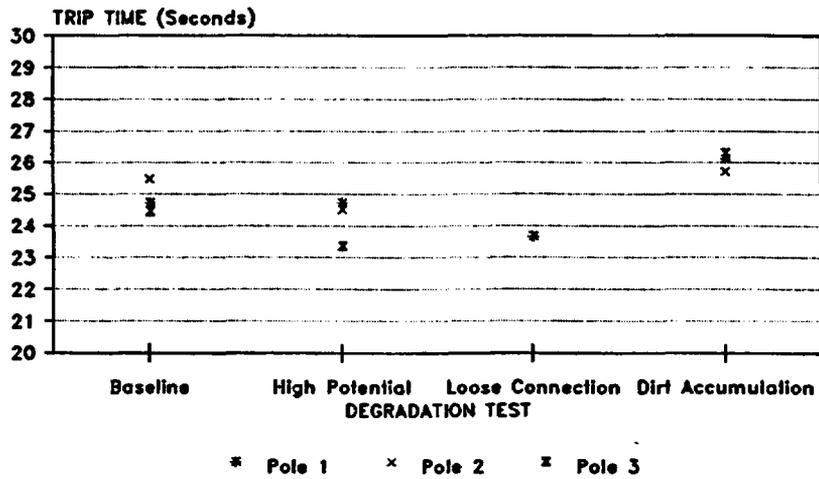
Figure 4-74. Time Delay Comparison at 300% Overcurrent, Degradation Tests Molded Case Circuit Breakers

significant change from original baseline parameters during any of the degradation tests. Figure 4-74 shows that the 300% overcurrent method did not change significantly for any of the degraded conditions.

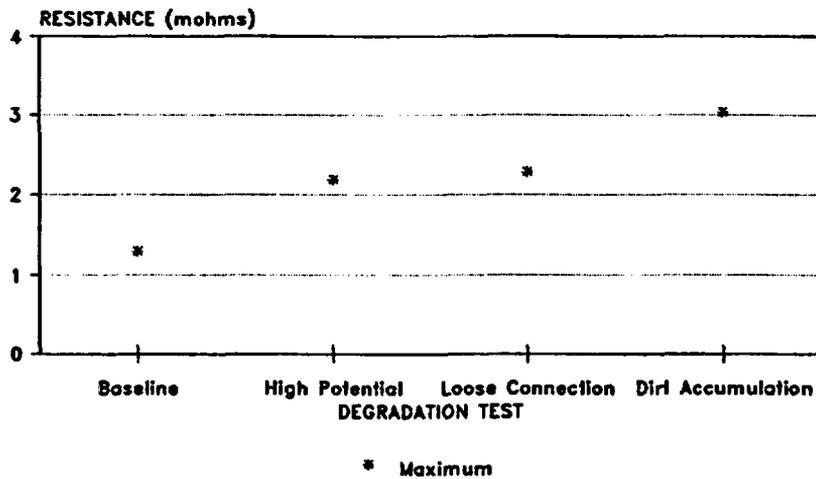
Figure 4-75. Pole Resistance Comparison Degradation Tests Molded Case Circuit Breakers

Pole resistance changed significantly in all three degraded conditions. Figure 4-75 shows that the pole resistance increased almost 200% due to high potential testing and loose connections and increased almost 300% due to dirt accumulation.

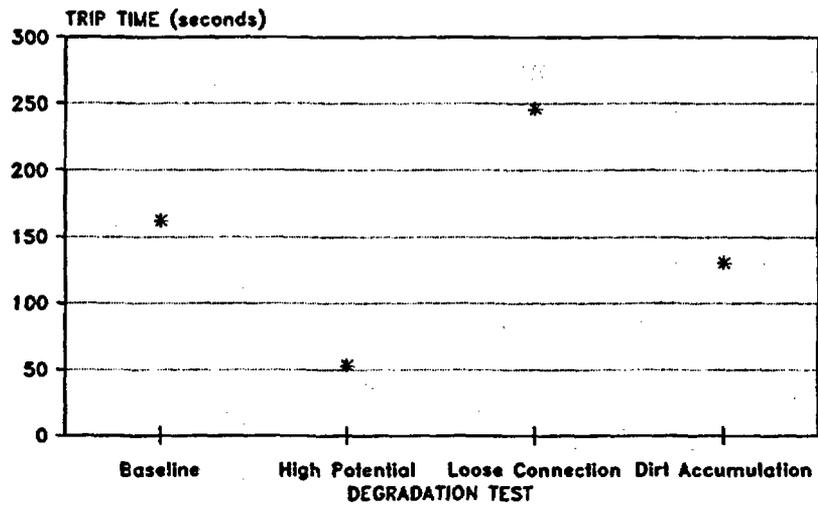
Figure 4-76. Trip Time Comparison at 135% Rated Current, Degradation Tests Molded Case Circuit Breakers

The trip time, when 135% rated current was applied, changed in all three degraded conditions, Figure 4-76. The trip time significantly decreased after the high potential tests and slightly decreased after dirt accumulation. The loose connection degradation caused a 35% increase in trip time.

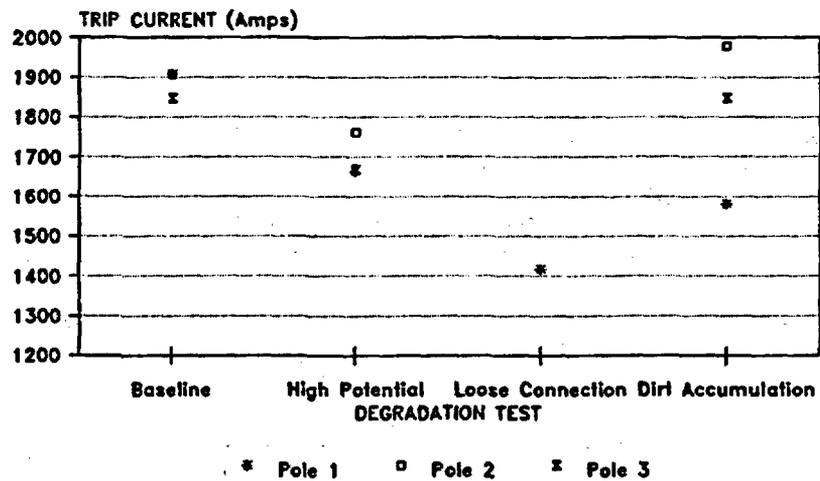
Figure 4-77. Instantaneous Trip Comparison, Degradation Tests Molded Case Circuit Breakers

The instantaneous trip current changed significantly in all three degraded conditions, Figure 4-77. The degradations of high potential and loose connections caused a decrease in the current necessary to cause an instantaneous trip. The degraded condition of dirt accumulation caused the instantaneous trip current of pole

1 to decrease, pole 2 to increase and pole 3 to effectively stay the same.

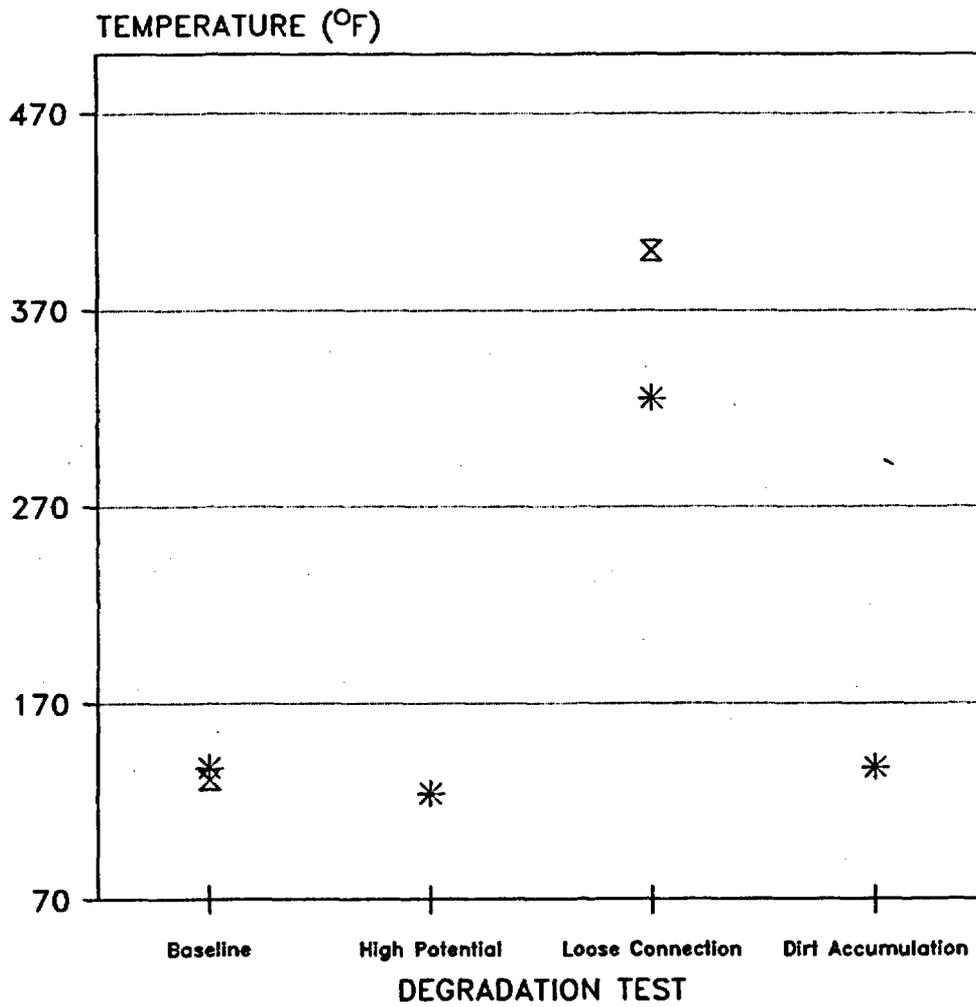
Figure 4-78. Infrared Pyrometry Comparison Degradation Tests Molded Case Circuit Breakers

Infrared pyrometry showed temperature changes in one out of three degraded conditions, Figure 4-78, for the Square D FAL36070. An increase in temperature of almost 200°F was caused by the loose connection degraded condition. For the ITE KMB2F800 circuit breaker, the loose connection degradation caused an increase in temperature of approximately 260°F, noted by the infrared scanner and pyrometer, Figure 4-78.

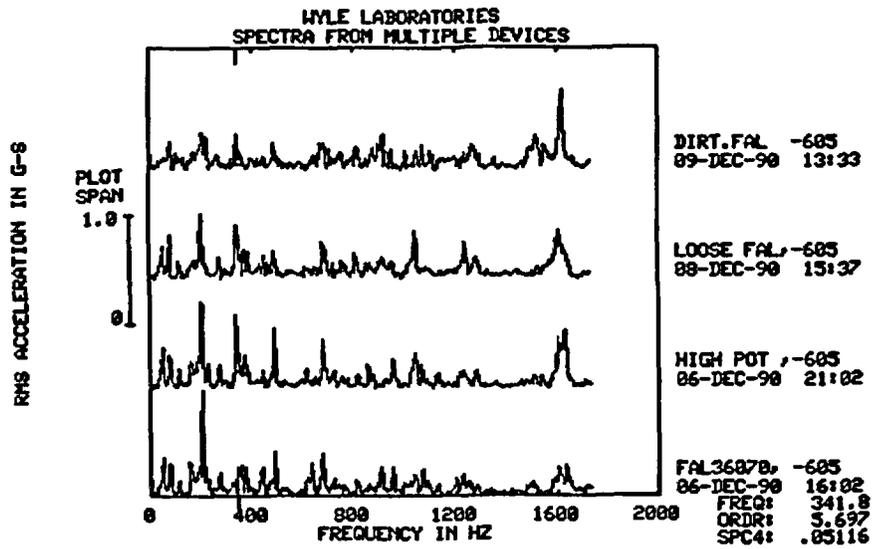
**Figure 4-79. Square D FAL36070 Molded Case
Circuit Breaker Vibration Signatures
During Degraded Conditions**

Vibration signature differences were caused by all three of the degraded conditions for the Square D FAL36070 molded case circuit breaker, Figure 4-79. Significant vibration signature differences were caused by the degraded condition of high potential by adding a peak at 340 Hz, by the degraded condition of loose connections by reduction in amplitude at 500 Hz and by the degraded condition of dirt accumulation by reducing the amplitude at several frequencies, most notably 203 Hz.

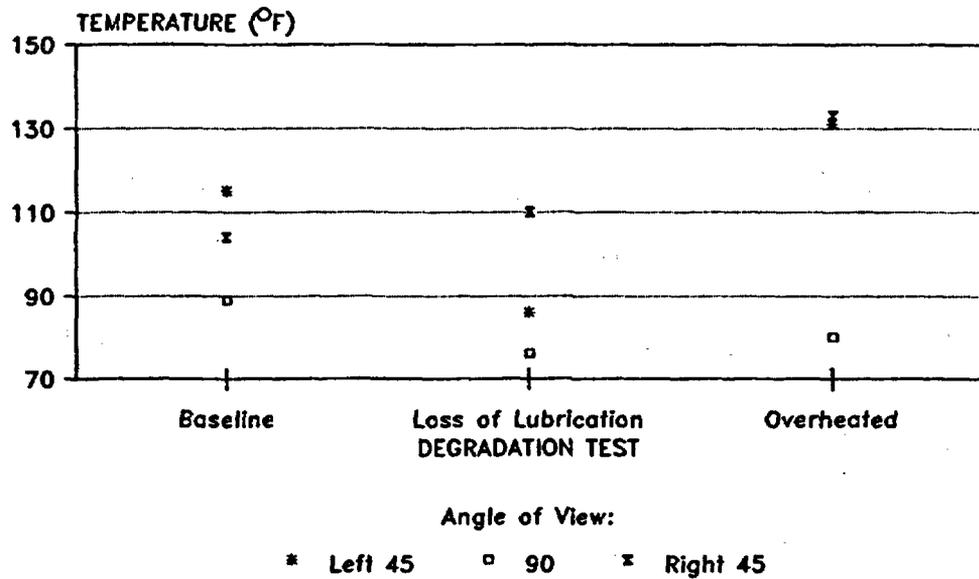
Figure 4-84. Infrared Pyrometry Comparison Degradation Tests Metal Clad Circuit Breaker

Infrared pyrometry showed temperature changes in one out of five degraded conditions, Figure 4-84. The overheated condition caused an increase of 30°F to the EC-1 series overcurrent trip devices.

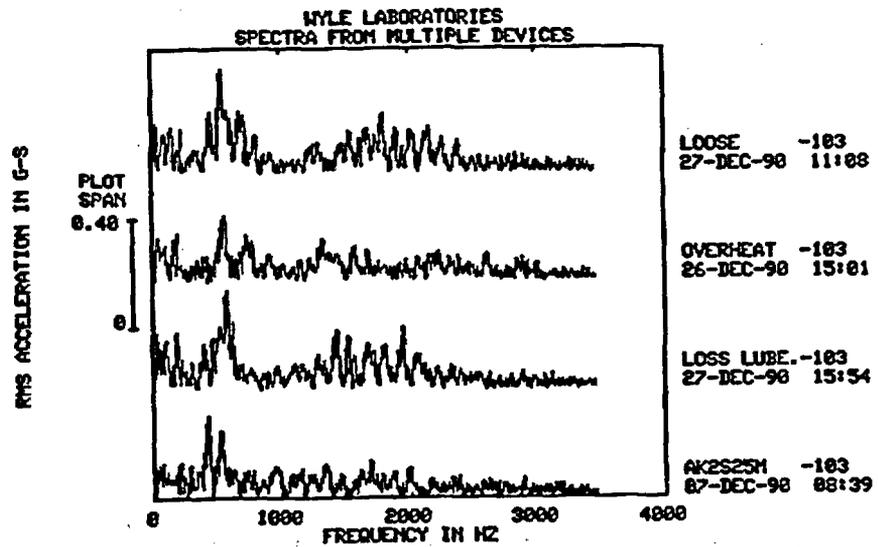
Figure 4-85. Vibration Signatures of Metal Clad Circuit Breakers During Degraded Conditions

Vibration signature differences were caused by all three of the degraded conditions for the GE AK-2S-25-M metal clad circuit breaker, Figure 4-85. Significant vibration signature differences were caused by the degraded condition of loss of lubricant by adding peaks at 180 Hz and below and between 1430 and 1950 Hz, as well as a change in the spectrum at 530 Hz. The degraded condition of overheat caused additional peaks at 730 to 780 Hz. The loose connections degradation caused additional vibration from approximately 1500 to 2400 Hz.

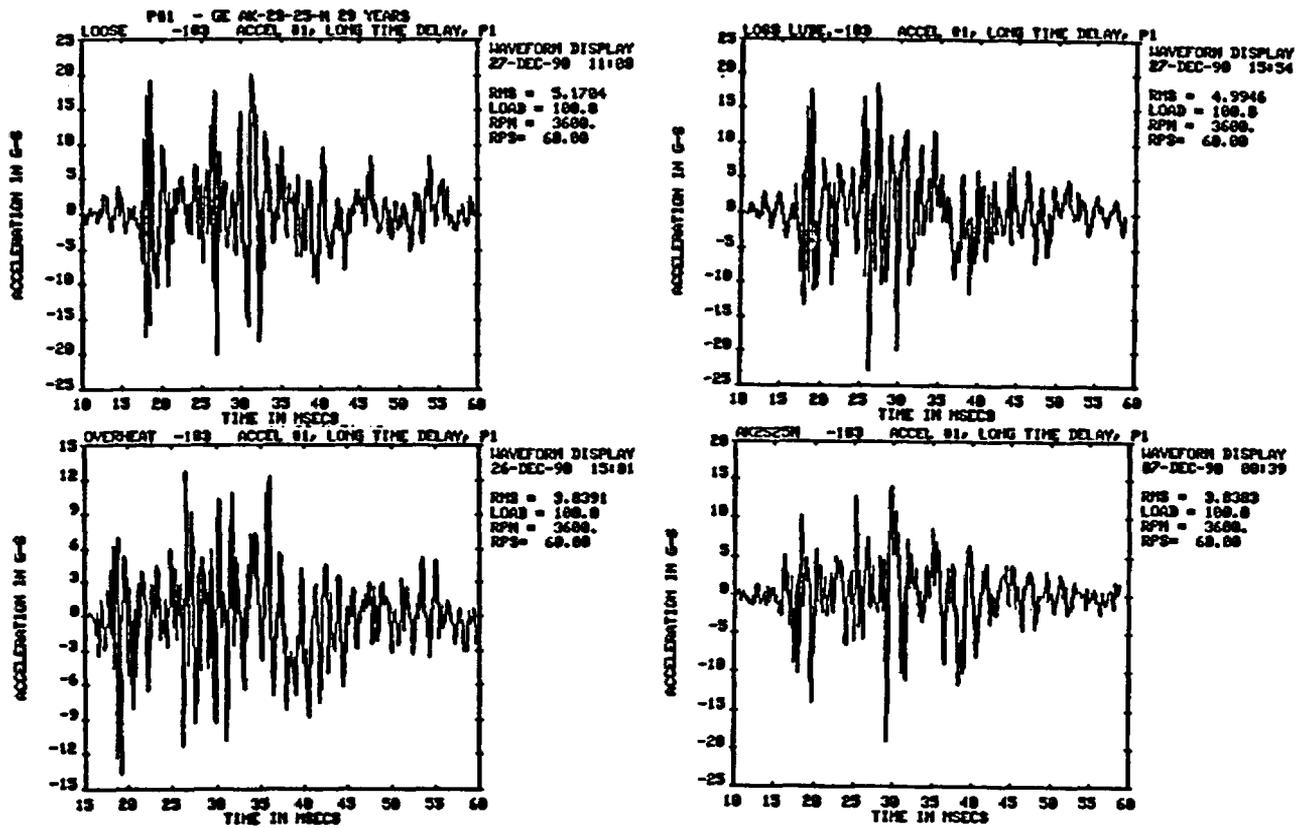
Figure 4-86. Vibration Time History Signatures of Metal Clad Circuit Breakers During Degraded Conditions

The time history of the vibration signatures also exhibited changes caused by the degraded conditions. Figure 4-86 shows the time history vibration signatures for the AK-2S-25-M breaker in the as received condition and after the degraded conditions. The as received condition is on the bottom and in ascending order, the degraded conditions of loss of lubrication, overheated and loose connections. Significant differences were noted in the number of peaks, highest amplitude and time between peaks. For instance the number of peaks which exceed 6 g were 12, 32, 13 and 24 for the

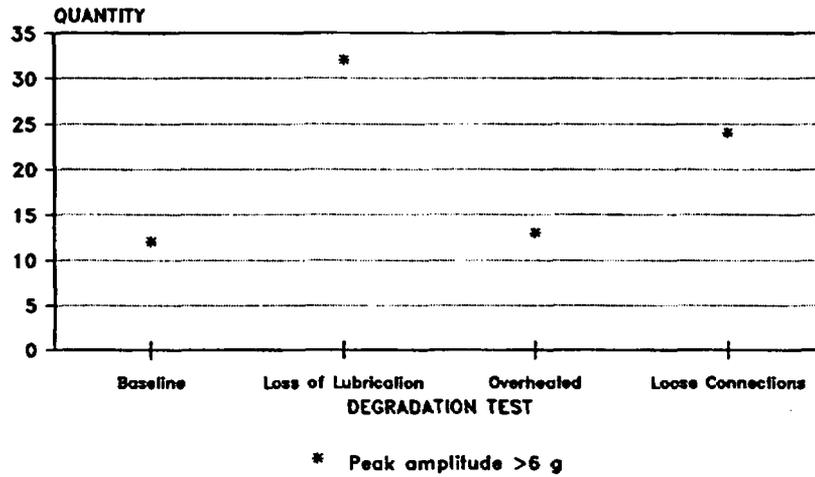
Figure 4-87. Analysis of Vibration Signatures, Quantity of Peaks Metal Clad Circuit Breakers

conditions , as received, loss of lubricant, overheated, and loose connections, respectively, Figure 4-87. Increases in the maximum amplitude were caused by the degraded conditions of loss of lubrication and loose connections, Figure 4-88, and the timing between the first through fourth highest peaks was most effected by the degraded condition of overheated, Figure 4-89.

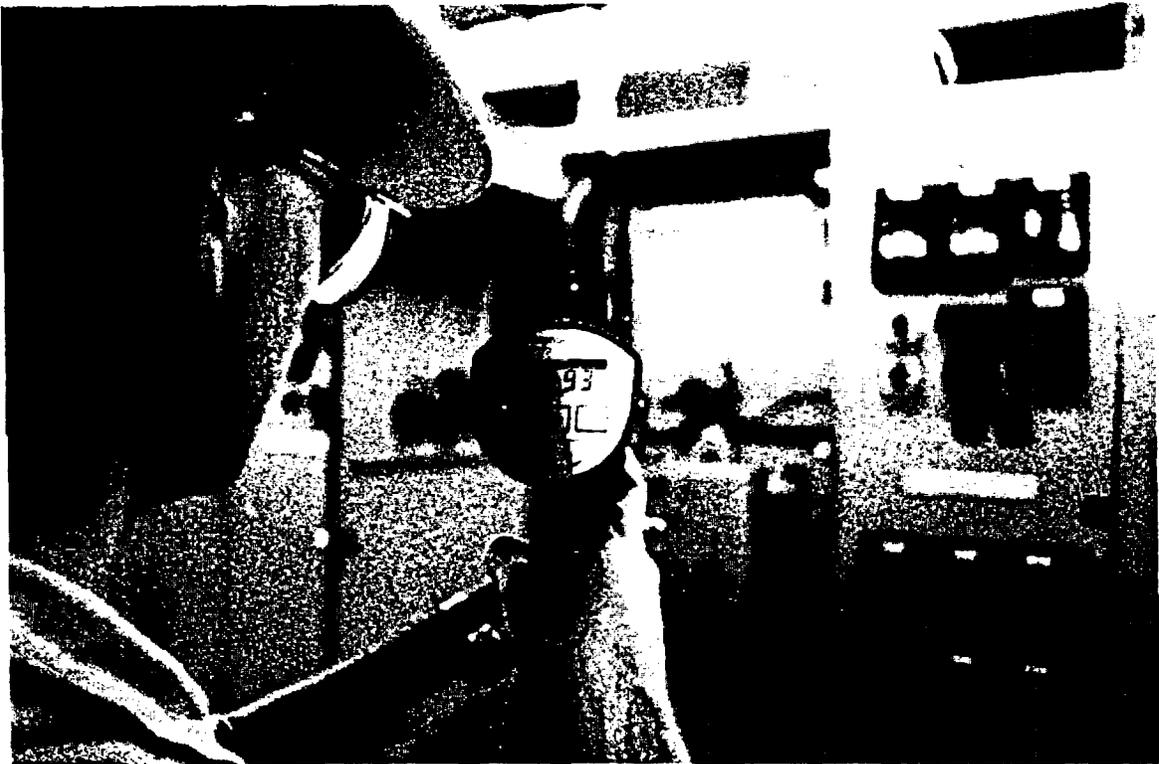
**Figure 4-92. Temperature Measurement of 4KV
Metal Clad Circuit Breaker at Nine Mile
Point Unit 1 with Hand Held Pyrometer**

The doors of two power boards were opened by Niagara Mohawk electricians so that infrared temperatures and vibration signatures could be obtained directly from the circuit breakers. The vibration signatures were obtained while the breakers were in their closed condition. Figure 4-92 shows the use of the infrared pyrometer on one of the 4 KV metal clad circuit breakers. The inside temperature on the Clean-up Pump No. 12 Breaker was approximately 15°F hotter than outside since the current in the breaker was approximately 1000 amps. All circuit breakers were operating near the same temperature regardless of the current. No significant changes in temperatures were observed. The circuit breakers and relays were clean and had no obvious problems.

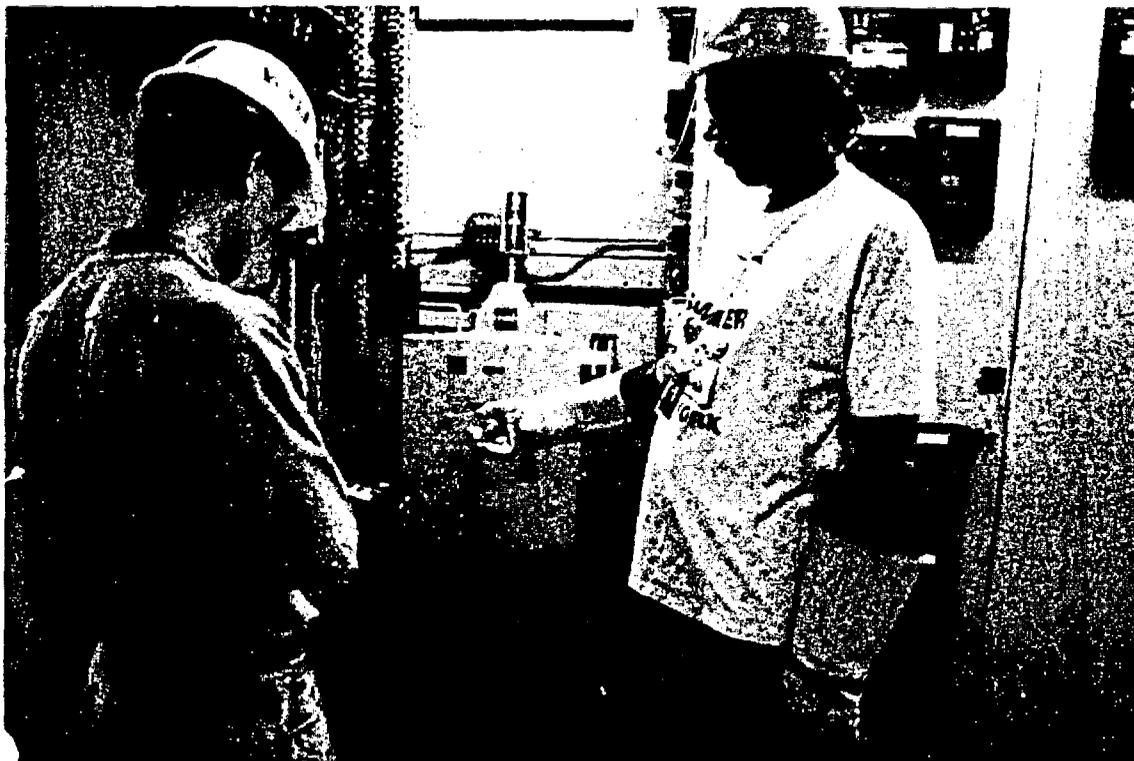
**Figure 4-93. Vibration Monitoring of 4KV
Metal Clad Circuit Breakers
at Nine Mile Point Unit 1**

Figure 4-93 shows the Niagara Mohawk electrician assisting in the vibration data acquisition. The vibration data was acquired with a hand held data acquisition computer. This computer was able to acquire and store several vibration signatures. The signature was displayed on the screen of the computer and data then transferred and reduced at the host computer after completion of the in-situ efforts.

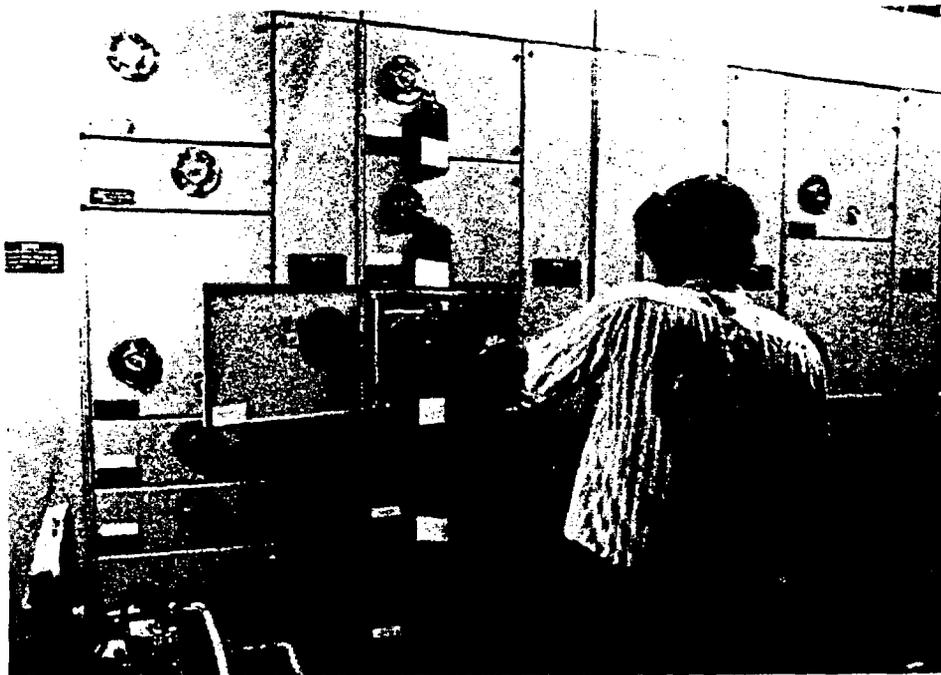
**Figure 4-94. Disconnecting Leads
of Molded Case Circuit Breakers Prior to
300% Overload Trip Test at Catawba Nuclear Station**

Plant personnel were observed performing inspection and surveillances on molded case circuit breakers in motor control centers (MCC). The procedures required the disconnection of the wiring to the breakers so that a 300% overload test could be performed on the breakers. Figure 4-94 shows the Catawba electrician disconnecting and tagging the leads. After the trip tests were performed, the leads were attached and voltages measured to assure proper connections, Figure 4-95.

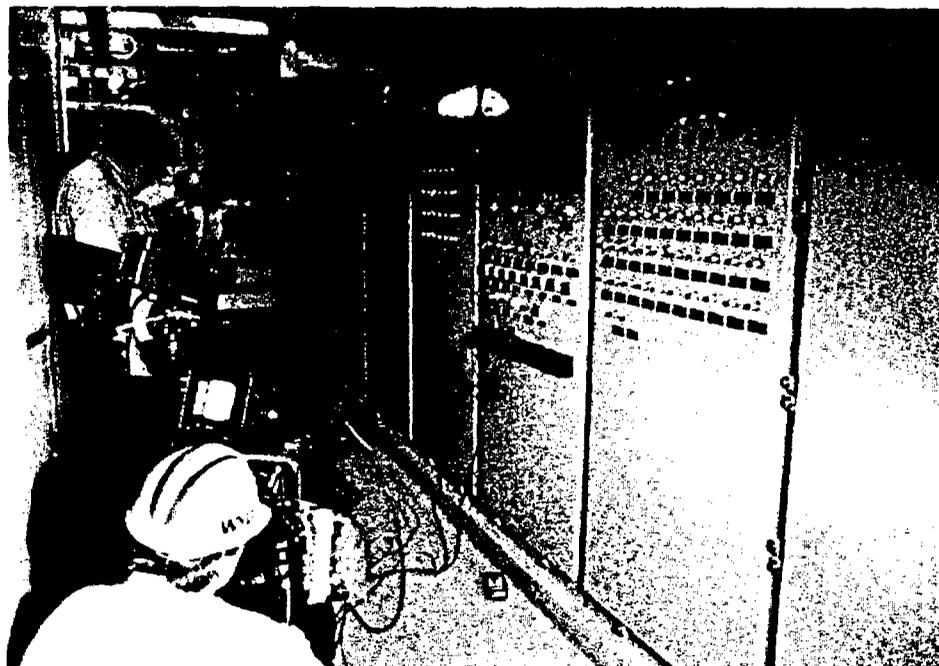
**Figure 4-96. Pick-up Voltage Testing and
Infrared Temperature Measurement with
AGEMA Thermovision 870 Infrared Scanner at Catawba**

Pick-up and drop out voltage tests of control relays were observed. In order to perform pick-up and drop out voltage tests, it was necessary to disconnect the relay from the circuit. The test set used at Catawba was designed to be portable and contained a variable power supply, volt meter and timing circuit. Test blocks had been installed in the circuits of relays which were tested monthly for pick-up and drop out voltage in order to facilitate the testing. This made connecting and disconnecting the relays an effortless process as compared to that required when testing the molded case circuit breakers. Figure 4-96 shows the Catawba staff testing pick-up and drop out voltage on relays in the diesel generator sequencing panel. These relays were tested at monthly intervals. The connections to the test blocks and the infrared scanning, which was performed during the pick-up and drop out voltage tests, were also evident.
