SECTION 6

FRACTOGRAPHY AND OTHER EXAMINATIONS

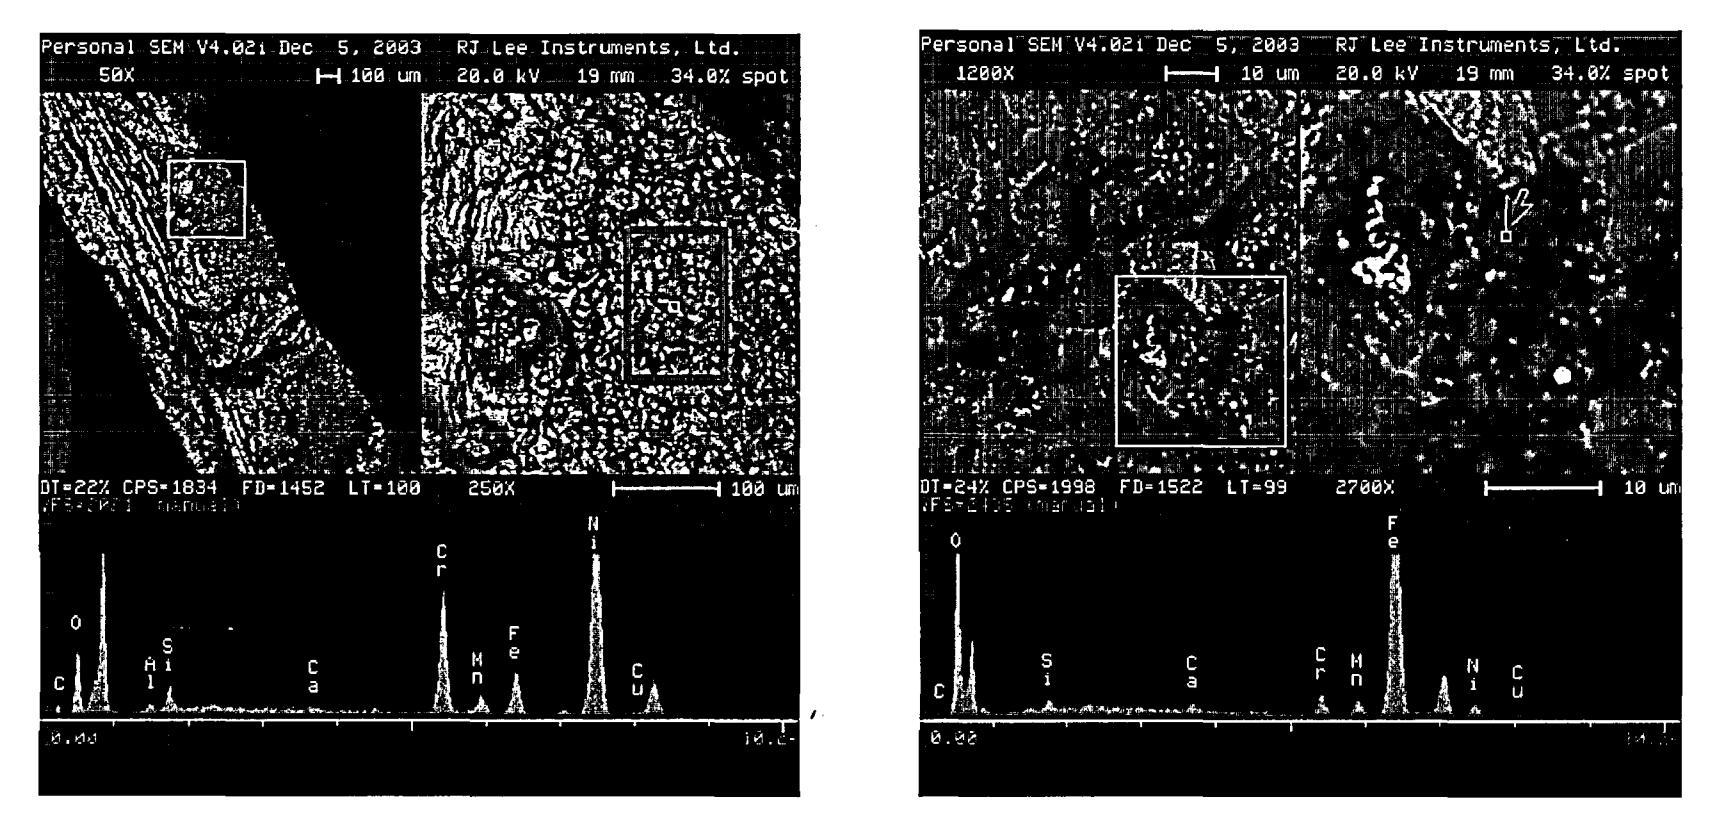
a) IGSCC (Area 1)

b) IGSCC (Area 3)

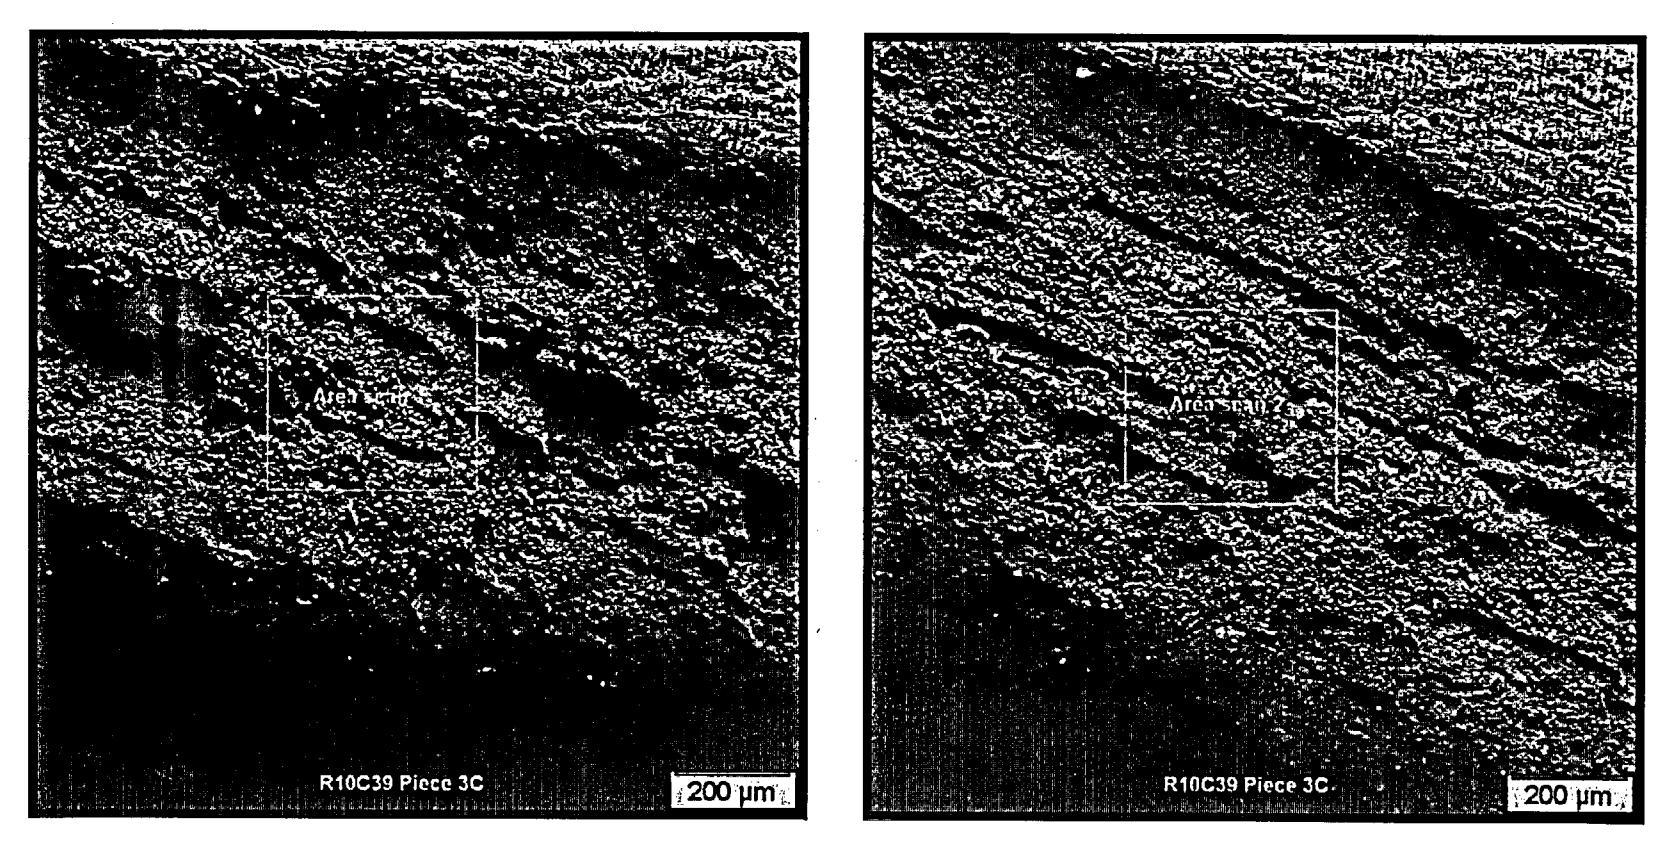
Figure 6 – 8 R10C39 – Piece 3C (Freespan) SEM Photographs Illustrating Ductile Areas Selected for EDS

a) Ductile Fracture Face (Area 1)

b) Ductile Fracture Face (Area 2)

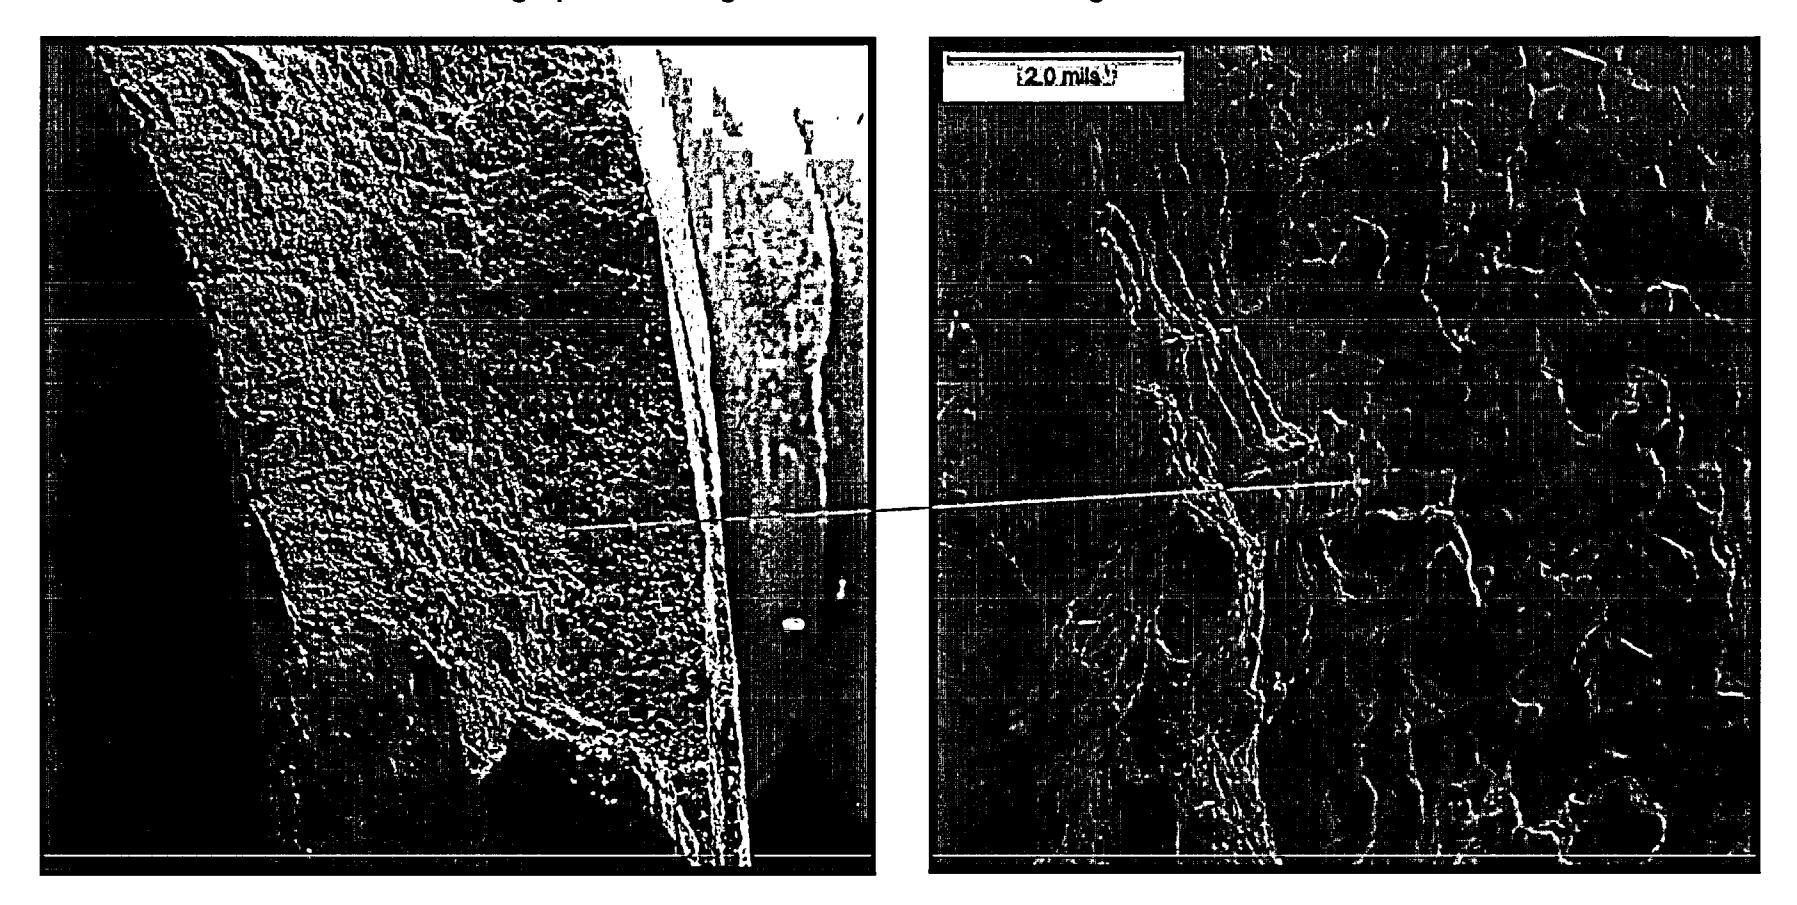
Figure 6 – 12 R10C39 – Piece 4B – Section 4B2A (H03 Plate) SEM Photograph Showing OD Surface Adjacent to Burst Fracture

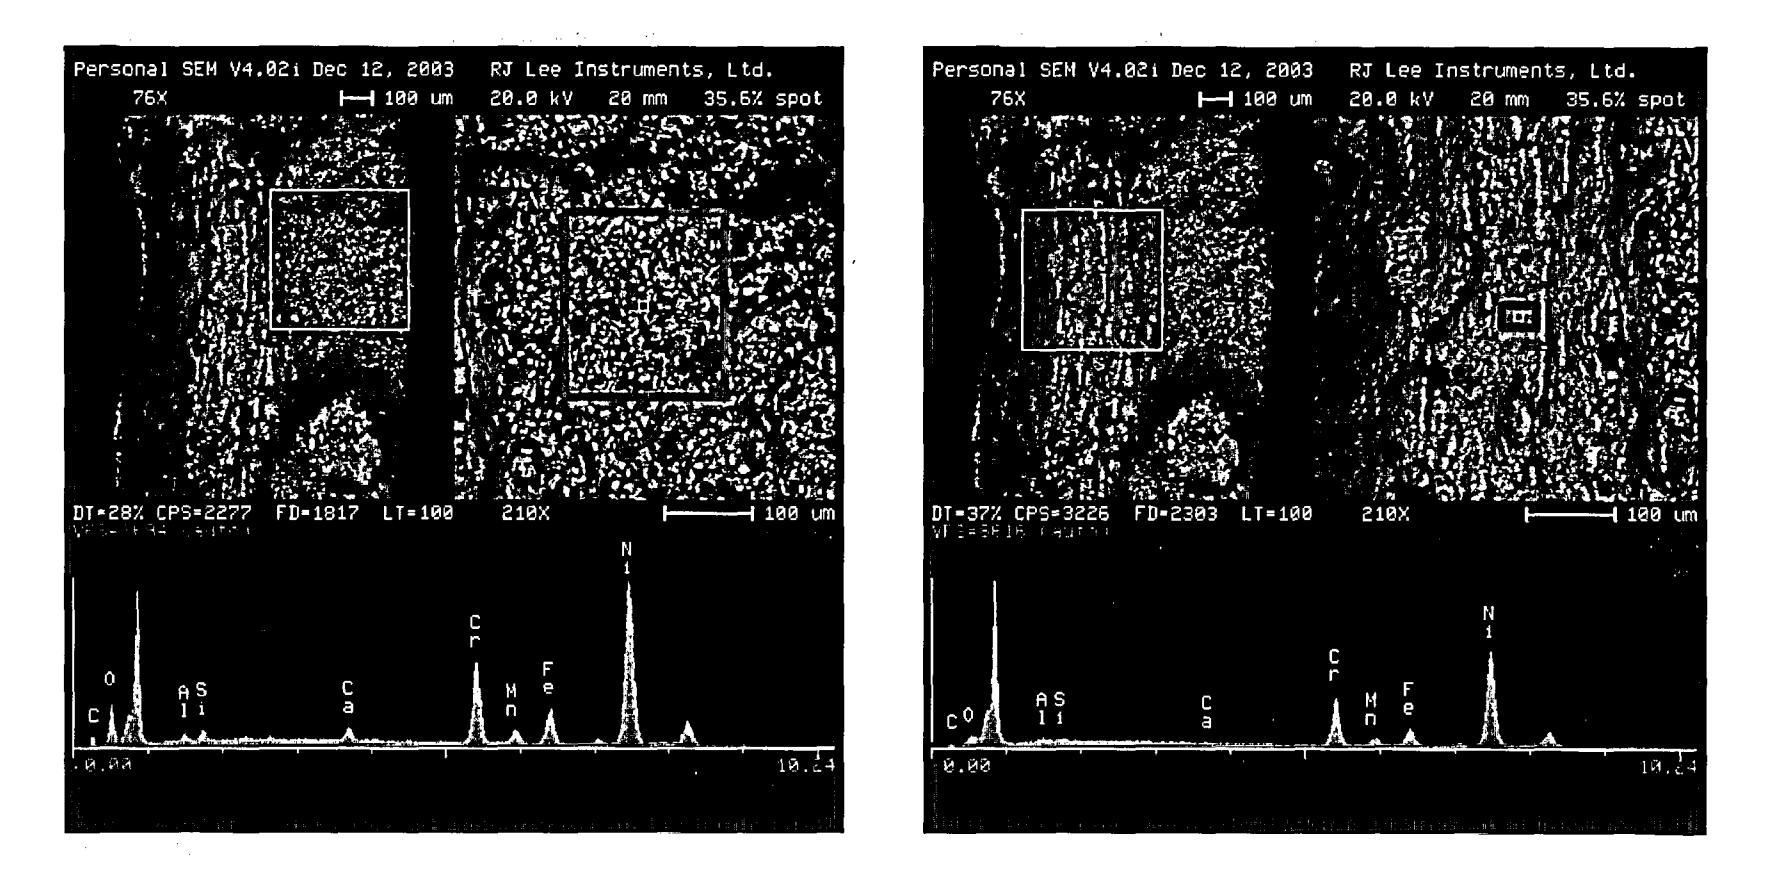
Figure 6 – 14 R10C39 – Piece 4B – Section 4B2A (H03 Plate) SEM Photographs Illustrating Areas Selected for EDS

d) Ductile Fracture (Area 4)

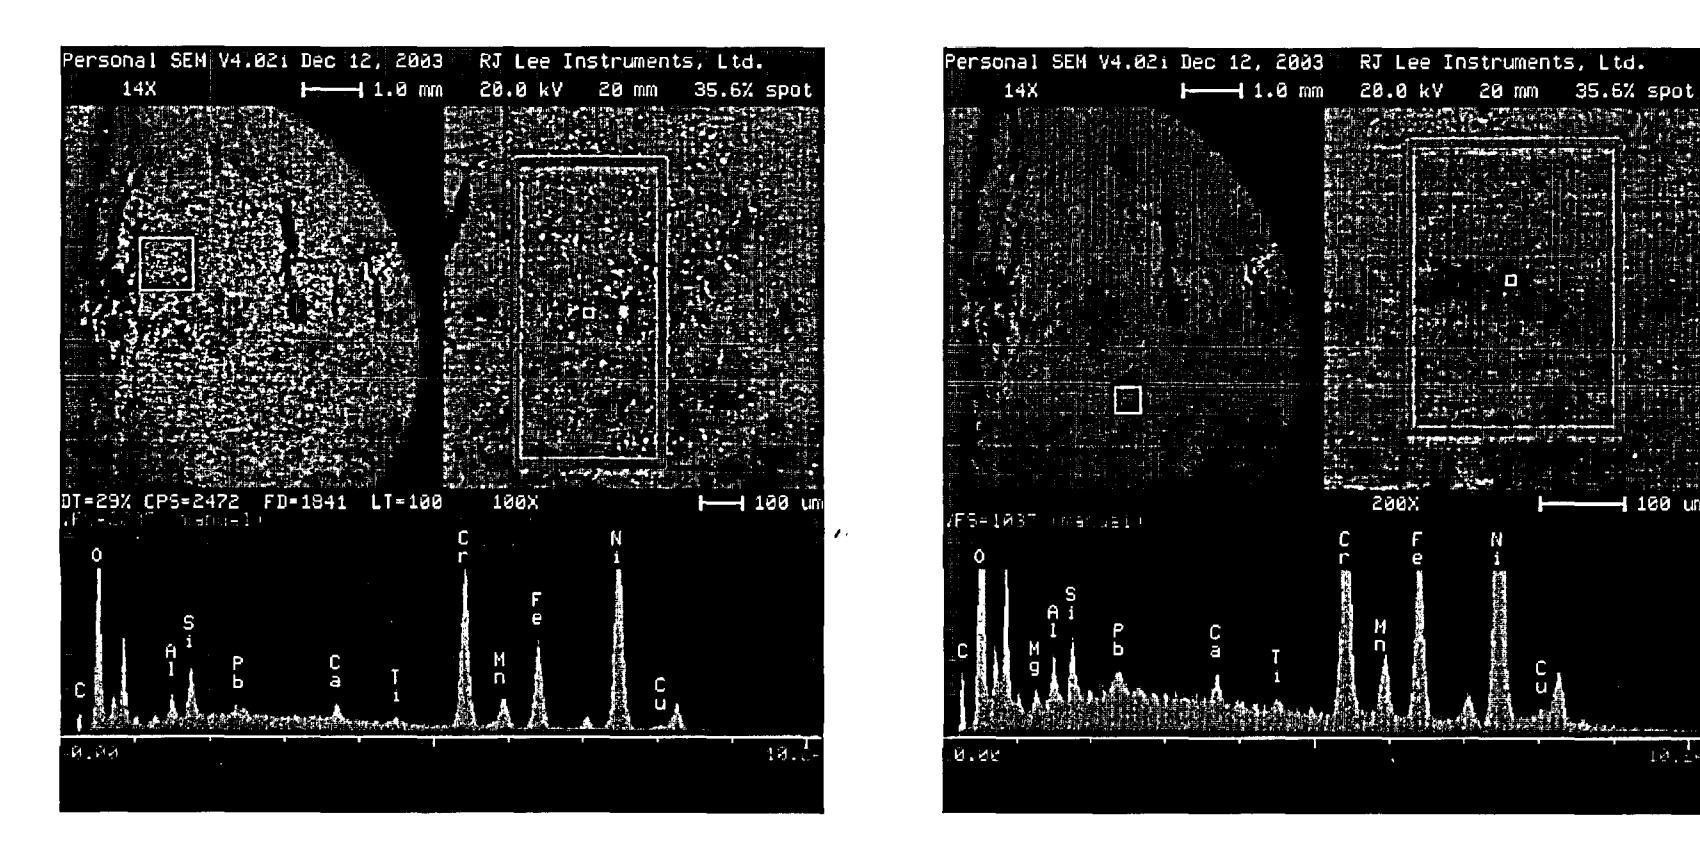
Figure 6 – 14 (Cont'd) R10C39 – Piece 4B – Section 4B2A (H03 Plate) SEM Photographs Illustrating Areas Selected for EDS

c) IGSCC (Area 3)

d) Ductile Fracture (Area 6)

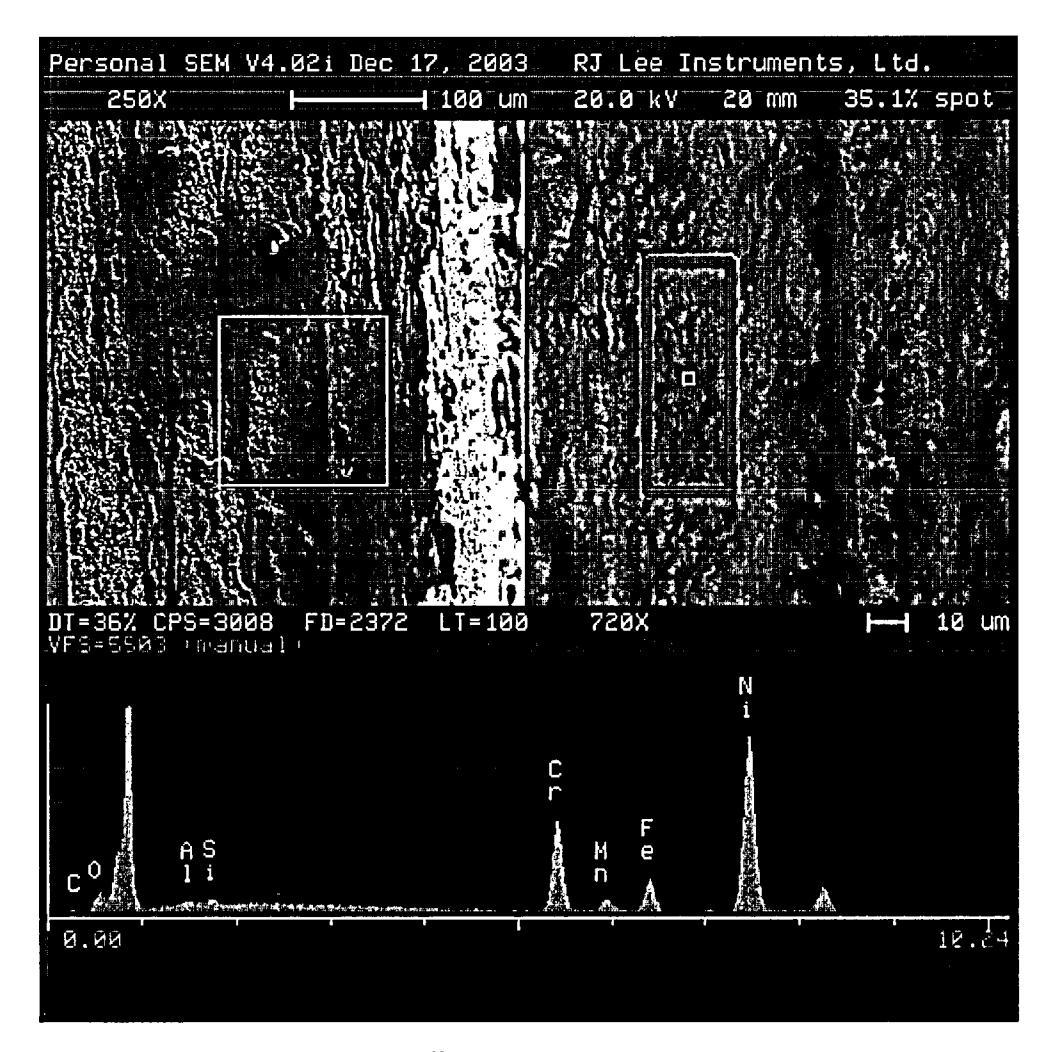
Figure 6-19 R11C41HL – Piece 2B – Section 2B2A General Appearance of Freespan Burst Fracture Face Located Above TTS

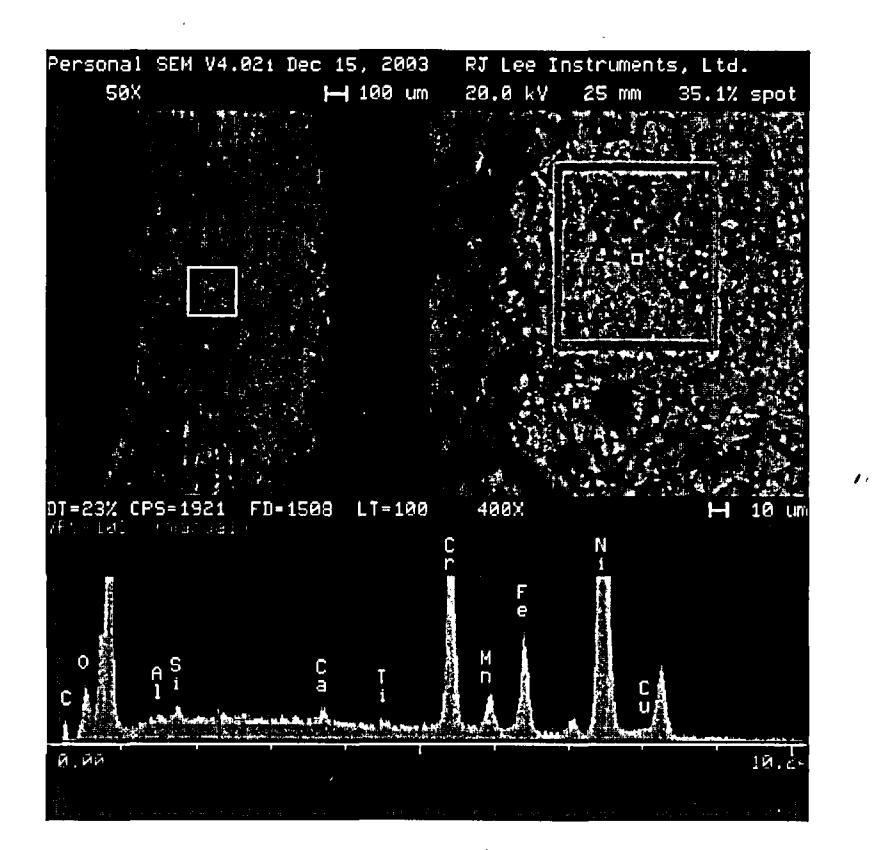
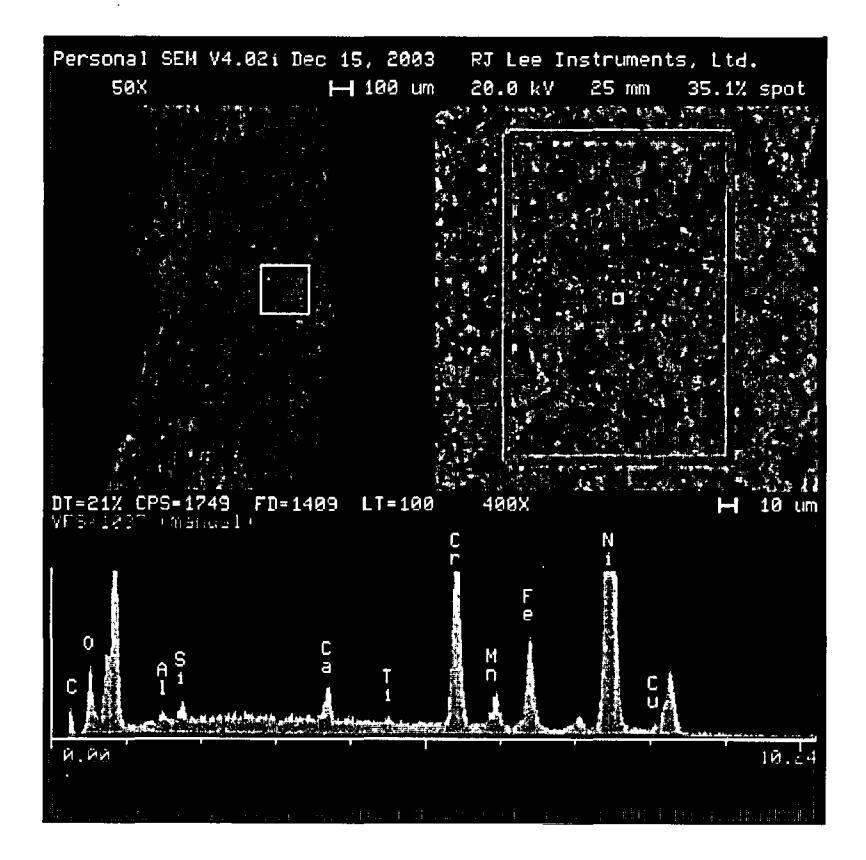
Figure 6 – 25 R11C41 – Piece 3B – Section 3B2A (H02 Plate) SEM Photograph Showing OD Surface Adjacent to Burst Fracture

b) Intergranular Near Crack Mouth

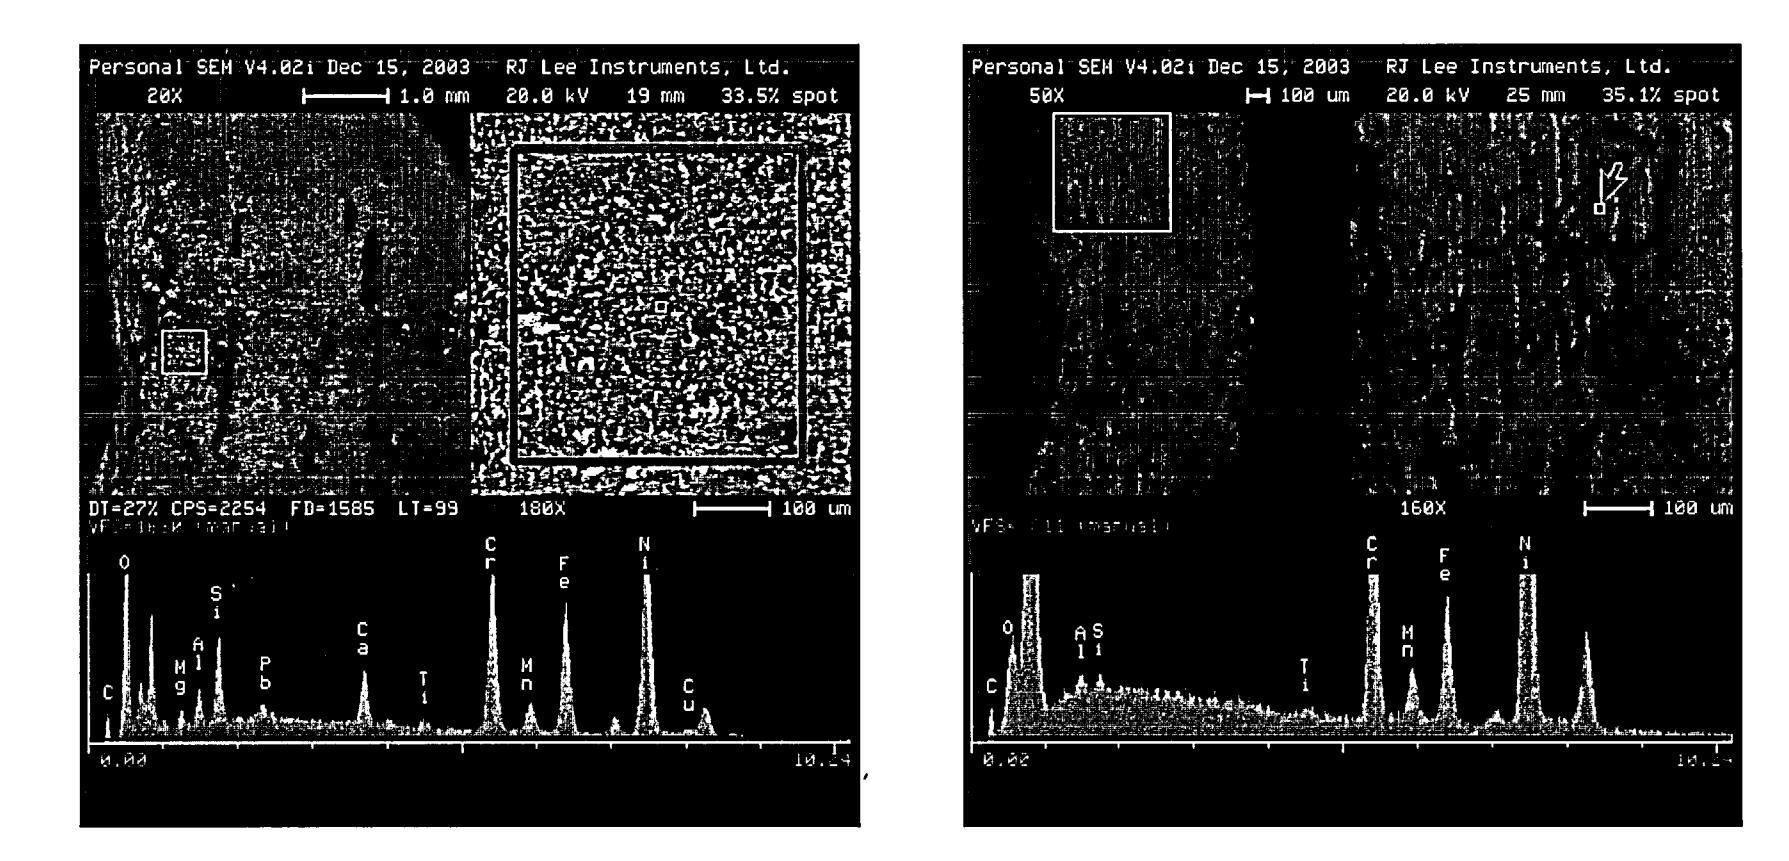
Figure 6 – 26 R11C41 – Piece 3B – Section 3B2A (H02 Plate) SEM Photographs Illustrating Areas Selected for EDS

c) OD Surface

d) Ductile Facture

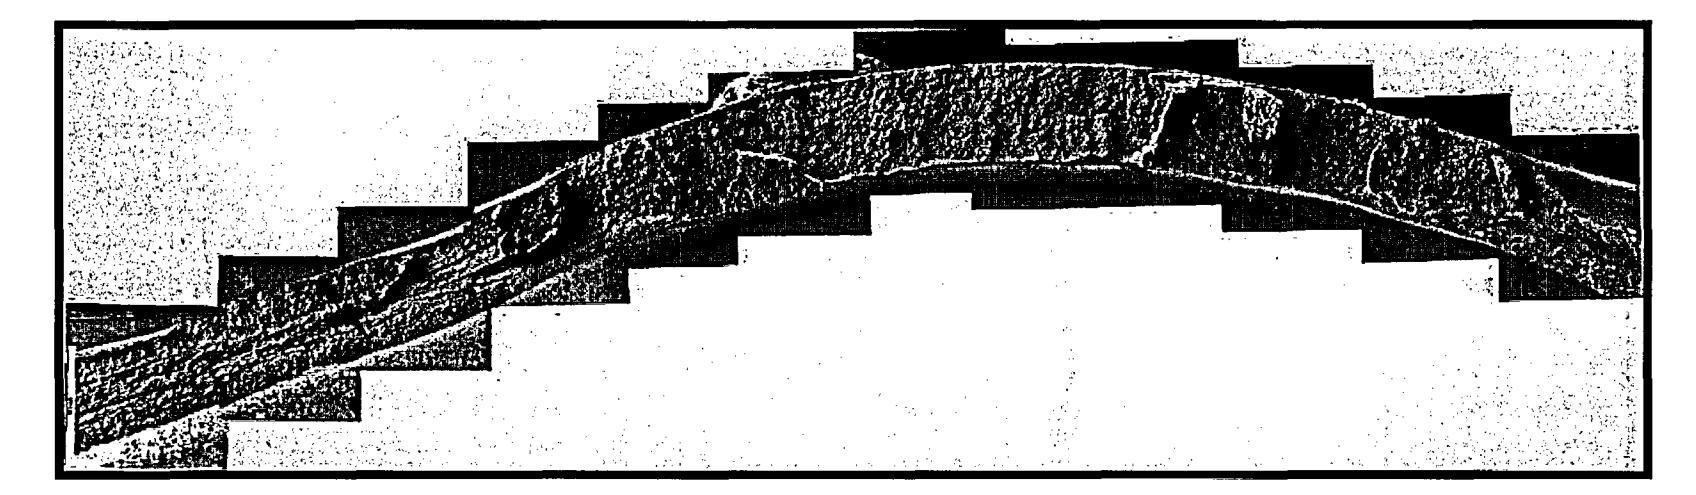
Figure 6-27 R11C41 – Piece 4B – Section 4B2A Montage of Burst Fracture Face Associated with H03 Plate

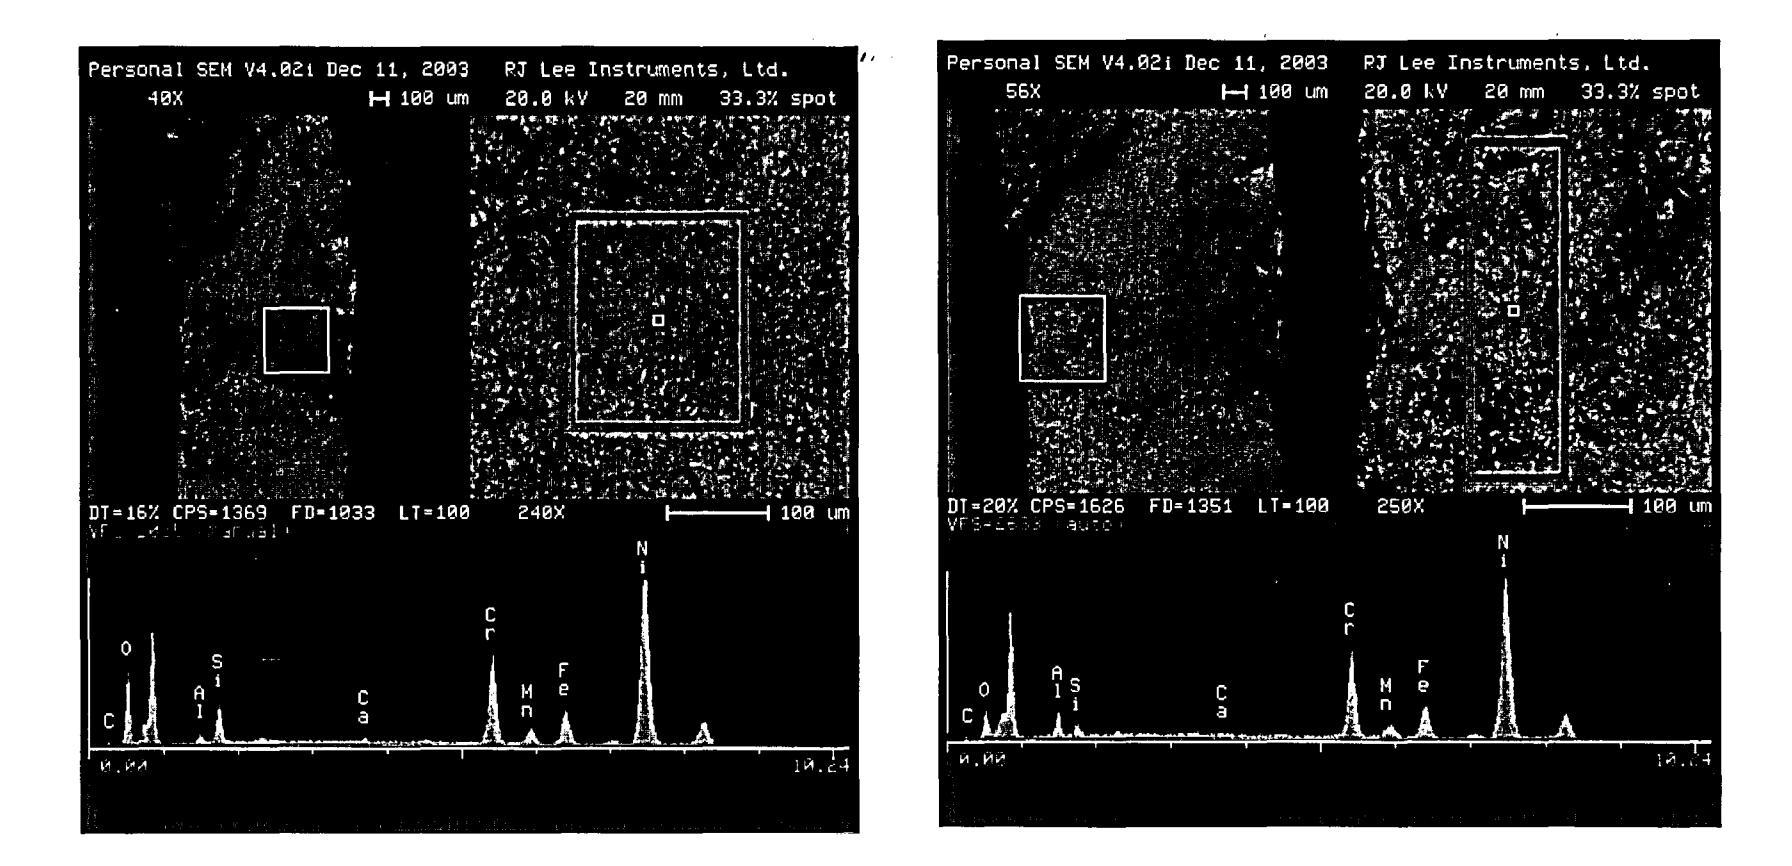
Figure 6 – 30 R11C41 – Piece 4B – Section 4B2A (H03 Plate) SEM Photographs Illustrating Intergranular Fracture Face

a) Intergranular Near Crack Mouth

b) Intergranular Near Crack Tip

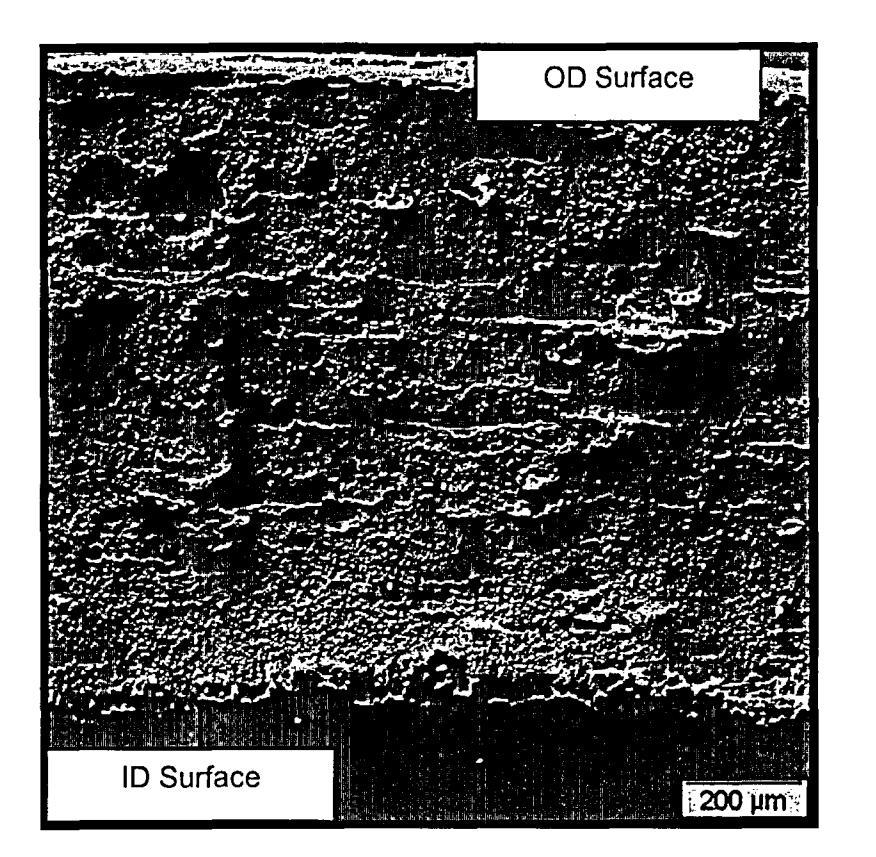
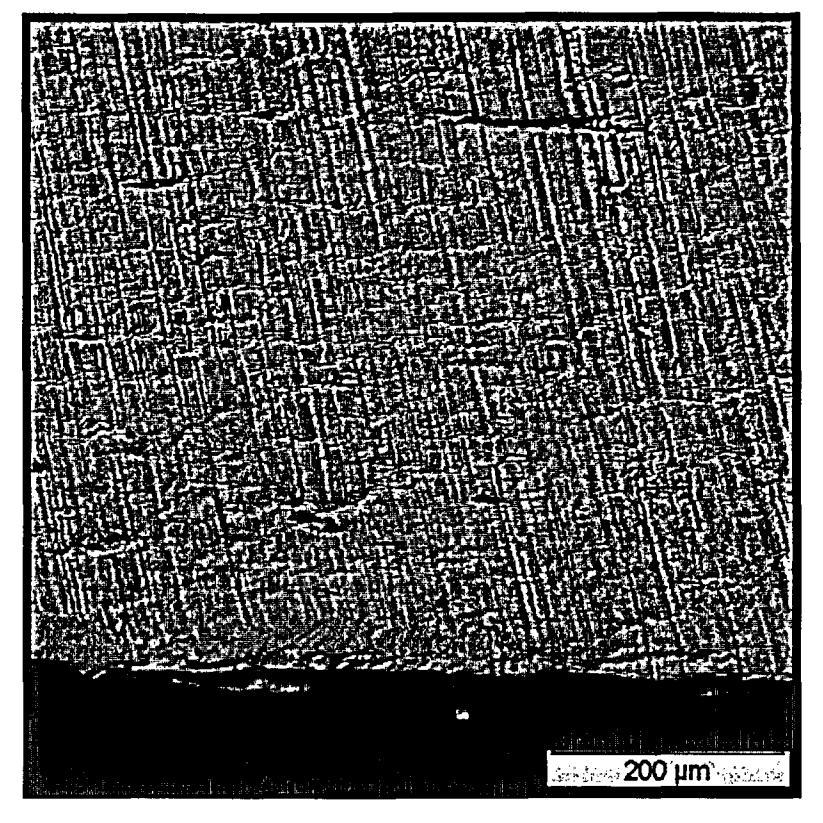
Figure 6 – 32 R11C41 – Piece 5A – Section 5A2A (Freespan) SEM Photograph Illustrating Ductile Fracture Face

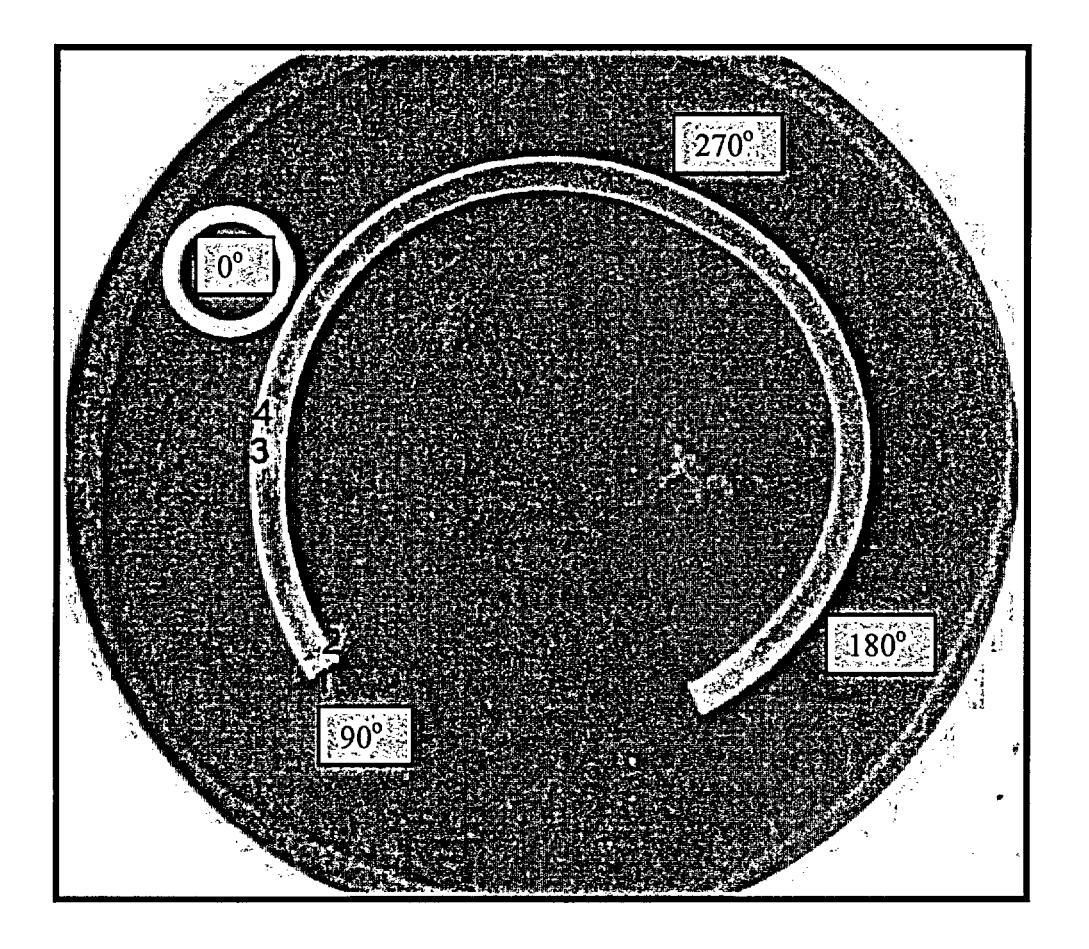
Transverse Section of R10C39 HL- Piece 3B – Specimen 3B2B2 (Mount 2621) Showing IGSCC Locations Associated with H02 Plate Intersection

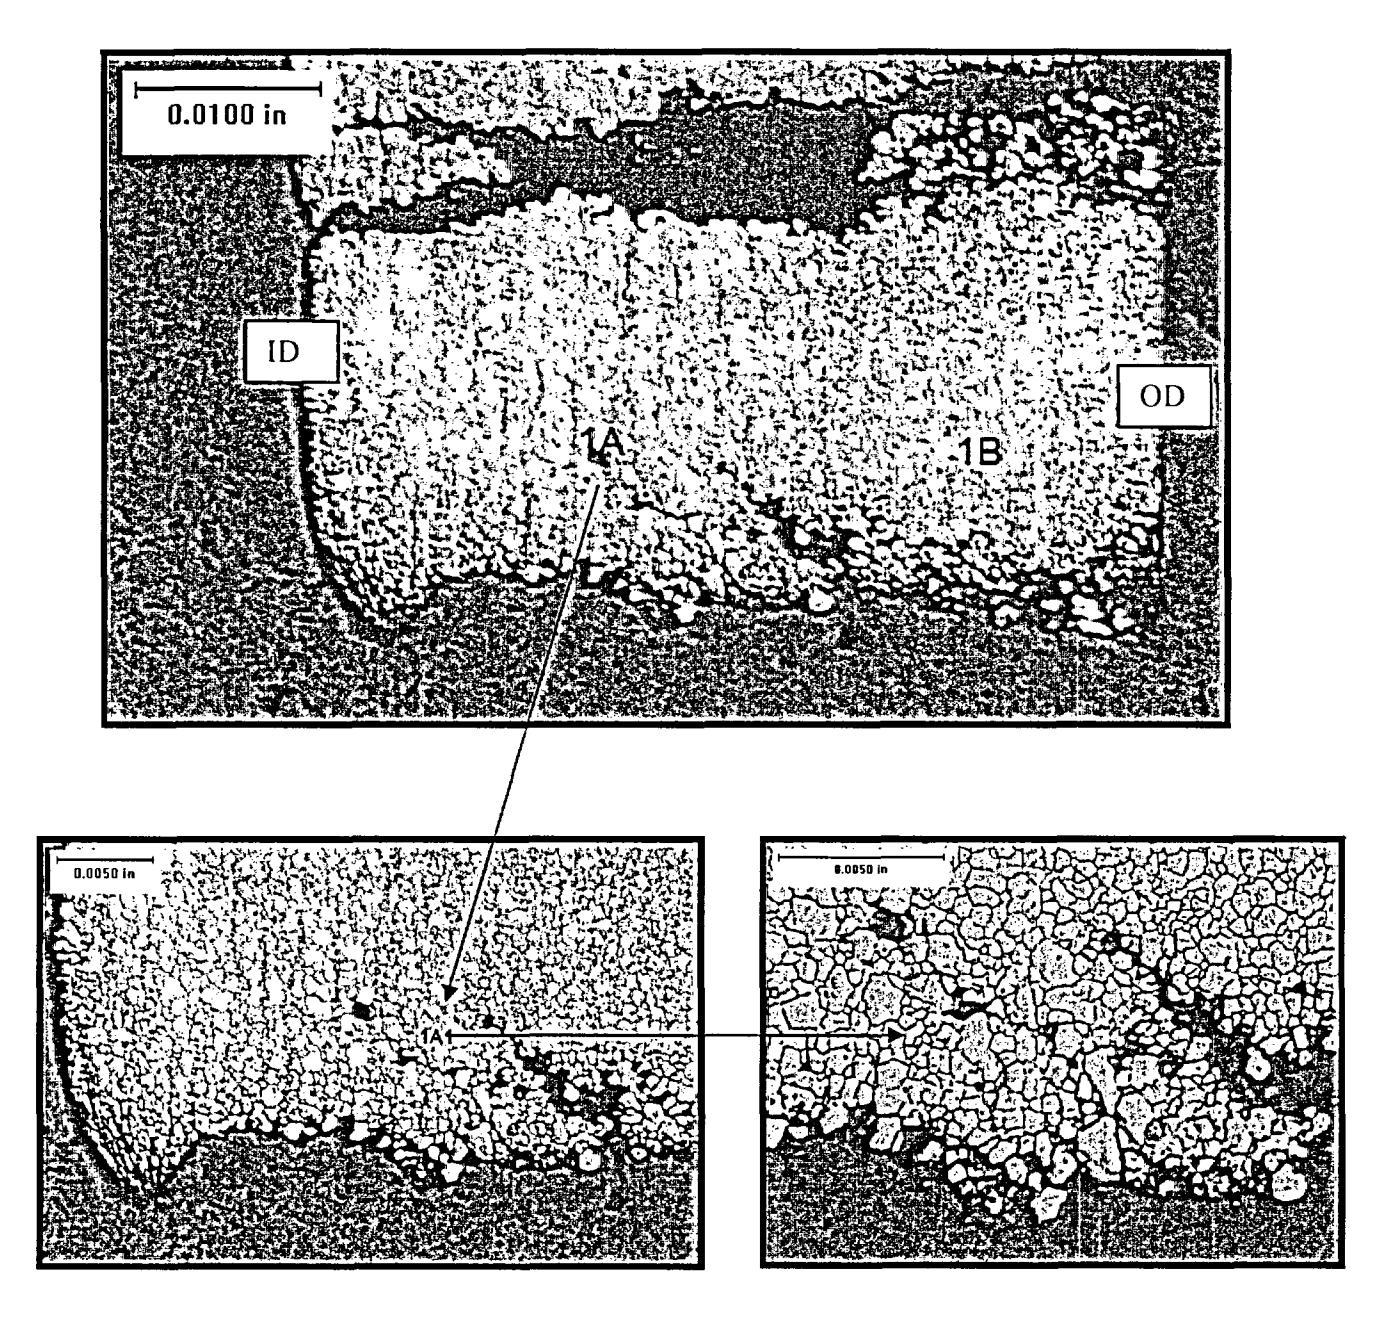
The orientation, extent, and morphology of the ODSCC reported at the H02 tube support plate of R10C39 HL were explored by examining a transverse metallographic specimen taken through the center of the axial burst. It should be noted that this region exhibited 100% through-wall IGSCC as determined by examination of the burst fracture face. The area examined is shown in Figure 7-1, while etched photomicrographs representing the ODSCC identified are shown in Figures 7-2 through 7-4. A total of four (4) OD locations were identified with IGSCC. The position 1 shown on Figure 7-1 corresponds to the burst fracture face. It should be noted that the condition shown in these figures is after the area has been pressurized to 4,931 psi. No attempt was made to find the deepest secondary crack. As seen in Figure 7-1, the observed cracking was limited to the quadrant of the tube that was likely in contact with the TSP and thereby promoted the buildup of deposits and the subsequent of secondary side chemicals. Figures 7-2 and 7-3 show the deepest crack seen on this specimen. Minimal evidence of branching or cellular corrosion was observed. Figure 7-4 illustrates the only additional region where IGSCC was seen on this specimen. Once again, minimal cellular corrosion or IGA was noted. The approximate depth of the IGSCC shown in Figure 7-4 was 0.014 inch.

Figure 7-2 R10C39 HL- Piece 3B (H02 Plate) – Specimen 3B2B2 Etched Transverse Section Showing IGSCC on Burst Face

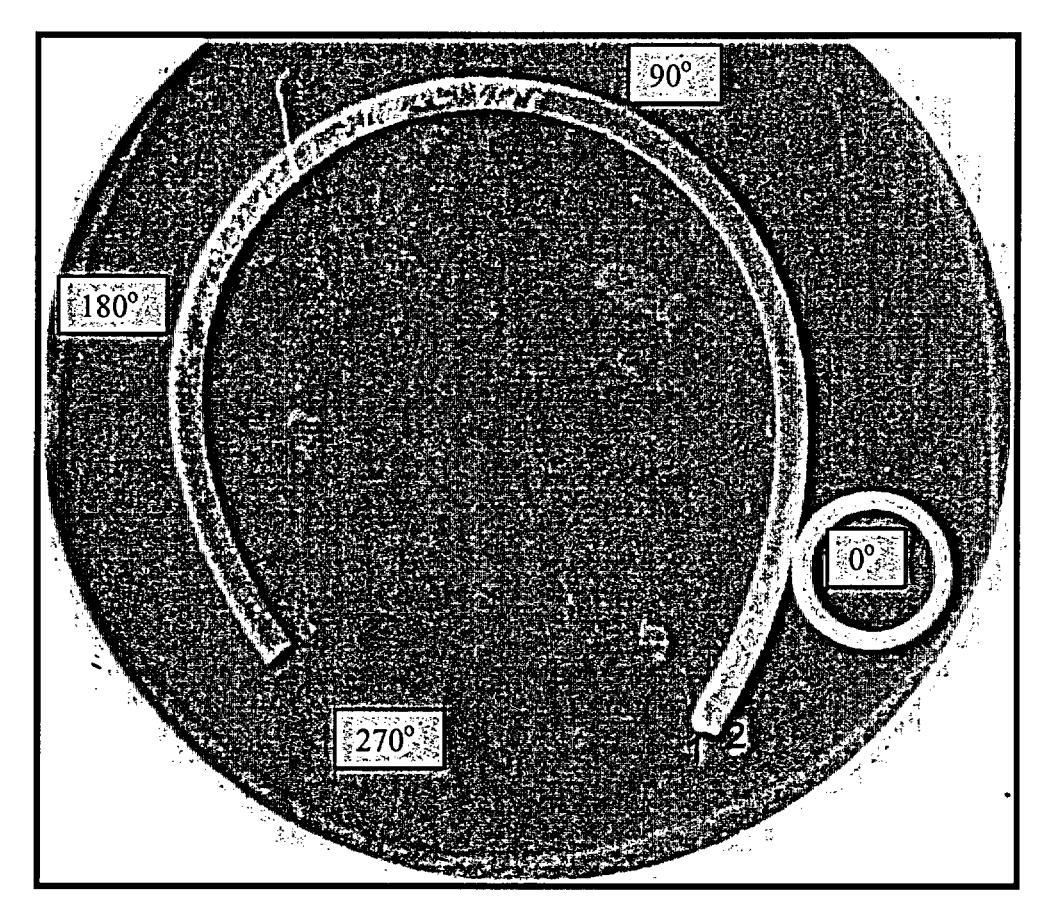
The orientation, extent, and morphology of the ODSCC reported at the H03 tube support plate of R10C39 HL were characterized by examining a transverse metallographic specimen taken through the center of the axial burst. This region exhibited 40% through-wall IGSCC as determined by examination of the burst fracture face. The area examined is shown in Figure 7-5, while etched photomicrographs representing the ODSCC identified are shown in Figures 7-6 and 7-7. Only two (2) OD locations were identified with IGSCC. Position 1 shown on Figure 7-5 corresponds to the burst fracture face. It should be noted that the condition shown in these figures is after the area has been pressurized to 12,058 psi. No attempt was made to find the deepest secondary crack. As seen in Figure 7-5, the observed cracking was limited to burst

Transverse Section of R10C39 HL- Piece 4B – Specimen 4B2B2 (Mount 2620) Showing IGSCC Locations Associated with H03 Plate Intersection

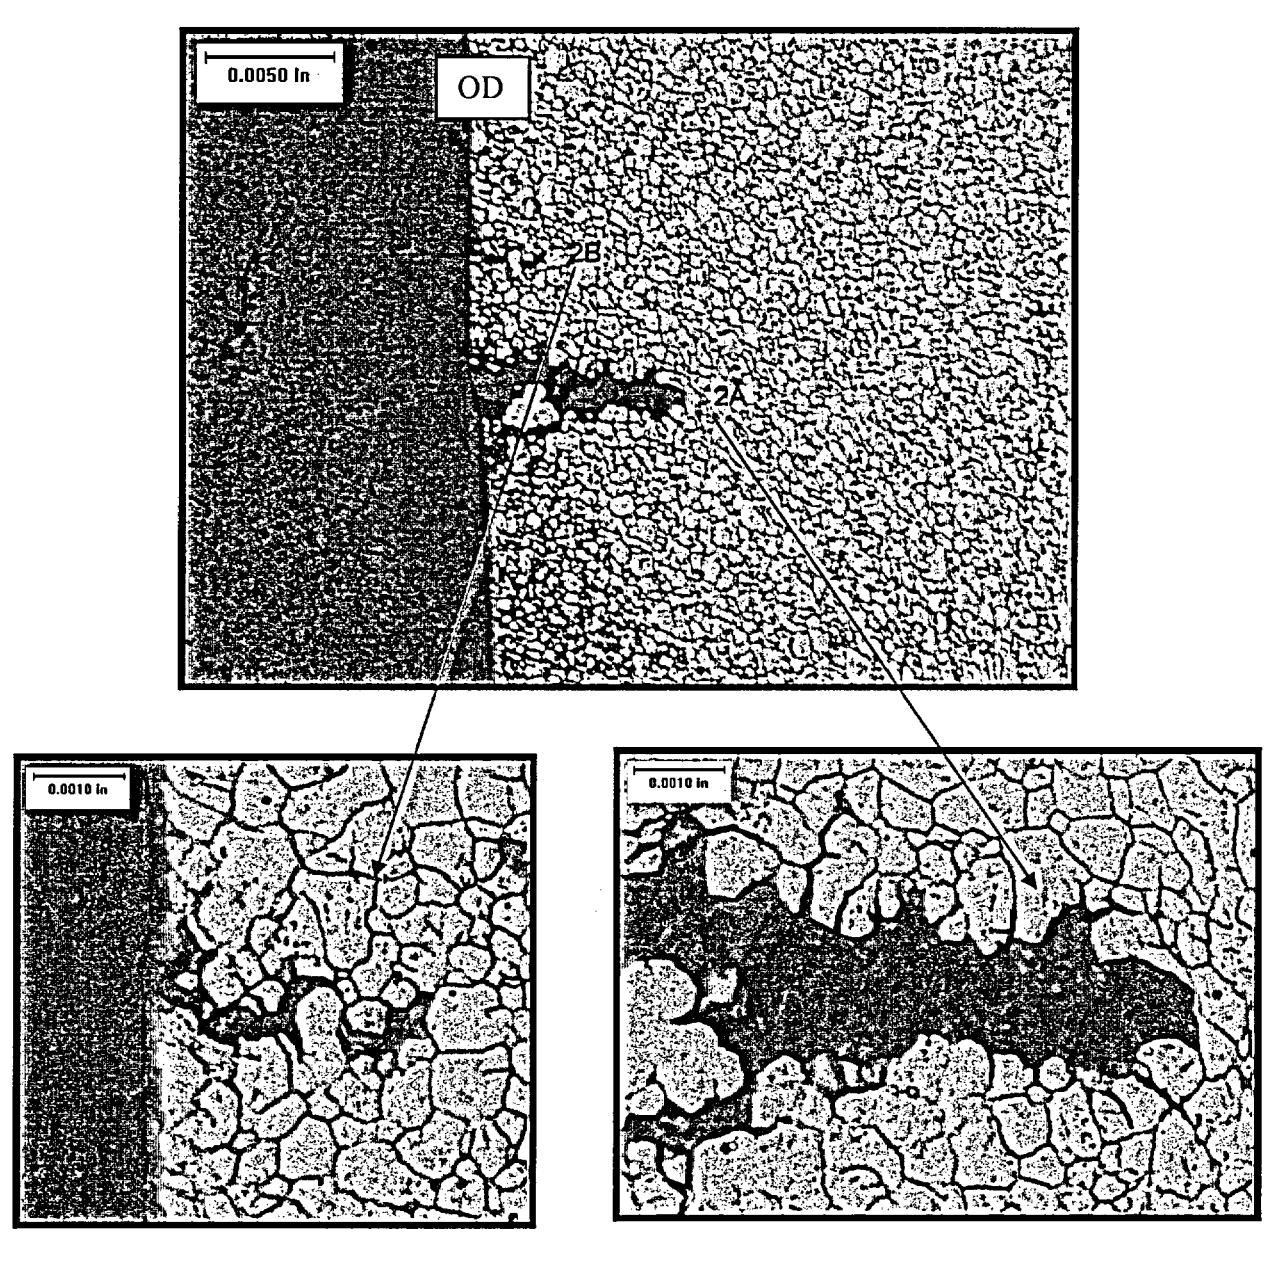
fracture area and an area near the burst face. Figure 7-6 shows that the IGSCC associated with the burst fracture face had none to minimal evidence of branching cracks or cellular corrosion. As is seen in Figure 7-6, the burst face is characterized by both intergranular and ductile fracture features. The only other evidence of IGSCC seen on this specimen was two (2) shallow indications seen near the burst fracture, Figure 7-7. The indications are intergranular in nature, with minimal evidence of cellular corrosion. The indications are blunted due to burst test pressurization. Once again, no appreciable evidence of intergranular penetration was noted on the OD surface.

Figure 7- 7 R10C39 HL- Piece 4B (H03 Plate) – Specimen 4B2B2 – Position 2 Transverse Section Adjacent to Burst Face Showing IGSCC
