SECTION 6

FRACTOGRAPHY AND OTHER EXAMINATIONS

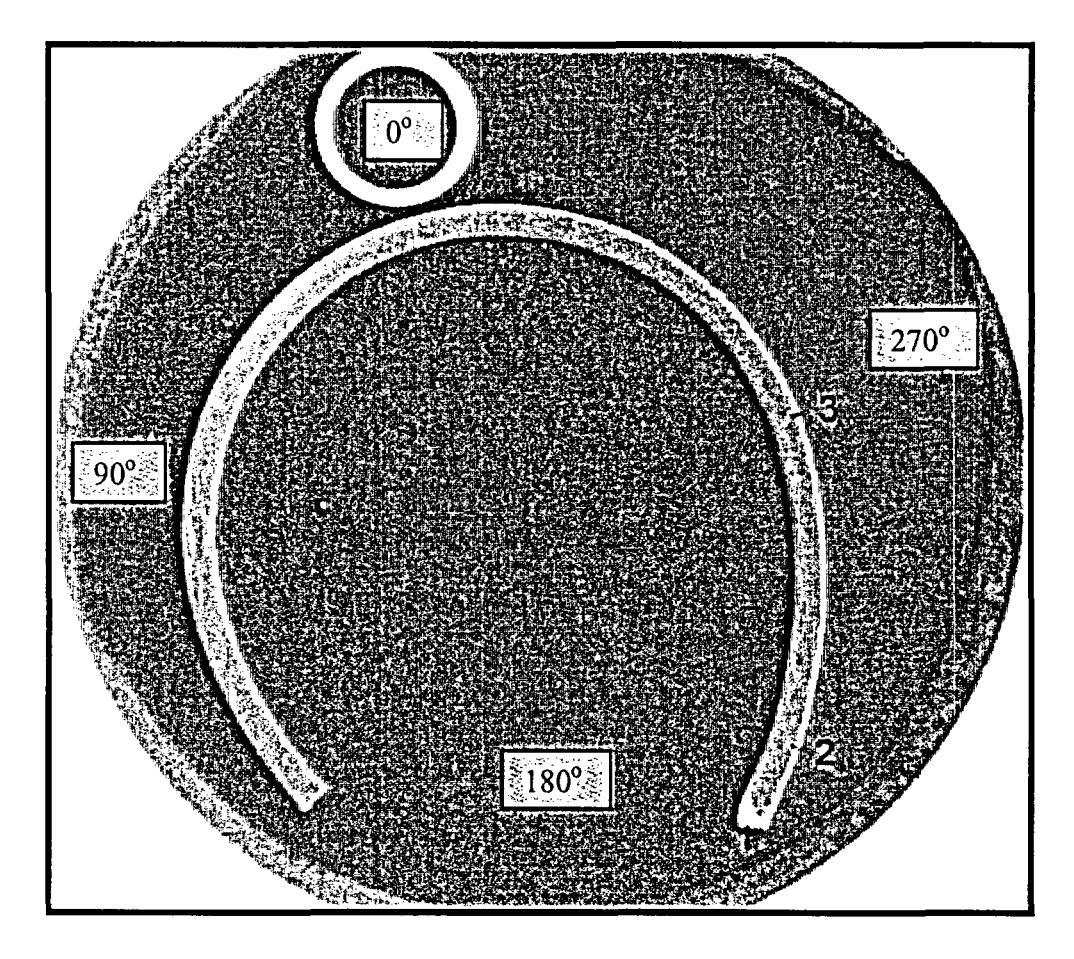
Figure 7-8

Transverse Section - R11C41HL- Piece 3B – Specimen 3B2B2 (Mount 2619) Showing IGSCC Locations Associated with H02 Plate Intersection

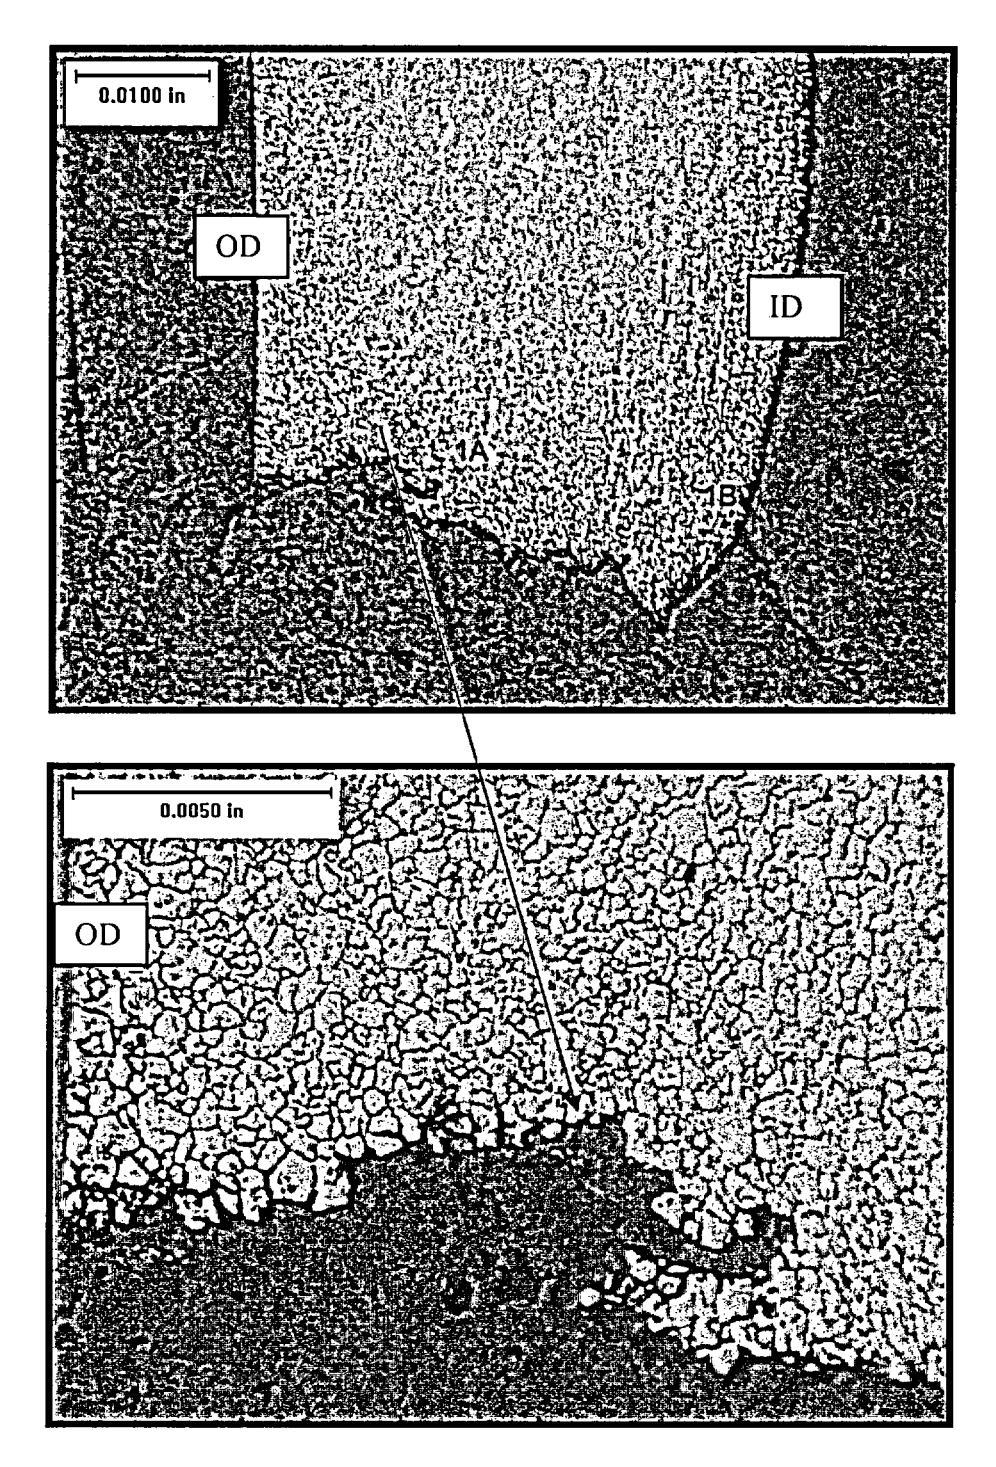
The orientation, extent, and morphology of the ODSCC reported at the H02 tube support plate of R11C41 HL were determined by examining a transverse metallographic specimen taken through the center of the axial burst. This region exhibited 50% through-wall IGSCC as determined by examination of the burst fracture face. The area examined is shown in Figure 7-8, while etched photomicrographs representing the ODSCC identified are shown in Figures 7-9 through 7-11. A total of three (3) OD locations were identified with IGSCC. Position 1 shown on Figure 7-8 corresponds to the burst fracture face. The condition shown in these figures is after the area has been pressurized to 12,649 psi. No attempt was made to find the deepest secondary crack. Figure 7-9 shows that the IGSCC associated with the burst fracture face had none to minimal evidence of branching cracks or cellular corrosion. As is seen in Figure 7-9, the burst face is characterized by both intergranular and ductile fracture features. Two other regions of OD-initiated IGSCC are shown in Figures 7-10 and 7-11. The indications are intergranular in nature, with minimal evidence of cellular corrosion. The indications are blunted due to burst test pressurization. Once again, no appreciable evidence of intergranular penetration was noted on the OD surface.

R11C41HL- Piece 3B (H02 Plate) – Specimen 3B2B2 – Position 1 Etched Transverse Section Showing IGSCC on Burst Fracture Face

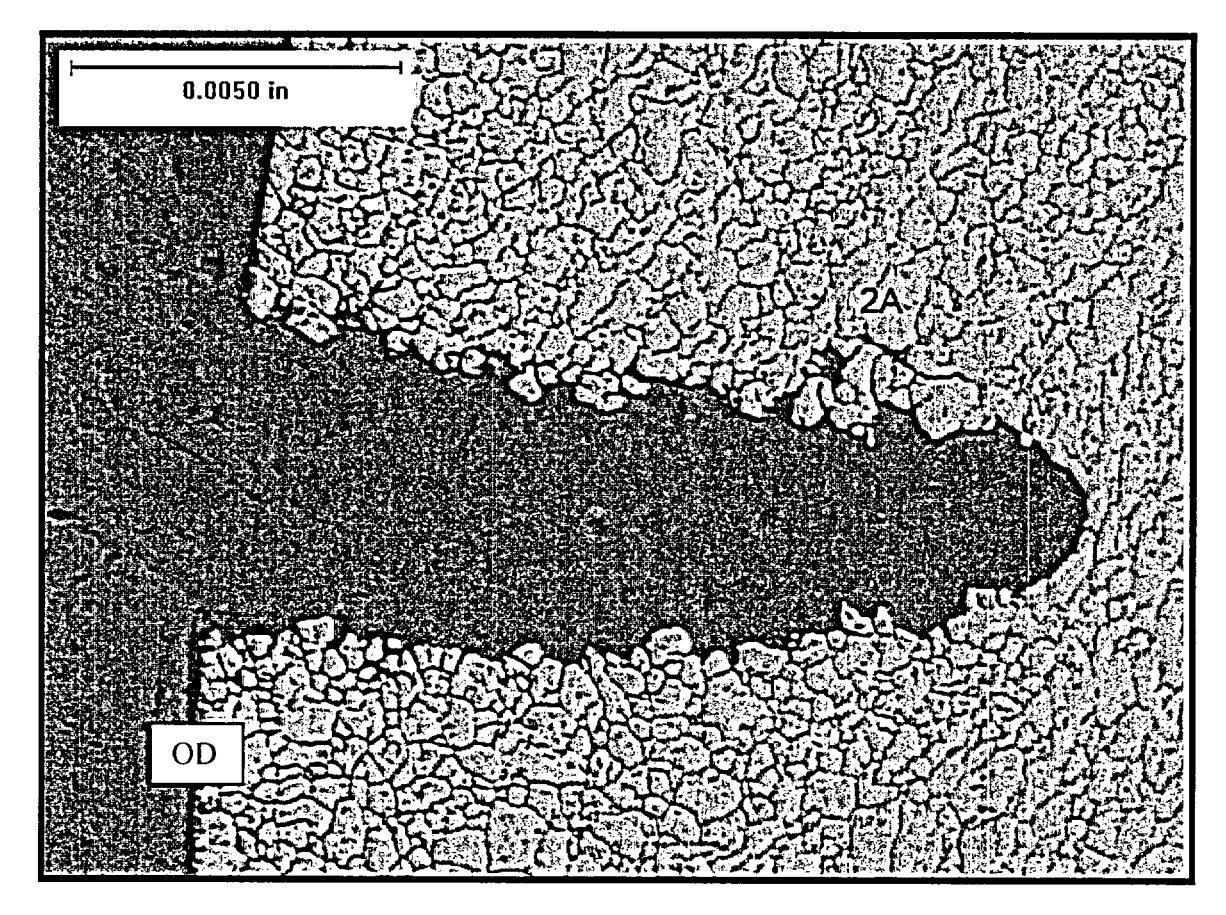
Figure 7-10

R11C41HL- Piece 3B (H02 Plate) – Specimen 3B2B2 – Position 2

Etched Transverse Section Adjacent to Axial Burst

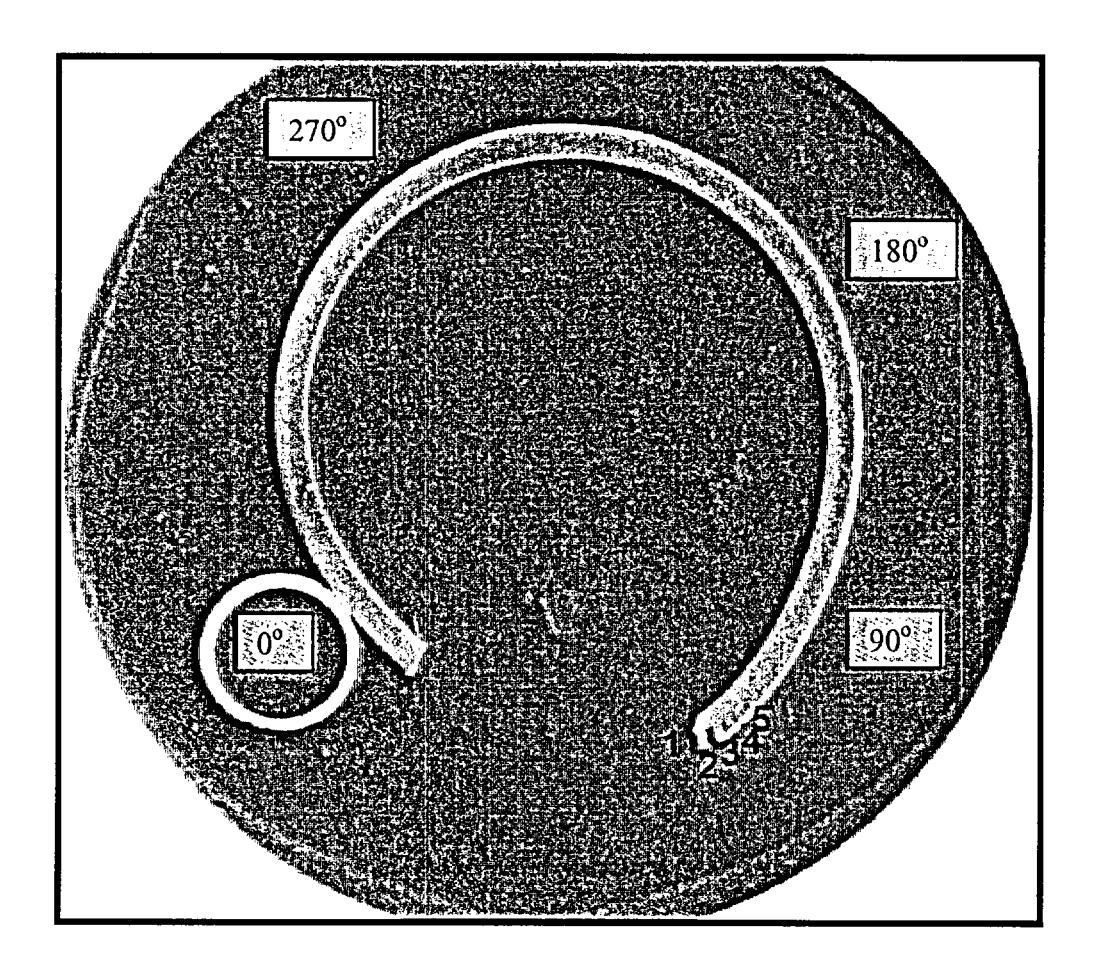
The orientation, extent, and morphology of the ODSCC reported at the H03 tube support plate R11C41 HL were explored by examining a transverse metallographic specimen taken through the center of the axial burst. The area examined is shown in Figure 7-12, while photomicrographs representing the ODSCC identified are shown in Figures 7-13 through 7-17. A total of five (5) OD locations were identified with IGSCC. Position 1 shown in Figure 7-12 corresponds to the burst fracture face. It should be noted that the condition shown in these figures is after the area has been pressurized to 6,999 psi. No attempt was made to find the deepest secondary crack. As is seen in Figure 7-13, the burst face is characterized by both intergranular and ductile fracture features, although this specimen did produce a small leak during the elevated temperature leak test. SEM depth profiles of the burst opening confirmed a

Transverse Section - R11C41HL- Piece 4B – Specimen 4B2B2 (Mount 2622) Showing IGSCC Locations Associated with H03 Plate Intersection

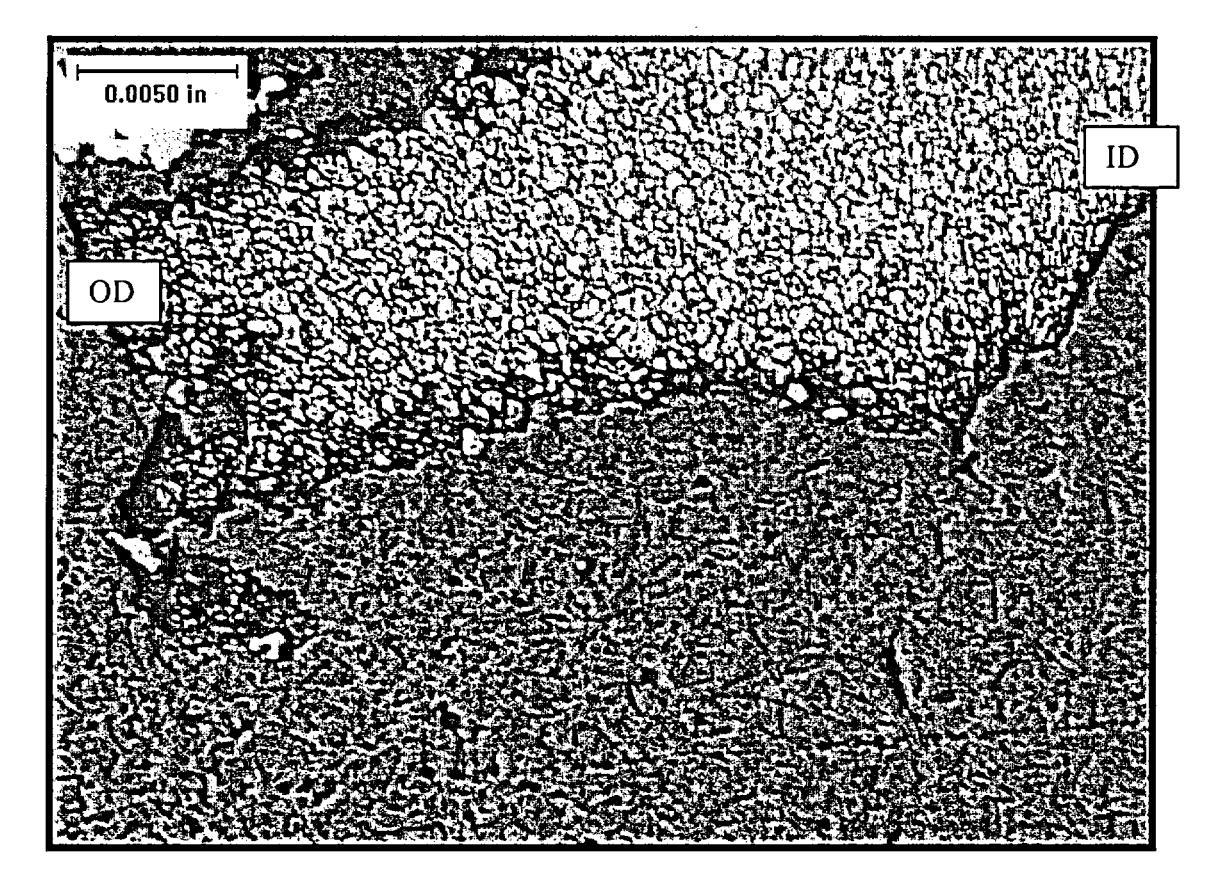
R11C41HL- Piece 4B (H03 Plate) – Specimen 4B2B2 – Position 1

Etched Transverse Section Showing IGSCC on Burst Fracture Face

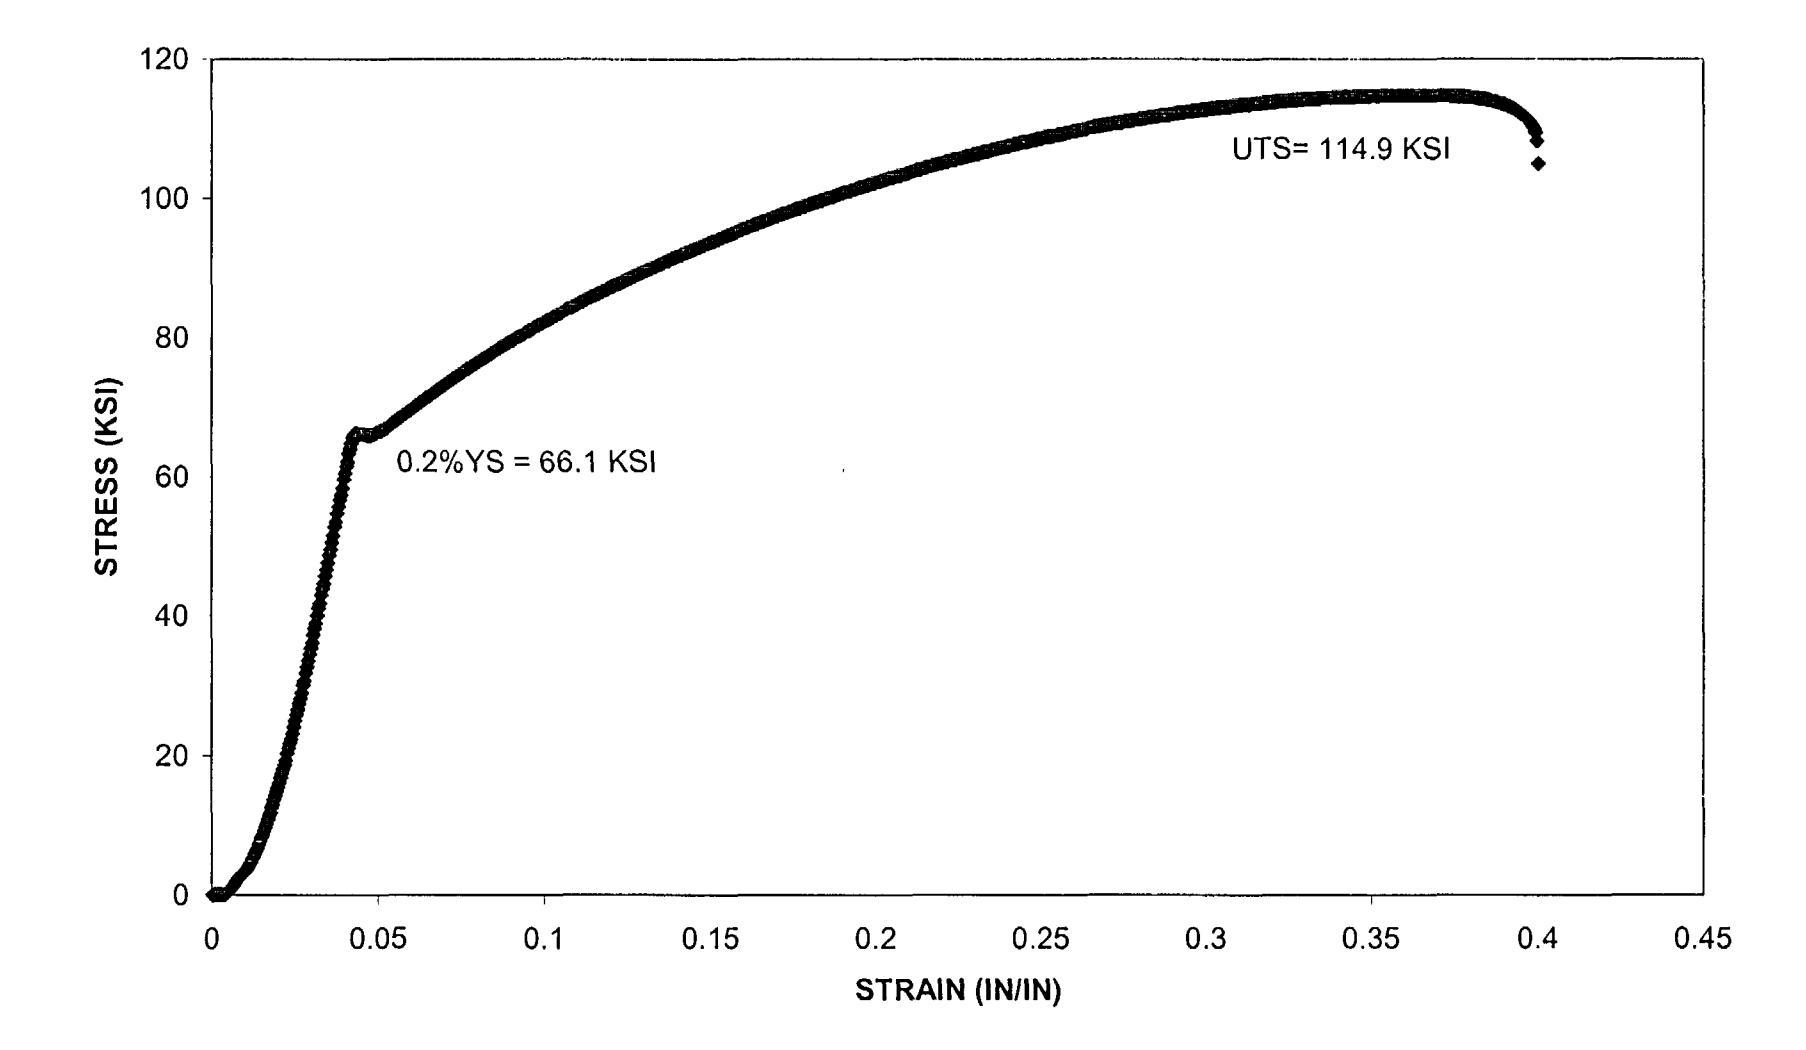
Figure 8-2 Stress-Strain Curve for R11C41 HL, Piece 5B

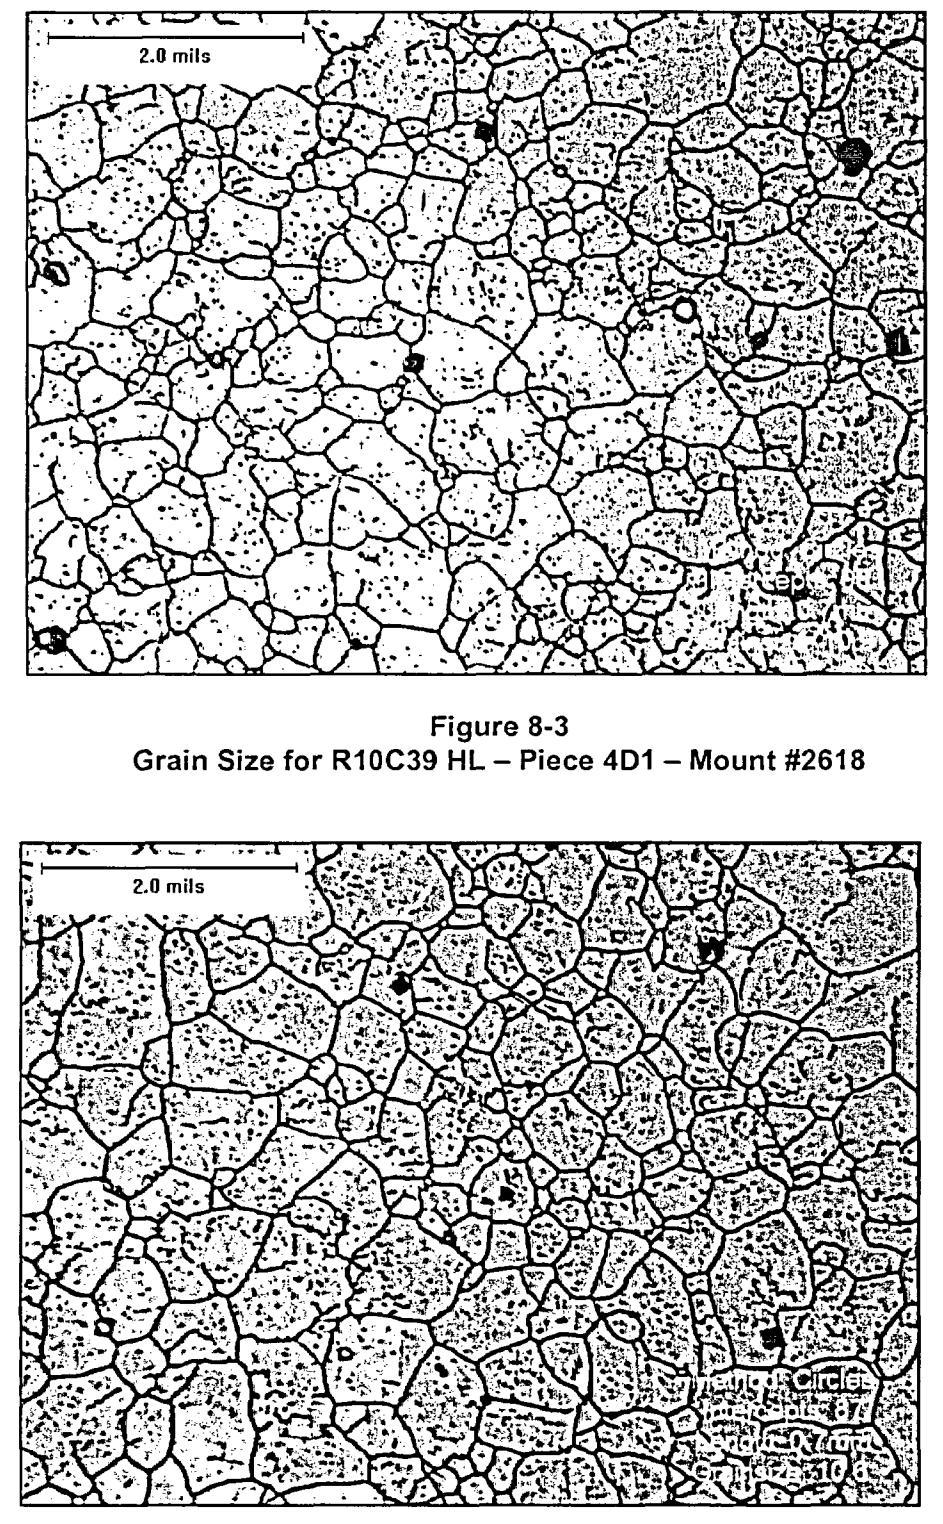
The grain size for R10C39 HL is shown in Figure 8-3, while the grain size for R11C41 HL is shown in Figure 8-4. The ASTM grain size for R10C39 HL is 10.9 and the ASTM grain size for R11C41 HL is 10.6. These grain sizes are typical of mill annealed Alloy 600 tubing produced for Model D4 steam generators.

Figure 8-4 Grain Size – R11C41 HL – Piece 4A3 – Mount #2617

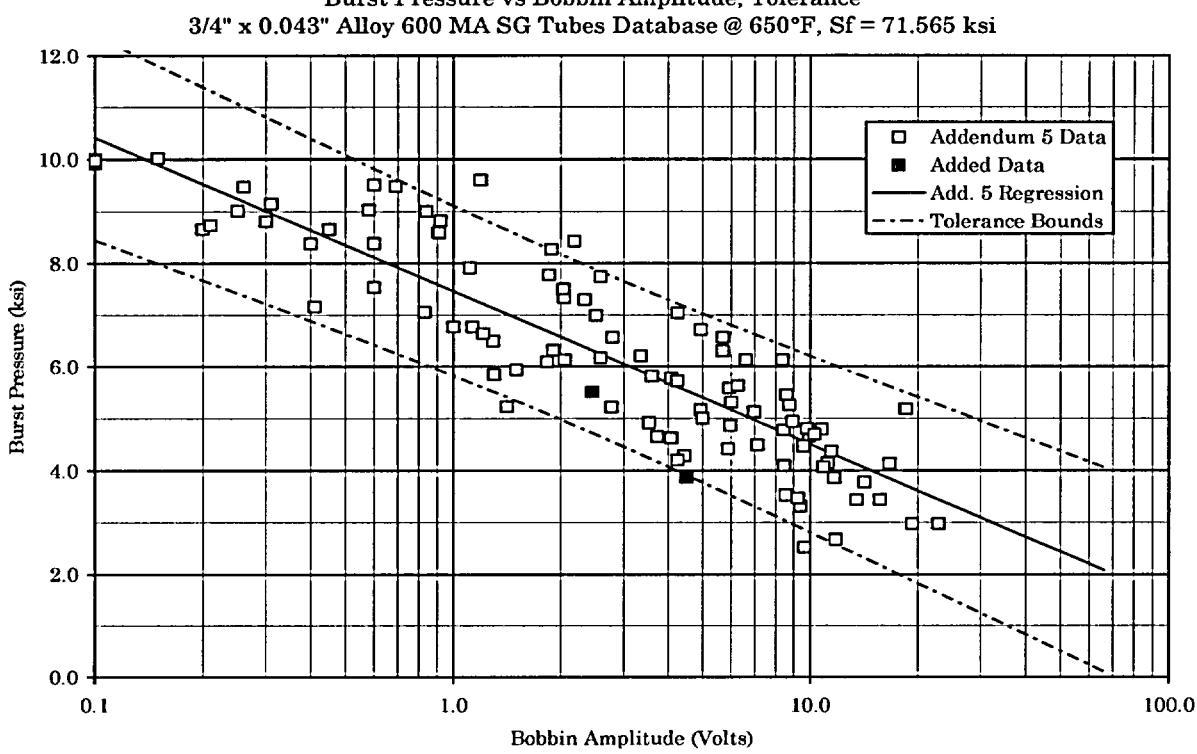
Figure 1: Comparison of additional test data to database tolerance bounds.

The result from burst tests, performed on both tube specimens which exhibited a non-zero bobbin amplitude at a TSP elevation location, were considered for evaluation. The measured burst pressures of the Watts Bar 1 tube specimens are depicted on Figure 1 and Figure 2 relative to the burst pressure correlation developed using the Reference 5 database. Figure 1 illustrates the results relative to a 90% tolerance band expected for future test results. The following observations are apparent from an examination of that figure:

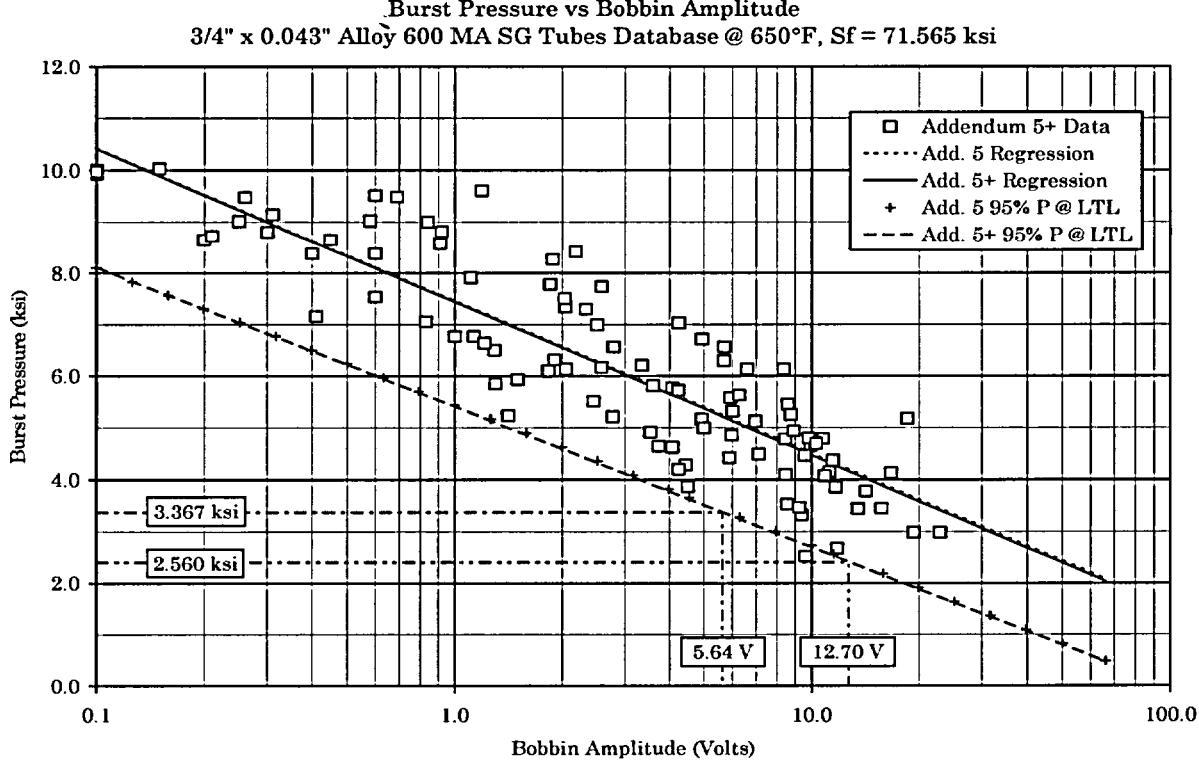
Figure 2: Affect of additional data on the burst pressure correlation.

Since the Watts Bar 1 burst pressure data were not indicated to be from a separate population from the reference data, the regression analysis of the burst pressure on the common logarithm of the bobbin amplitude was repeated with the additional data included. A comparison of the regression results obtained by including these data in the regression analysis is provided in Table 2. Regression predictions obtained by including these data in the regression analysis are also shown on Figure 2. A summary of the changes is as follows:

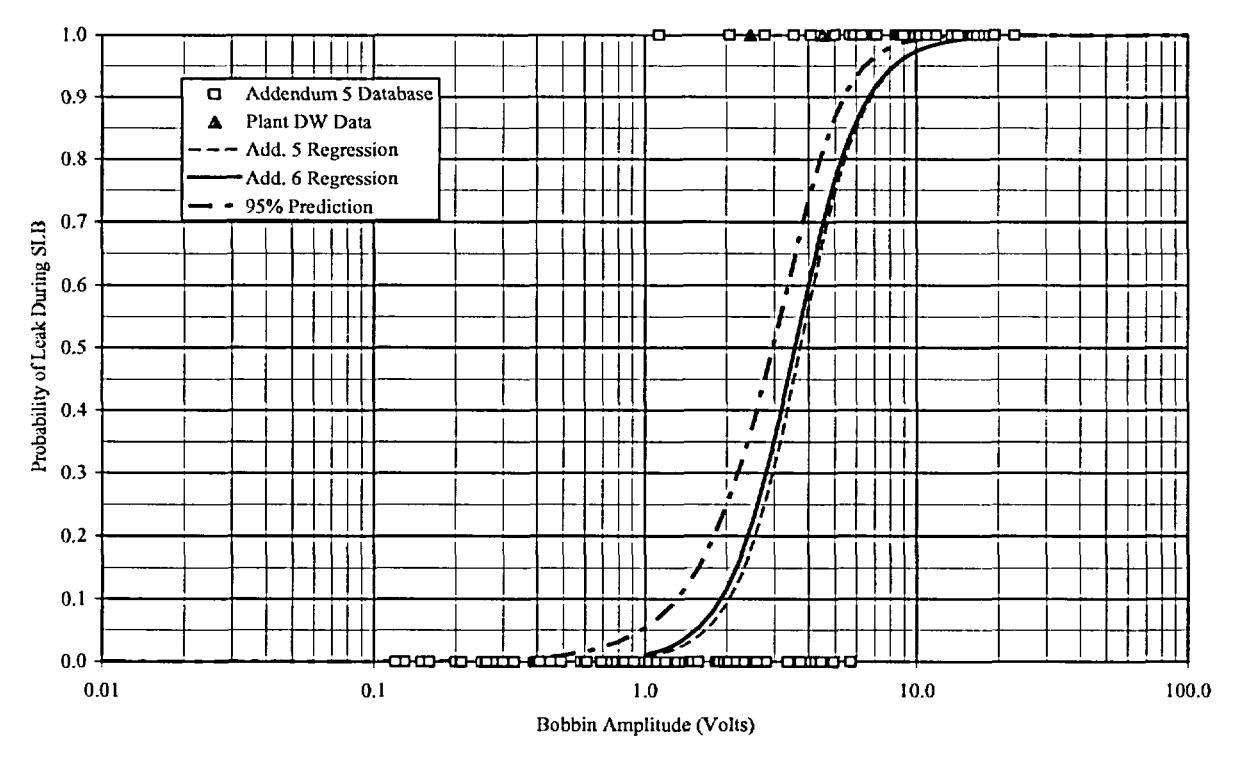
Figure 4: Probability of leak correlation with additional data

The Watts Bar 1 data were examined relative to the reference correlation for the POL as a function of the common logarithm of the bobbin amplitude. Figure 4 illustrates the Watts Bar 1 data relative to the reference correlation. The lower amplitude indication had a calculated POL of 16% and it leaked. The POL for the higher amplitude indication was calculated to be 70% it also leaked. There is no implication of irregular results, i.e., outlying behavior is not indicated. The fact that the lower voltage indication leaked is not totally unexpected although the odds against

- 2. Slope A 4.2% decrease in the *logistic* slope parameter.
- 3. Variance/Covariance The values of the elements of the covariance matrix of the parameters changed from 14 to 21%. Examination of Figure 4 indicates that there is an increase in the POL over the entire range of interest for the application of the ARC. The POL increased by a factor of two at an amplitude of 0.1V (from 1.7 to 3.5 \cdot 10^{-6}) and by a factor of 1.4 at 1V (from 8 \cdot 10^{-3} to 1.1 \cdot 10^{-2}). However, the POL is of secondary importance in determining the total estimated leak rate and the effect on predicted 95th percentile values would be expected to be small.

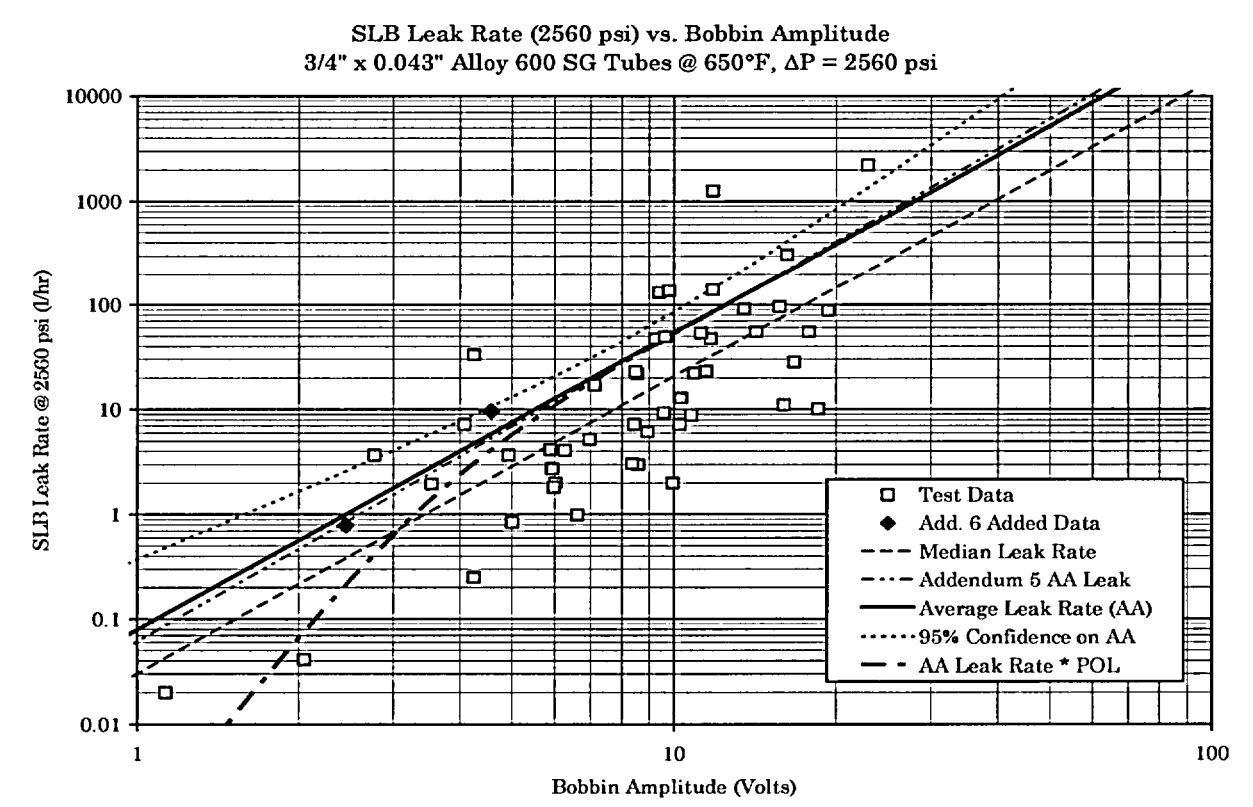
Figure 6: Affect of additional data on the leak rate at 2560 psid

Figure 6 illustrates the results from the tests of the leaking specimens relative to the database for a differential pressure of 2560 psi. Figure 7 provides a similar illustration for a differential pressure of 2405 psi. The magnitude of the leakage from both indications is not remarkable relative to the rest of the database. Both figures illustrate the effect of the added data points on their respective fitted regression lines (the median of the log-normal distribution) and on the expected leak rate (the mean of the log-normal distribution). The net effect of adding the results is a slight increase in the predicted leak rates for bobbin amplitudes up to about 10V, regardless of the differential pressure of consideration, with a slight decrease thereafter.

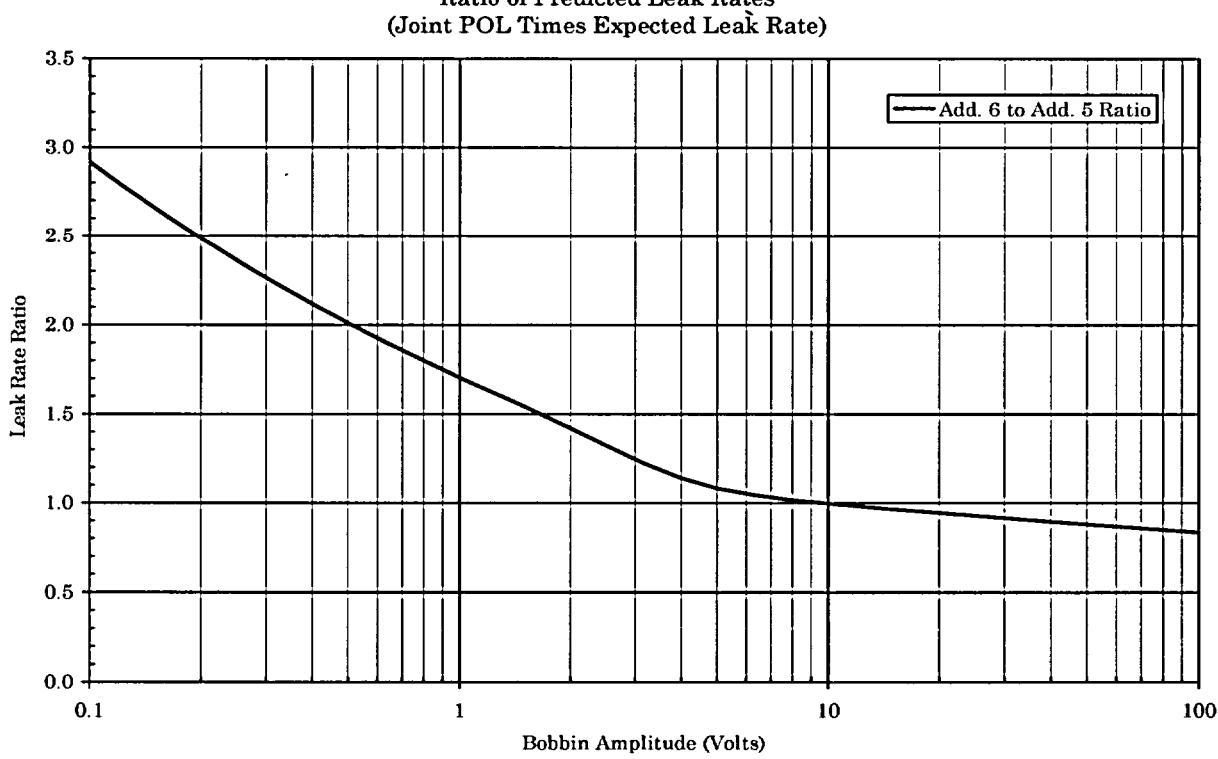
Figure 10: Ratio of expected leak rate as a function of amplitude.

A scatter plot of the residuals of the regression analysis for a SLB differential pressure of 2405 psi is provided on Figure 8. A normal plot of the residuals is provided on Figure 9. Both of the charts are confirmatory of assumptions made in performing the regression analysis, i.e., the residual log leak rates are independent of the predicted log leak rates, and the residuals log leak rates approximate a normal distribution. Finally, an illustration of the combined effect of the added data on the POL and leak rate is provided by the ratio information presented on Figure 10. The relative increase in the leak rates is greatest for small indications with small leak rates.
