STEAM GENERATOR PULLED TUBE EXAMINATION
Watts Bar Unit 1 – Cycle 5 RFO

FINAL REPORT

Prepared by
Westinghouse Electric Company LLC

Prepared for
Tennessee Valley Authority

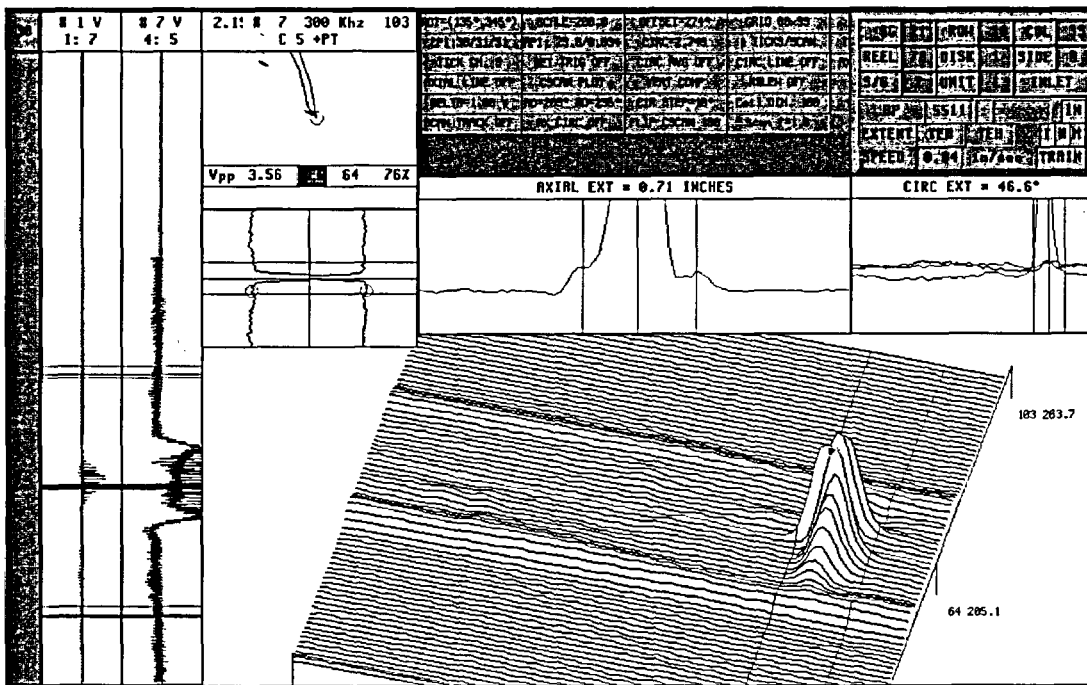
Figure 4-1 shows a data display of the reevaluated field bobbin probe data for the indication at H02. Since a bobbin coil indication was identified at this location, the H02 region of the tube was inspected with a +Pt probe. The field analysis identified a single axial indication (SAI) corresponding to the bobbin indication. The laboratory data review of the field +Pt coil data confirmed the SAI of 3.56 volts and estimated the through wall extent to be 76% and an indication length of 0.71 inches. Figure 4-2 presents the +Pt data display showing the axial-sensitive channel at 300 kHz.

Figure 4-2 +Pt response for the H02 tube support intersection of Watts Bar Unit 1 steam generator 2 tube R10 C39 HL. Two axially oriented indications were identified at this location.

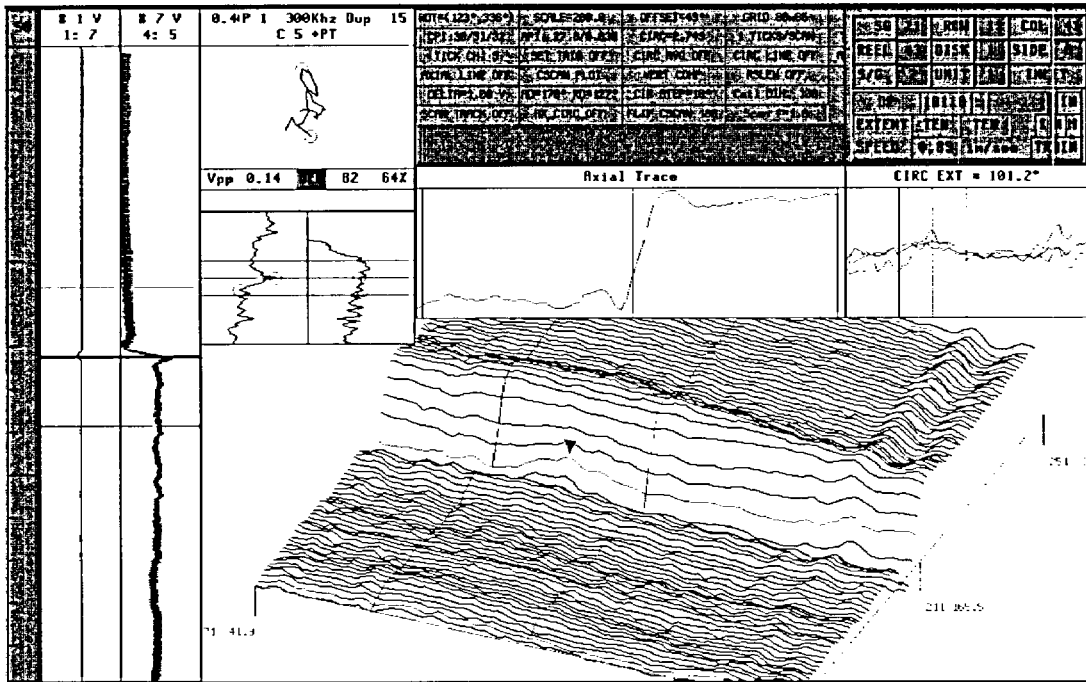
Figure 4-3 Field +Pt response at the top of tube sheet (TTS) for Watts Bar Unit 1 steam generator 2 tube R11 C41 HL, Piece 2. A circumferentially oriented indication was identified at this location.

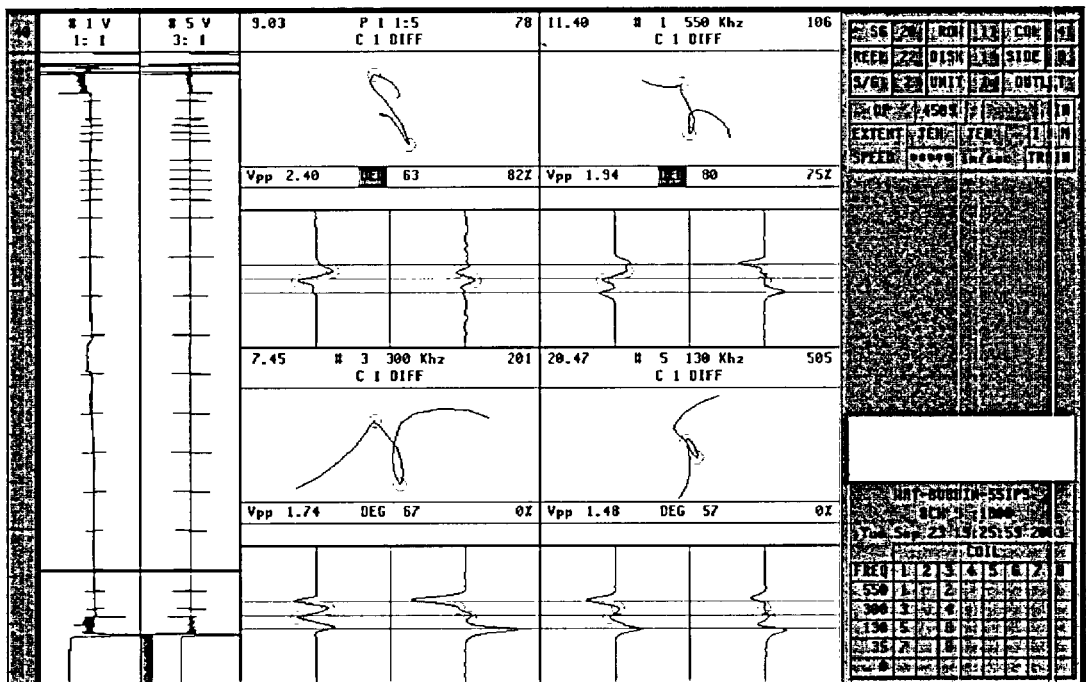
Figure 4-4 Field bobbin coil response for the H03 tube support intersection of Watts Bar Unit 1 steam generator 2 tube R11 C41 HL, Piece 4. A distorted support indication was identified at this location.

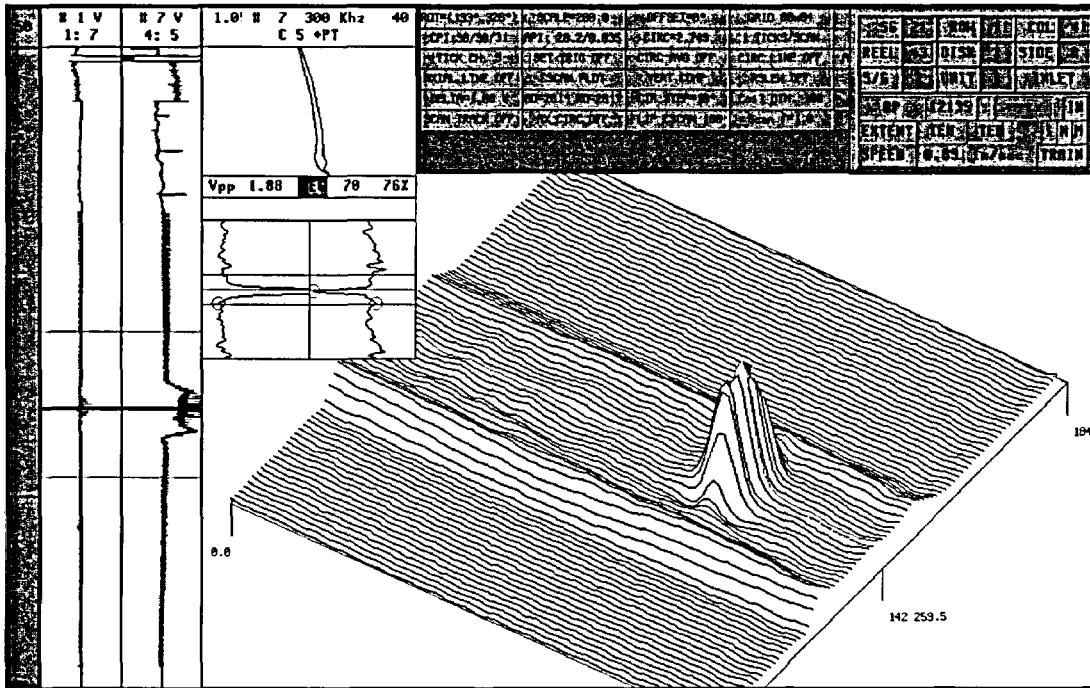
Figure 4-5 Field plus point coil response for the H03 tube support intersection of Watts Bar Unit 1 steam generator 2 tube R11 C41 HL, Piece 4. An axially oriented indication was identified at this location.

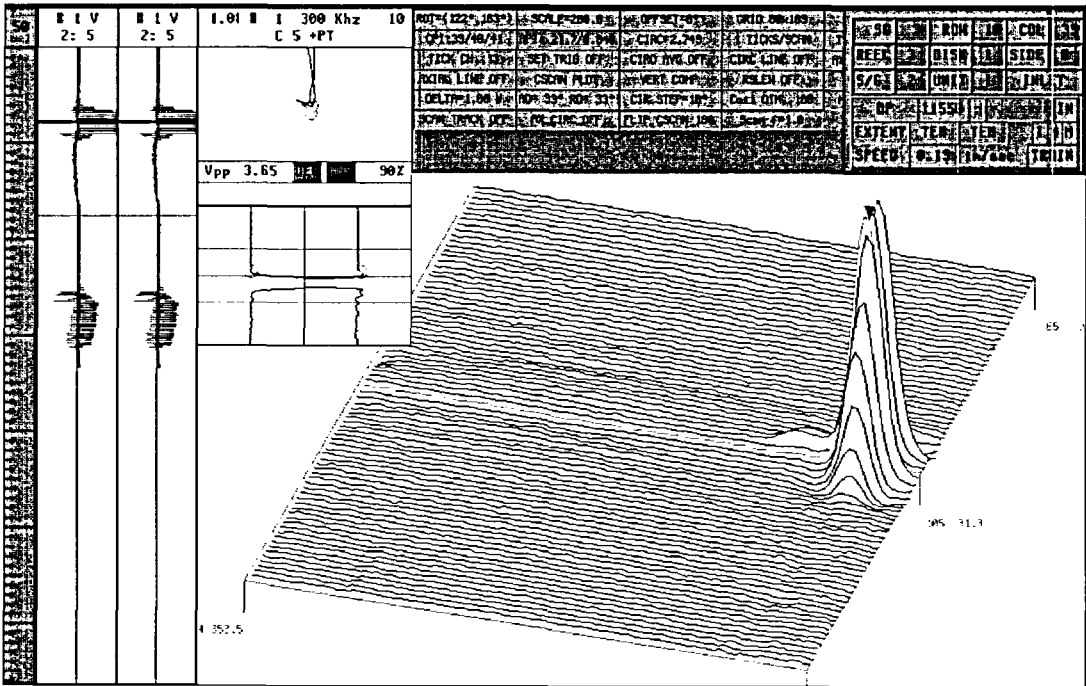
Figure 4-8 Laboratory plus point response for the H2O tube support intersection of Watts Bar Unit 1 steam generator 2 tube R10 C39 HL, Piece 3. Two axial indications were identified at this intersection.

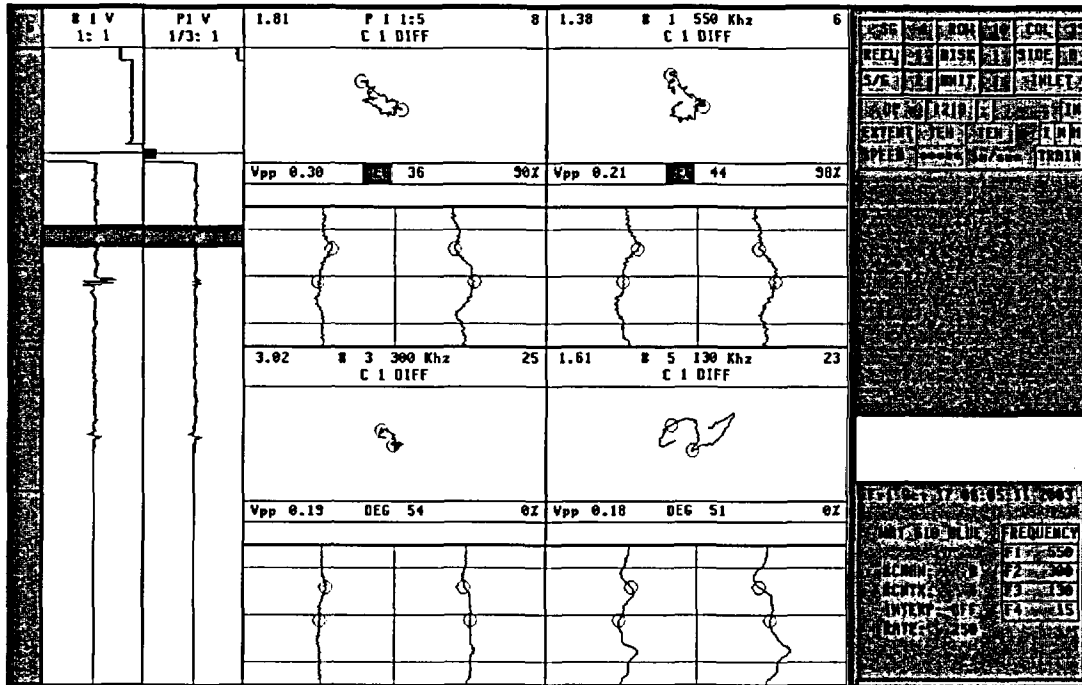
Figure 4-9 Laboratory bobbin coil response for the H03 tube support intersection of Watts Bar Unit 1 steam generator 2 tube R10C39 HL, Piece 4. No indication was identified at this location.

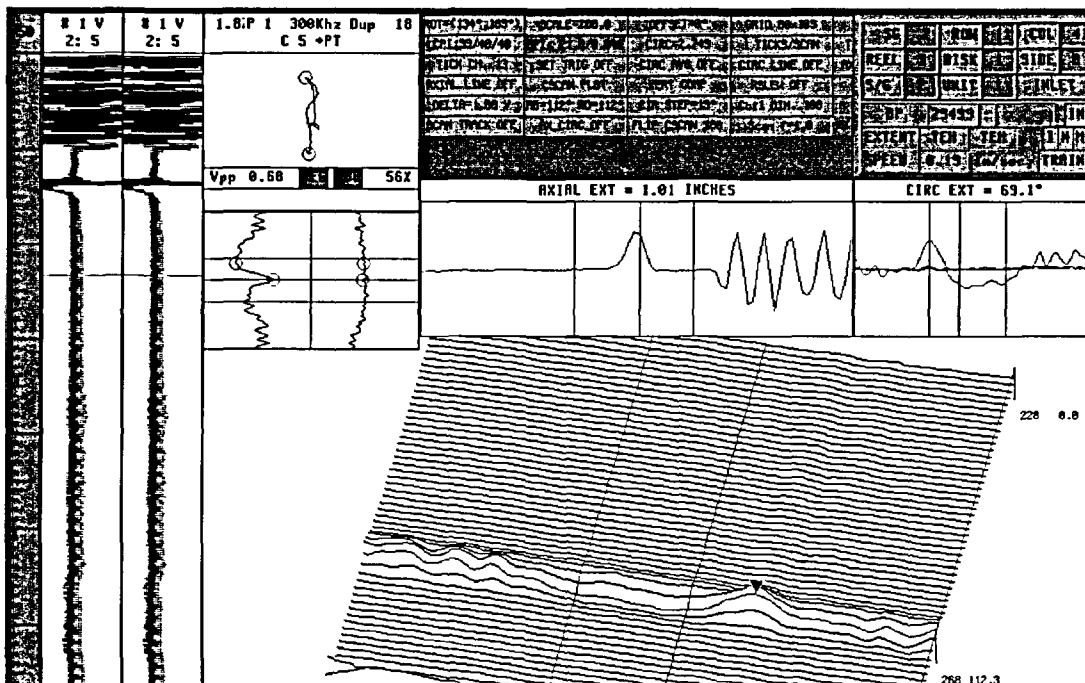
Figure 4-10 Laboratory +Pt response for the top of tube sheet (TTS) of Watts Bar Unit 1 steam generator 2 tube R11 C41 Piece 2. A circumferential indication was identified at this location.

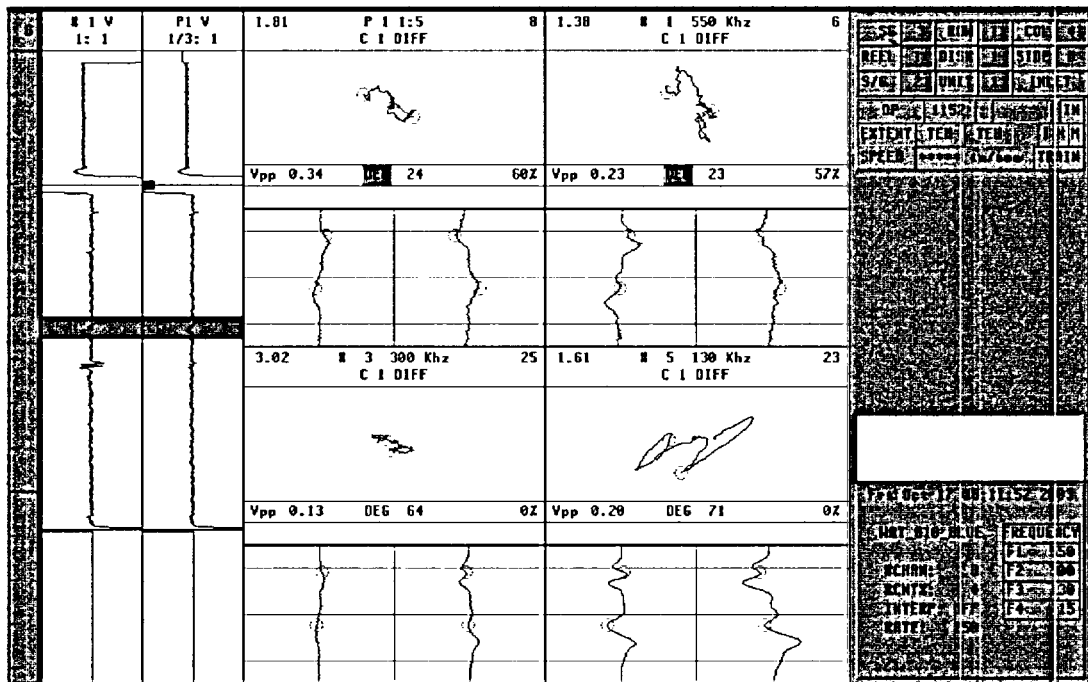
No indications were identified by either the bobbin (Figure 4-12) or +Pt probe inspections.

Figure 4-12 Laboratory bobbin coil response for H02 tube support intersection of Watts Bar Unit 1 steam generator 2 tube R11 C41 HL Piece 3. No indication was identified at this location.

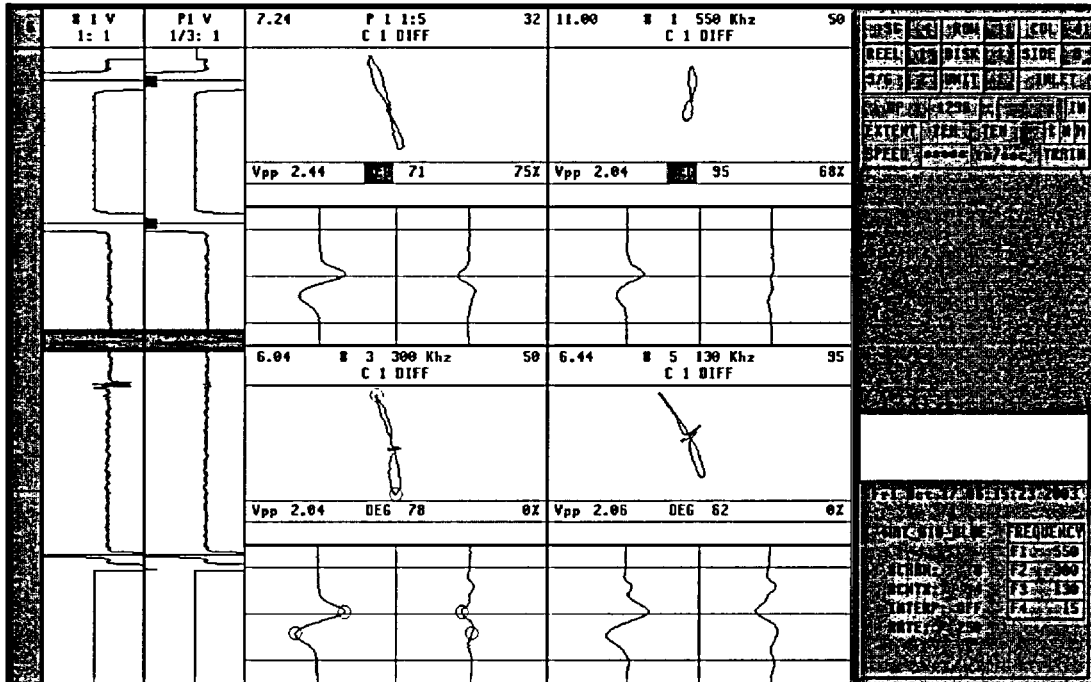
Figure 4-13 Laboratory bobbin coil response for H03 tube support intersection of Watts Bar Unit 1 steam generator 2 tube R11 C41 HL Piece 4. A distorted support indication was identified at this location.

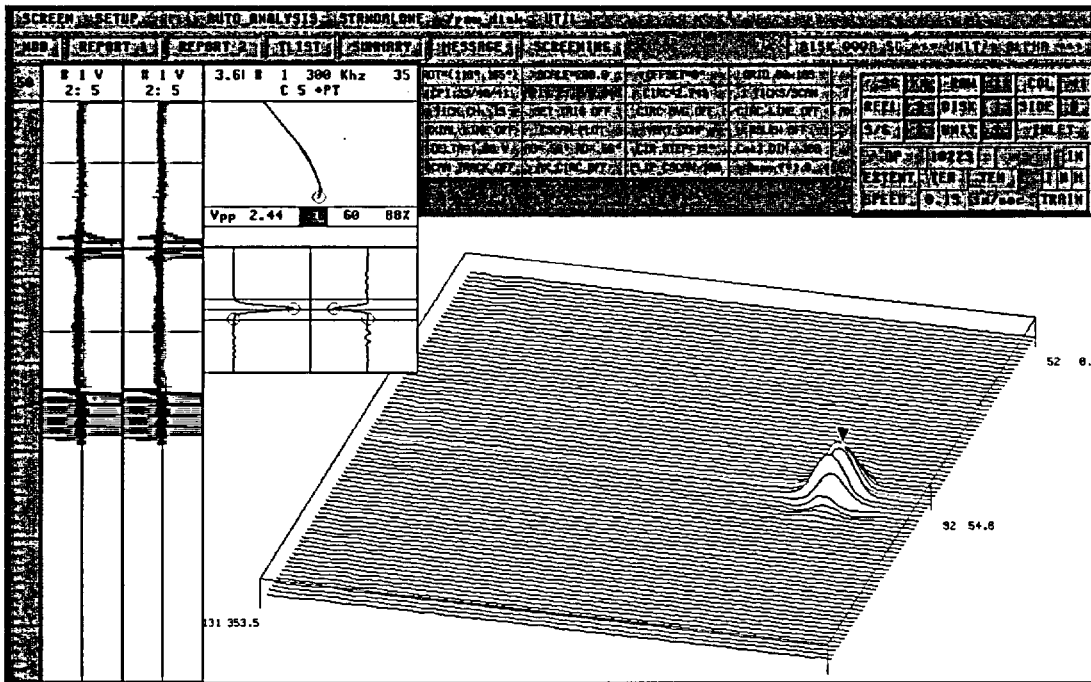
The +Pt response for this region is shown in Figure 4-14; only one indication is identified. The amplitude of the response was found to be 2.44 Volts with an apparent depth of 88% and a length of 0.67 inches. The bobbin coil response is essentially identical to the field response, while the +Pt response is slightly larger in both apparent depth and amplitude. From the +Pt and bobbin coil measurements, the tube removal process did not significantly alter the underlying degradation morphology.

Figure 4-14 Laboratory +Pt response for H03 tube support intersection of Watts Bar Unit 1 steam generator 2 tube R11 C41 HL Piece 4. A single axial indication was identified at this intersection.

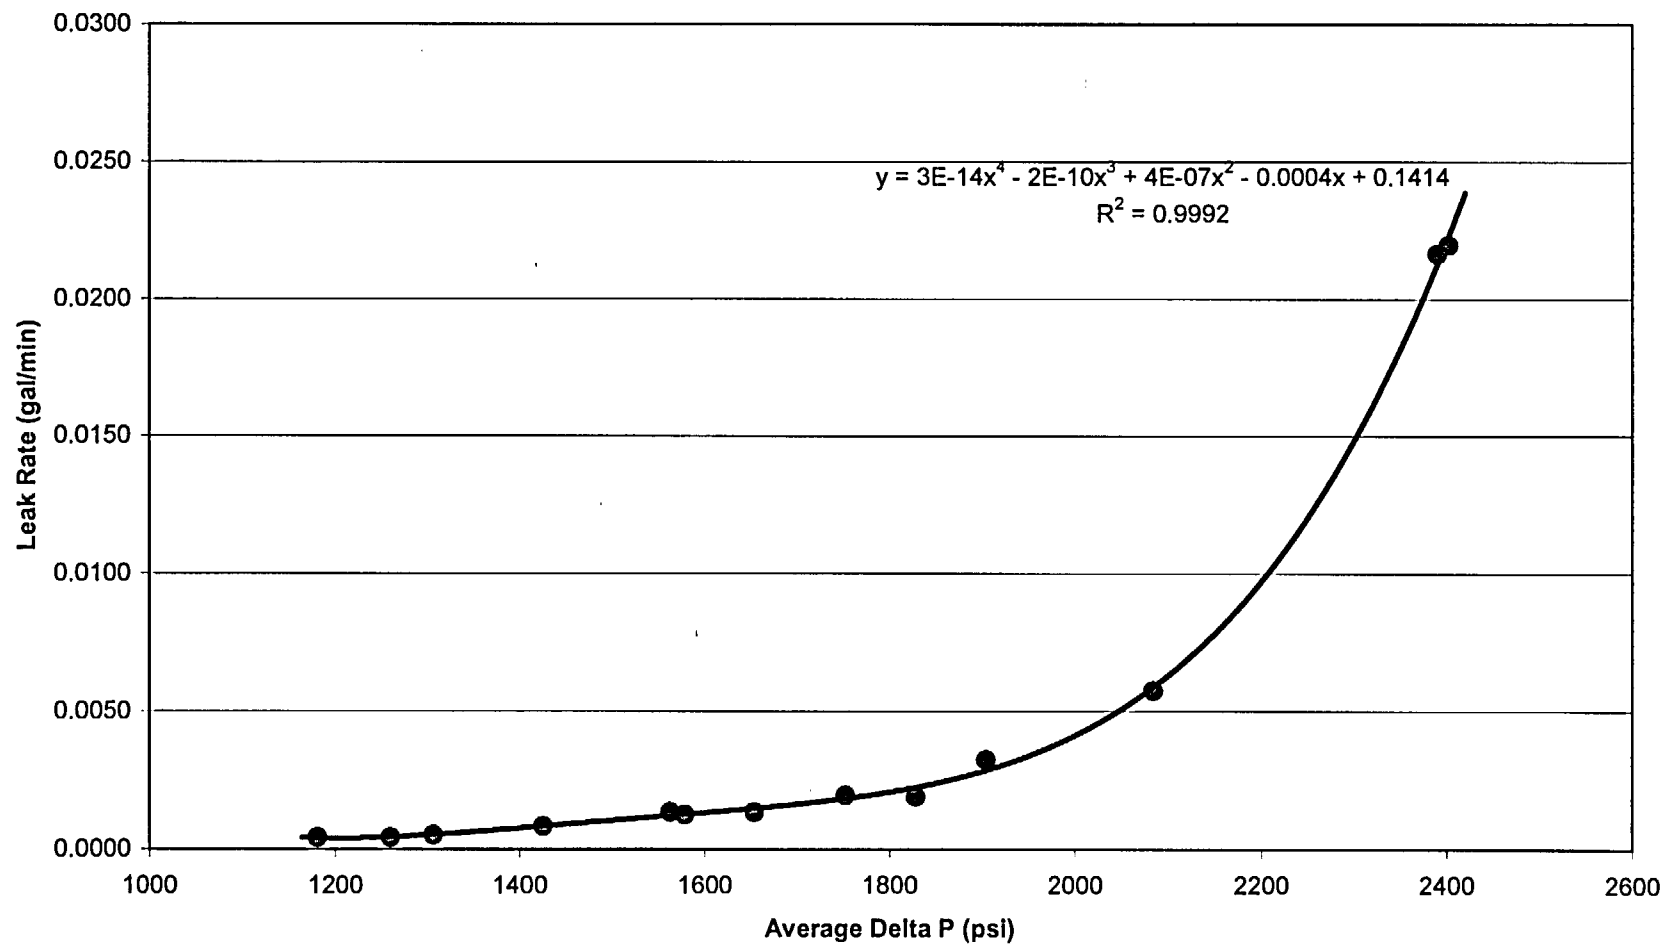
Table 5-2 presents a summary of the elevated temperature leak test results on Piece 3B from R10C39. Figure 5-1 presents a plot of the leak rate as a function of average pressure differential. A leak rate of 0.0004 gpm at approximately the Normal Operating Condition pressure differential (1283 psi) and 0.0032 gpm at approximately the Steam Line Break pressure (2355 psi) was established for this tube. As can be seen from this figure, the leak rate through the indication displays an exponential function of the pressure differential. This behavior is likely due to a change in the orifice size. It is likely that the width of the indication opened at higher pressures (rather than staying the same size), probably tearing ligaments as it opened. Post leak test eddy current data indicate a marked change in the voltage of the reported indication. This change was discussed previously in Section 4 of this report. Temperature and pressure plots measured during the elevated temperature test are provided in Figures 5-2 and 5-3. Visual examination of the OD surface was performed following the leak test. No unusual features were noted.

Figure 5-1
Elevated Temperature Leak Rate Curve for R10C39 HL – Piece 3B (H02 Plate)

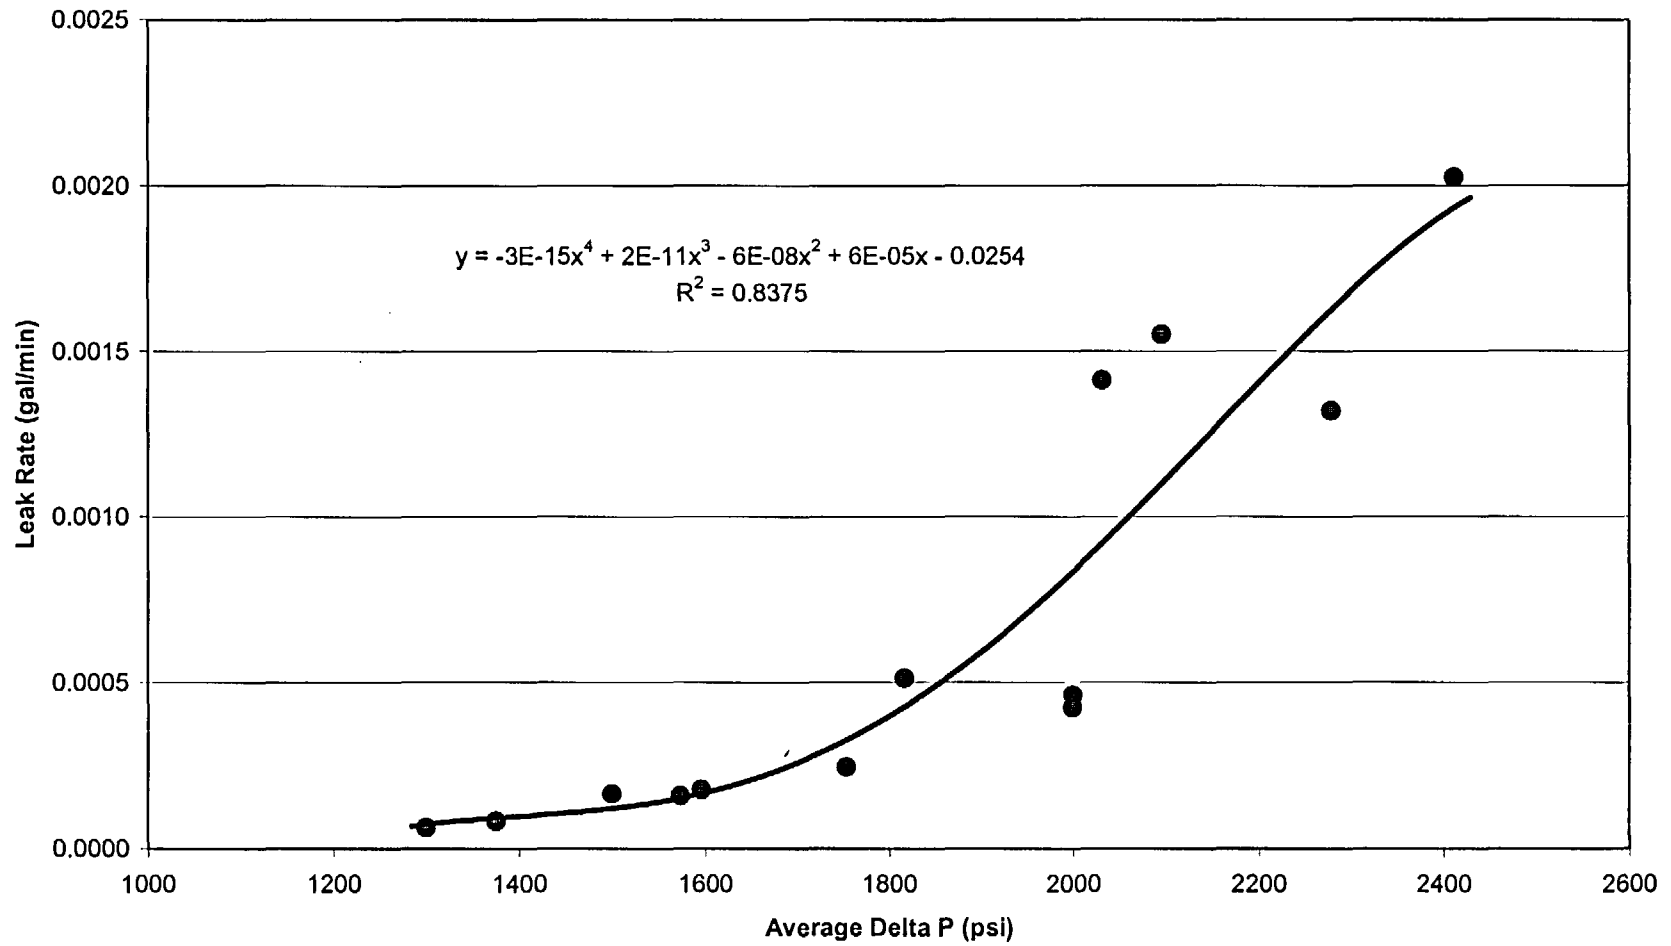
Table 5-3 presents a summary of the elevated temperature leak test results on Piece 4B from R11C41. Figure 5-4 presents a plot of the leak rate as a function of average pressure differential. A leak rate of 0.0001 gpm at Normal Operating Condition pressure differential (1283 psi) and 0.0002 gpm at Steam Line Break pressure (2355 psi) was established for this tube. As can be seen from this figure, the leak rate through the indication displays an exponential function of the pressure differential and is lower in magnitude than that observed for Piece 3B from R10C39, although the shape of the curve is similar. Temperature and pressure plots measured during the elevated temperature test are provided in Figures 5-5 and 5-6. Visual examination of the OD surface was performed following the leak test. No unusual features were noted.

Figure 5-4
Elevated Temperature Leak Rate Curve for R11C41 HL – Piece 4B (H03 Plate)

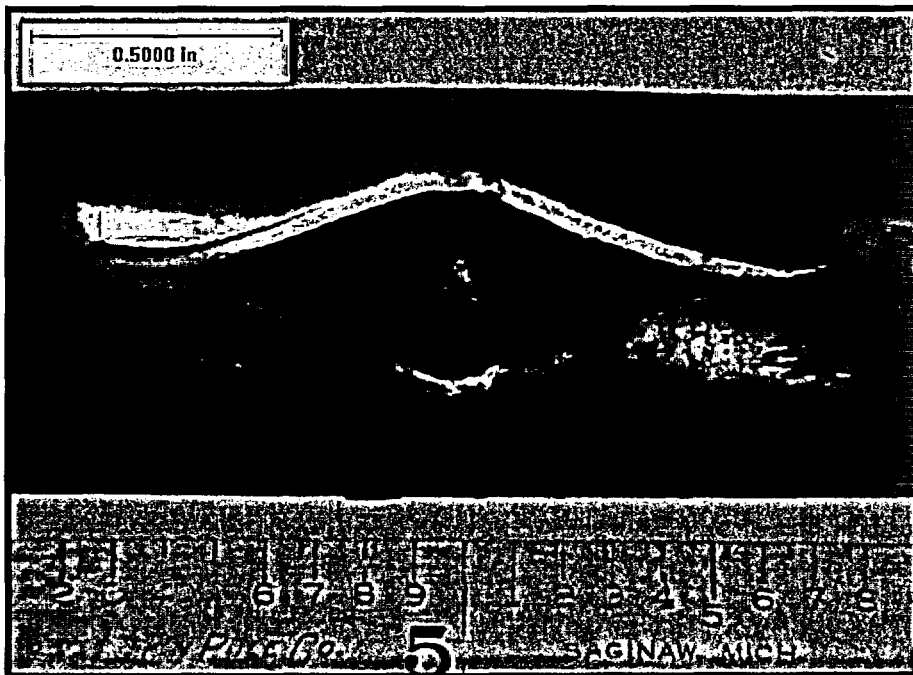
The H02 plate region of R10C39 HL was identified with an SAI by both field and laboratory eddy current. The burst pressure for Piece 3B was 4,931 psi. This burst pressure is less than the undegraded freespan sections and above the limiting $3\Delta P_{NOP}$. The axial burst opening was centered on the centerline of the H02 plate and was 0.438 inches in length and 0.168 inches in width. The burst opening, Figure 5-7, had an azimuthal orientation of 90°. Both ductile and intergranular fracture features were noted on the burst face. Cracking was not observed outside of the H02 plate to tube

Figure 5-7
Burst Opening for R10C39 HL, Piece 3B (H02 Plate) @ 90° Orientation

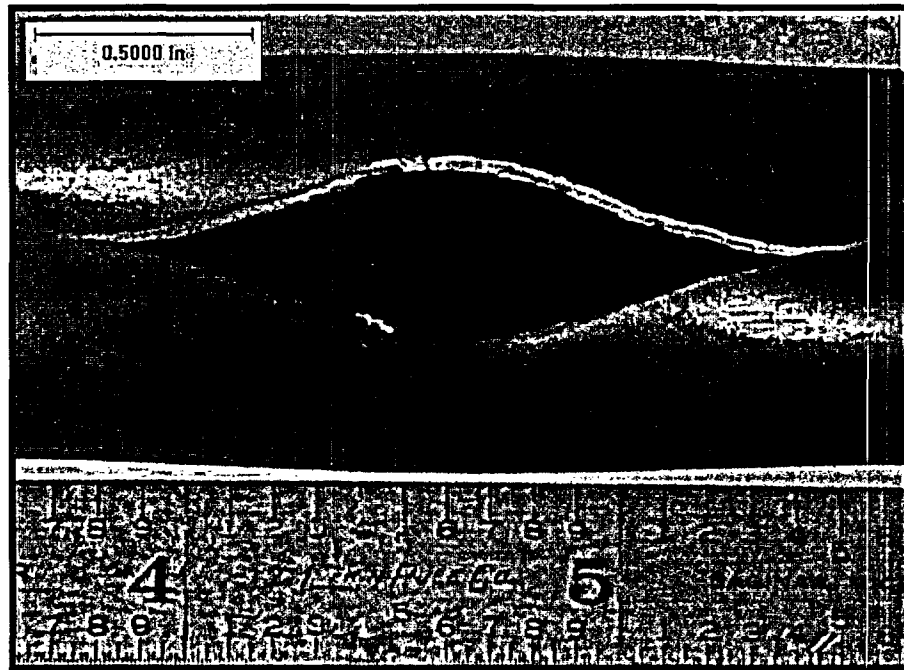
The H03 plate region of R10C39 HL was NDD by both field and laboratory eddy current. The burst pressure for Piece 4B was 12,058 psi. This burst pressure is slightly less than the undegraded freespan sections and well above the limiting $3\Delta P_{NOP}$. The axial burst opening was centered on the centerline of the H03 plate and was 1.510 inches in length and 0.384 inches in width. The burst opening, Figure 5-8, had an azimuthal orientation of 315°. Both ductile and intergranular fracture features were noted on the burst face. Cracking was not observed outside of the H03 plate to tube intersection region.

Figure 5-8
Burst Opening for R10C39 HL, Piece 4B (H03 Plate) @ 315° Orientation
