Entergy Vermont Yankee

Root Cause Analysis Report

CR-VTY-2004-2015

Electrical Fault / Fire

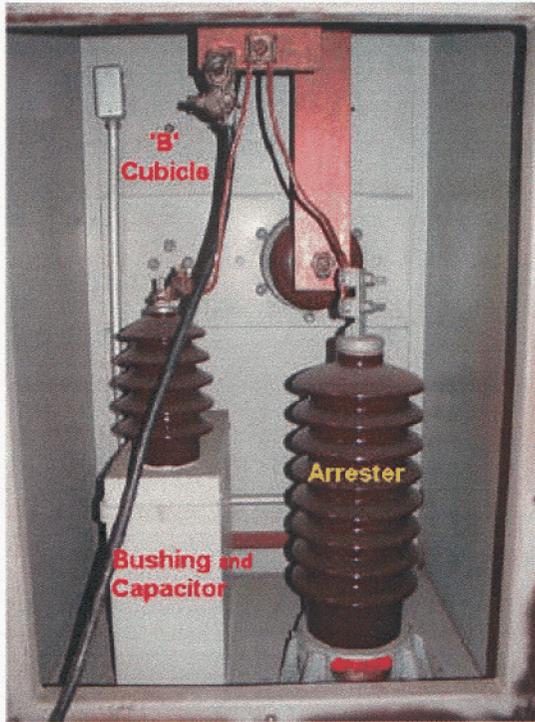
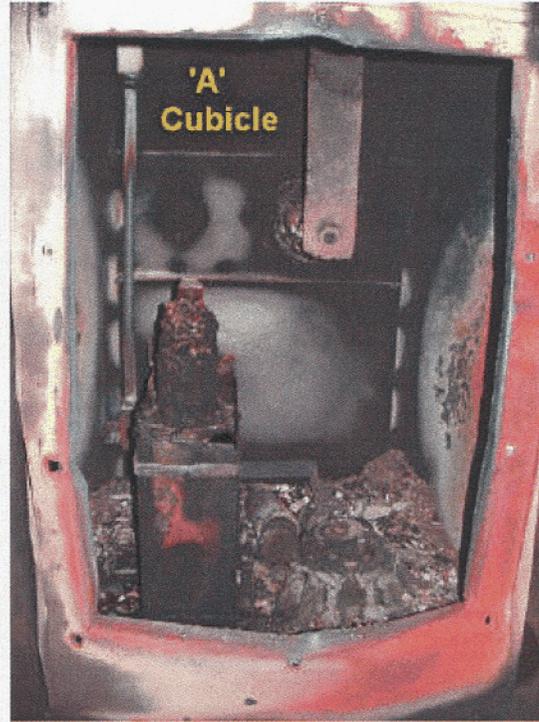
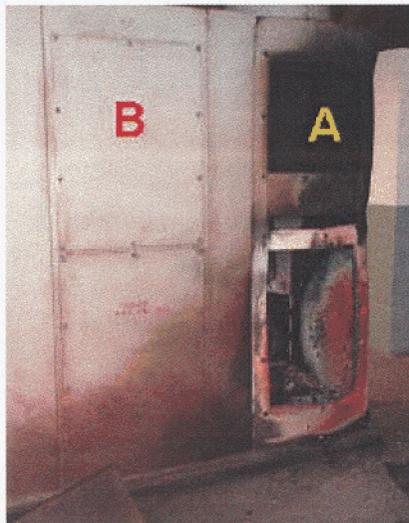
If the arrester had deteriorating internal insulation due to aging or other factors, it could have had significantly reduced current limiting capability. A concurrent fault-to-ground on another phase could cause the arrester to catastrophically fail in a fashion similar to what was observed as a result of this event.

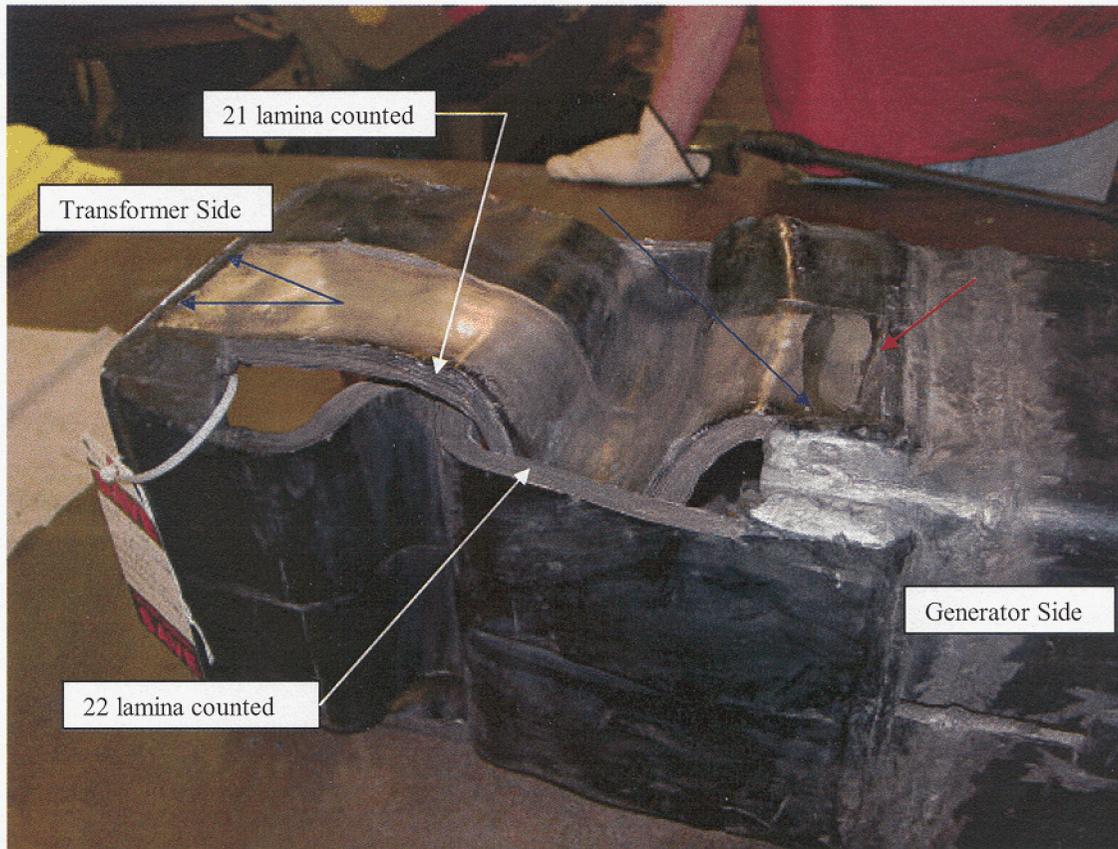
B Phase Flexible Connector Showing Overall View

In an effort to determine if a section of lamina had in fact existed in this area, I counted the lamina in the affected section at 21 and 22 in other areas indicating that one lamina sheet was potentially missing.

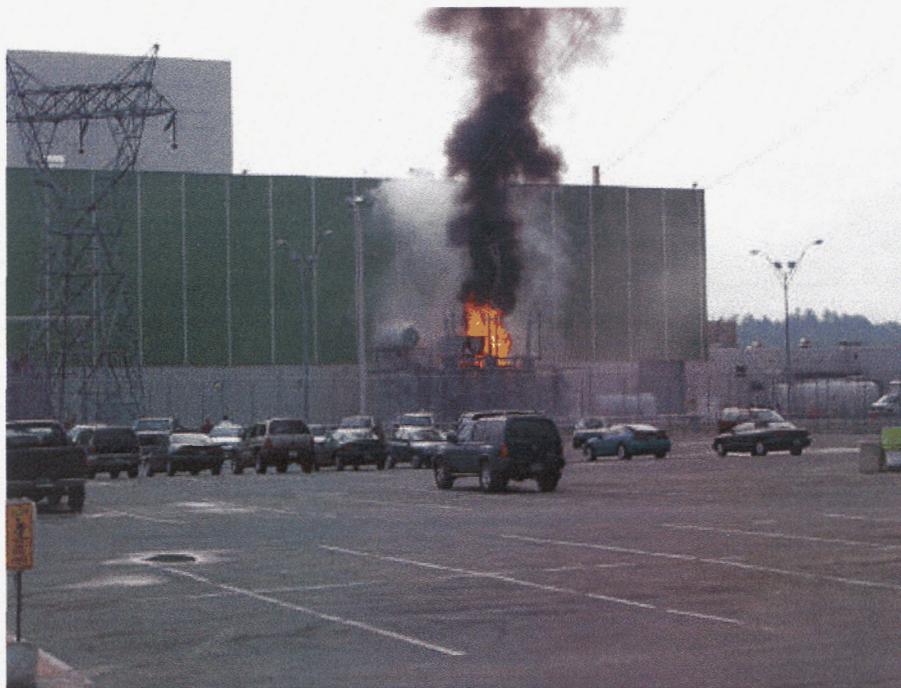
Photograph : Fire 0130

No evidence was found to suggest that the fire started around the base of the Main Transformer. Melted metal and burned artifacts were found around the base of the Main Transformer. These components appeared to come from the top area of the Main Transformer in the area of the fire. Most of the metal remains appeared to be just melted masses of aluminum from the secondary bushing enclosure. Aluminum will melt at 1200 degrees Fahrenheit. Deformed aluminum is typically the result of an impinging flame and radiant heat from an oil fire.

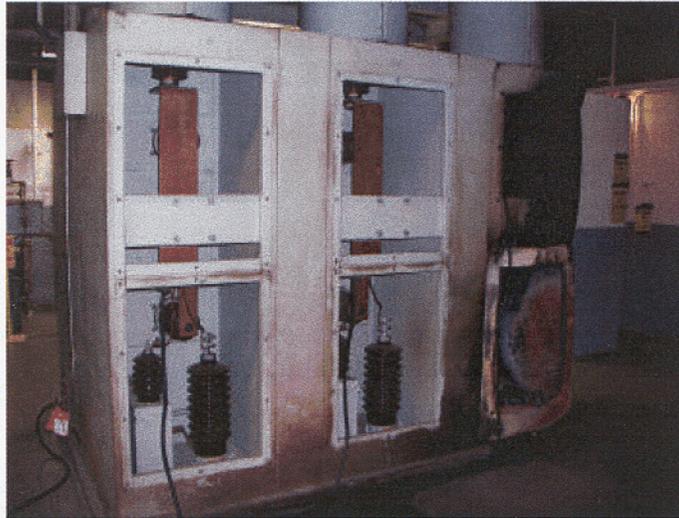
Photograph : Surge Cubicle 11

No information was found to suggest that a fire had started outside of the Generator PT Cabinet. Further, no evidence was found to suggest that the electrical flash on the "A" phase surge arrester was started by a fire outside of the "A" phase surge cubicle. The electrical flash damage appeared to have been contained in the compartment.

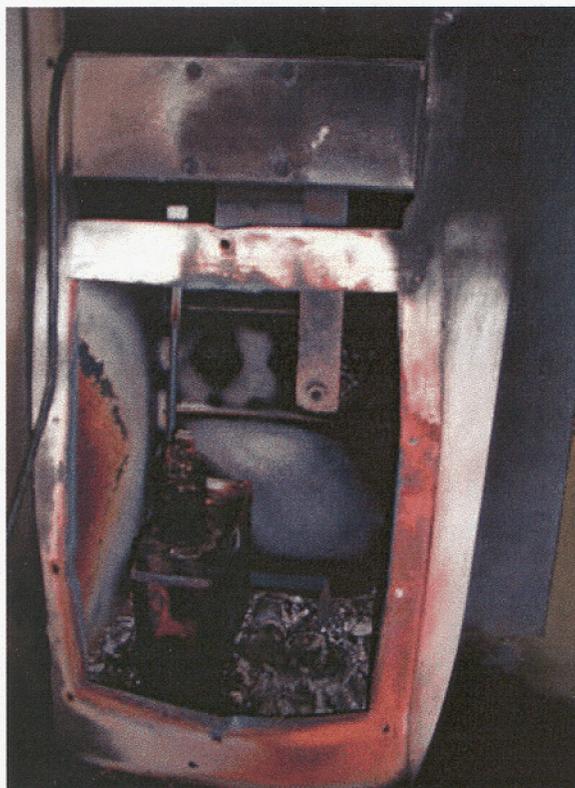
Photograph : Surge Cubicle 01

There was severe damage found in the "A" phase surge cubicle of the Generator PT Cabinet containing the associated surge arrester and capacitor. The surge arrester appeared to have catastrophically failed. The porcelain surge arrester was completely destroyed. More information may be gained by further examining the components removed from the compartment.

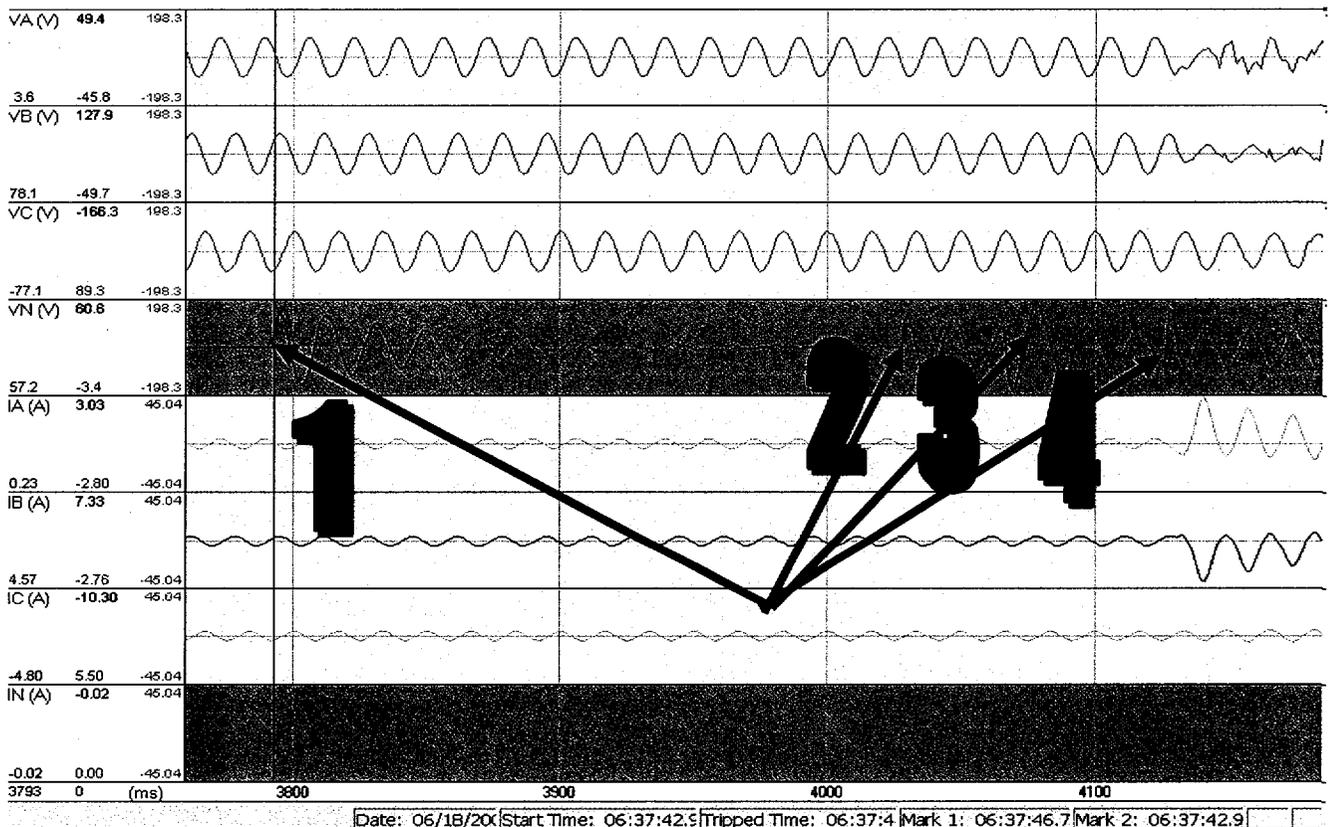
Arcing Phenomena From Beckwith Output (VLN)

Four occasions of arcing at approximately the following times

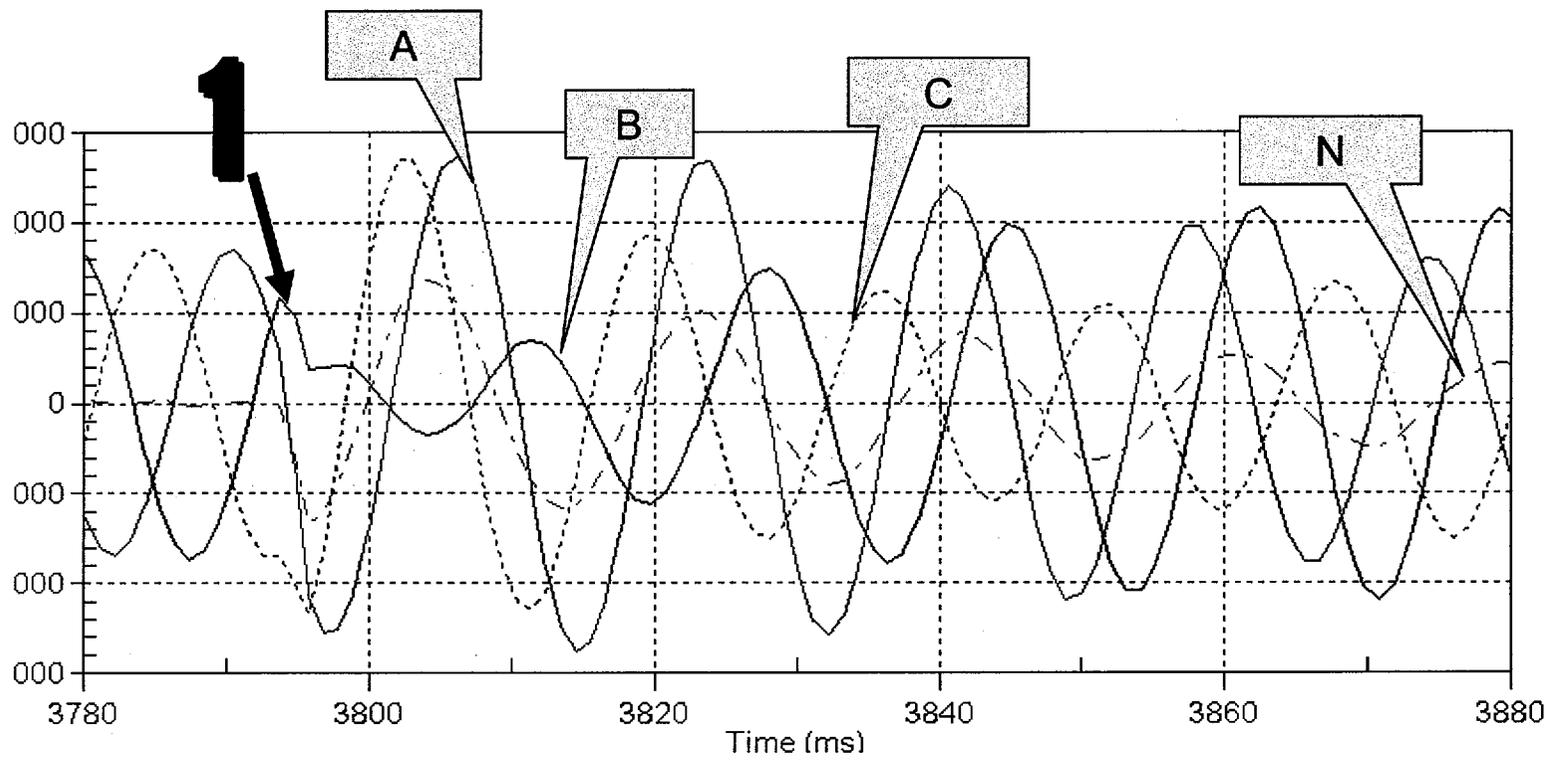
First Arcing Incident

- When arc is removed:
 - Neutral voltage response is oscillatory in nature (due to the RLC circuit)
- Long decay due inherent low resistance of the reactance grounded system
- Due to the slight detuning of the resonating ground tank circuit, the neutral voltage rotates in space with respect to the phase voltages

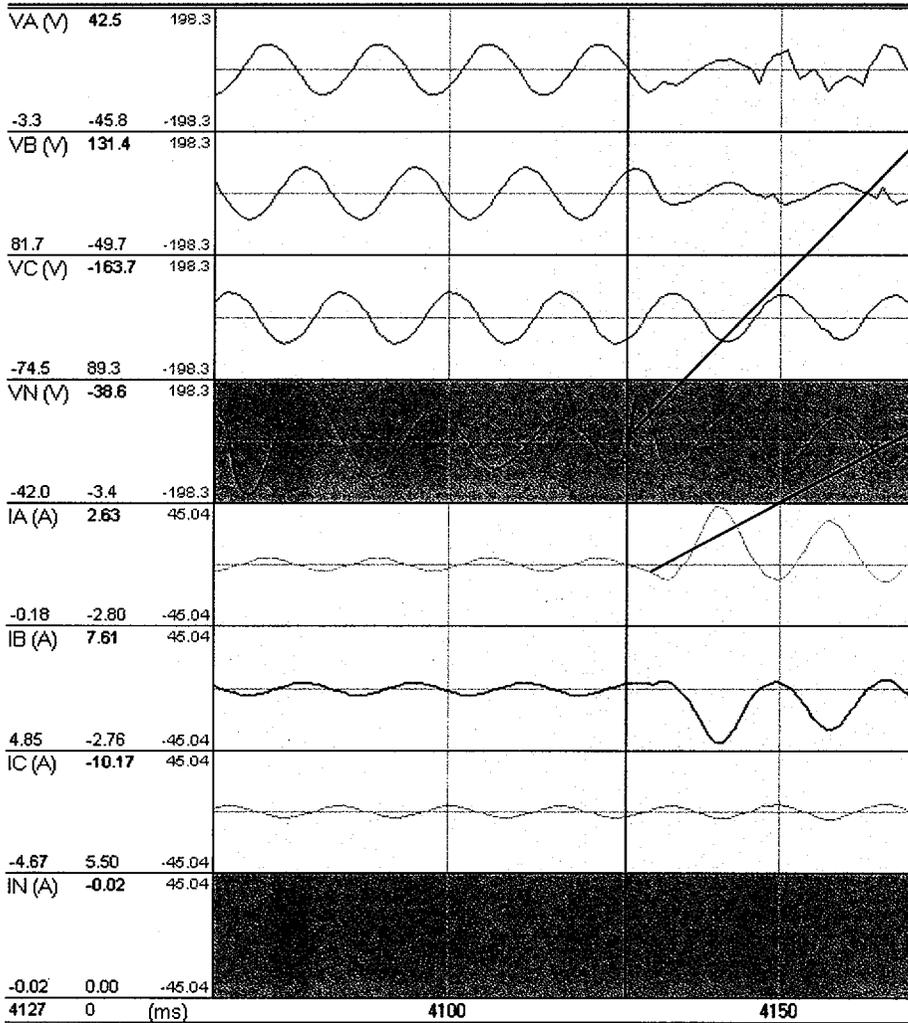
Fourth Arcing and Arrester Failure

Fourth Arcing

Phase to Phase fault due to arrester failure

The capacitor did not fail; it was destroyed following the fault.

Evaluate the need for Generator surge arresters and surge capacitors.
