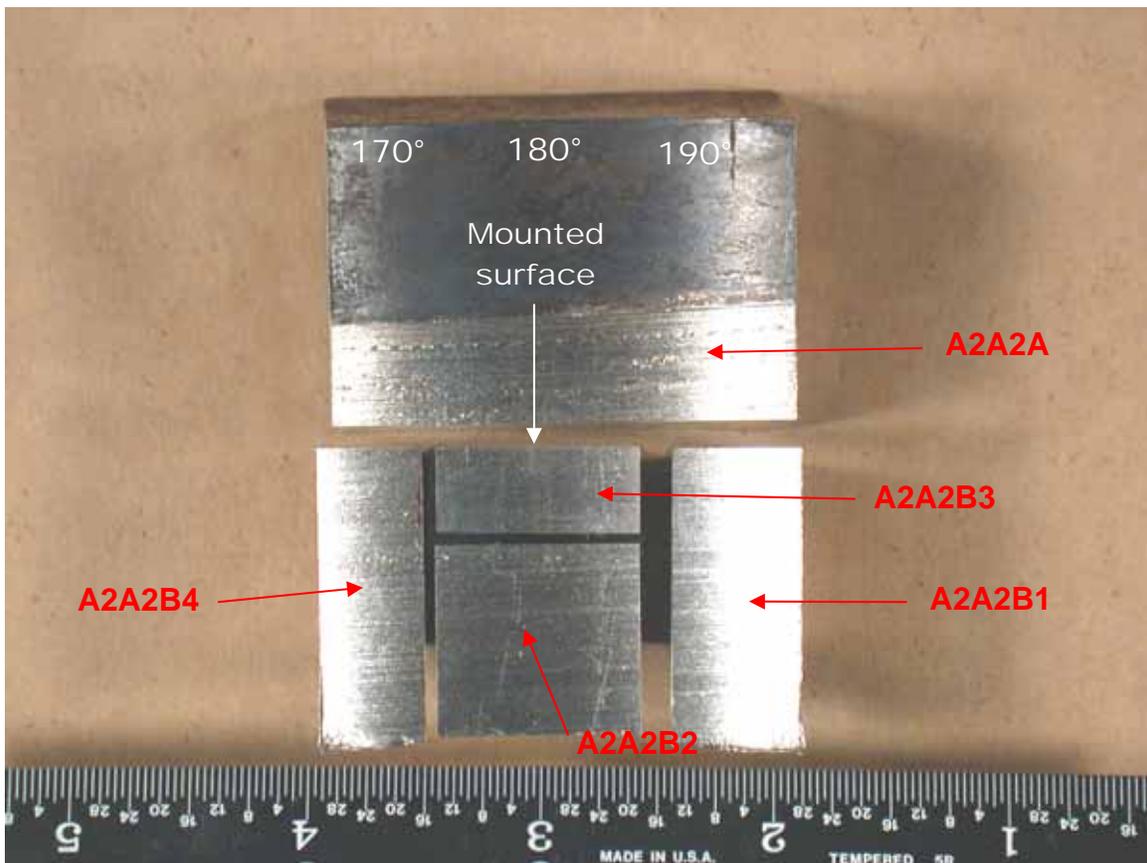
Piece ID	Location	Test Plan	Met	SEM
A2A2A	Upper portion of nozzle #3 bore	No plan	--	--
A2A2B1	Lower portion of nozzle #3 bore at ~190°	No plan	--	--
A2A2B2	Lower portion of nozzle #3 bore ~180°	No plan	--	--
A2A2B3	Contains axial cracks at ~180° in the J-groove weld.	Met sample through axial cracks	1	--
A2A2B4	Lower portion or nozzle #3 bore at ~170°	No plan	--	--

Figure 5.2: Sectioning of Piece A2A2, looking at the ID of the J-groove weld bore.

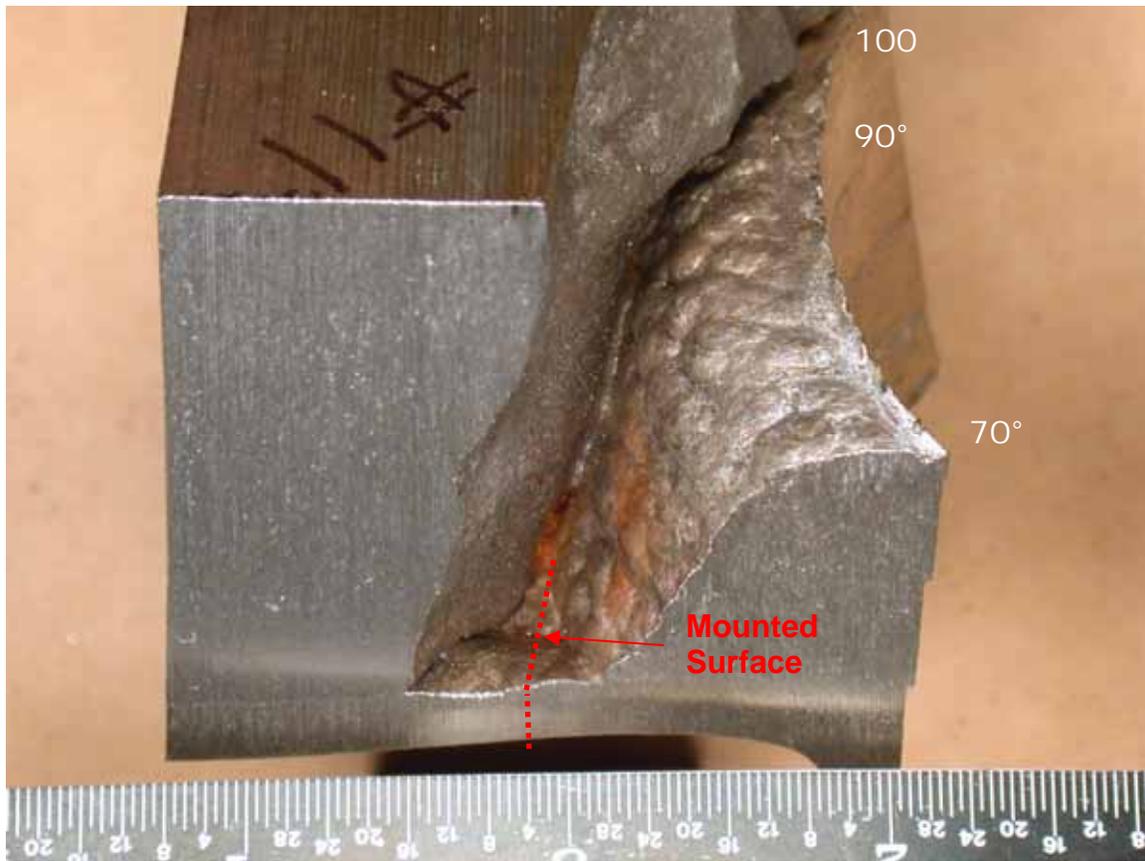
Figure 5.3: Piece A2A5 before sectioning. The mounted surface is indicated.

Figure 5.3 (cont.): Piece A2A5 after sectioning, looking down on the front face of previous photo. The mounted surface on sample A2A5C is indicated. This area contained the thinnest measured cladding (0.202”).

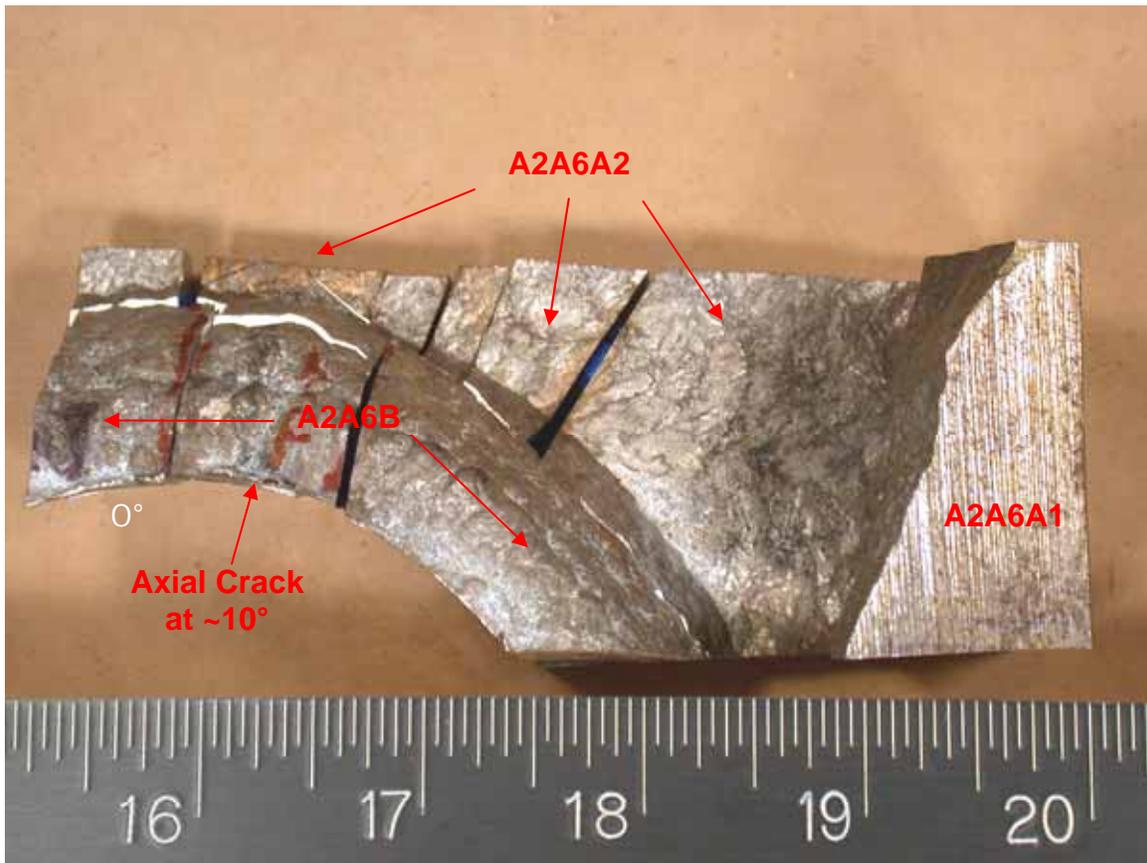
Piece ID	Location	Test Plan	Met	SEM
A2A6A1	RV head near 90°	No plan	--	--
A2A6A2 (see below)	Lower portion of J-groove weld and clad from 350°-70°	Contains lower portion of axial crack at ~10° and circ cracks (0°-45°)	3	2
A2A6B (see below)	Upper portion of J-groove weld from 350°-70°	Contains upper portion of axial crack at ~10°	1	2

Figure 5.4: Piece A2A6 was first sectioned into Pieces A2A6A and A2A6B. Piece A2A6A was further sectioned into Pieces A2A6A1 and A2A6A2. Both cuts were made on the same plane, parallel to the paper. The first cut line is partially visible; Piece A2A6B is the upper portion of the weld. The second cut line between Pieces A2A6A1 and A2A6A2 is obscured by Piece A2A6A1.

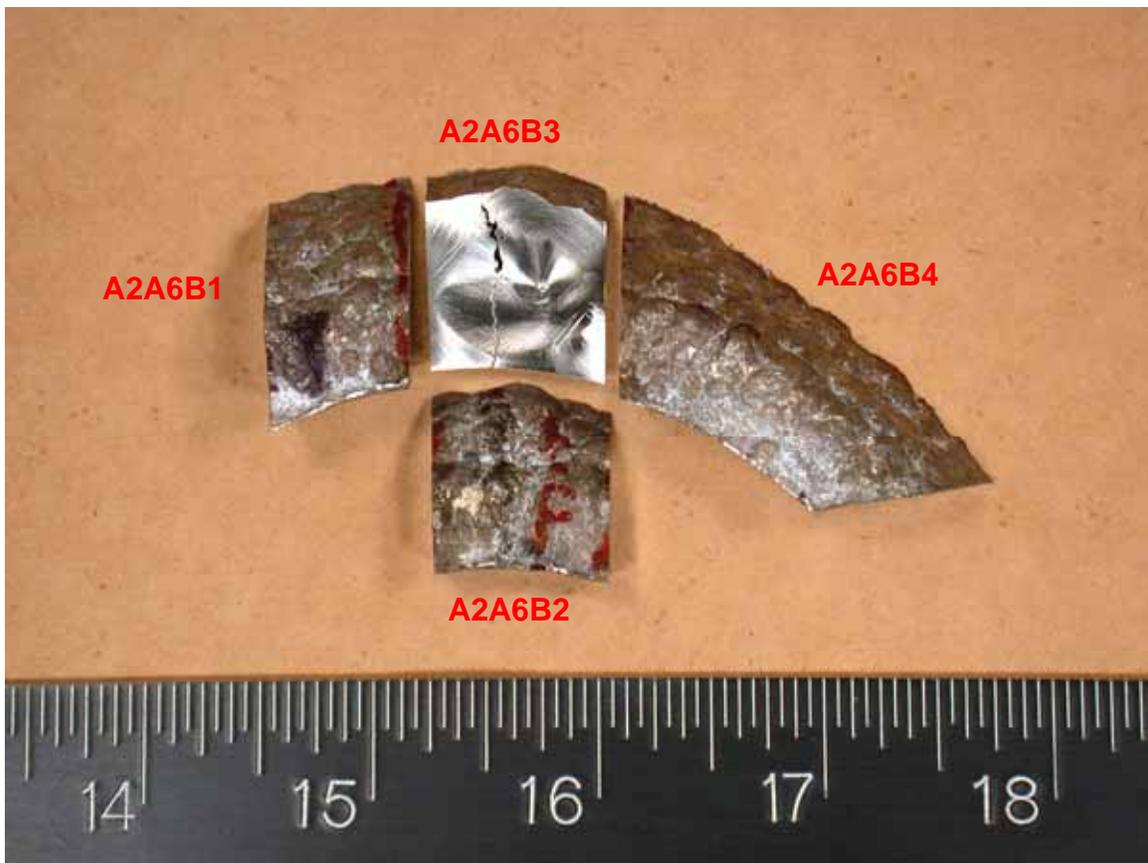
Piece ID	Location	Test Plan	Met	SEM
A2A6B1	Upper portion of J-groove weld at ~350°	No plan	--	--
A2A6B2	Upper portion of J-groove weld axial crack at ~10°	Lower surface mounted for met/SEM	1	1
A2A6B3	Mid portion of J-groove weld axial crack at ~10°	Open crack SEM sample	--	1
A2A6B4	Upper portion of J-groove weld from 30°-70°	No plan	--	--

Figure 5.5: Piece A2A6B after sectioning. The bottom surface of A2A6B2 was mounted. The axial crack in A2A6B3 was opened up for SEM.

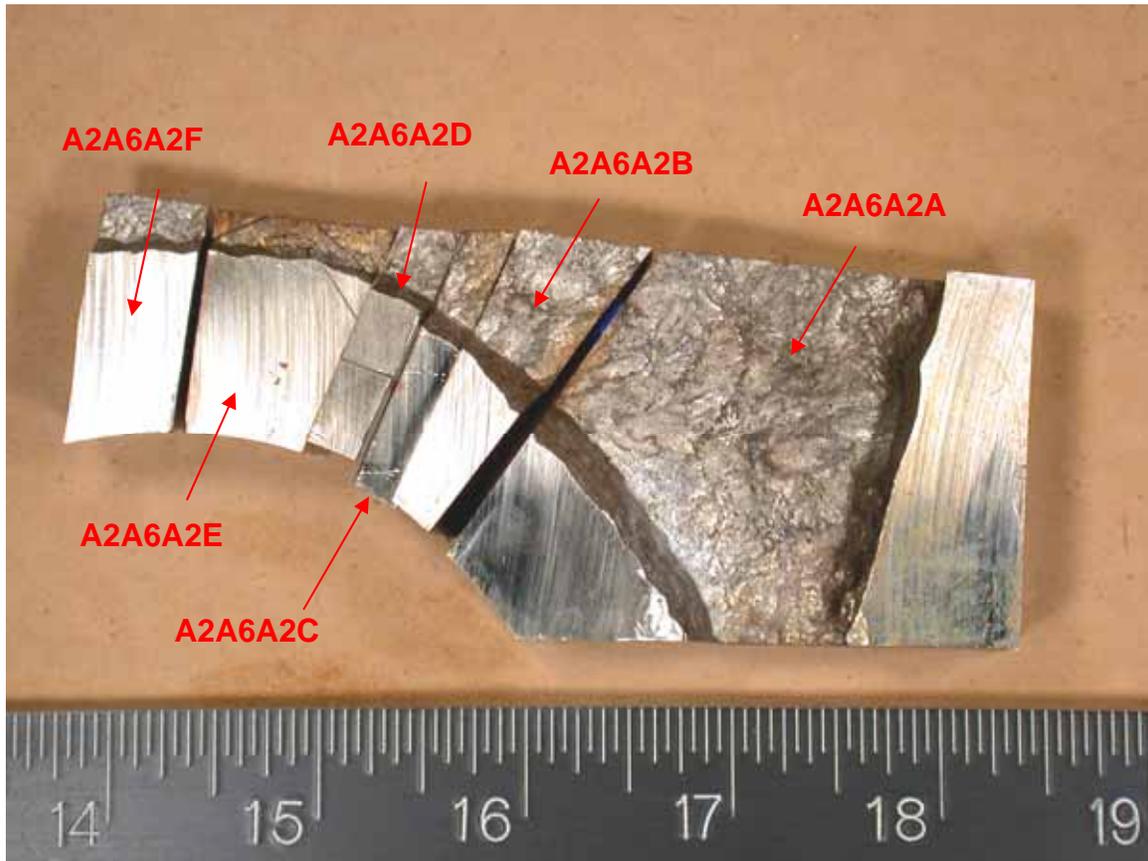
Piece ID	Location	Test Plan	Met	SEM
A2A6A2A	Lower portion of J-groove weld and clad at ~70°	No plan	--	--
A2A6A2B	Lower portion of J-groove weld and clad at ~45°	Contains circ crack near 45°	1	--
A2A6A2C	Lower portion of J-groove weld and clad at ~30°	Open circ crack sample for SEM	--	1
A2A6A2D	Lower portion of J-groove weld and clad at ~20°	Contains circ crack near 20°	1	1
A2A6A2E	Lower portion of J-groove weld and clad at ~10°	Contains axial crack and circ cracks at 10°	1	--
A2A6AF	Lower portion of J-groove weld and clad at ~0°	No plan	--	--

Figure 5.6: Piece A2A6A2 after sectioning. Additional sections were made on A2A6A2B, -C, -D, and -E. Refer to the following four tables and figures.

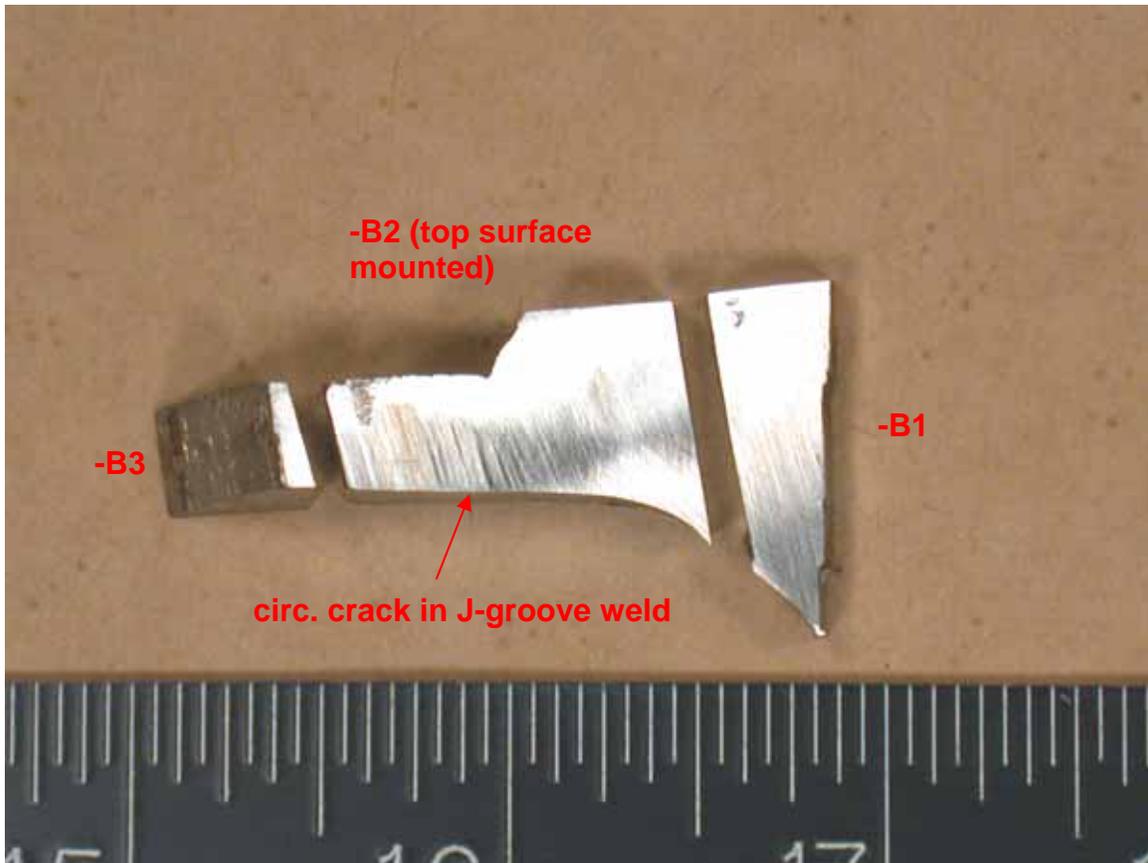
Piece ID	Location	Test Plan	Met	SEM
A2A6A2B1	Lower portion of J-groove weld at ~45° (includes bore)	No plan	--	--
A2A6A2B2	Lower portion of J-groove weld and clad at ~45°	Contains circ crack near 45°	1	--
A2A6A2B3	Clad at ~45°	No plan	--	--

Figure 5.7: Piece A2A6A2B after sectioning (side view of Figure 5.6). The top surface of A2A6A2B2 was mounted.

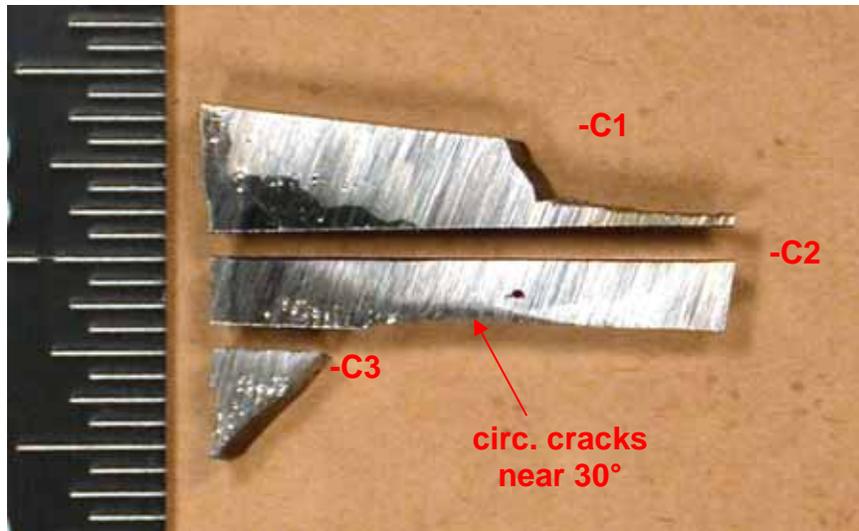
Piece ID	Location	Test Plan	Met	SEM
A2A6A2C1	Lower portion of J-groove weld and upper surface of clad at ~30° (includes bore)	No plan	--	--
A2A6A2C2	Lower portion of J-groove weld and clad at ~30°	Circ crack near 30° bent open for SEM	--	1
A2A6A2C3	Lower portion of J-groove weld (RCS side)	No plan	--	--

Figure 5.8: Piece A2A6A2C after sectioning (side view of Figure 5.6). The circumferential cracks were bent open for SEM.

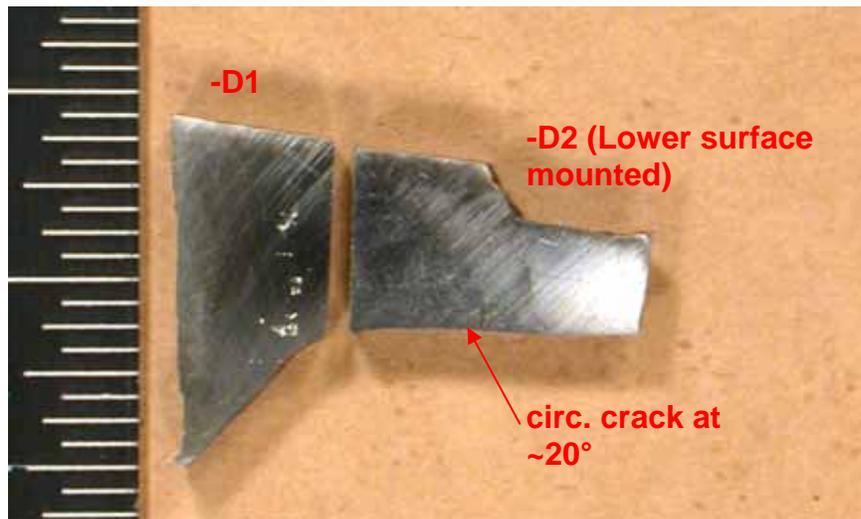
Piece ID	Location	Test Plan	Met	SEM
A2A6A2D1	Lower portion of J-groove weld at ~20° (includes bore)	No plan	--	--
A2A6A2D2	Lower portion of J-groove weld and clad at ~20°	Contains circ crack at ~20°	1	1

Figure 5.9: Section photo for Piece A2A6A2D (side view of Figure 5.6). The mounted surface of Piece A2A6A2D2 for optical and SEM examination is the lower surface (not visible) in the photo.

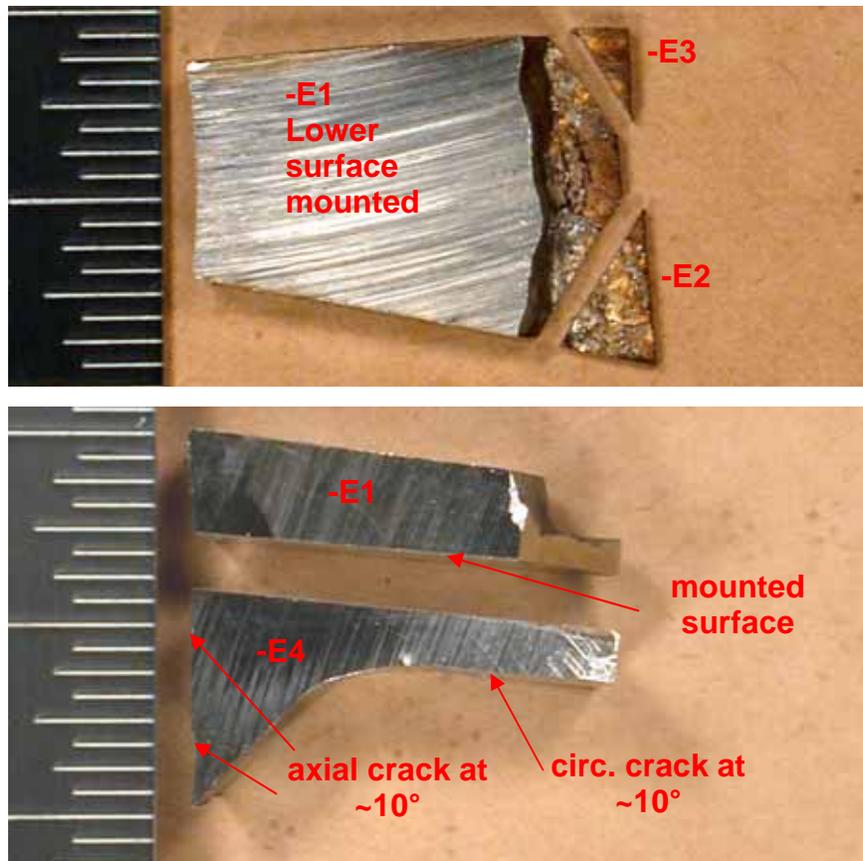
Piece ID	Location	Test Plan	Met	SEM
A2A6A2E1	Lower portion of J-groove weld at ~10°	Lower surface mounted for met	1	--
A2A6A2E2	Contains clad at ~20°	No plan	--	--
A2A6A2E3	Contains clad at ~0°	No plan	--	--
A2A6A2E4	Lower portion of J-groove weld (RCS side)	Contains axial and circ cracks at ~10° (PNL Sample)	--	--

Figure 5.10: Section photo for Piece A2A6A2E (side view of Figure 5.6). The mounted surface of Piece A2A6A2E1 is indicated. Piece A2A6A2E4 is reserved for PNL.

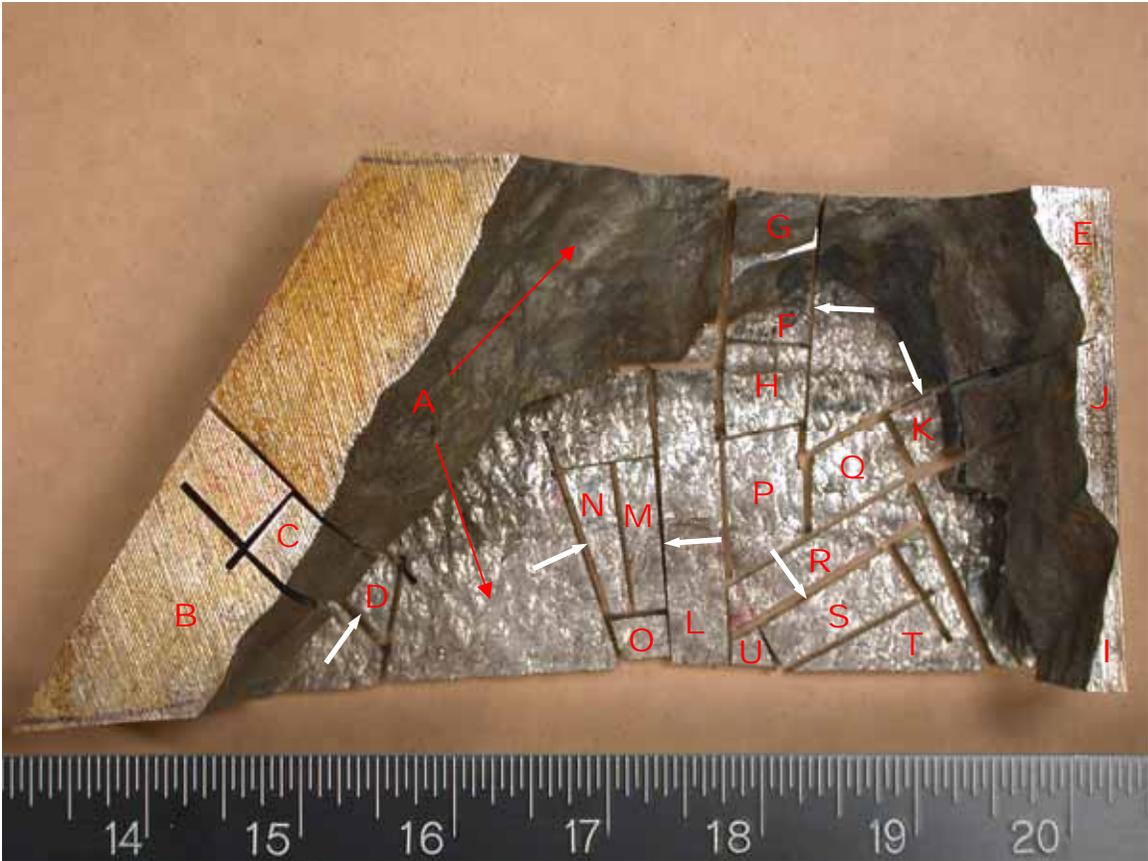
Piece ID	Location	Test Plan	Met	SEM
A2A7A	RV head and clad near 350°	No plan	--	--
A2A7B	RV head and clad near 340°	No plan	--	--
A2A7C	RV head near 345°	No plan	--	--
A2A7D	Undercut region near 345°	Met mount	1	--
A2A7E	RV head and clad near nose	No plan	--	--
A2A7F	Undercut region near nose	Met mount	1	--
A2A7G	RV head near nose	No plan	--	--
A2A7H	Clad prior to nose	No plan	--	--
A2A7I	RV head and clad near 50°	No plan	--	--
A2A7J	RV head and clad near 40°	No plan	--	--
A2A7K	Undercut region near 40°	Met mount	1	--
A2A7L	Center portion of clad cracks	SEM open crack sample	--	1
A2A7M	Adjacent to center cracks	Met mount (center portion)	1	1
A2A7N	Clad cracks toward 270°	Met mount (270°)	1	1
A2A7O	Clad near 0°	No plan	--	--
A2A7P	Center portion of clad cracks	Reserved for PNL	--	--
A2A7Q	Clad near 40°	No plan	--	--
A2A7R	Clad near 40°	No plan	--	--
A2A7S	Clad cracks toward 90°	Met mount	1	1
A2A7T	Clad near 60°	No plan	--	--

Figure 5.11: Section photo for Piece A2A7. The mounted surfaces for the -D, -F, -K, -M, -N, and -S samples are indicated by the white arrows. Further sectioning of Piece A2A7L is shown in Figure 5.12.

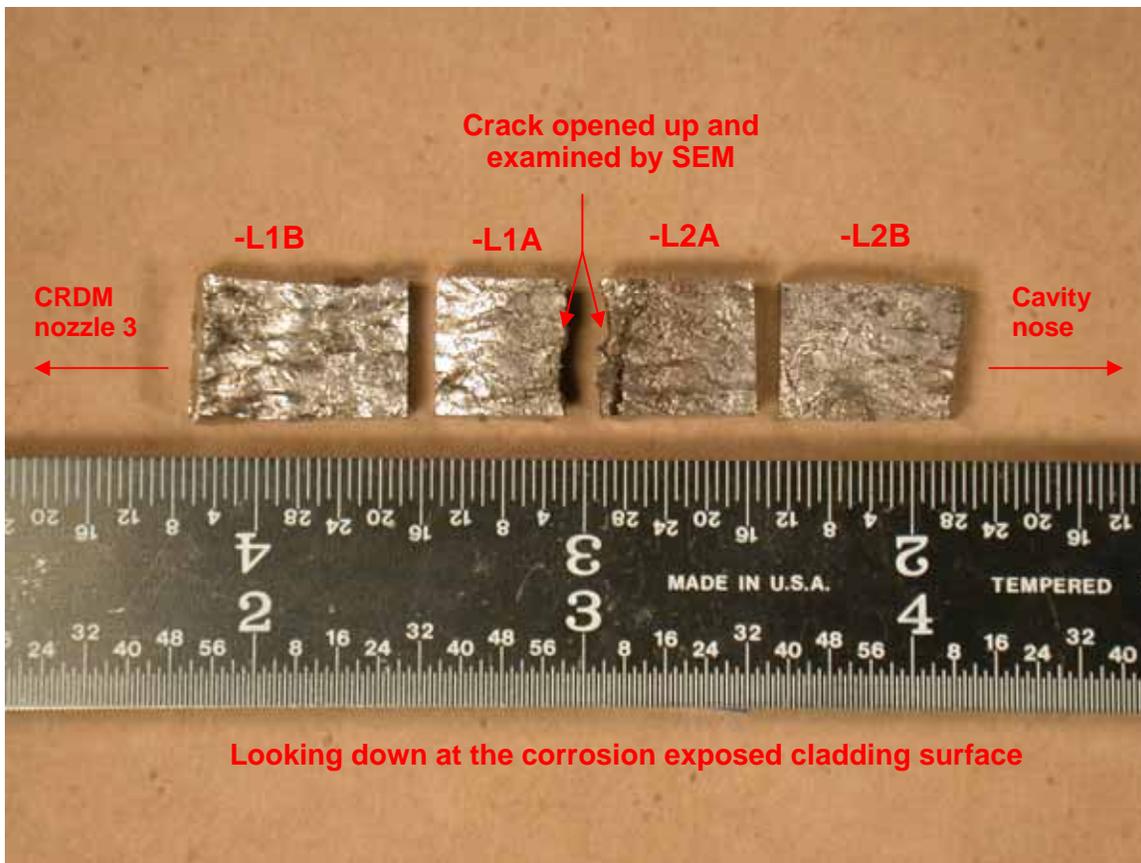
Piece ID	Location	Test Plan	Met	SEM
A2A7L1A	Center portion of clad cracks	SEM open crack sample	--	1
A2A7L1B	Adjacent to center cracks	No plan	--	--
A2A7L2A	Center portion of clad cracks	SEM open crack sample	--	1
A2A7L2B	Adjacent to center cracks	No plan	--	--

Figure 5.12: Section photo for Piece A2A7L. The main crack located near the center of A2A7L was opened in the laboratory, resulting in Pieces A2A7L1 and A2A7L2. Additional sections, which created the -A and -B pieces, were made to facilitate the SEM examinations. The surfaces examined by SEM are indicated.
