**BWX Technologies, Inc.**

**FINAL REPORT:**  
**EXAMINATION OF THE REACTOR VESSEL (RV) HEAD DEGRADATION  
AT DAVIS-BESSE**

**PREPARED FOR  
FRAMATOME ANP, INC.**

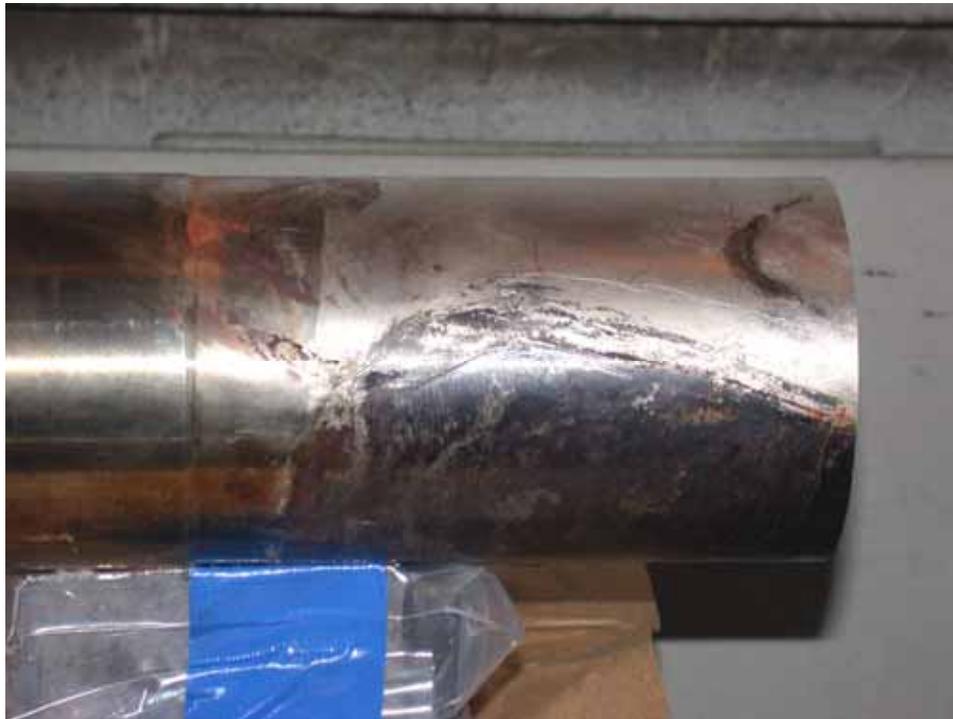
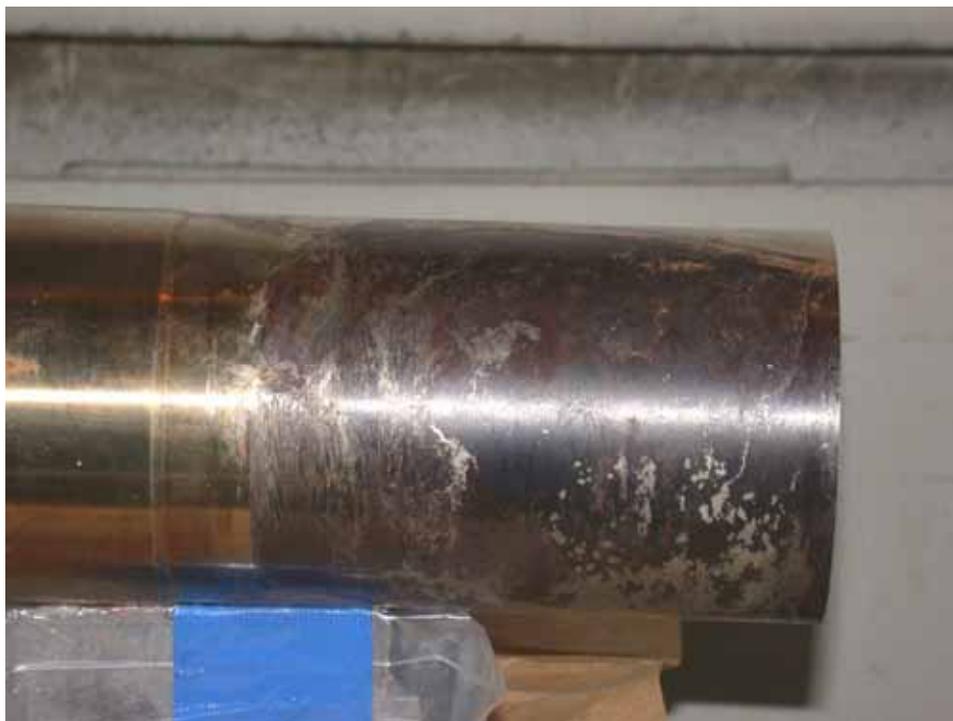
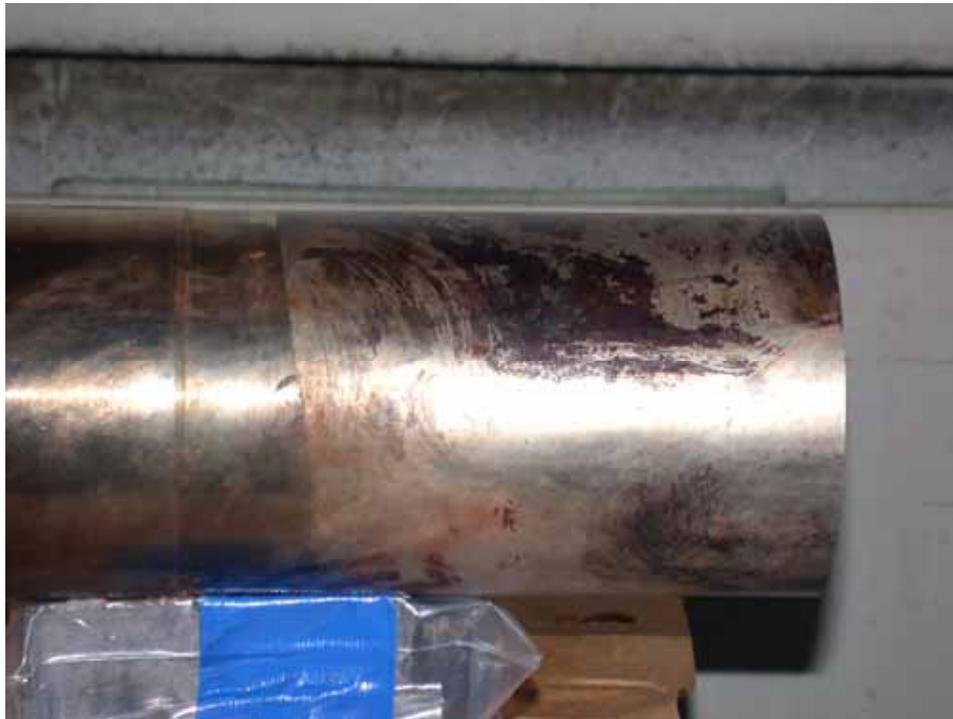
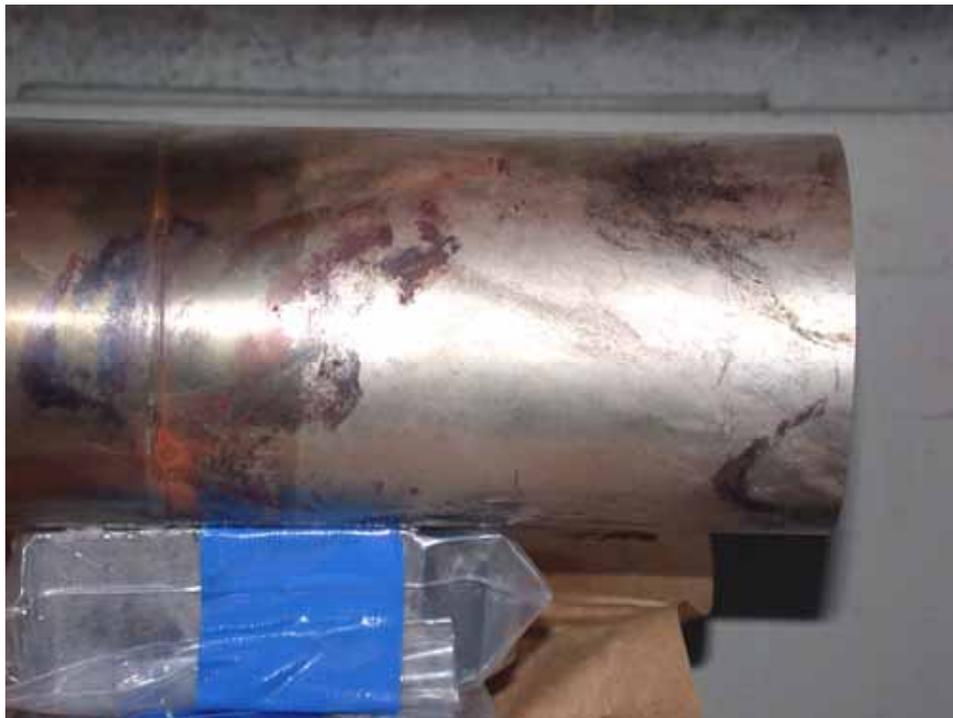
These photographs show the bright appearance of the nozzle outer diameter (OD) that was adjacent to the corrosion cavity from approximately 270° - 0° - 90°. The bright appearance was due to the oxide film being removed by the boric acid in the corrosion cavity on the downhill side. The opposite side of the nozzle OD in contact with the RV head contained a fairly uniform dark oxide layer. Figure 2.2.3 shows the end view of nozzle #3. Unlike nozzle #2, the remaining portion of nozzle #3 had its full wall thickness on the lower end.

Figure 2.2.2: Higher magnification photographs showing end of nozzle #3. Reduced section length was 6-1/2". ~0.5X

Figure 2.2.2 (cont.): Higher magnification photographs showing end of nozzle #3. Reduced section length was 6-1/2". ~0.5X

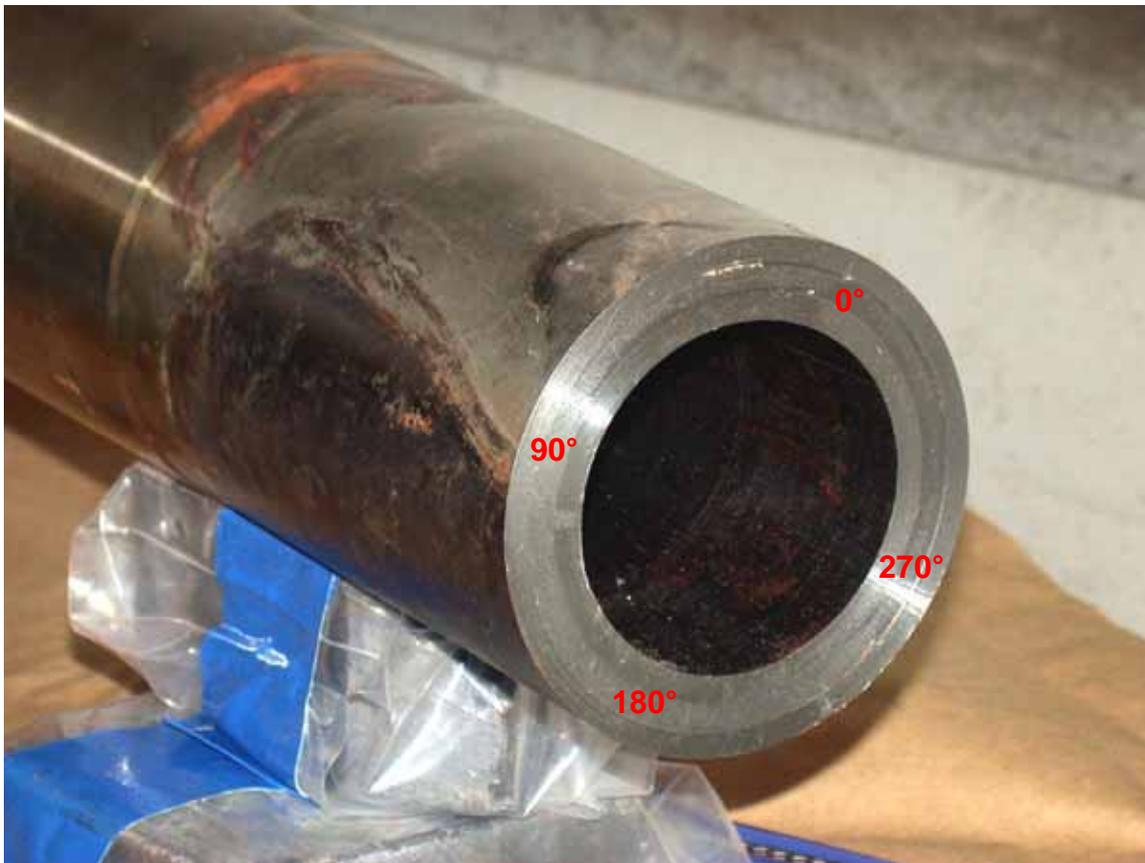
Figure 2.2.3: Photograph showing end view of nozzle #3.

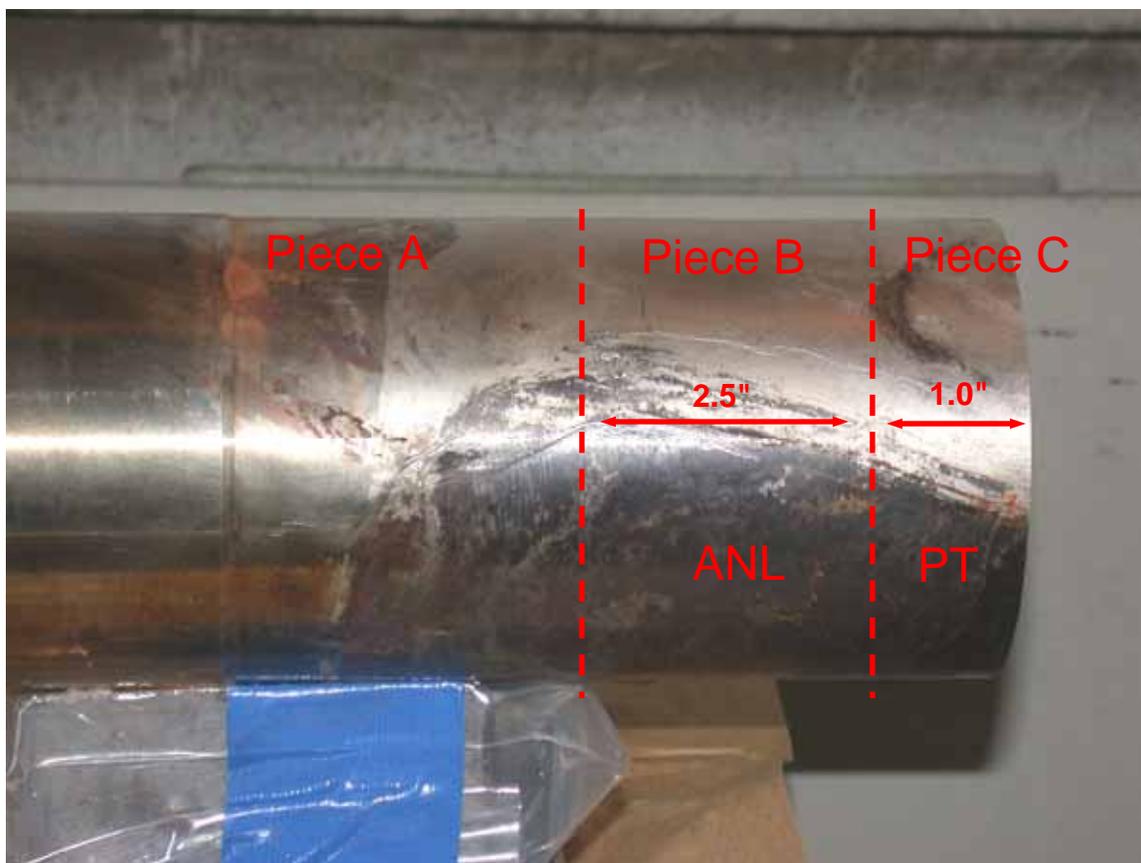
Figure 2.3.1 provides the initial section locations for nozzle #3. Two transverse sections were made through the nozzle from the lower end as shown in Figure 2.3.1. These cuts were made using a lubricated horizontal band saw. The lowest piece (piece C) was a 1" wide ring potentially containing in-service cracks; the 2-1/2" ring was designated piece B and was shipped to Argonne National Laboratory for additional testing. The testing to be performed at Argonne National Laboratory is outside the scope of this investigation. No work was performed on the balance of the nozzle, which was designated piece A.

Figure 2.3.1: Sectioning photo for nozzle #3. Piece B was shipped to Argonne National Laboratory and piece C was further tested at BWXT.

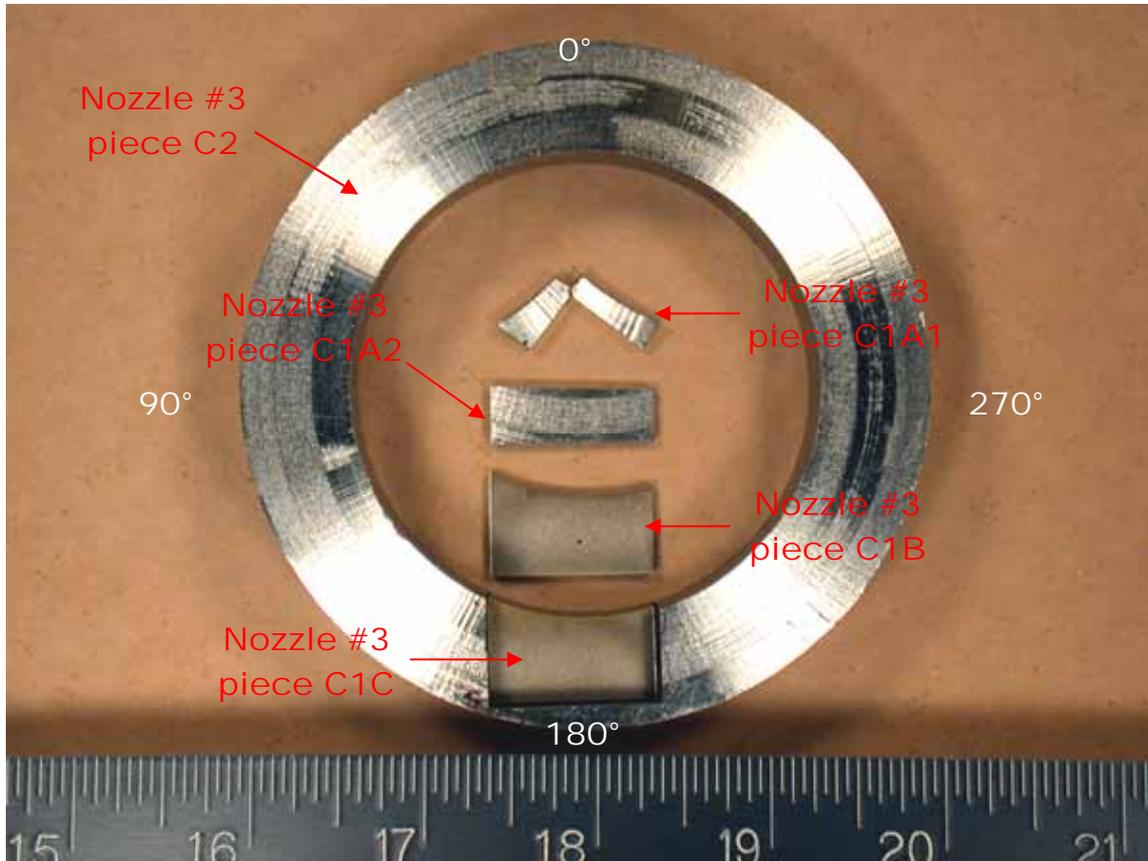
Sectioning for nozzle #3 piece C - looking at lower surface

Figure 2.5.1: Section locations and new sample identifications for nozzle #3 piece C.

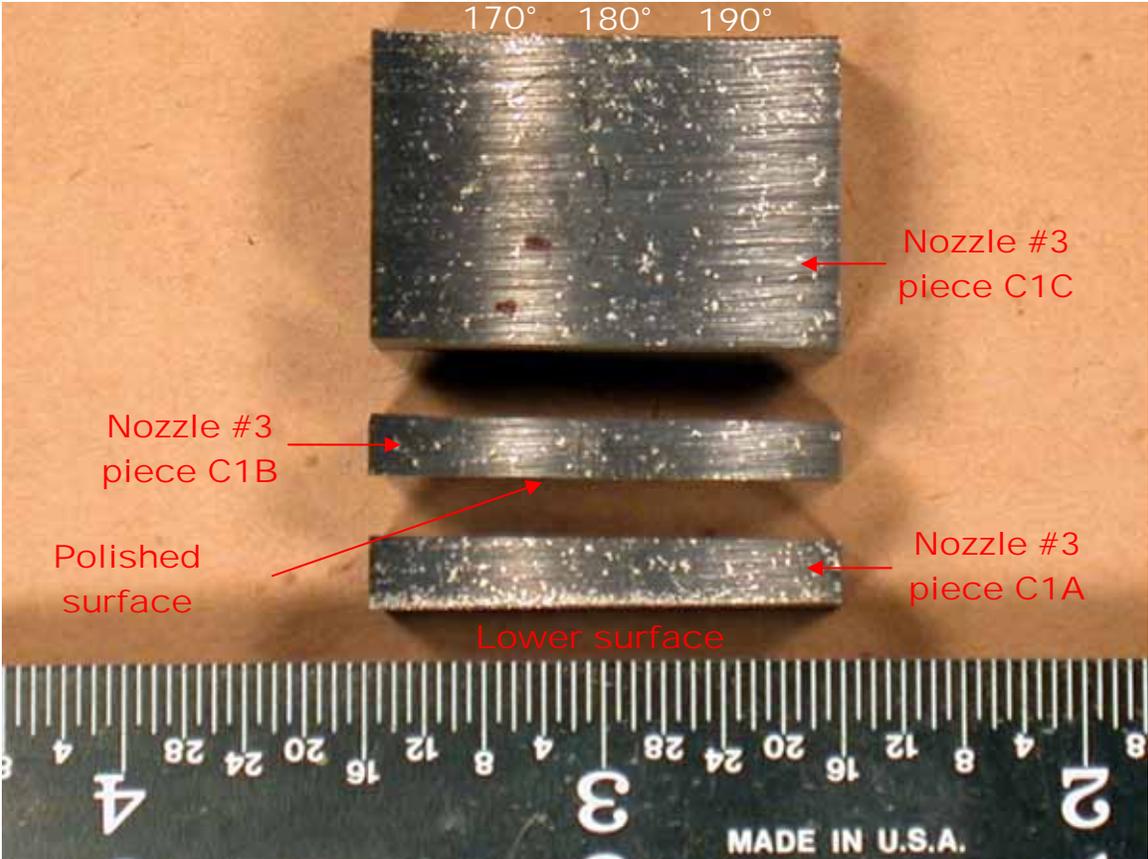
Sectioning for nozzle #3 piece C1 prior to opening lower portion of crack. Looking at nozzle ID surface; the largest crack is located near 180°.

Figure 2.5.2: Photograph of nozzle #3 samples C1A, C1B, and C1C.

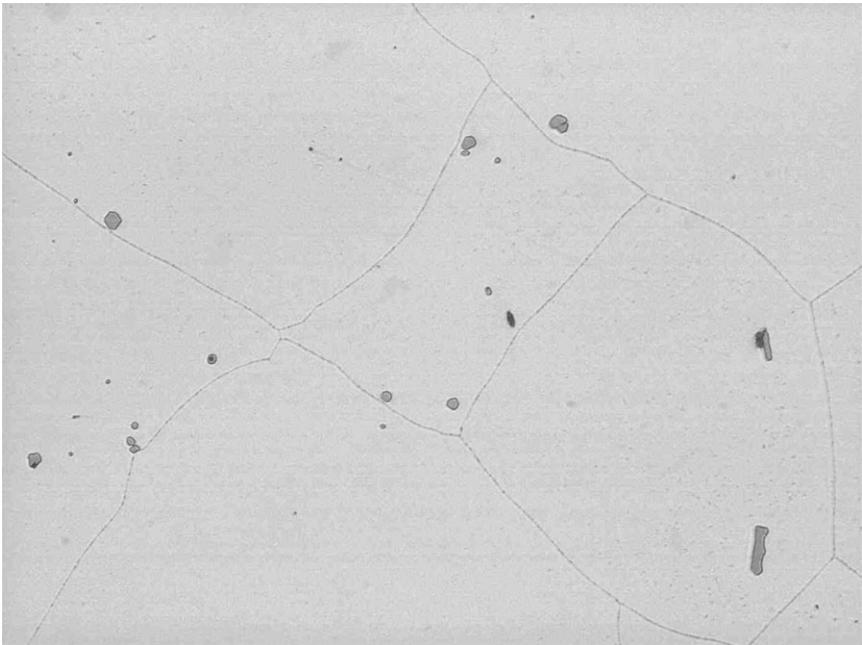
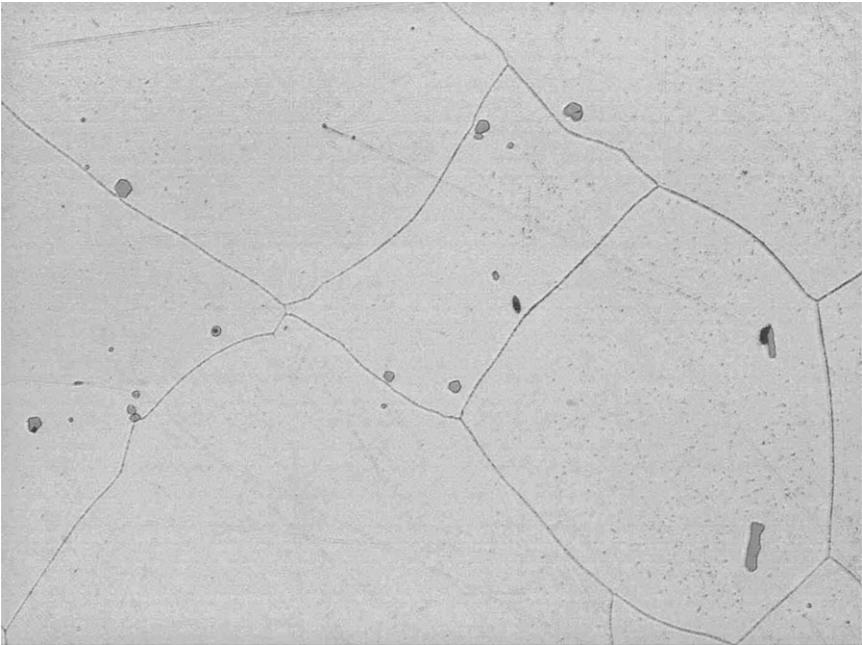
Figure 2.6.5: Typical micrographs taken of the nozzle base material.
