**FINAL REPORT:
EXAMINATION OF THE REACTOR VESSEL (RV) HEAD DEGRADATION
AT DAVIS-BESSE**

**PREPARED FOR
FRAMATOME ANP, INC.**

SUMMARY

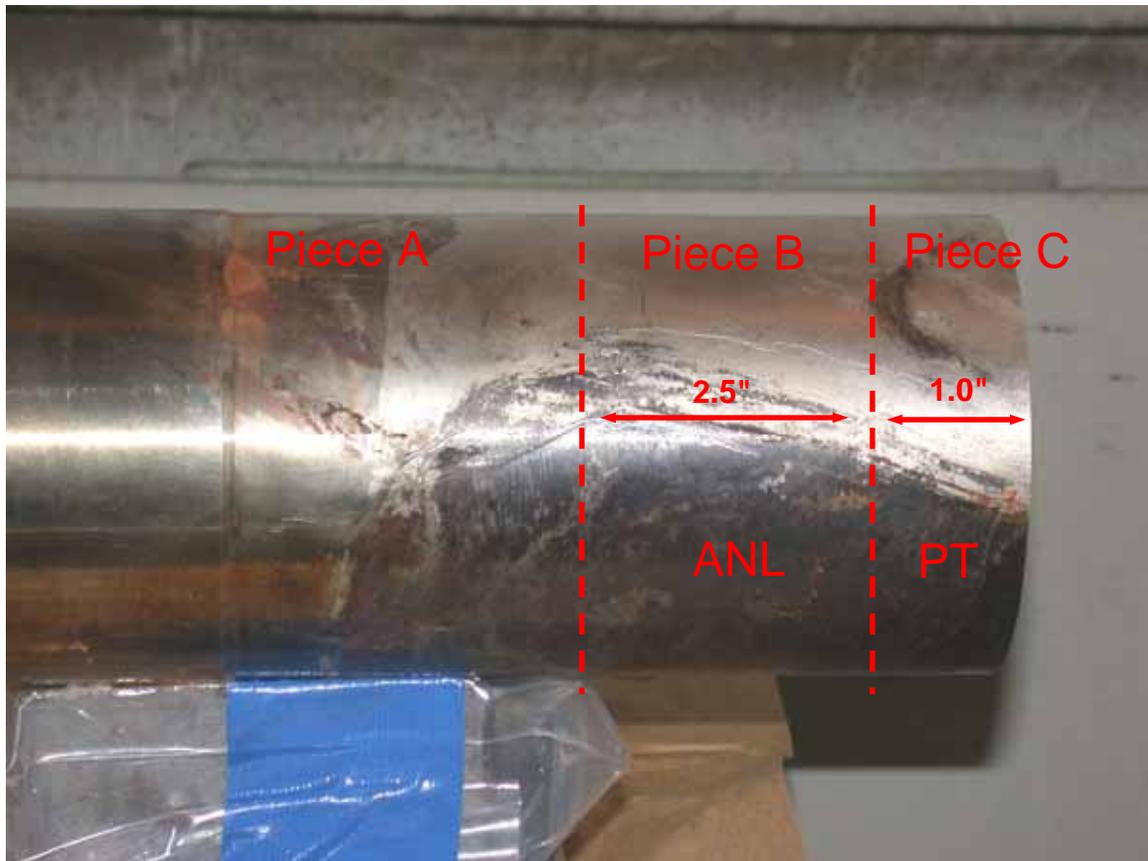
Figure 2.3.1 provides the initial section locations for nozzle #3. Two transverse sections were made through the nozzle from the lower end as shown in Figure 2.3.1. These cuts were made using a lubricated horizontal band saw. The lowest piece (piece C) was a 1" wide ring potentially containing in-service cracks; the 2-1/2" ring was designated piece B and was shipped to Argonne National Laboratory for additional testing. The testing to be performed at Argonne National Laboratory is outside the scope of this investigation. No work was performed on the balance of the nozzle, which was designated piece A.

Figure 2.3.1: Sectioning photo for nozzle #3. Piece B was shipped to Argonne National Laboratory and piece C was further tested at BWXT.

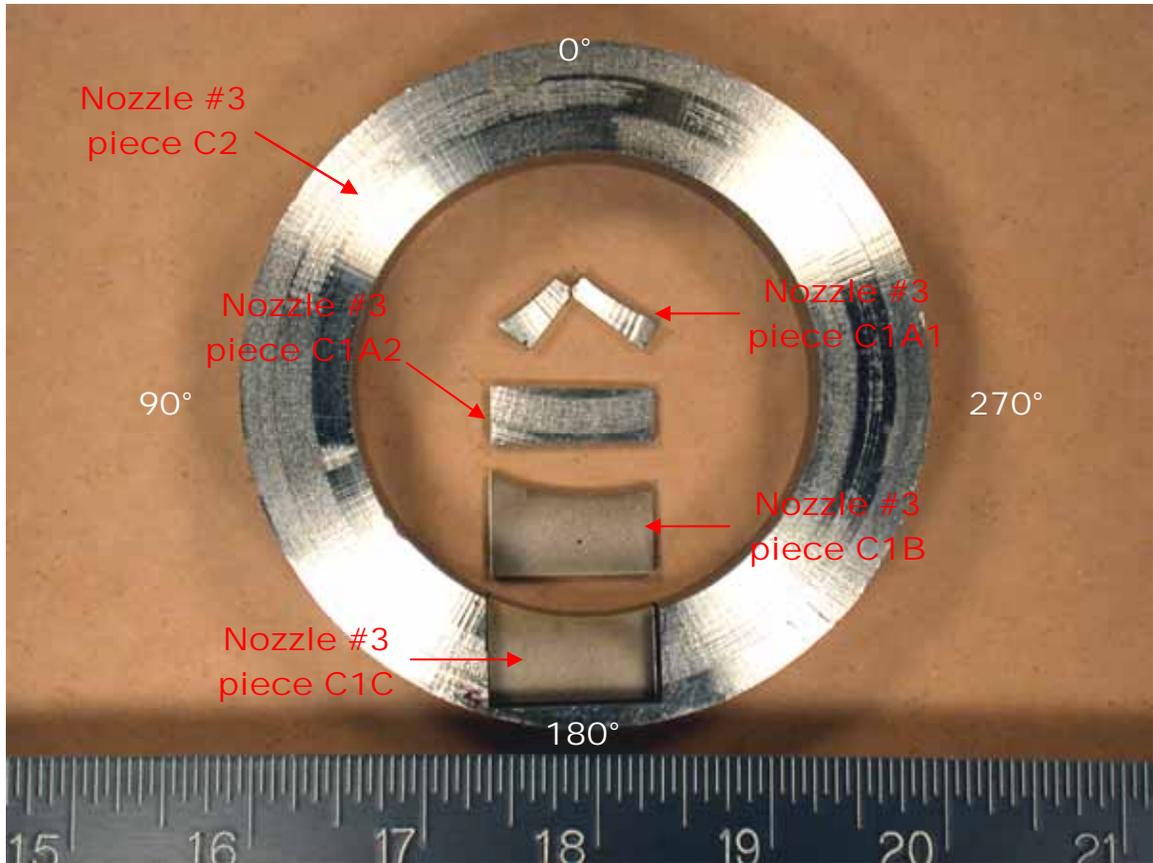
Sectioning for nozzle #3 piece C - looking at lower surface

Figure 2.5.1: Section locations and new sample identifications for nozzle #3 piece C.

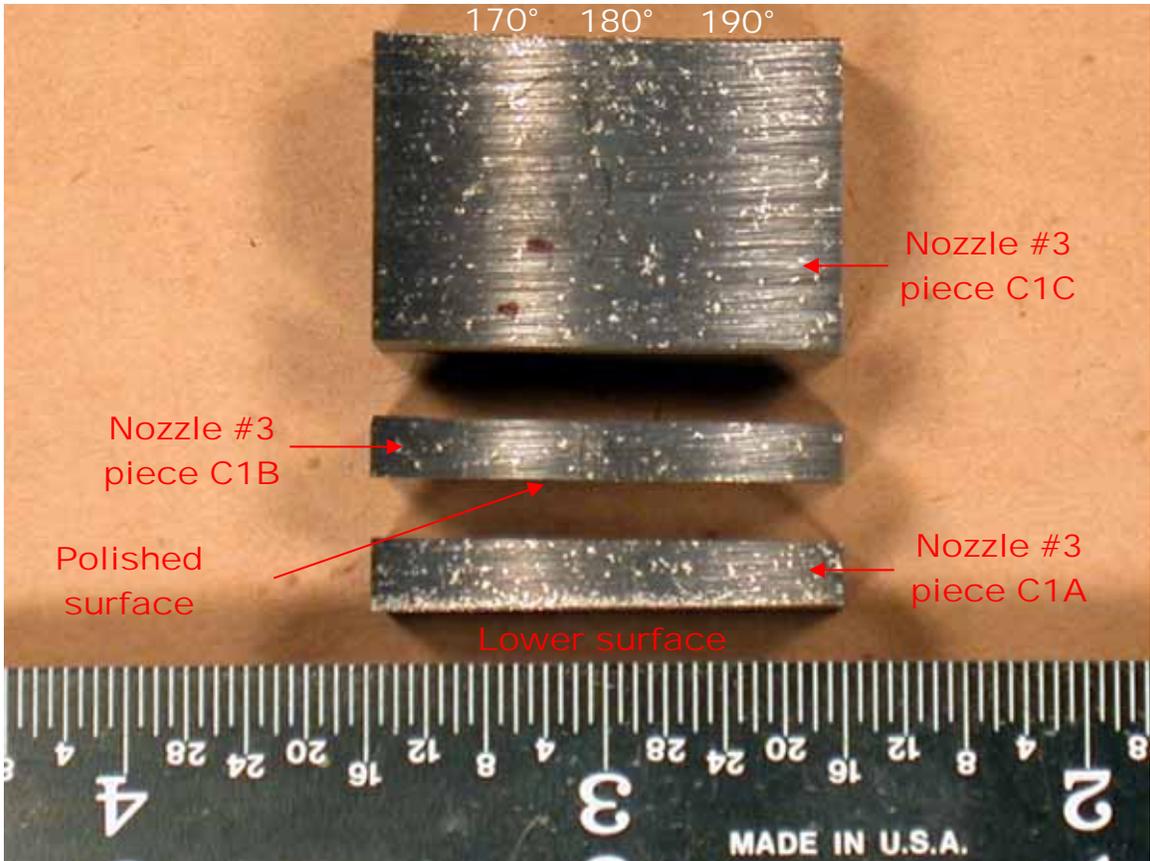
Sectioning for nozzle #3 piece C1 prior to opening lower portion of crack. Looking at nozzle ID surface; the largest crack is located near 180°.

Figure 2.5.2: Photograph of nozzle #3 samples C1A, C1B, and C1C.
