Subject: Duke Energy
Oconee Nuclear Station, Unit 1, 2, and 3
Docket No. 50-269,-270,-387
Third Ten Year Inservice Inspection Interval
Request for Relief No. 04-ON-006

Proposed Relief in Accordance with 10 CFR 50.55a (a)(3)(ii)**Inservice Inspection Hardship****Duke Energy Corporation**

Third 10-Year Interval – Inservice Inspection Plan**ASME Section XI Code – 1989 Edition with No Addenda**

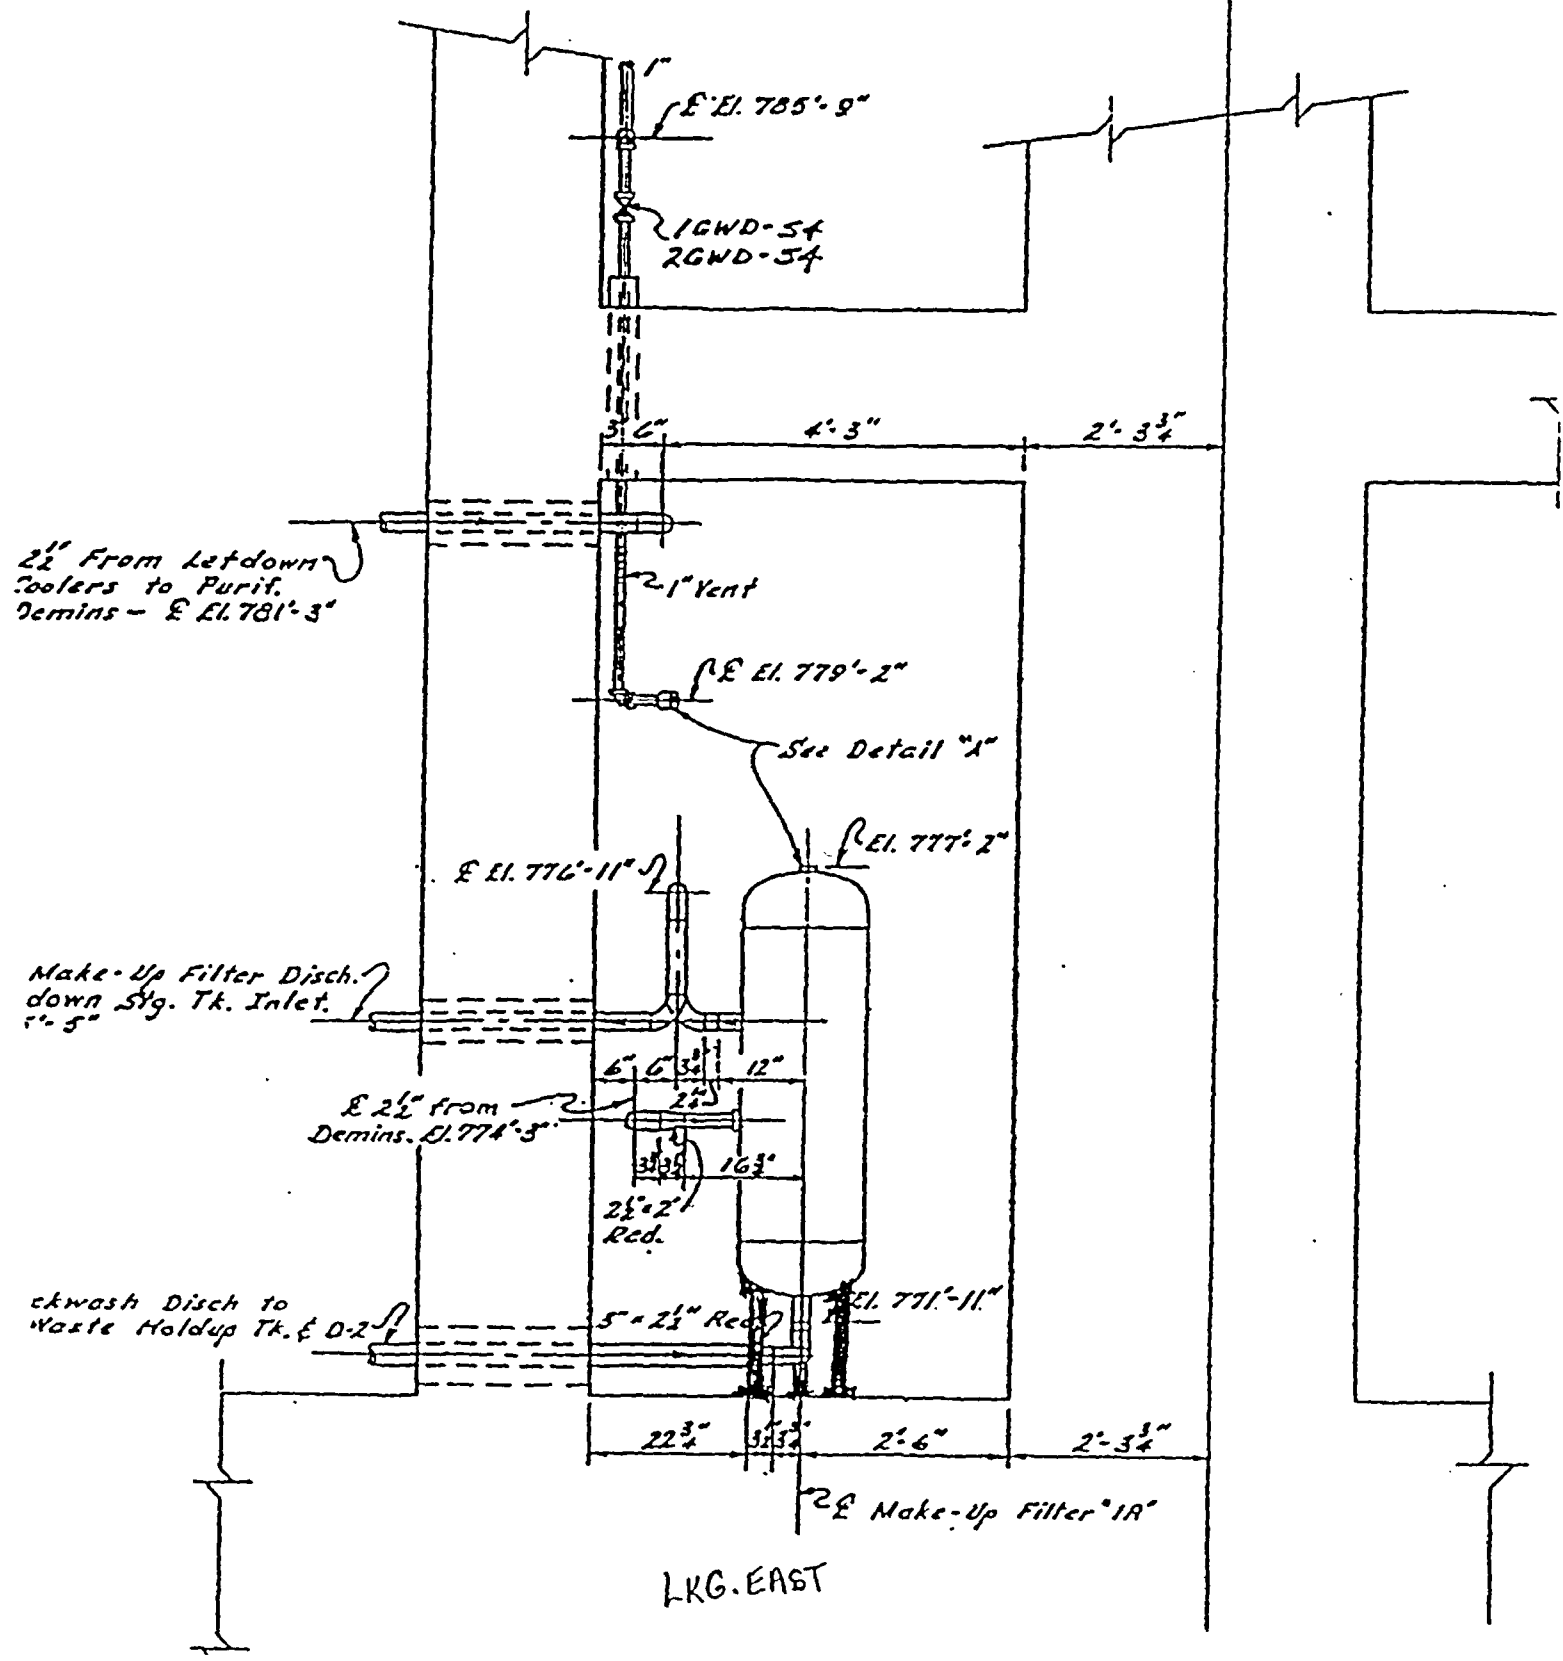
CAMERA LOWERED FROM HATCH ABOVE - INSULATION COVERED PART OF ANGLES TO TANK - LEGS SOUTHEAST, NORTH, WEST, LEGS VISIBLE - BASE PLATES VISIBLE - EVERYTHING ELSE NOT LOOKED AT - PARTIALLY

"Using a RP camera mounted on an extendable boom, VT-3 of the support posts and their anchorage for 1A & 1B Letdown Filter Housing was performed. The filter housing is insulated, covering parts of the legs under the housing. With lighting on the camera, QC was able to see a portion of the legs and the base plates/anchors. There has been some leakage in the past during filter changes. This has caused some surface rust but not bad enough to have buckled paint. This is a limited inspection. However, QC feels that the overall condition of the support is good."

Civil engineering also observed/inspected the support posts and their anchorage for 1A & 1B Letdown Filter Housing along with the QC inspectors in aux. bldg. unit-1. Since the filter housing is insulated covering parts of the legs under the housing, some visibility of the support legs and the anchorage is restricted due to limited access. Based on what was seen during inspection using the RP camera with lighting mounted on an extendable boom, the support legs, base plates and anchor bolts do not appear to have any degradation or damage that could raise a concern about its structural integrity besides some minor surface rust as reported. However, a Request For Relief for 1A & 1B Letdown Filter Housing needs to be processed since the complete inspection can not be performed.
