# **Loss of Control of Cesium-137 Well Logging Source Resulting in Radiation Exposures to Members of the Public**

**U.S. Nuclear Regulatory Commission  
Region IV  
Arlington, TX 76011-4005**

Manuscript Completed: April 2004  
Date Published: October 2004

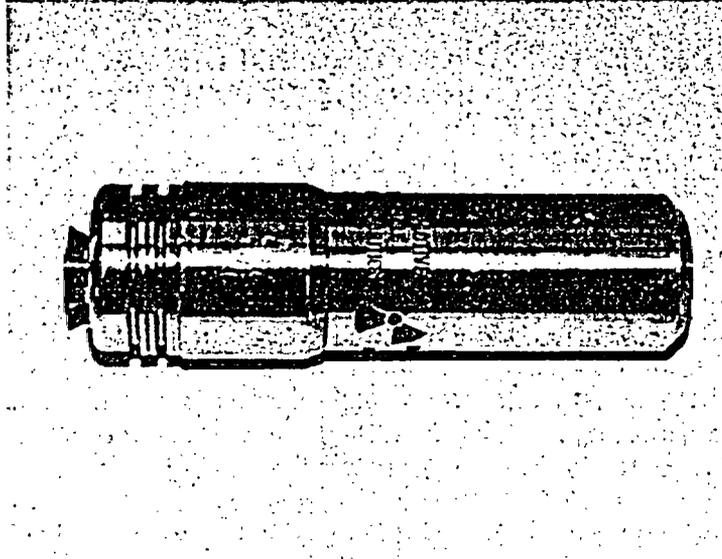
**Figure 2.2.1 A cesium-137 source similar to the one used in well logging left on the rig floor during the event**

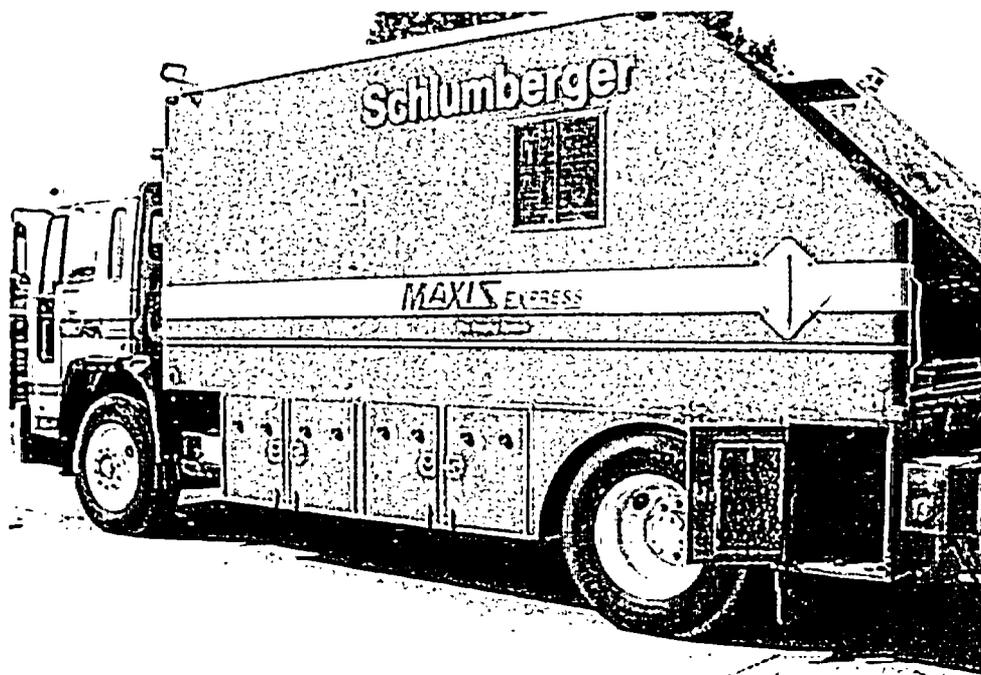
**Figure 3.3.1 Well logging truck, showing the source shield storage bin, used to transport the radioactive sources between logging sites. The bin, at the bottom rear of the truck, is shown empty with its door open. The shielded source container fits into the bin.**
