Loss of Control of Cesium-137 Well Logging Source Resulting in Radiation Exposures to Members of the Public

**U.S. Nuclear Regulatory Commission
Region IV
Arlington, TX 76011-4005**

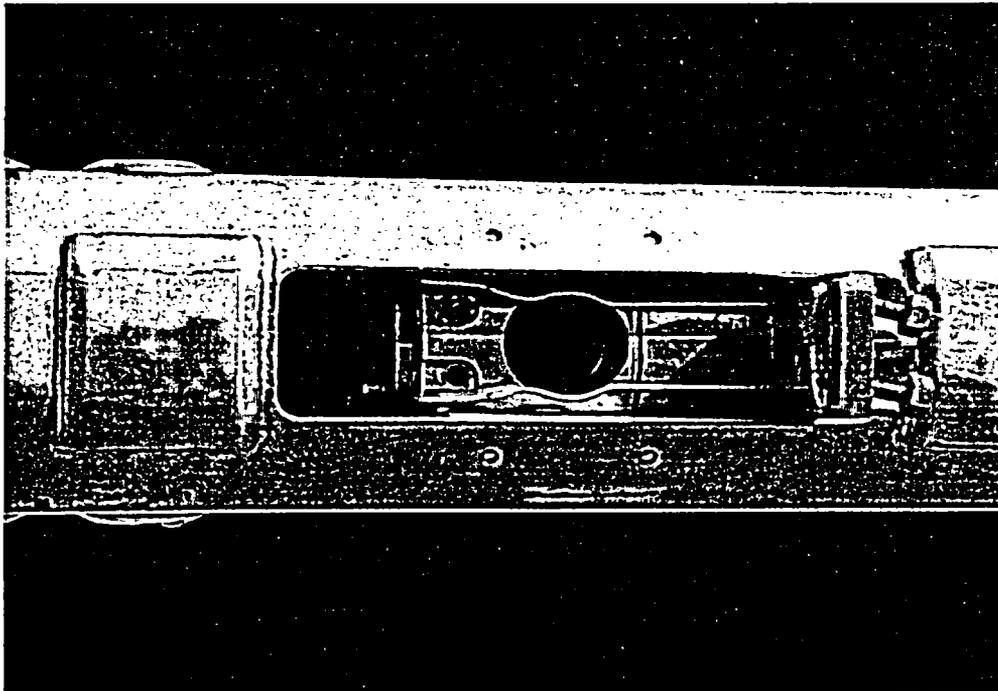
Figure 2.1 Section of the logging tool showing the slot for the radioactive source

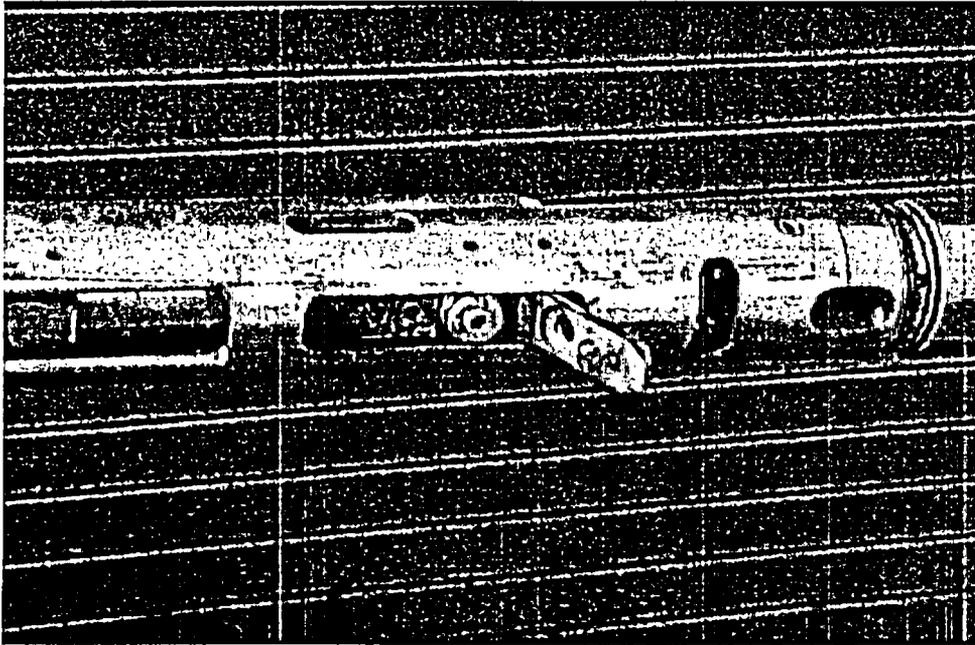
Figure 2.2 Section of the logging tool showing the radioactive source inserted in place in the tool

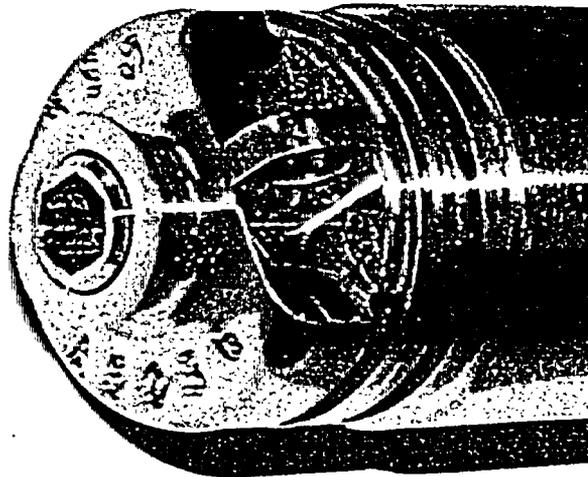
Figure 2.2.2 A detailed view of the flared end of the source assembly. The bracket, with a hole into which the safety clip is inserted, is also shown.

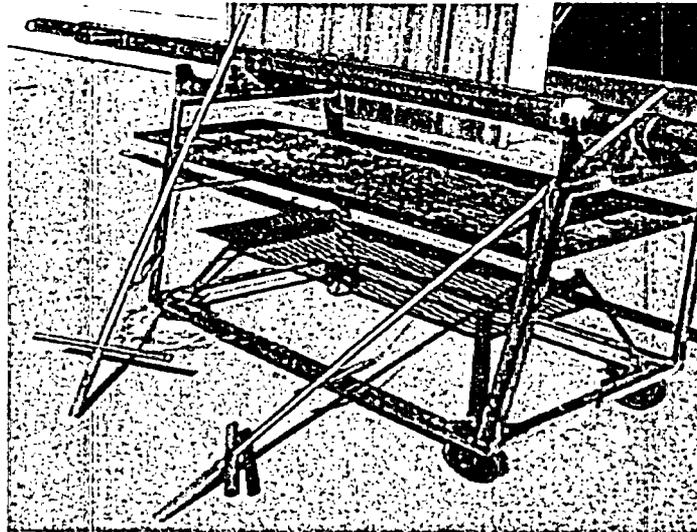
Figure 2.3.1 Two handling tools of the type used to handle the sources during the event. The end that grasps the source is at the top end of the tool in the photograph

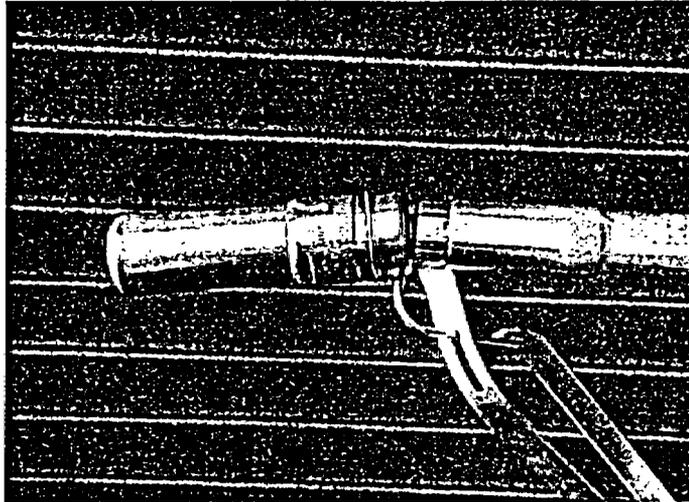
Figure 2.3.2 Source assembly attached to the end of the source tool with the safety clip shown attached to the source

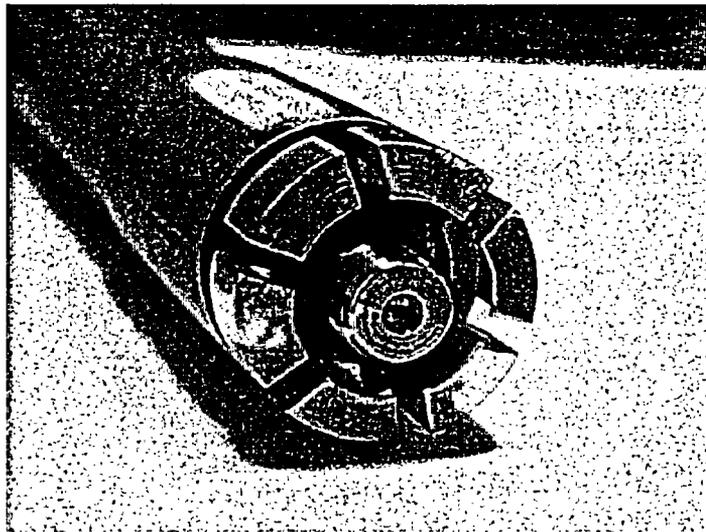
Figure 2.3.3 Detail showing the grasping fingers on the end of the source handling tool. The fingers fit over the beveled end of the source assembly and are then tightened by the operator to grasp the beveled end. The knob in the center is the plunger that is used to push the source off the tool when the fingers are released.
