**CROW BUTTE MINE
DAWES COUNTY, NEBRASKA**

2004 POND INSPECTION REPORT

By: David V. Coe, PE
Nebraska Registration No. E - 4295

October 27, 2004

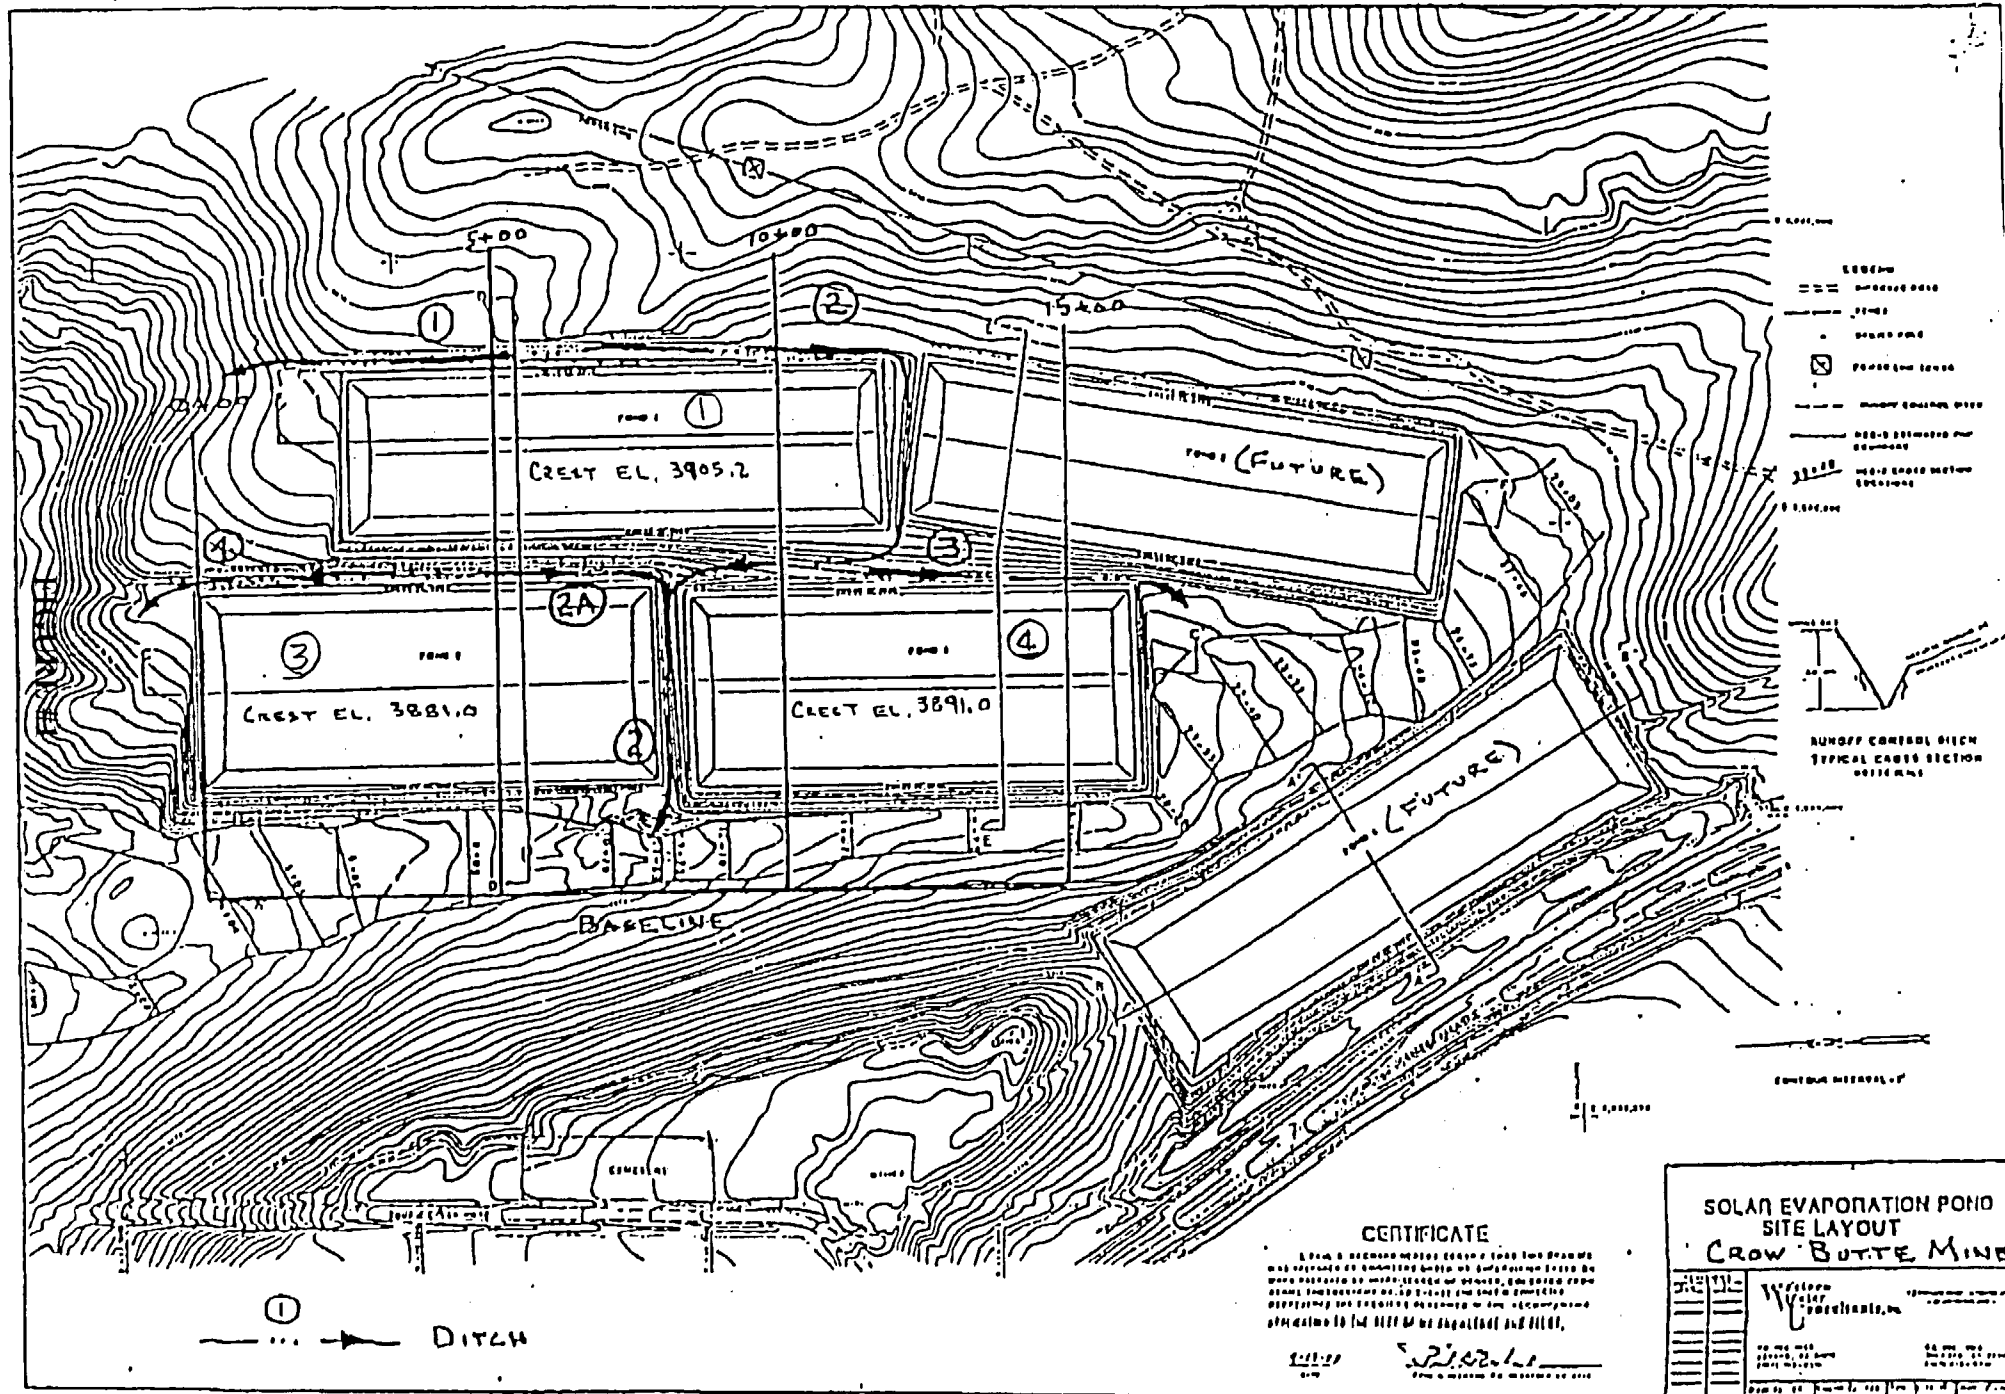
Figure 1 Commerical Pond Layout

An elevated underdrain conductivity level was detected on the northwest monitoring tube of Pond 1 in May, 2004. The causes of the leaks were small holes in the liner caused by the apparent abrasion on the liner from the spray system. The spray system probably rubbed against the liner during windy weather. A repair of the pond liner was accomplished and the conductivity level reduced to an acceptable level. The monitoring tubes were flushed with fresh water a many times after the liner was repaired. The records indicate the pond liner was repaired and a report was file with Nebraska Department of Environmental Quality August 13, 2004. This is the third consecutive year Pond #1 has had a leaking problem. The leaks seem to appear after the pond depths exceed the 9 foot depth in Pond #1. The aeration system has been blamed for the principle cause of the leaks.

There has been a line leak in pond #1 the last three years. The leak has occurred in the northwest corner of the pond and the aeration system seems to be the cause of the liner damage. An aeration system with a more secure anchor system may prevent future liner damage. High wind activity on this pond must cause the aeration system to drift to the northwest corner of the pond. Most of the aeration systems have been removed from the ponds. A new and different aeration system is being considered by Crow Butte Resources. A new system will probably reduce the chances of liner damage and leaks. Vegetation was in good shape. Mowing of the embankment slopes may cause more damage to the slope than improvement in the vegetative cover.
